MESA PROJECT REVIEW CHECKLIST

Brook Street over Nashoba Brook – Bridge #A-02-009

# PHASE I- PRELIMINARY REPORT

Summary of Conditions and Recommendations for the  
Repair/Rehabilitation of Town Owned Bridges

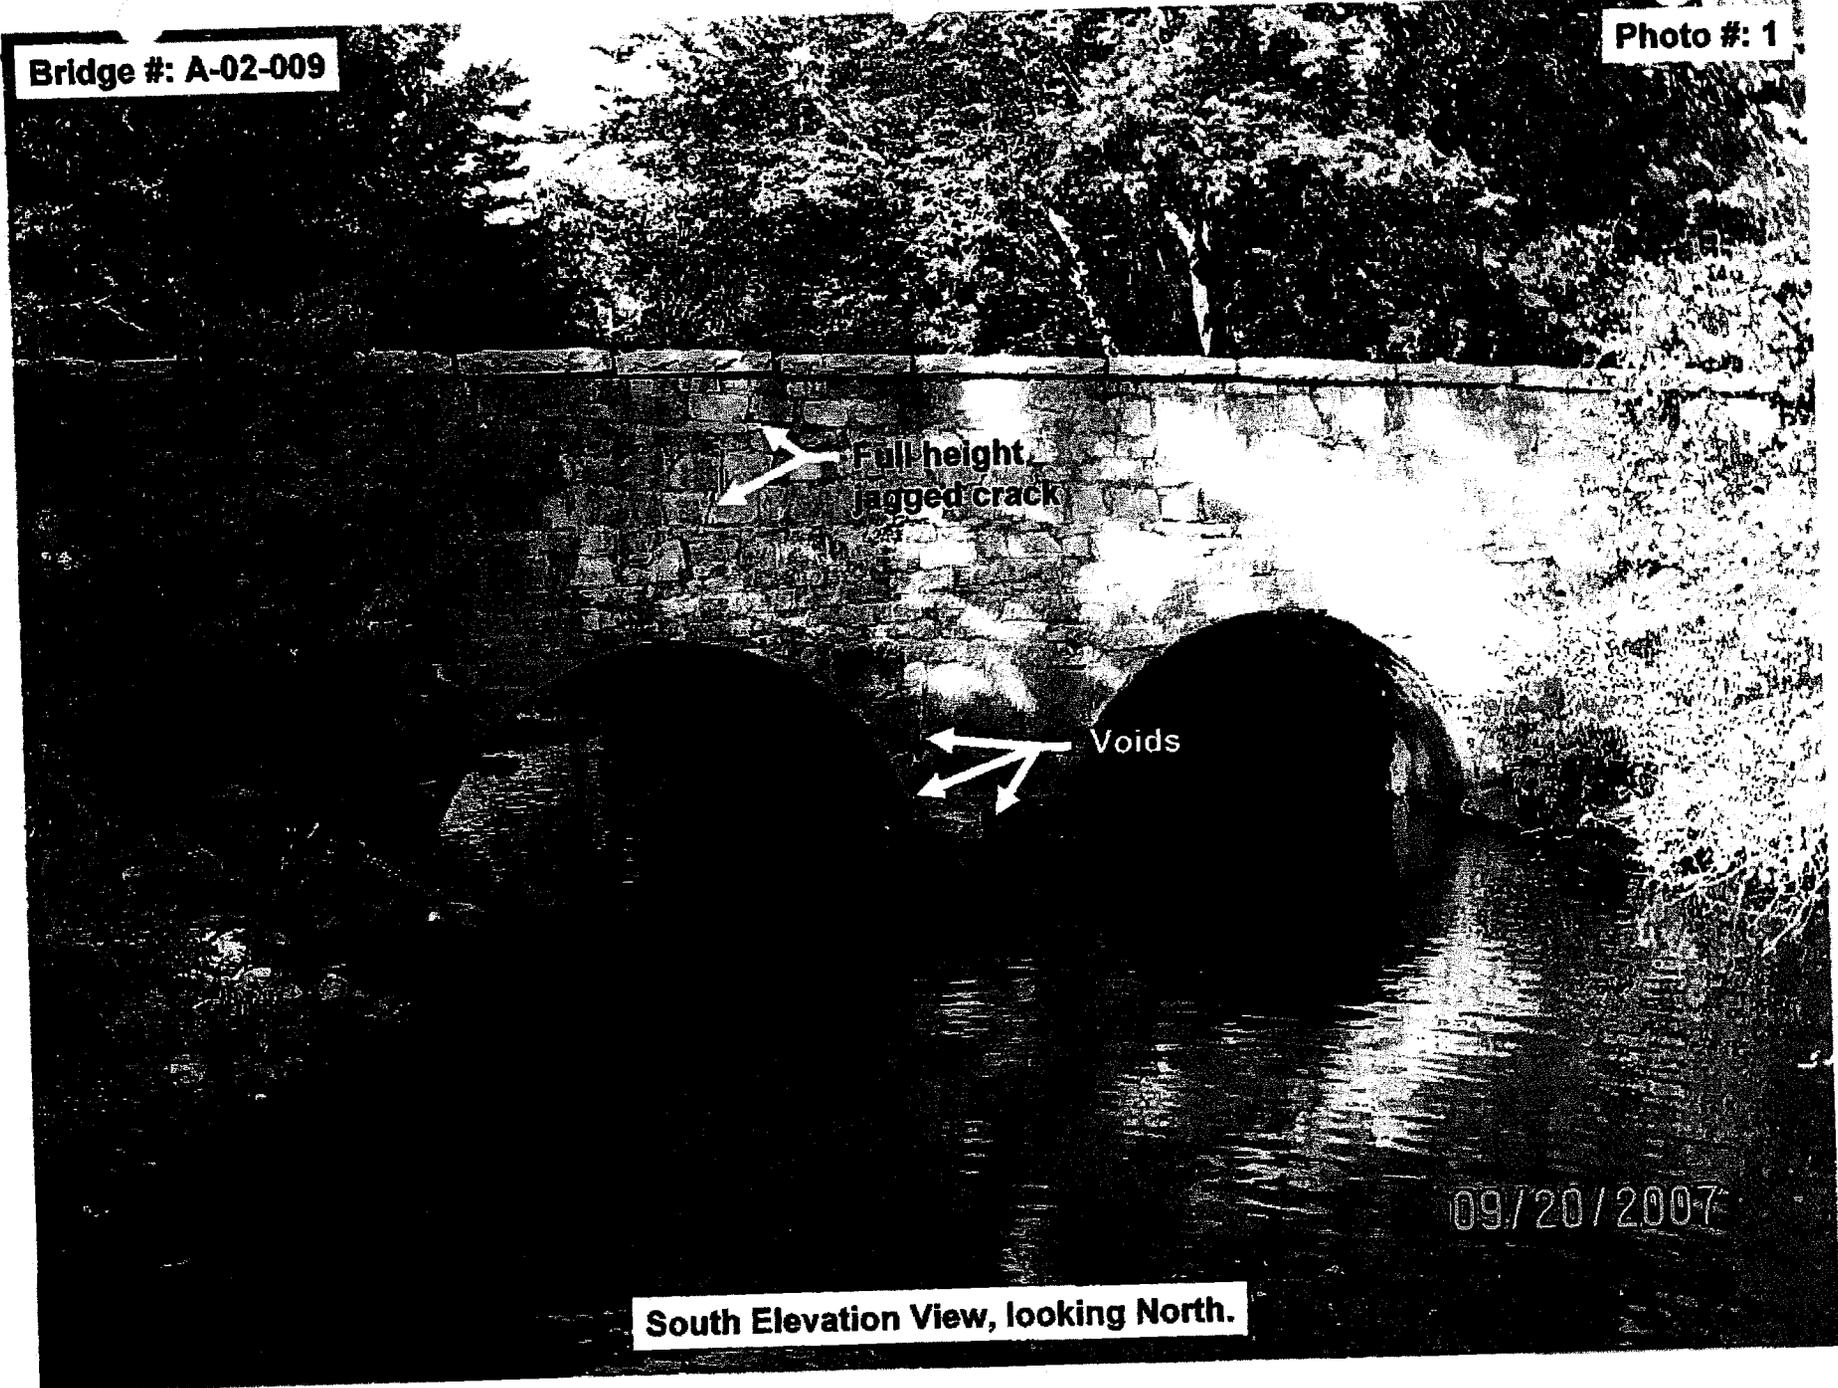
**Photo #: 2**

South Elevation View, looking North.

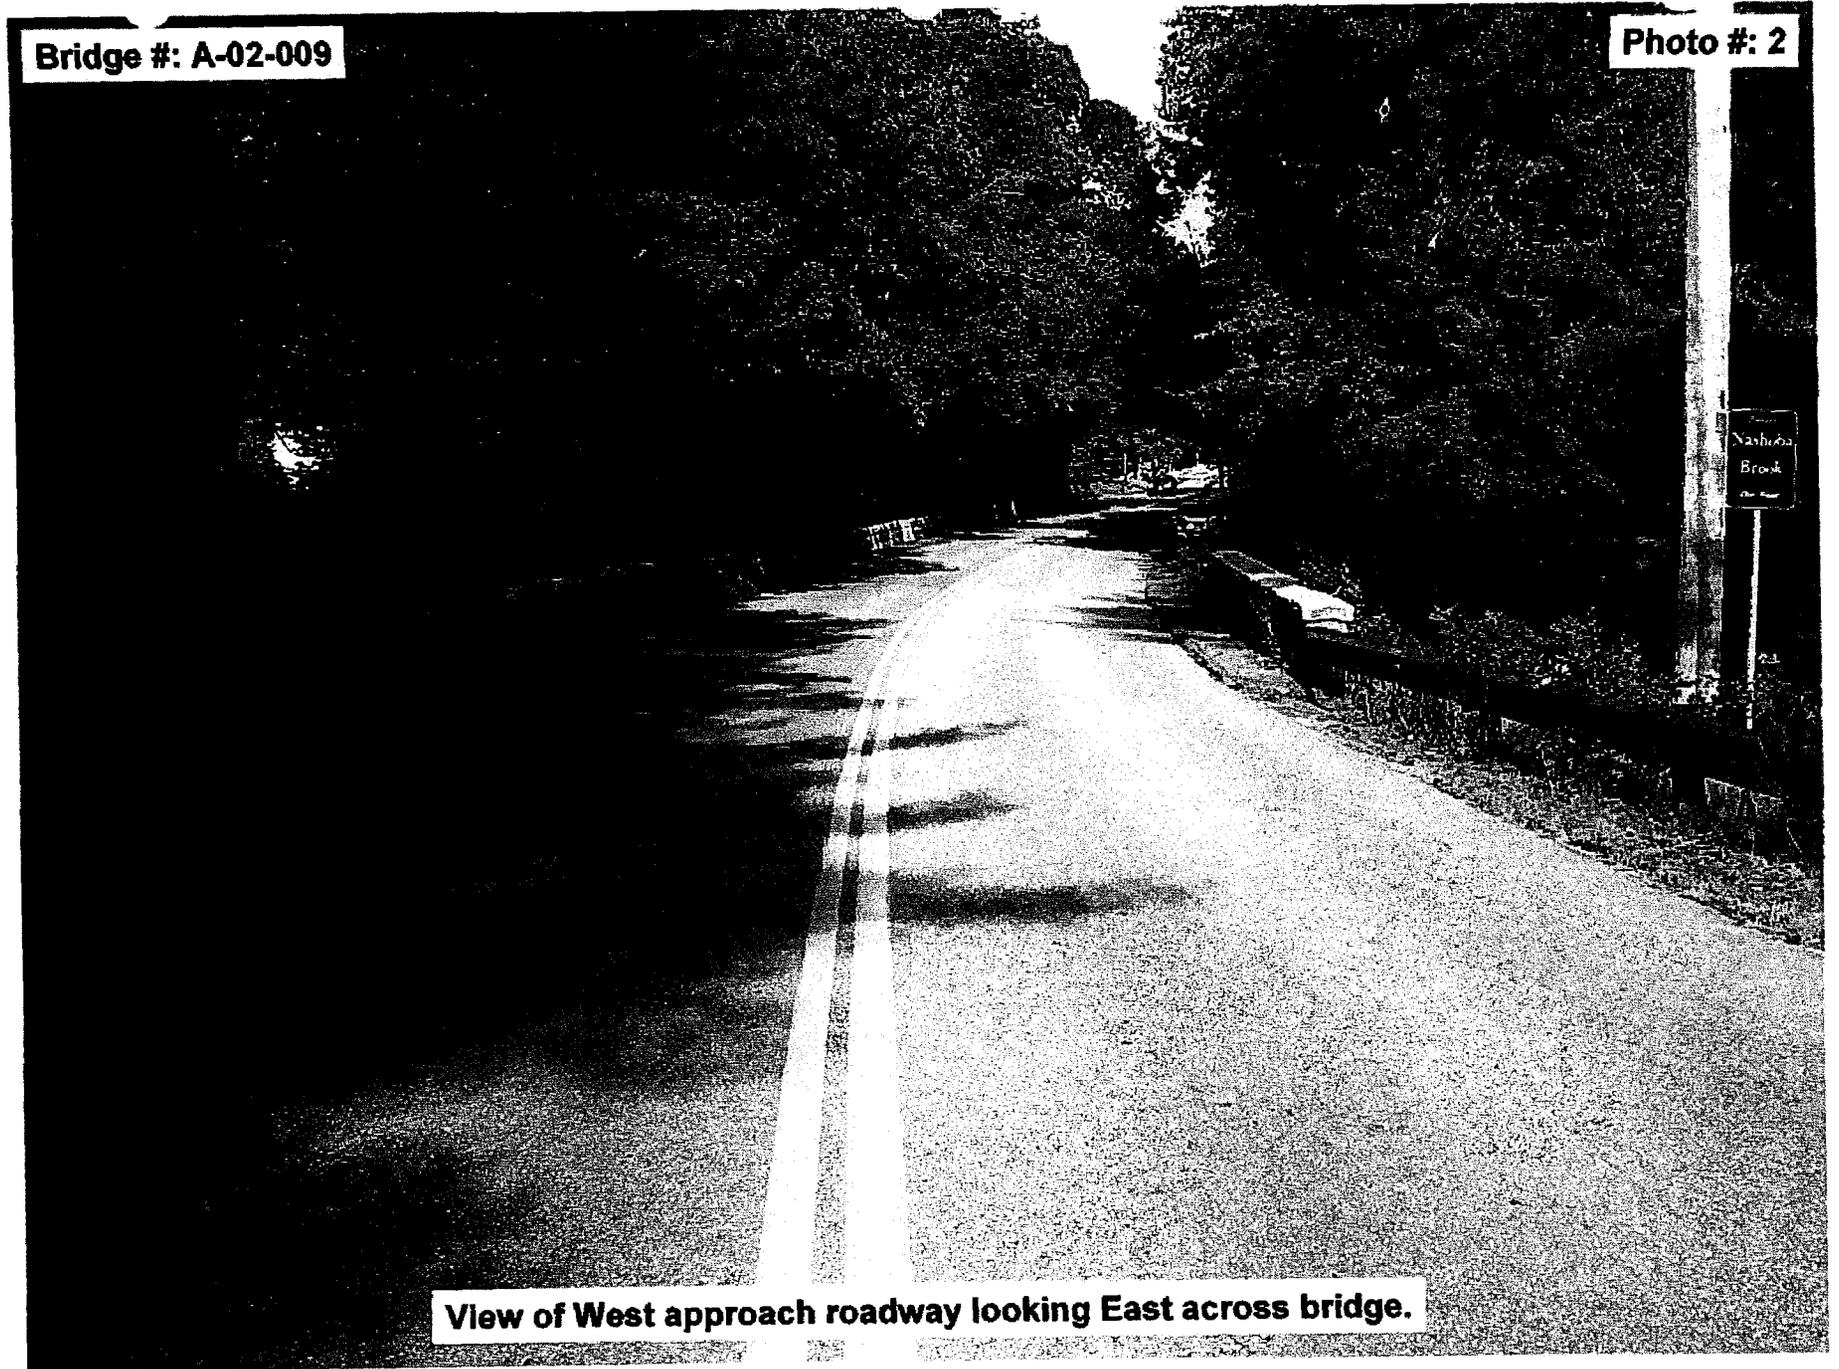
**View of West approach roadway looking East across bridge.**

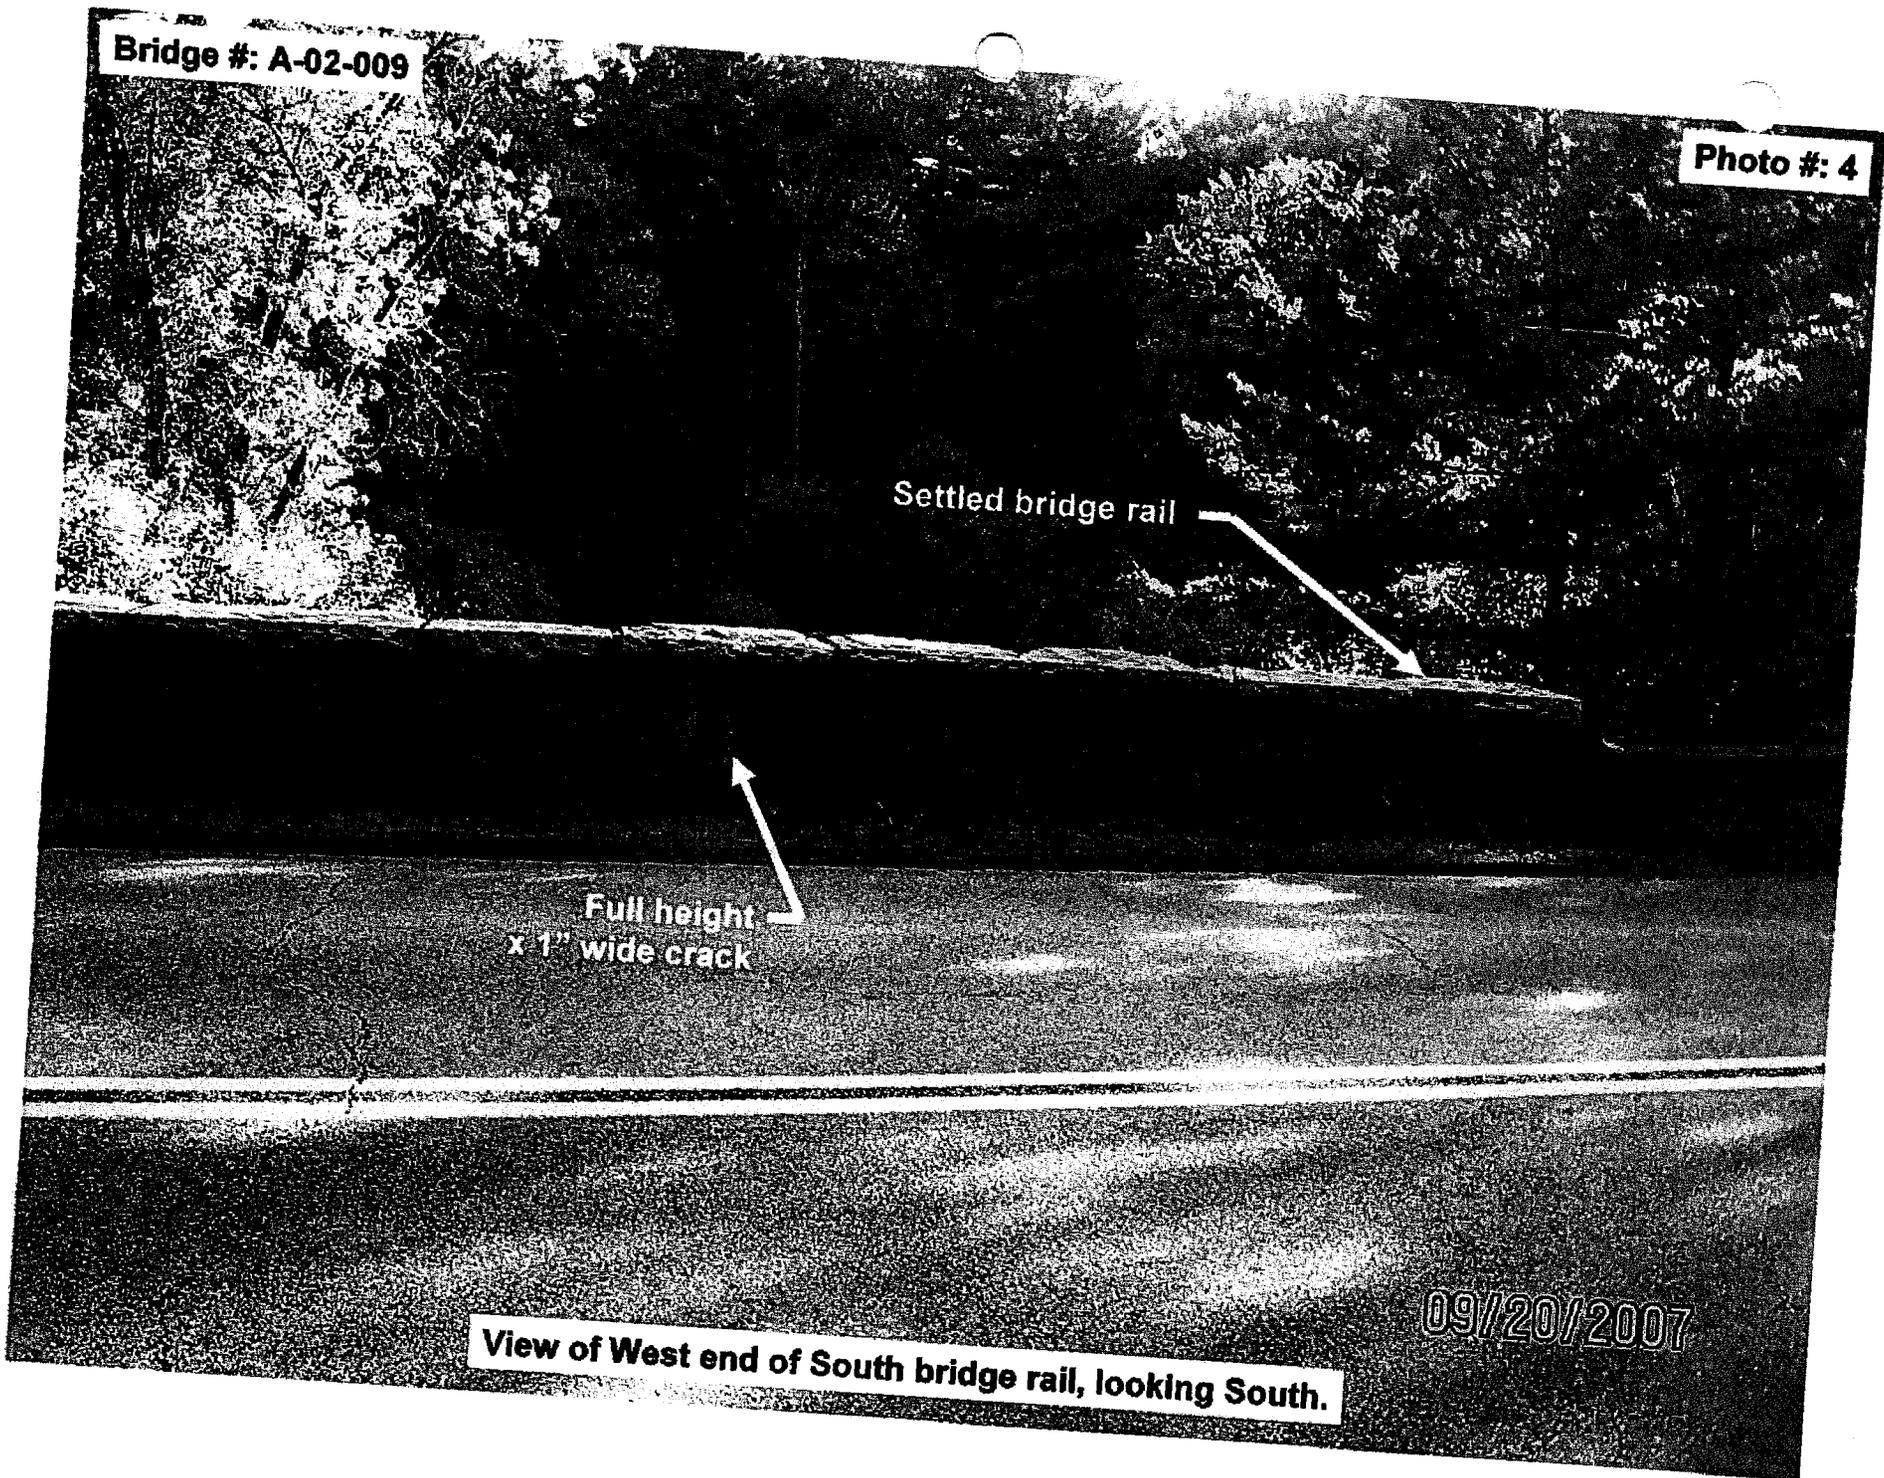
Photo #: 5

| Element | Deficiency | Reference Photo(s) |
|---|---|---|
| | • Wide crack in mortar in South bridge rail over West barrel that measures FH x up to 1"W, located approximately 12'-0" from the West end | |
| | • West end of South bridge rail is settled several inches beginning at the crack over the West barrel | 4 |

Full height  
x 1" wide crack

View of West end of South bridge rail, looking South.

| Element & Location | | Deficiency | Repair Needed | Priority |
|---|---|---|---|---|
| #3 | North and South bridge rail | Hairline to narrow cracks in mortar | Repoint stones as needed | Low |

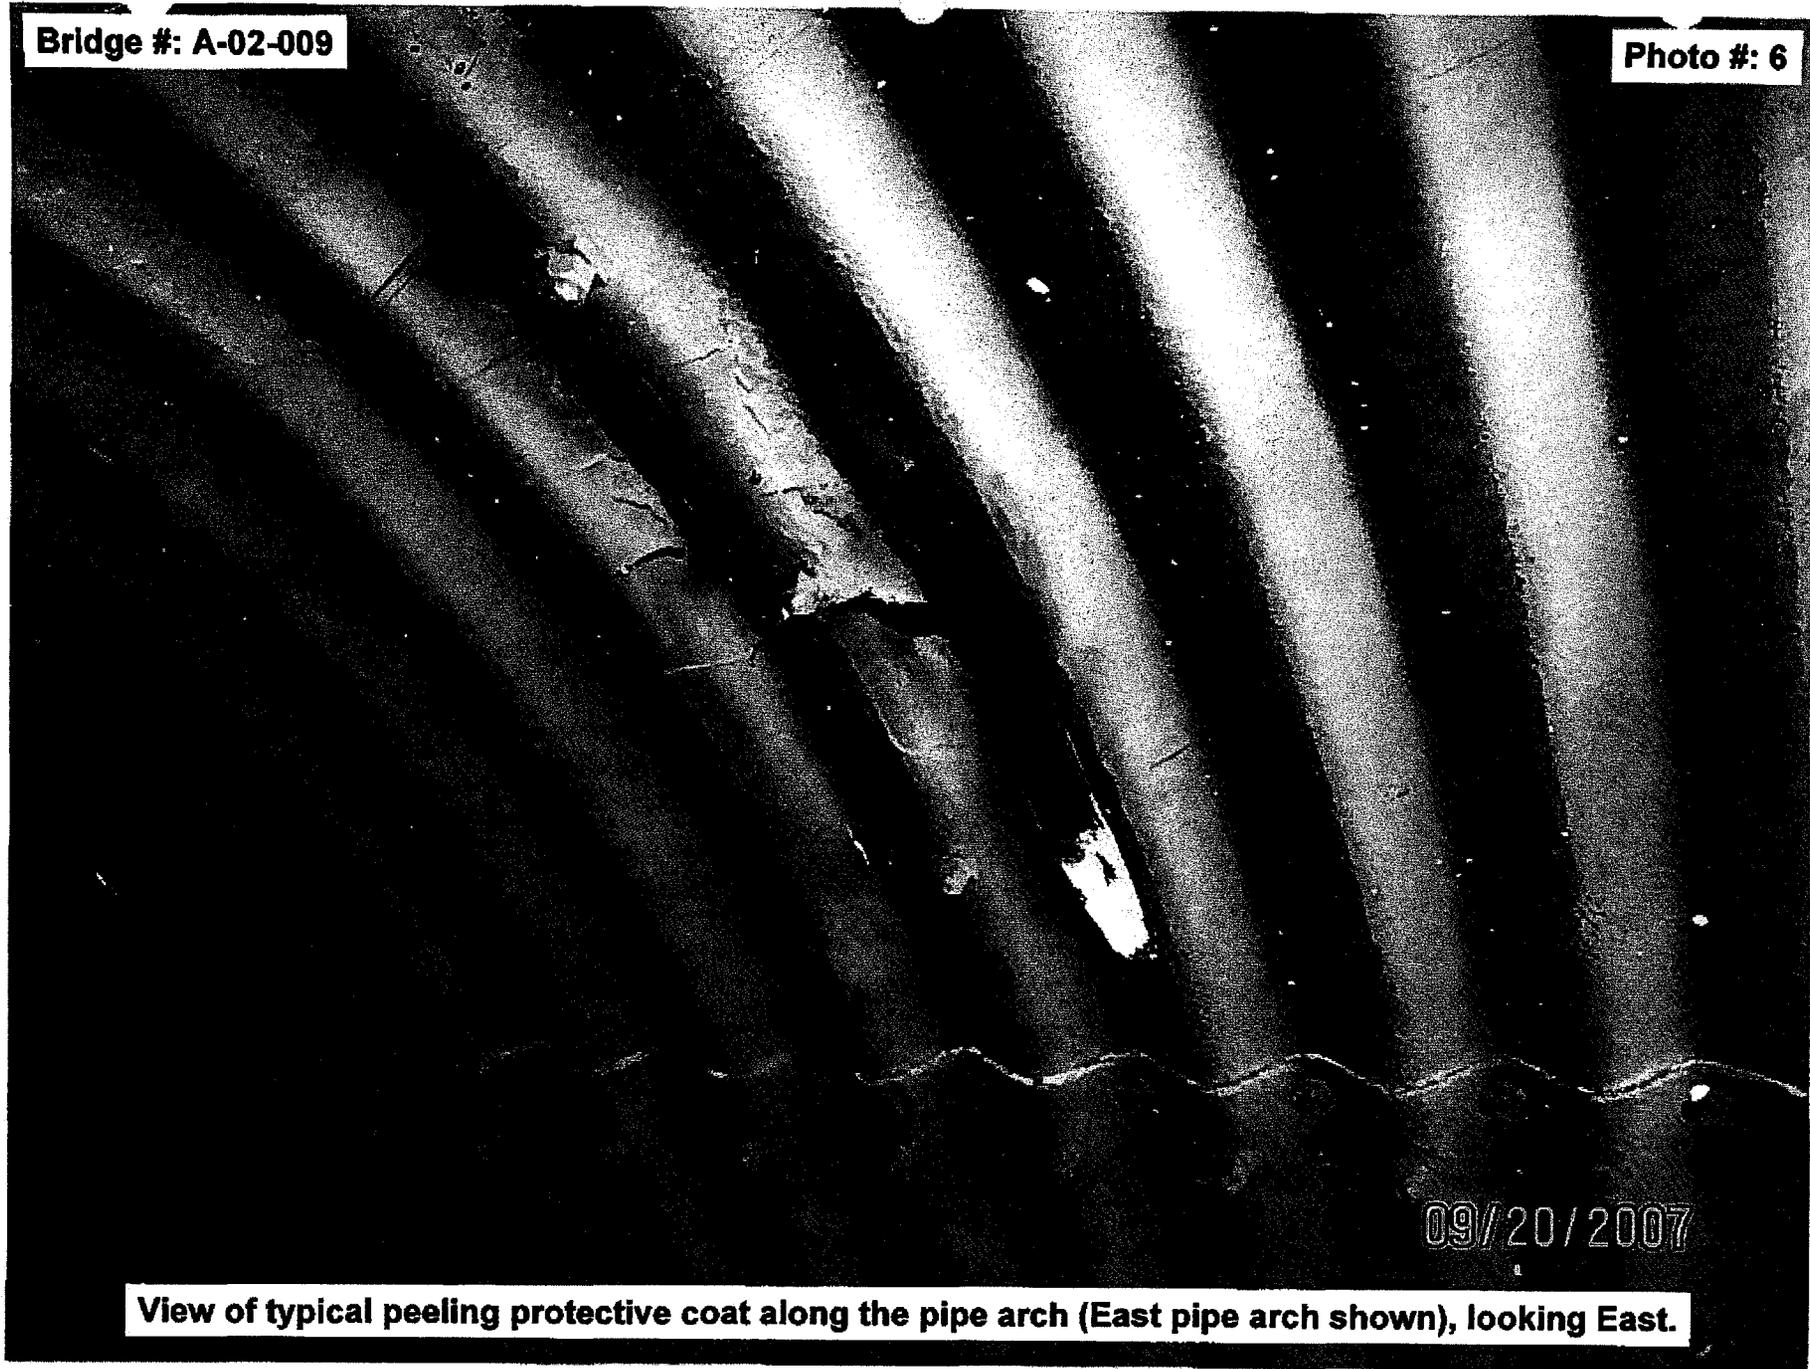
Photo #: 6

View of typical peeling protective coat along the pipe arch (East pipe arch shown), looking East.

| Element & Location | | Deficiency | Repair Needed | Priority |
|---|---|---|---|---|
| #4 | Protective coating of steel barrels | Cracking and peeling throughout | Clean and place new protective coating | High |

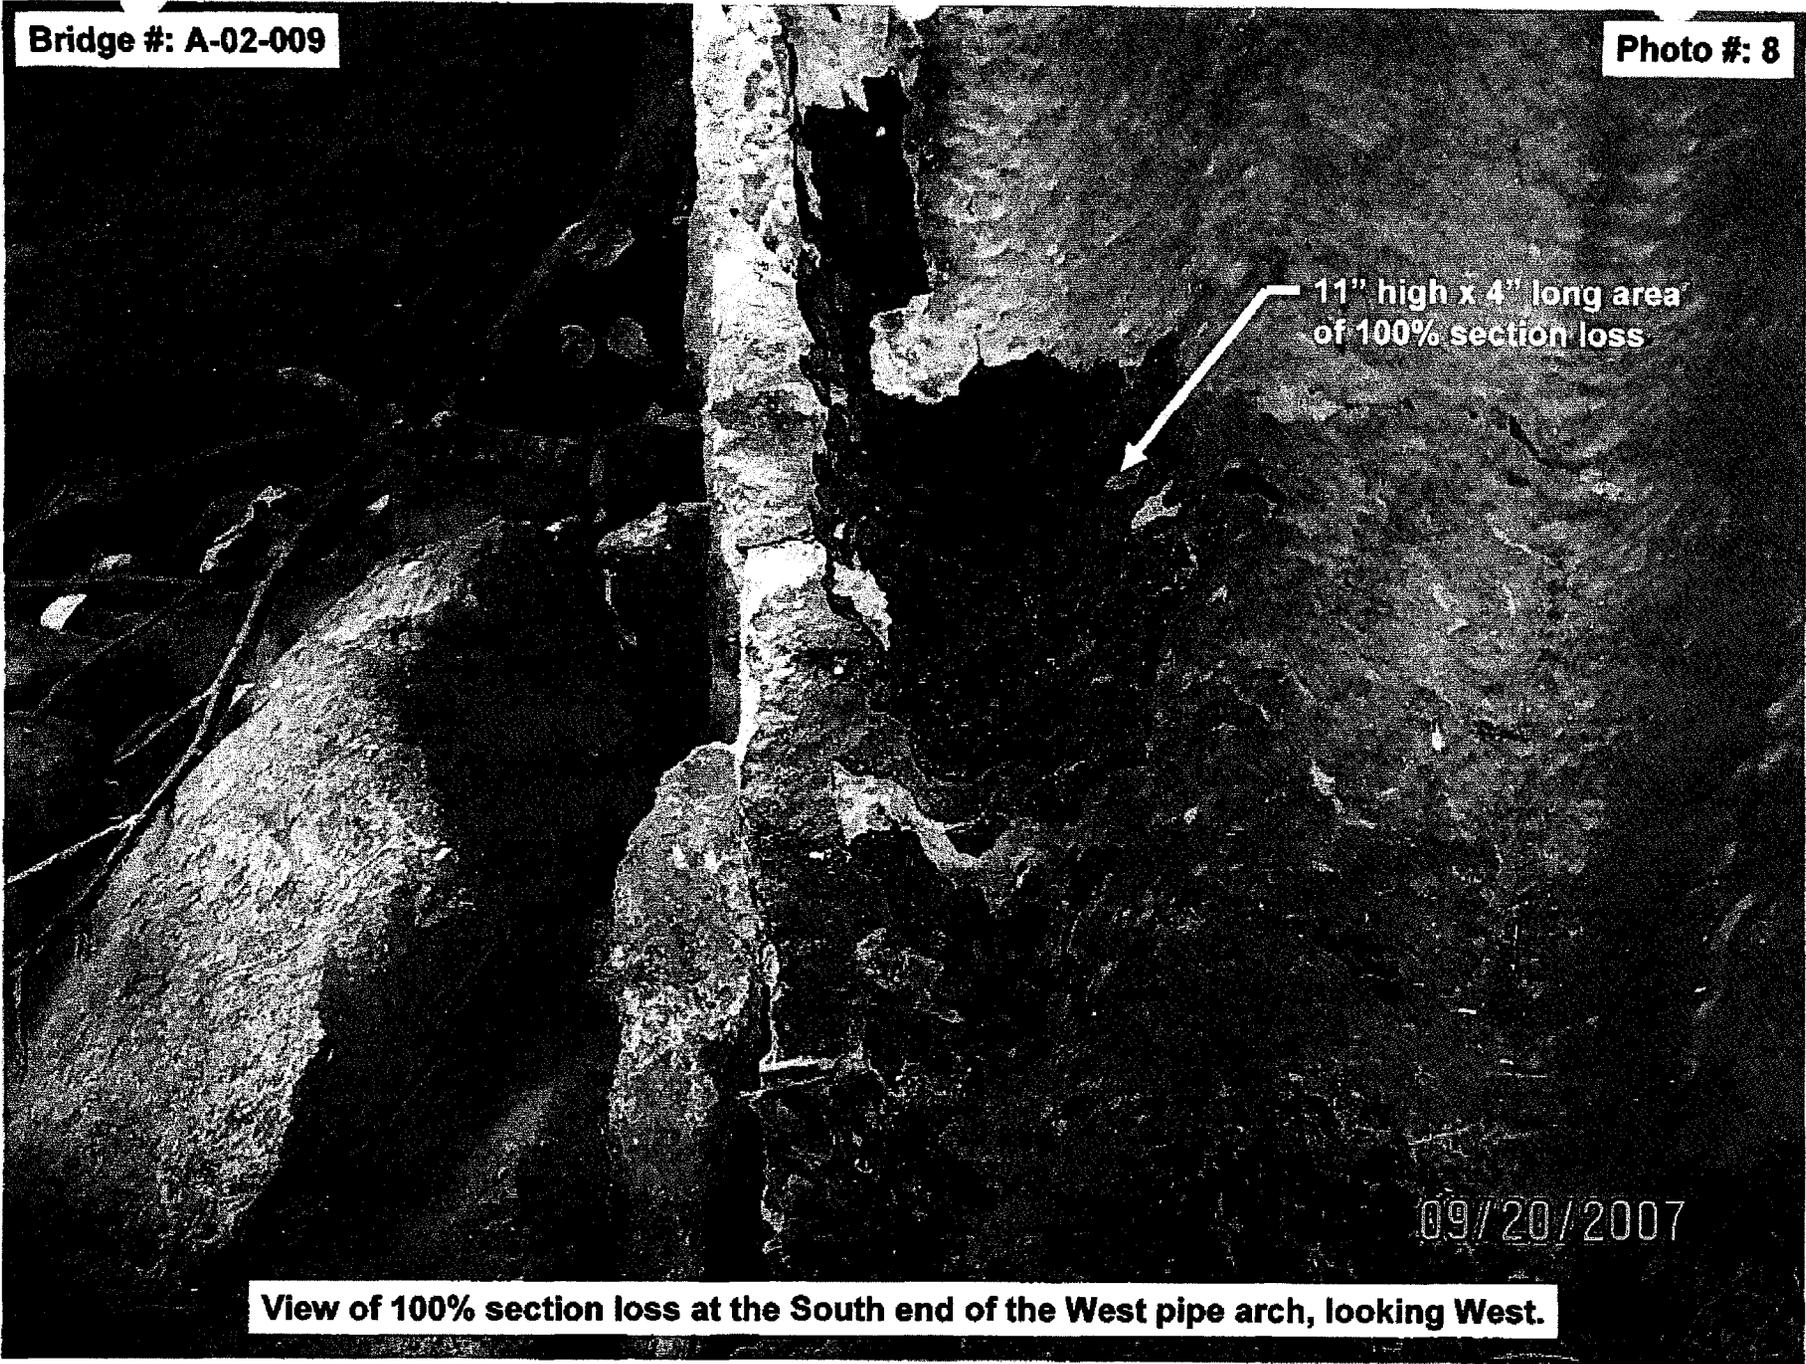
View of 100% section loss at the South end of the West pipe arch, looking West.

| Element & Location | | Deficiency | Repair Needed | Priority |
|---|---|---|---|---|
| #6 | South end of West barrel, East side | 100% Section loss | Remove deteriorated steel | High |

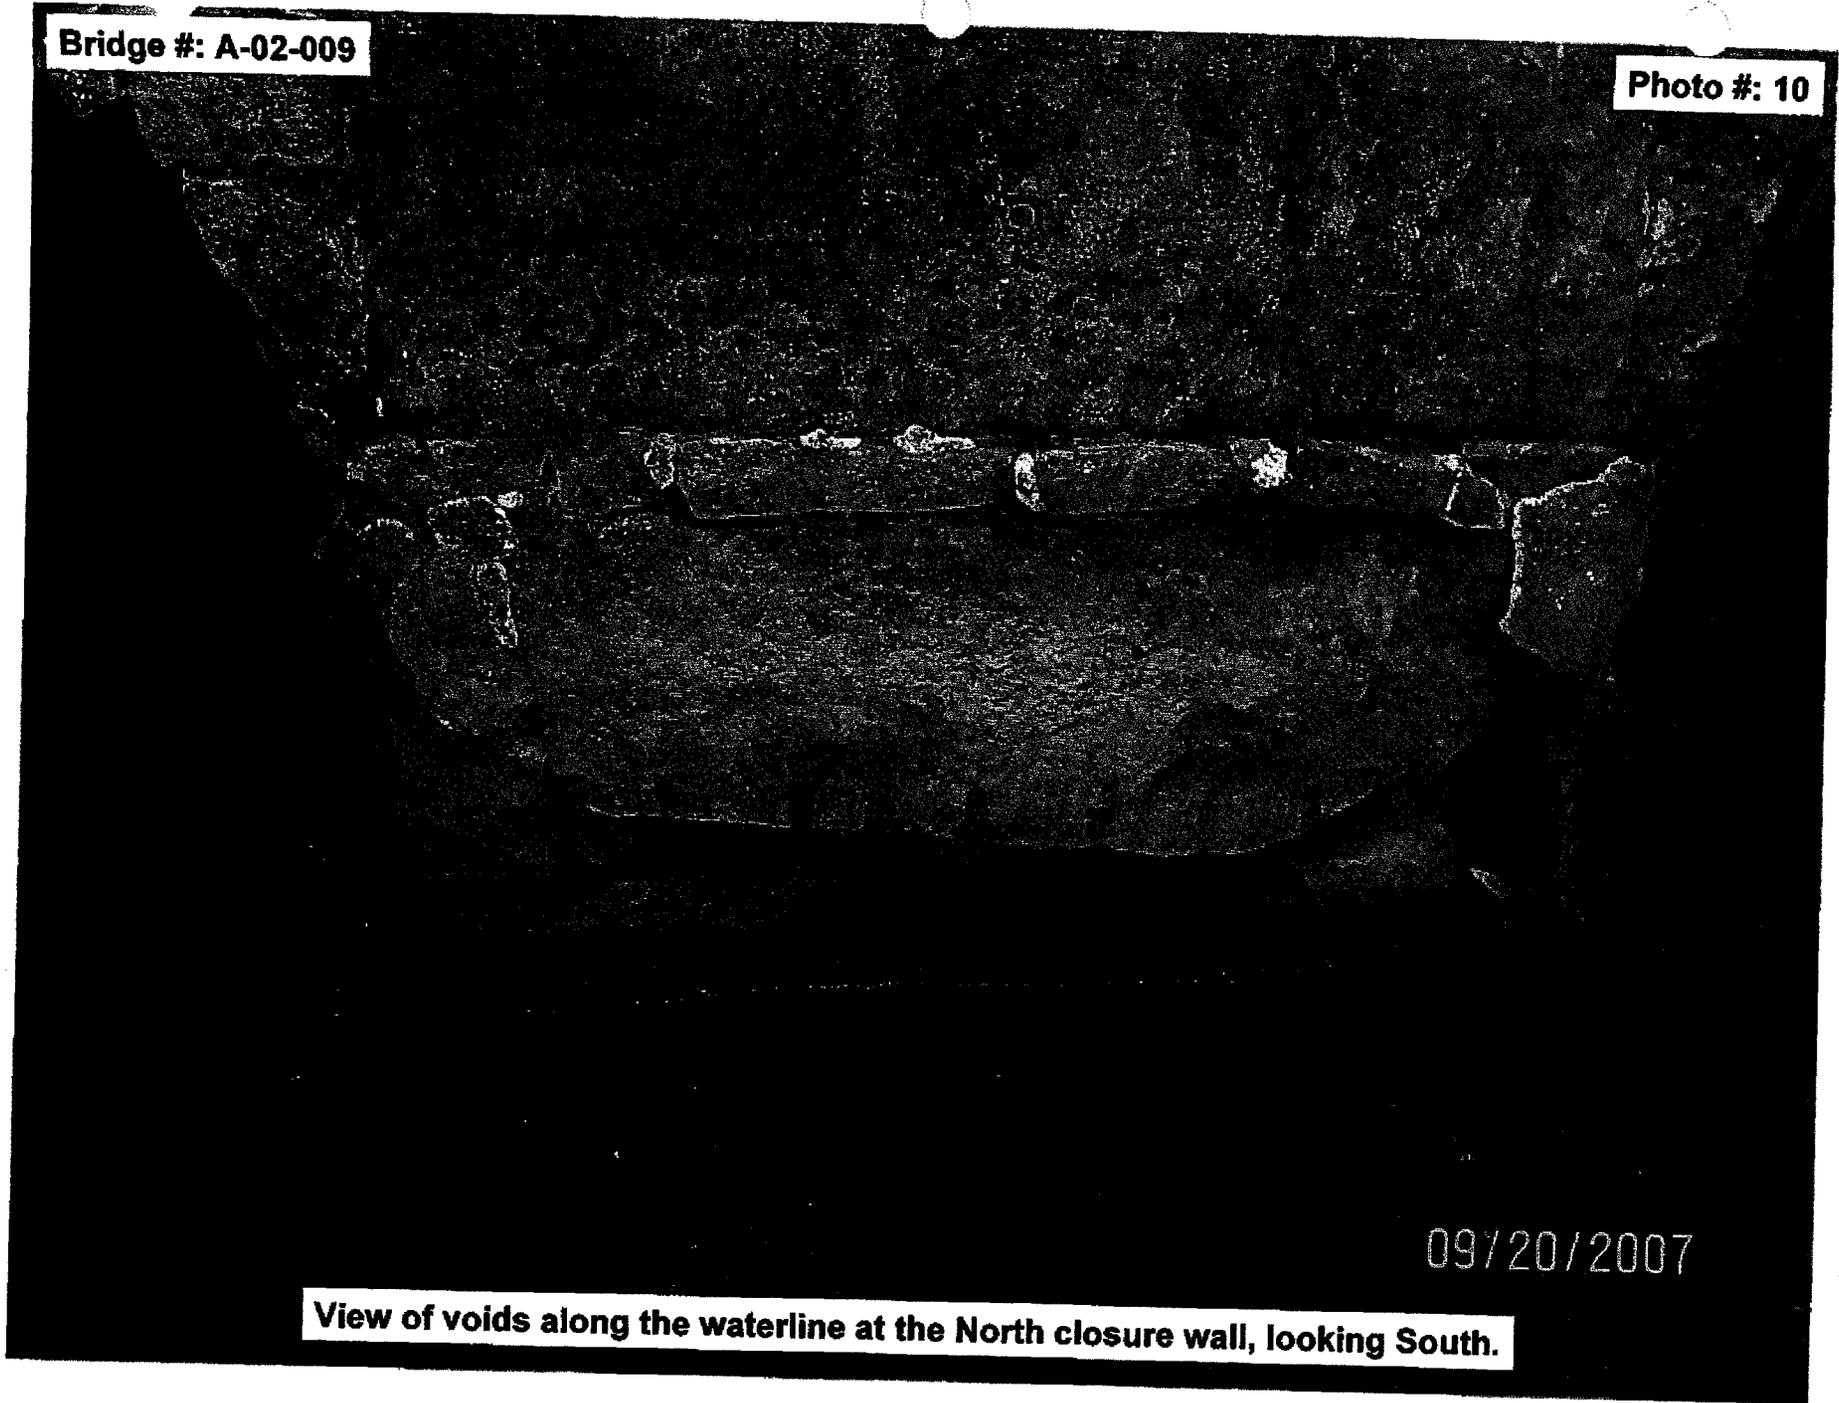
**Photo #: 11**

View of voids along the waterline at the North closure wall, looking South.

| #10 | South headwall around barrels | Voids | Fill holes/voids with concrete | Moderate |

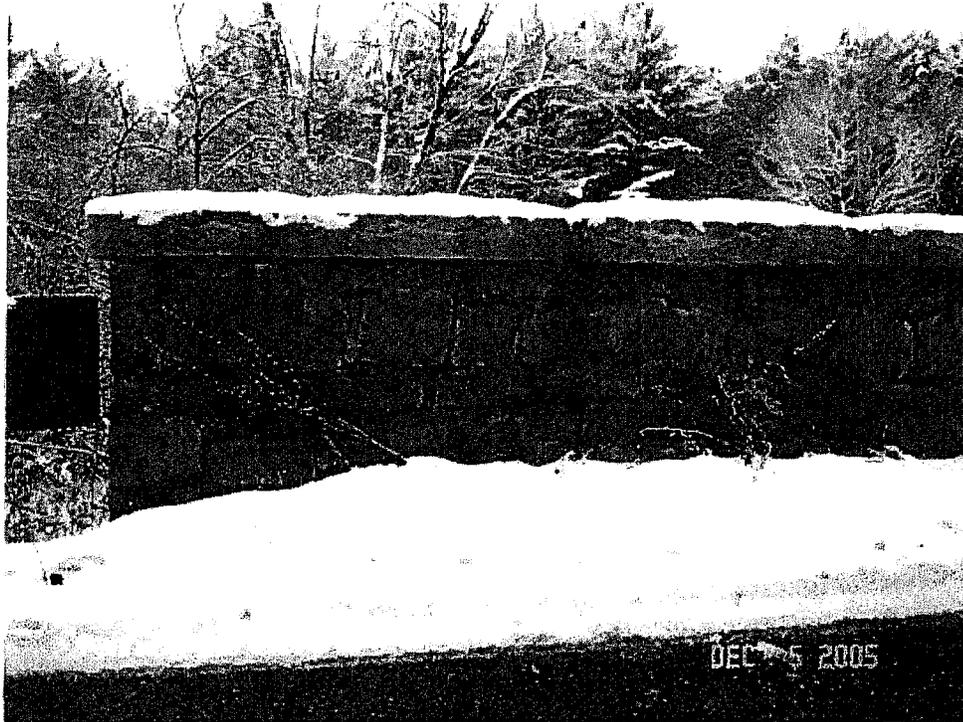
**Photo 1: Northeast bridge rail.**

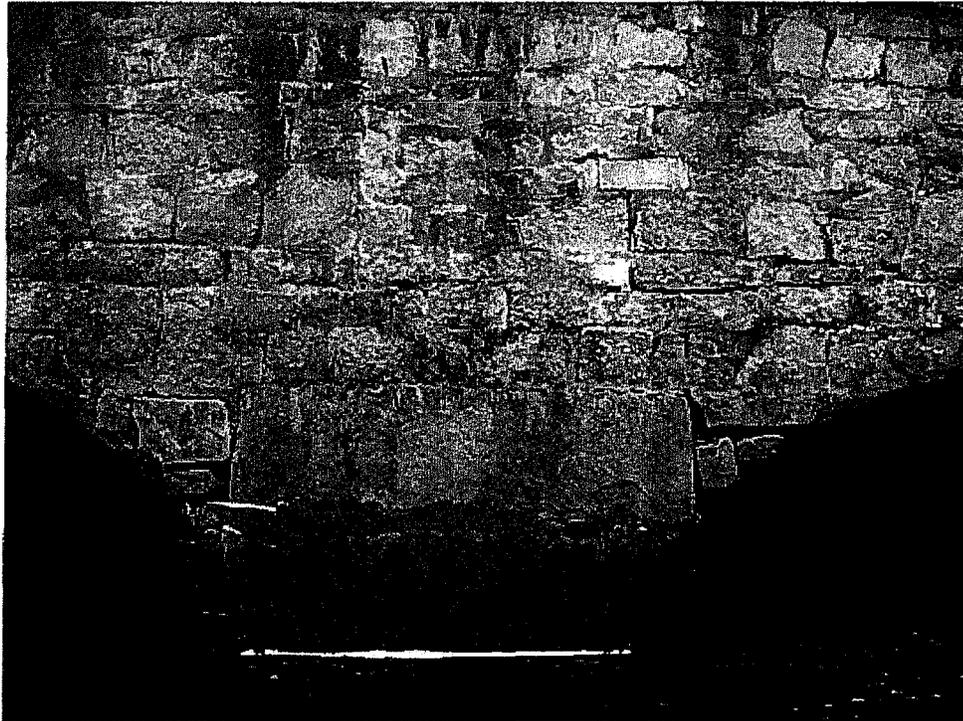
**Photo 3: North headwall.**

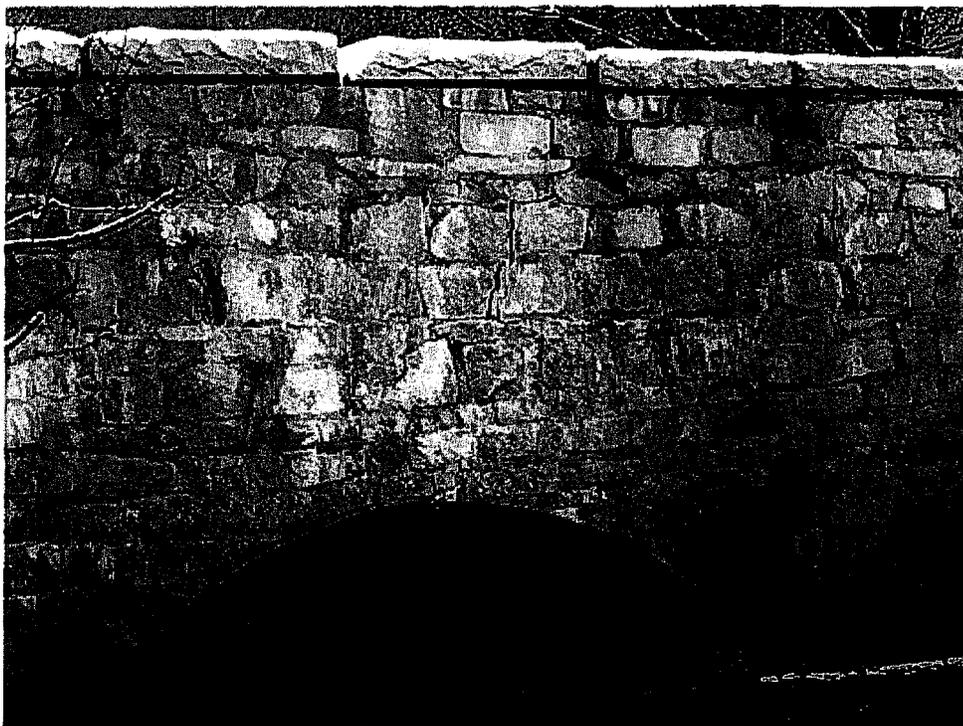
were measured to be up to 30 in. deep. There are areas of hairline surface efflorescence in the mortar joints below the street surface in the south headwall primarily on the east side of culvert 2. There is a wide crack in the mortar joints located above culvert 1 and extending vertically from the cap stone to the keystone area. (See Photo 4.)

**Photo 4: South end of culvert 1.**
