# PHASE I- PRELIMINARY REPORT

## Town of Acton

### Summary of Conditions and Recommendations for the Repair/Rehabilitation of Town Owned Bridges

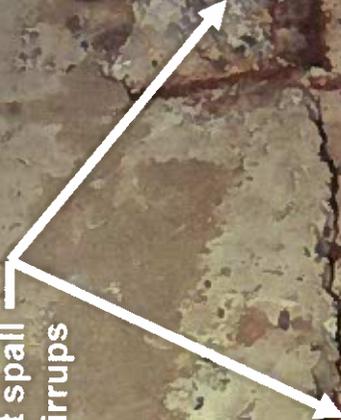
View of the East face of Beam #5 at the North end, looking North.

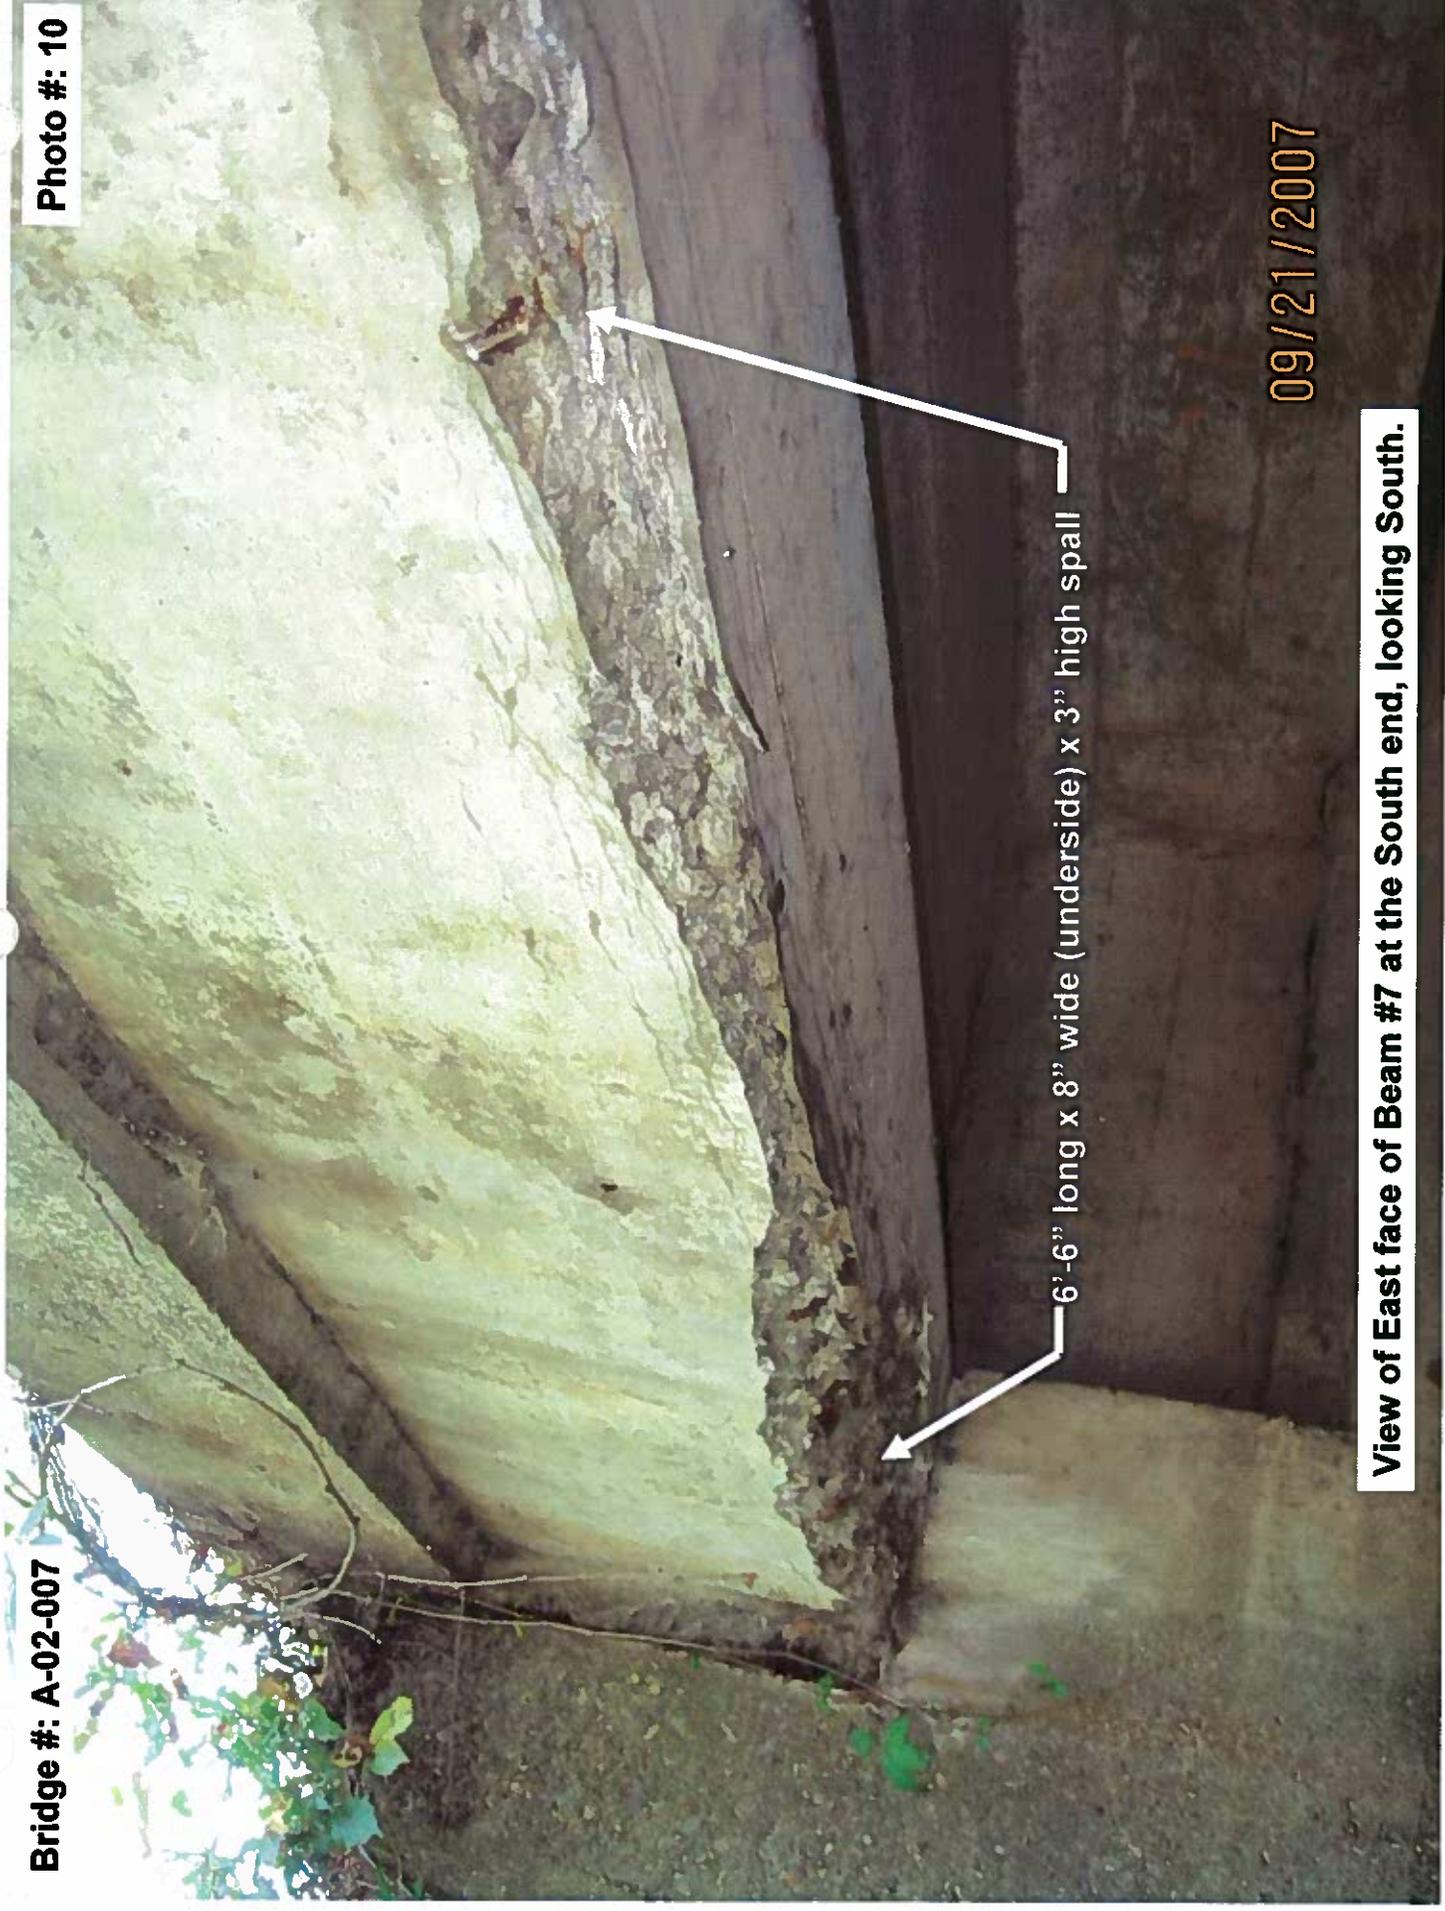
6'-6" long x 8" wide (underside) x 3" high spall

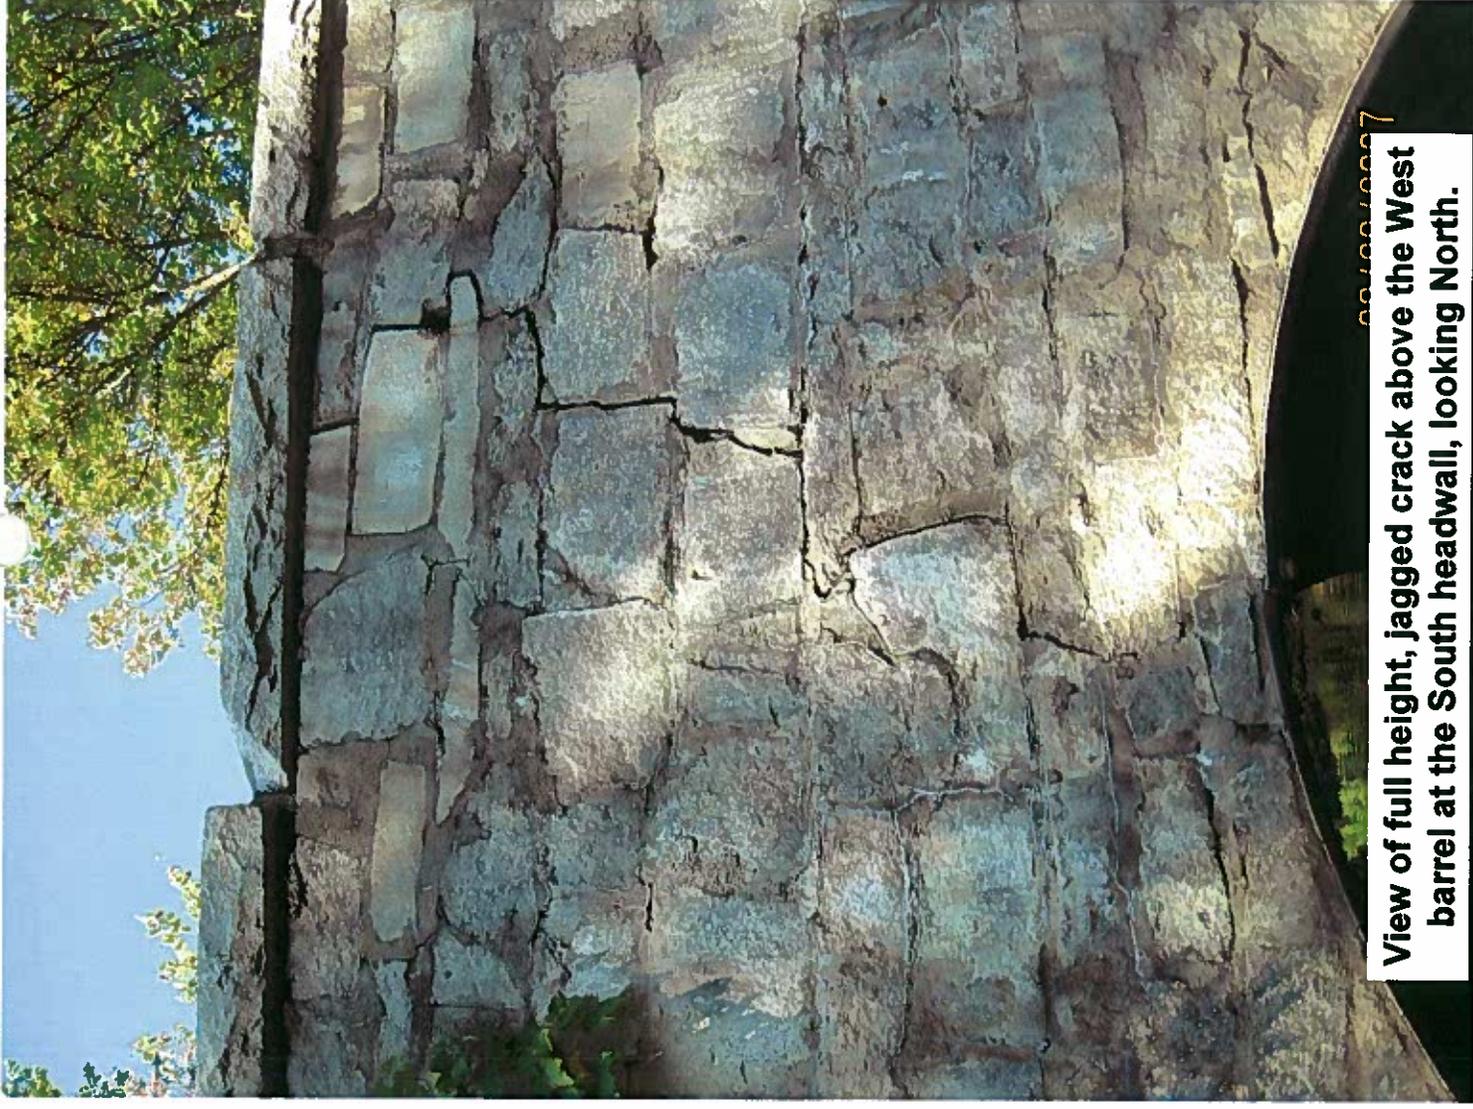
**View of full height, jagged crack above the West barrel at the South headwall, looking North.**

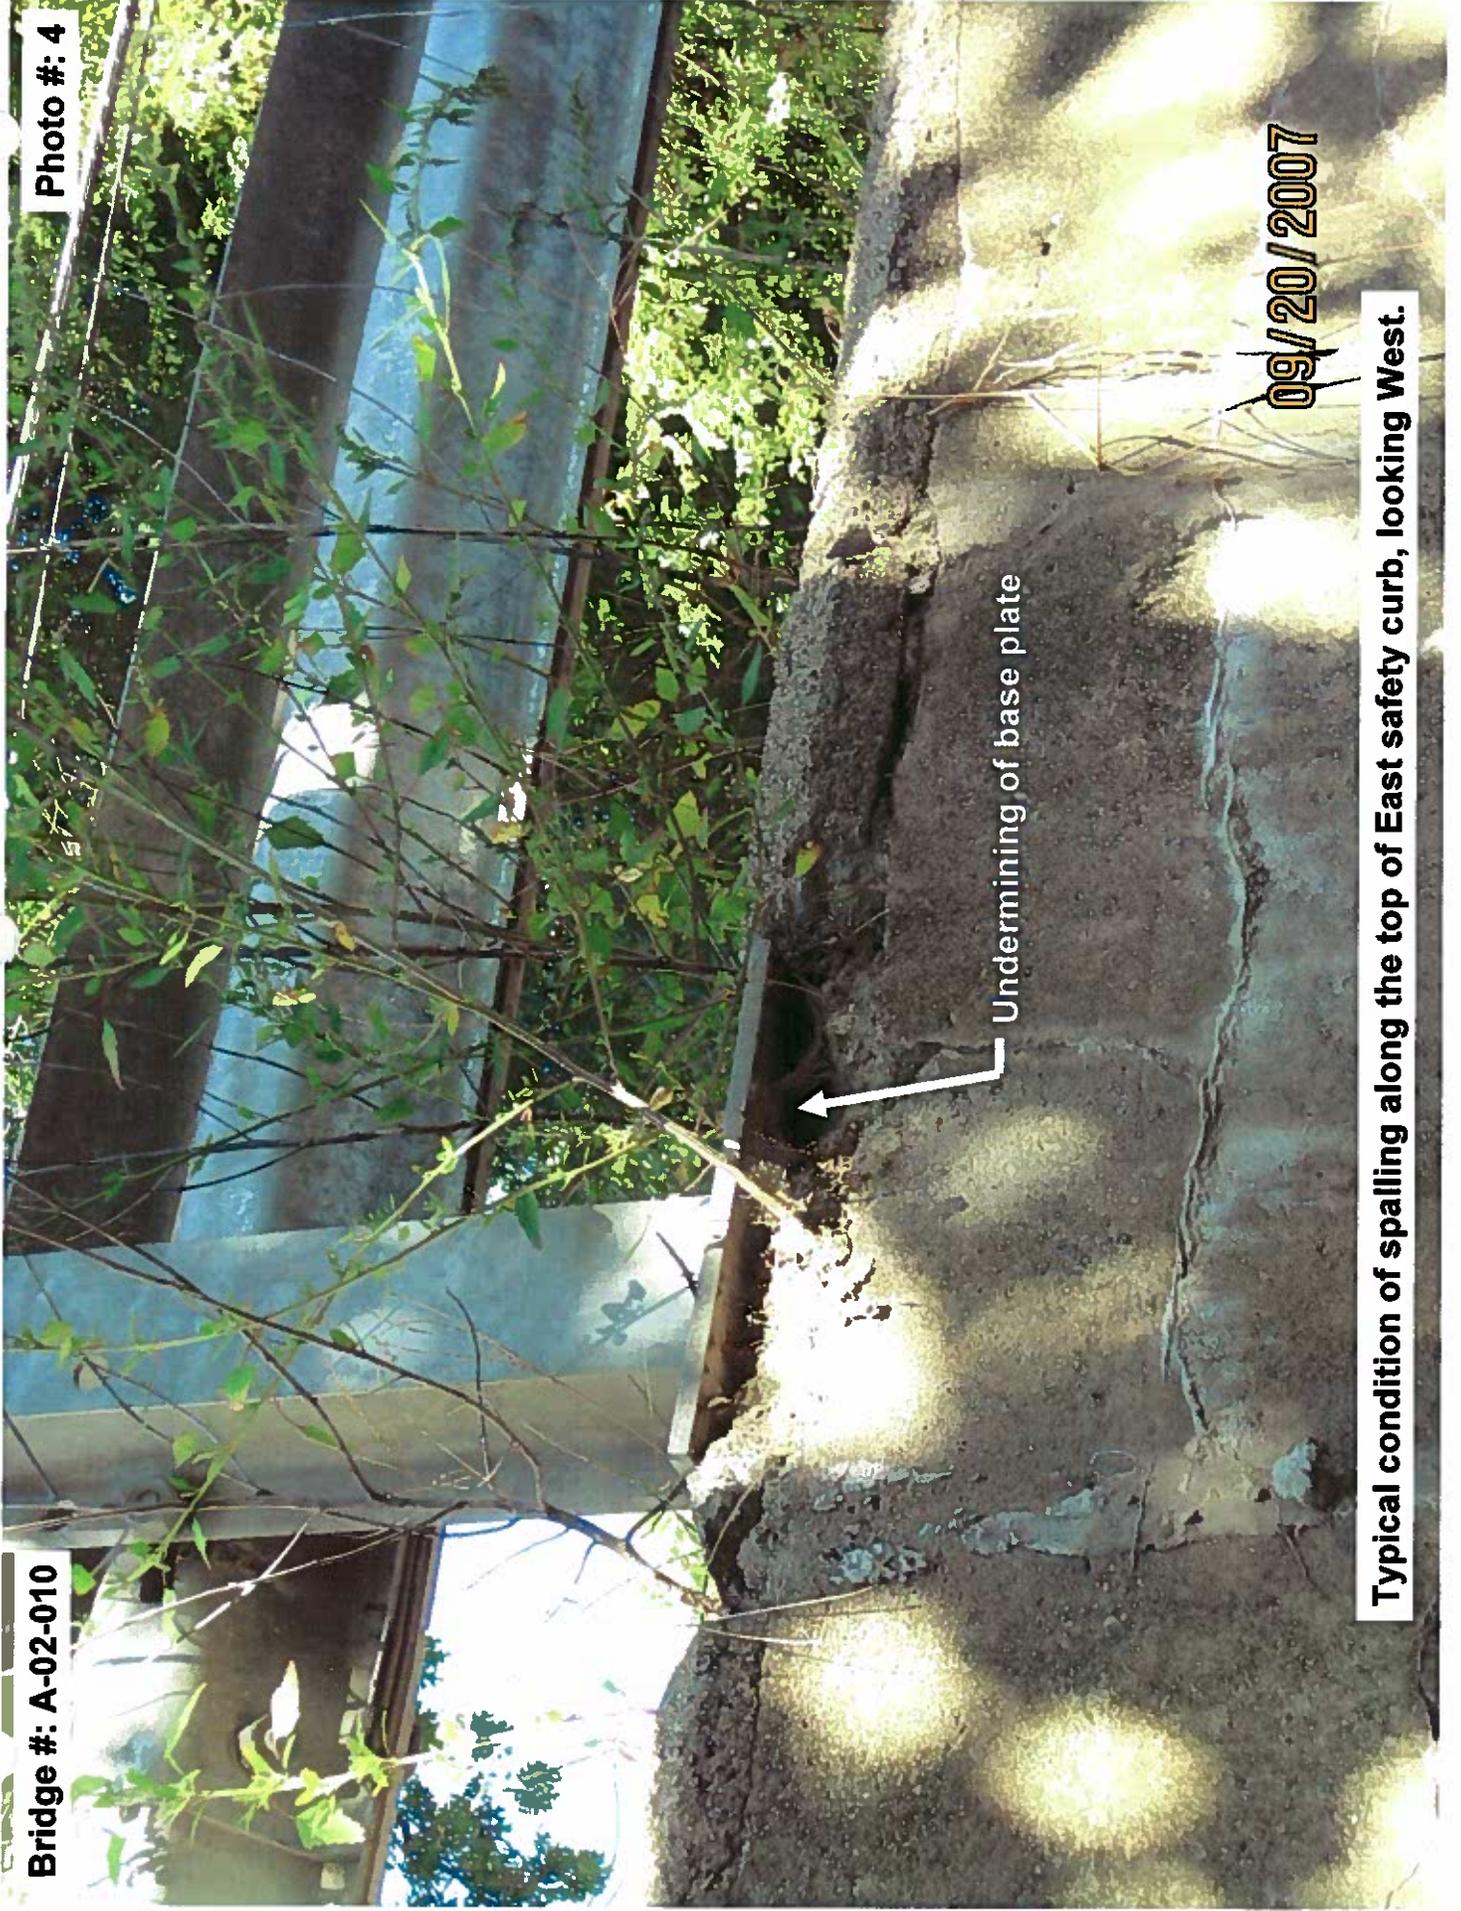
Typical condition of spalling along the top of East safety curb, looking West.

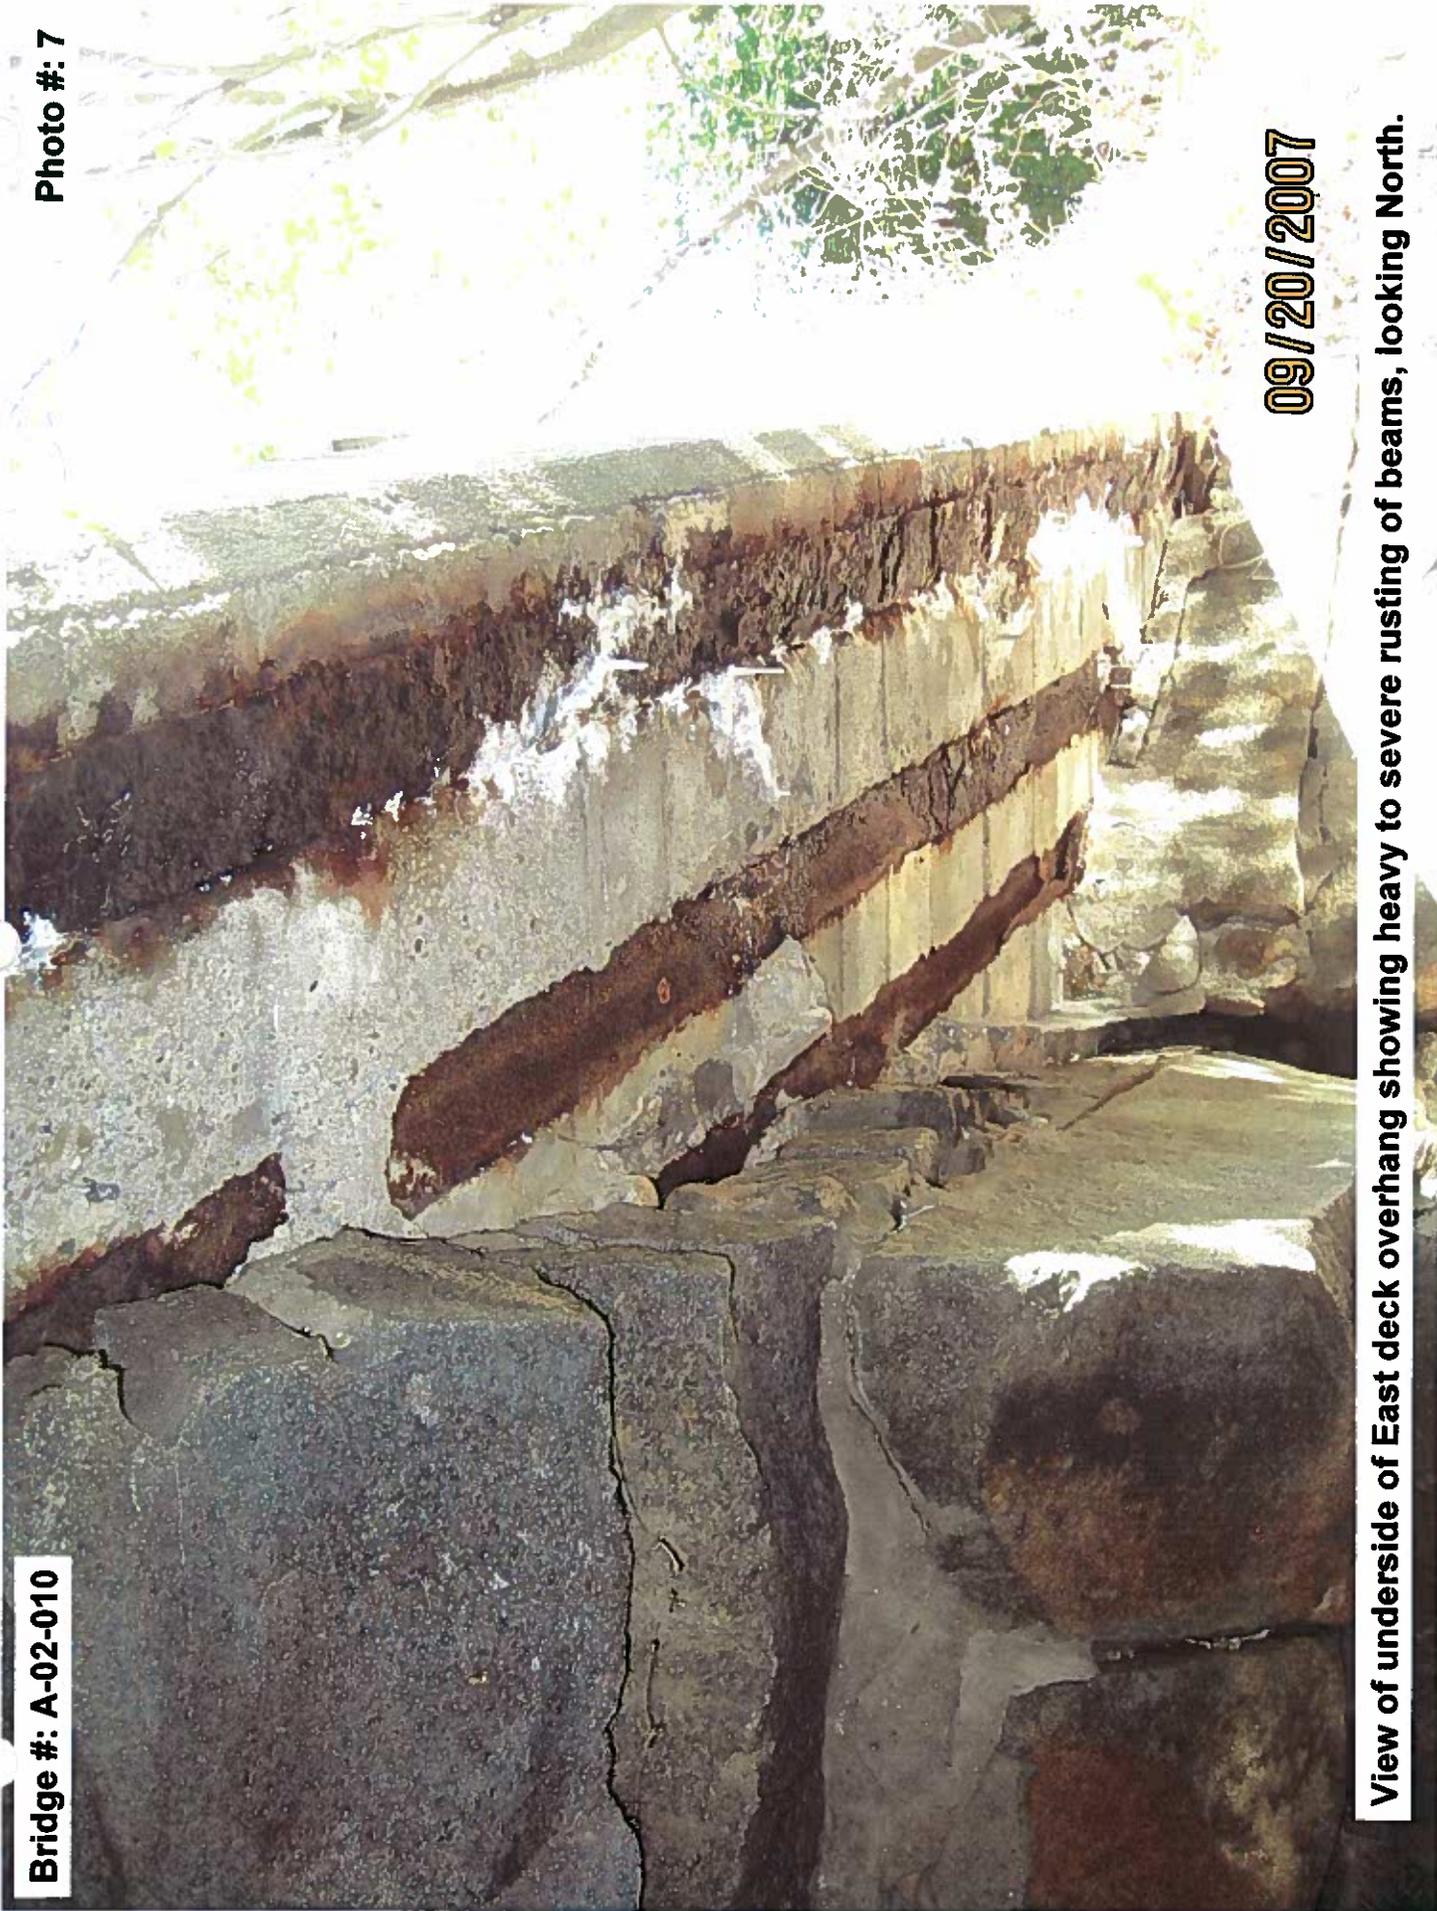
View of underside of East deck overhang showing heavy to severe rusting of beams, looking North.

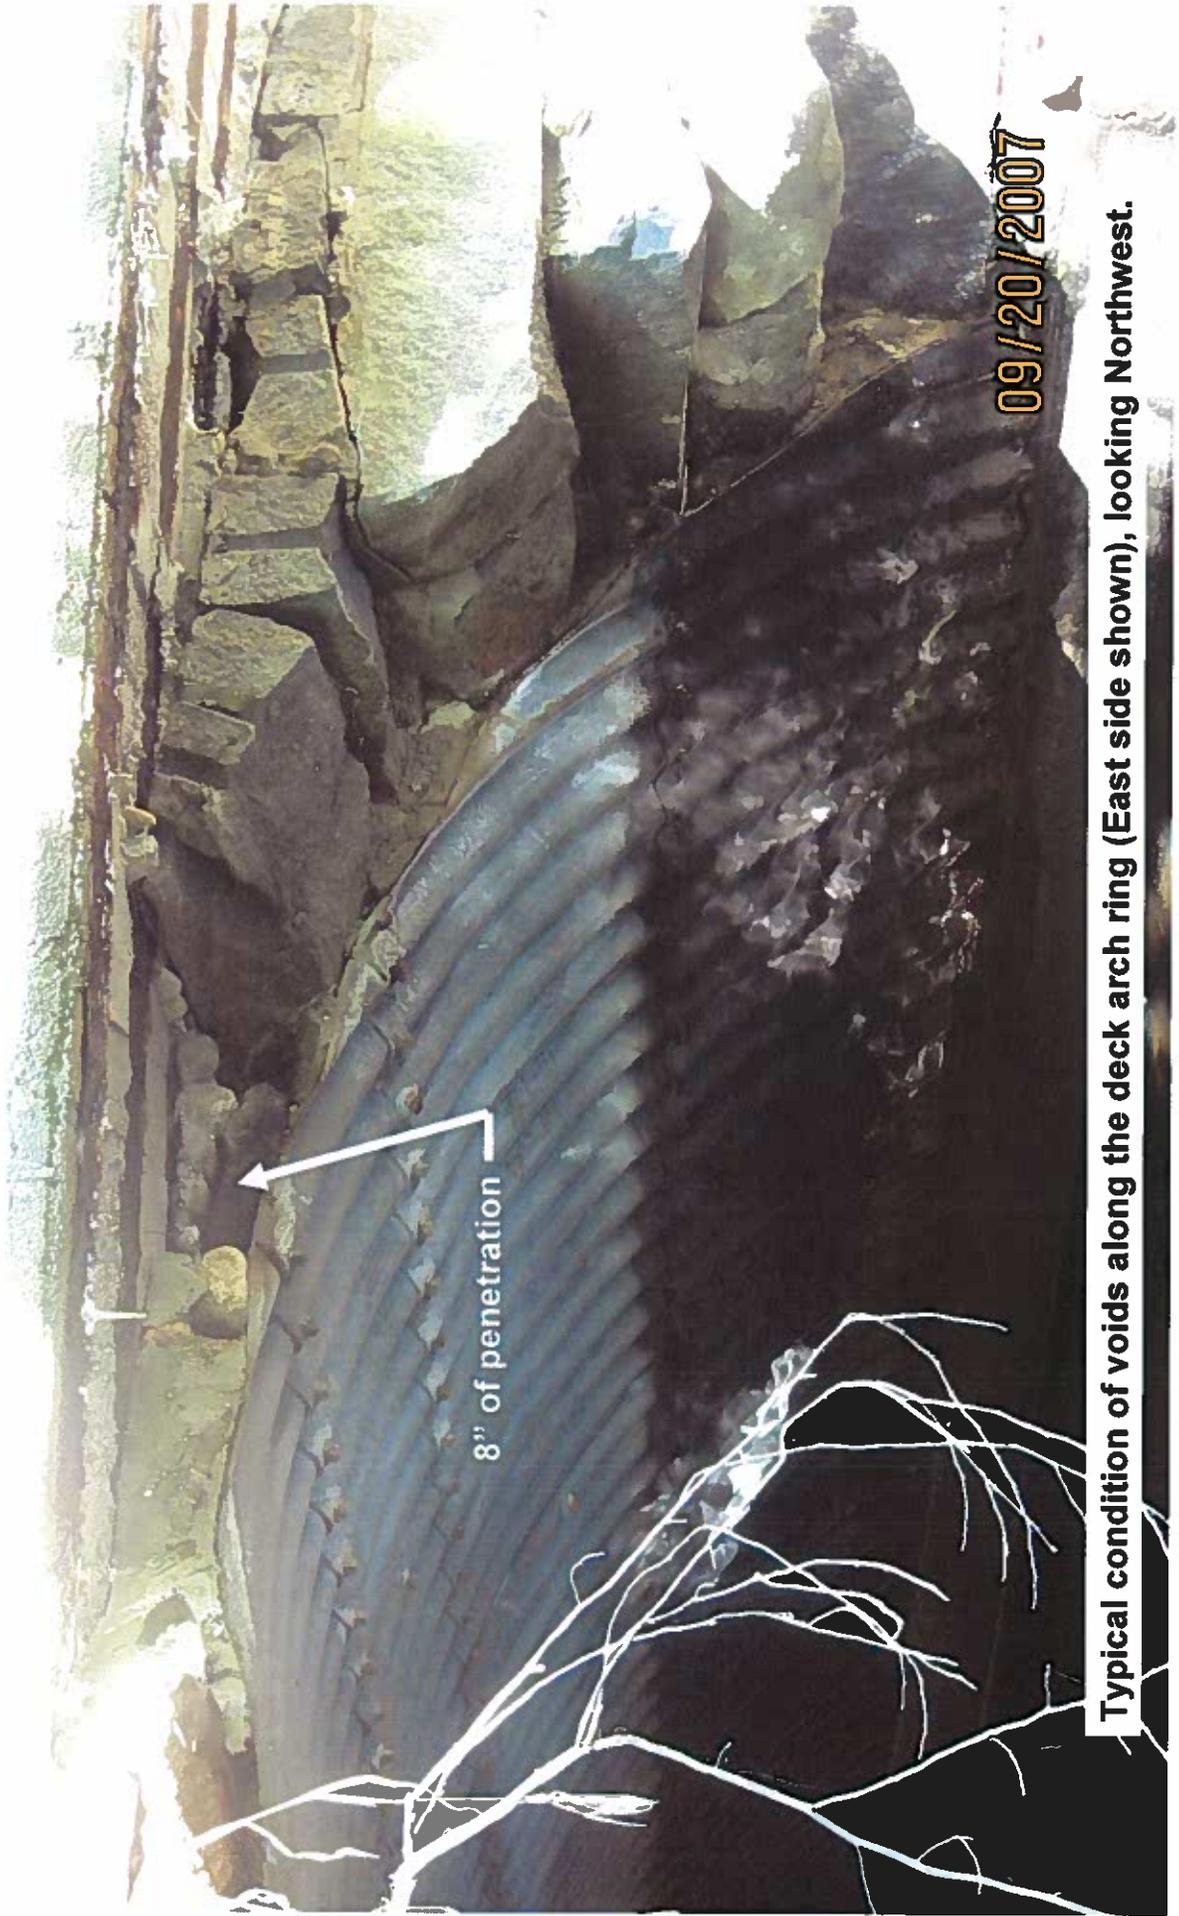
Typical condition of voids along the deck arch ring (East side shown), looking Northwest.

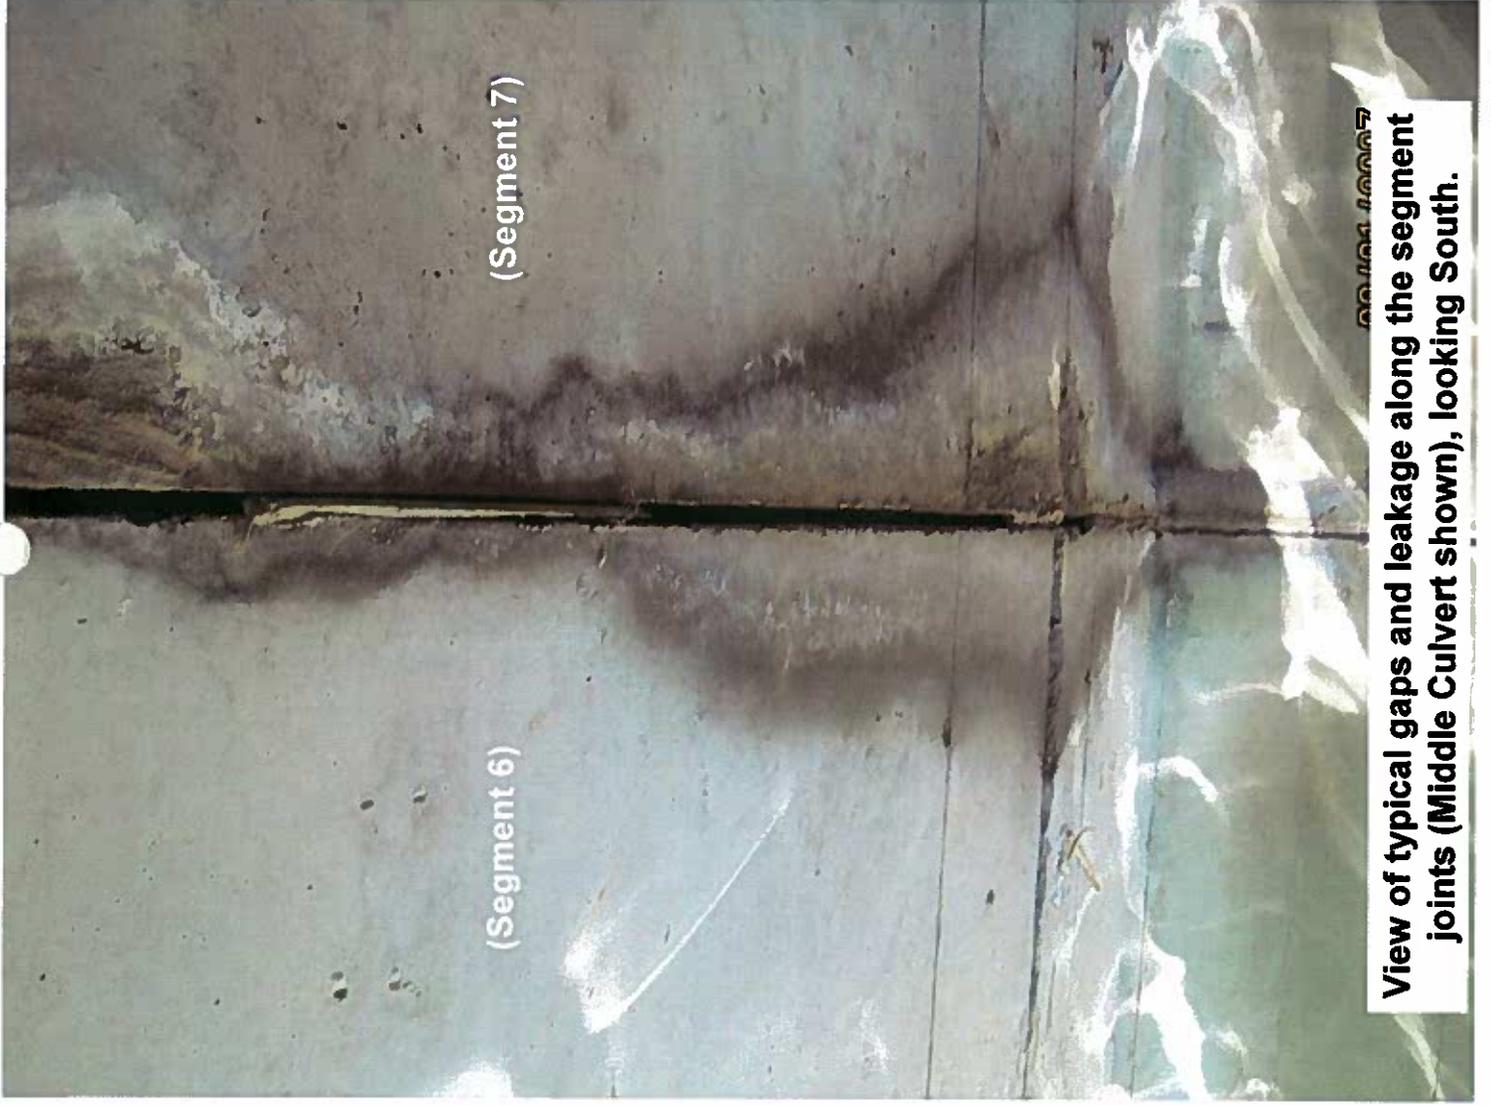
View of typical gaps and leakage along the segment joints (Middle Culvert shown), looking South.

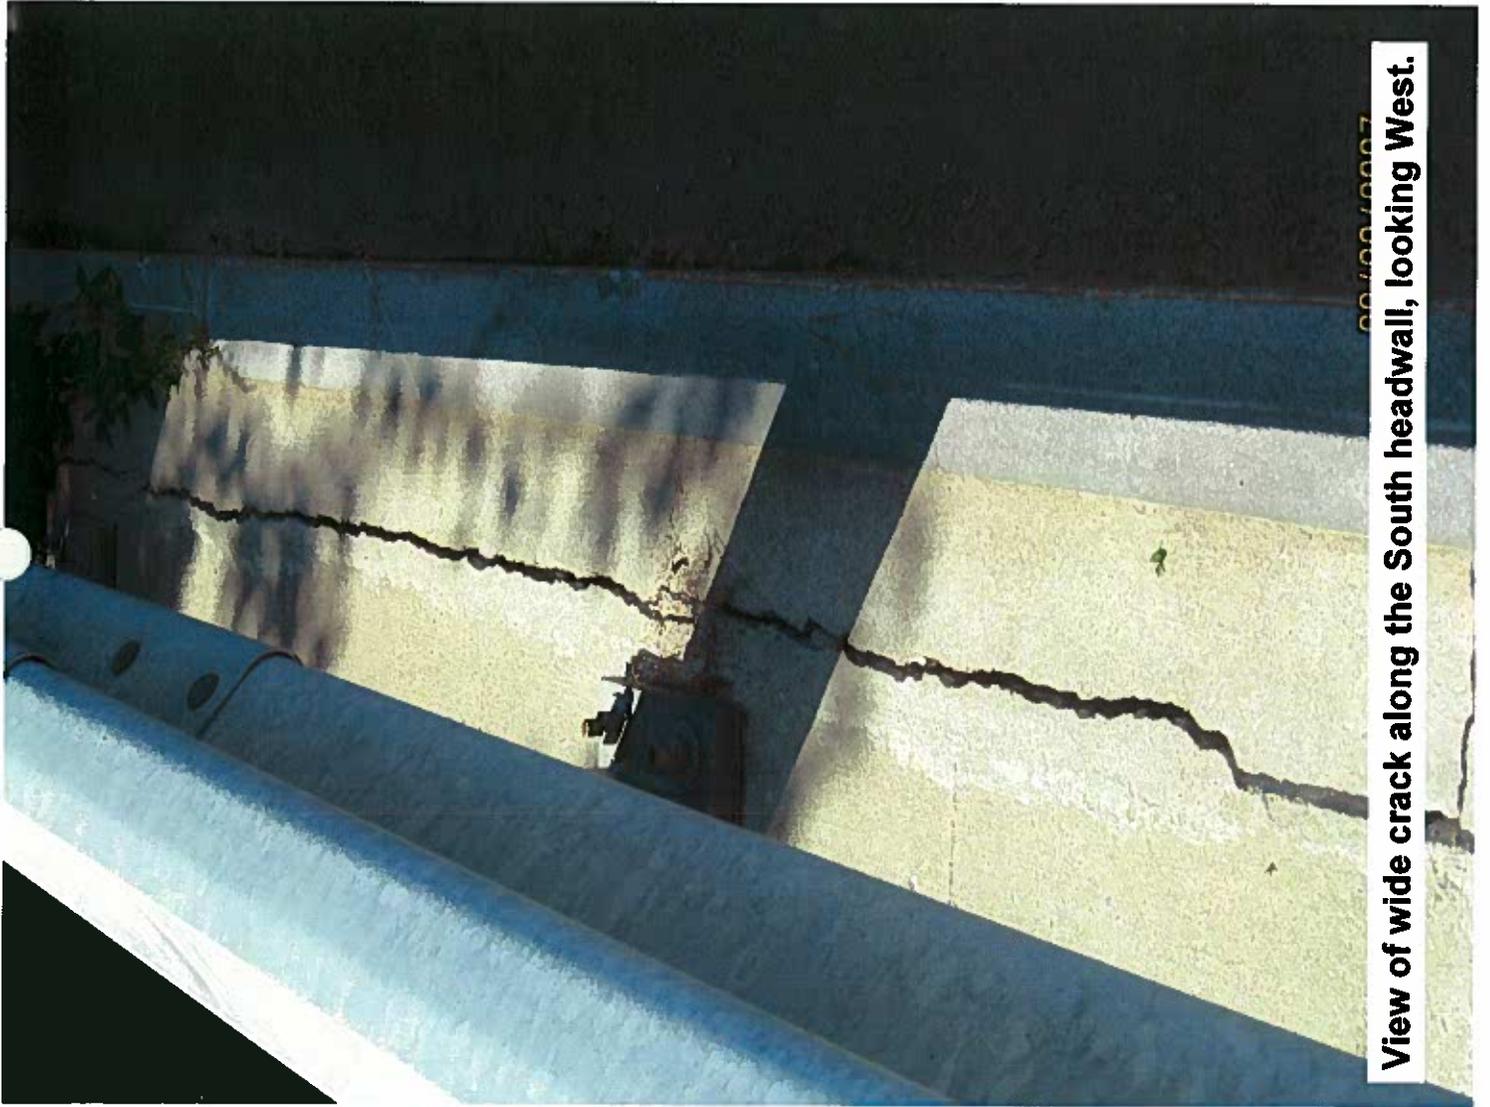
View of wide crack along the South headwall, looking West.

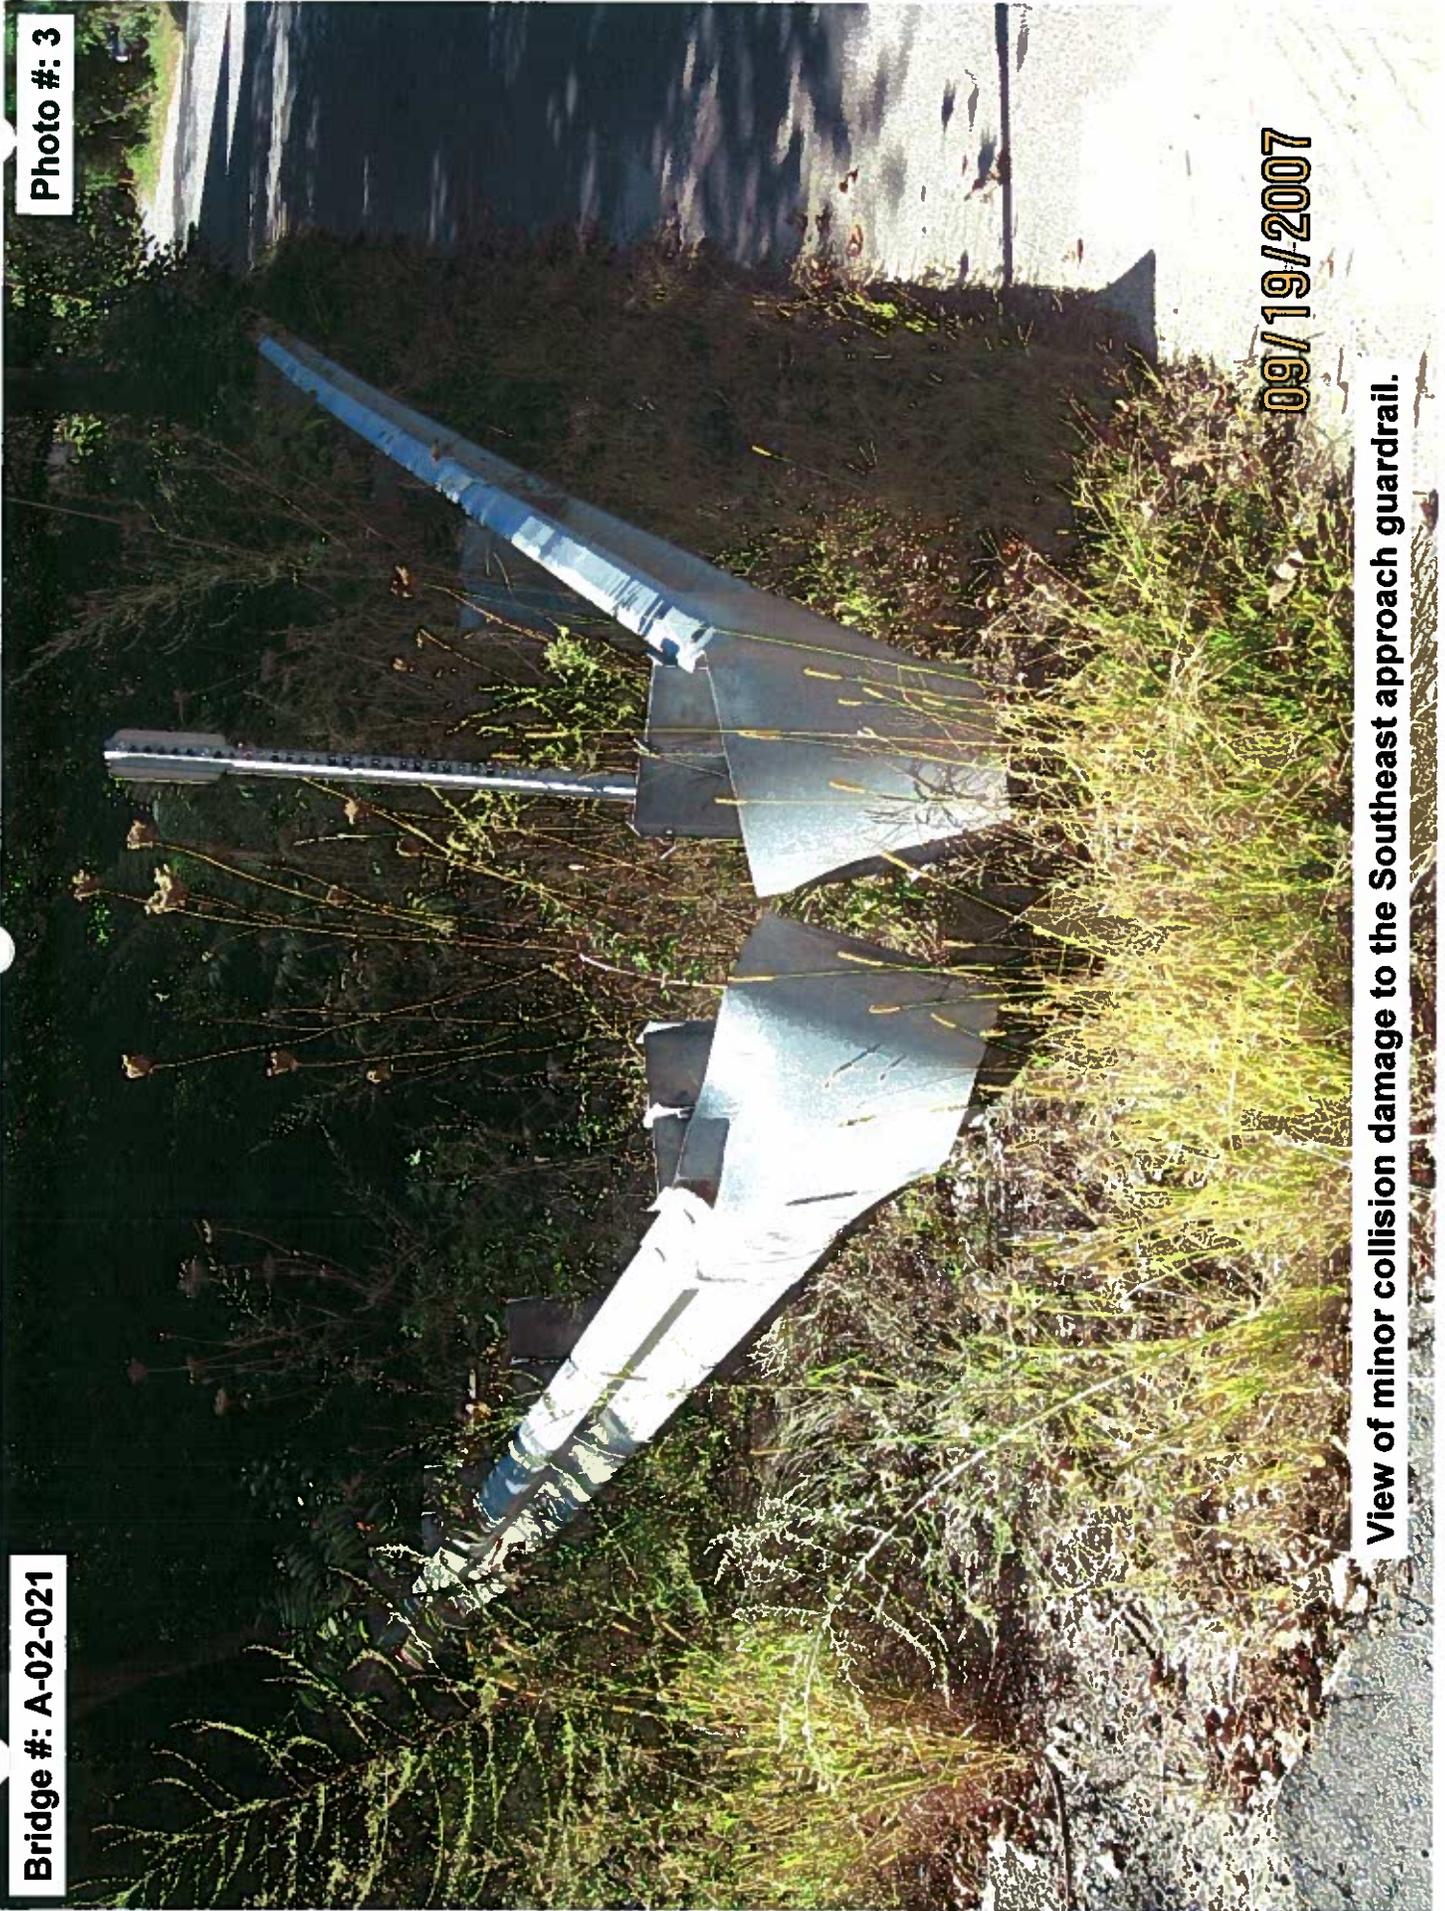
View of minor collision damage to the Southeast approach guardrail.

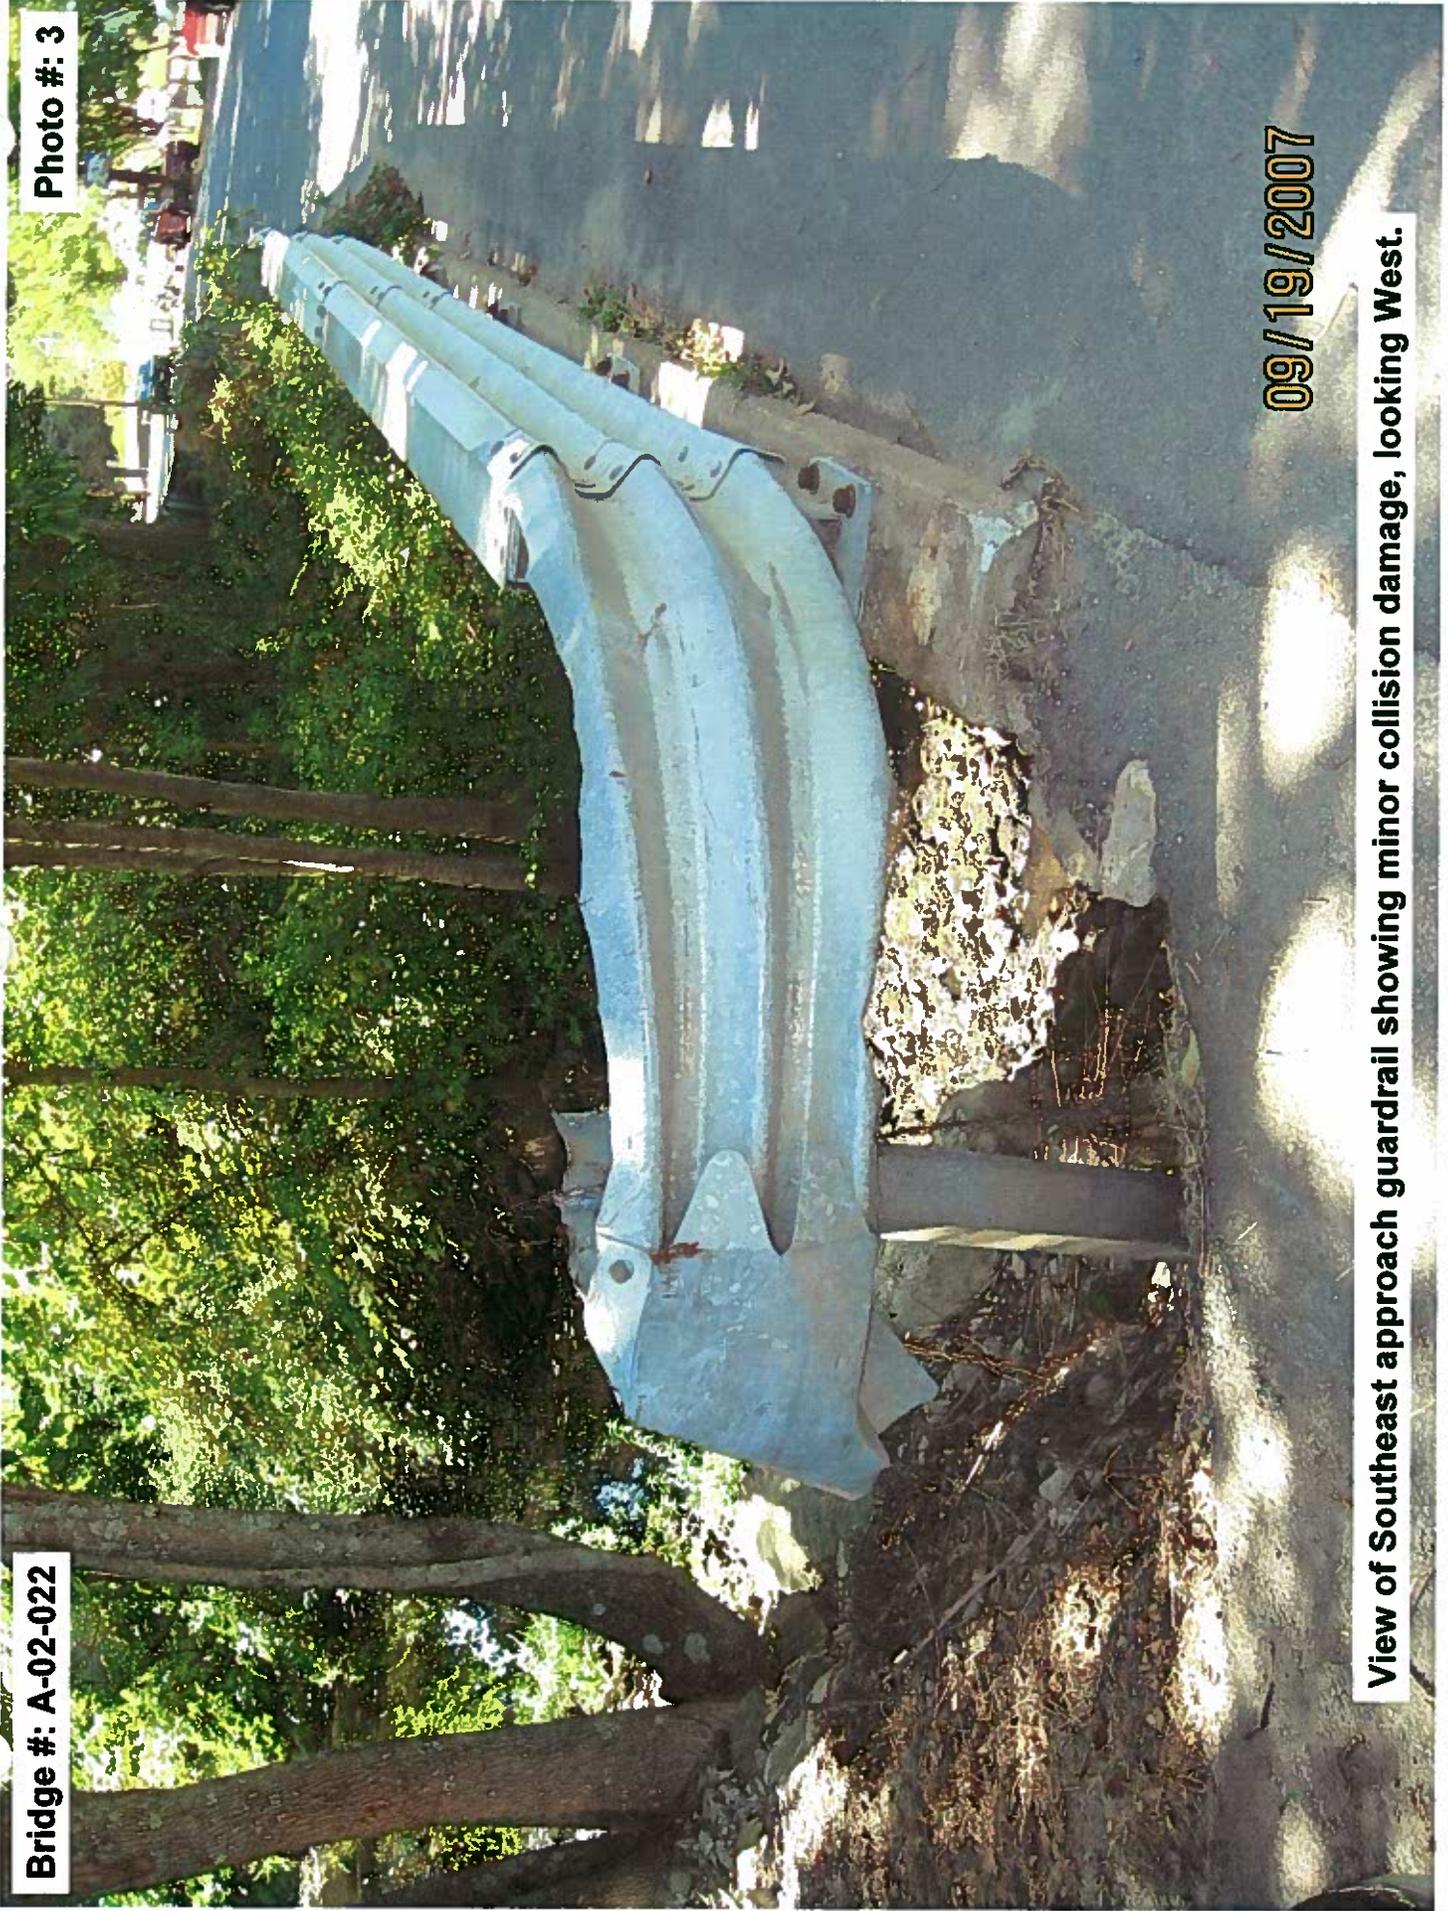
View of Southeast approach guardrail showing minor collision damage, looking West.

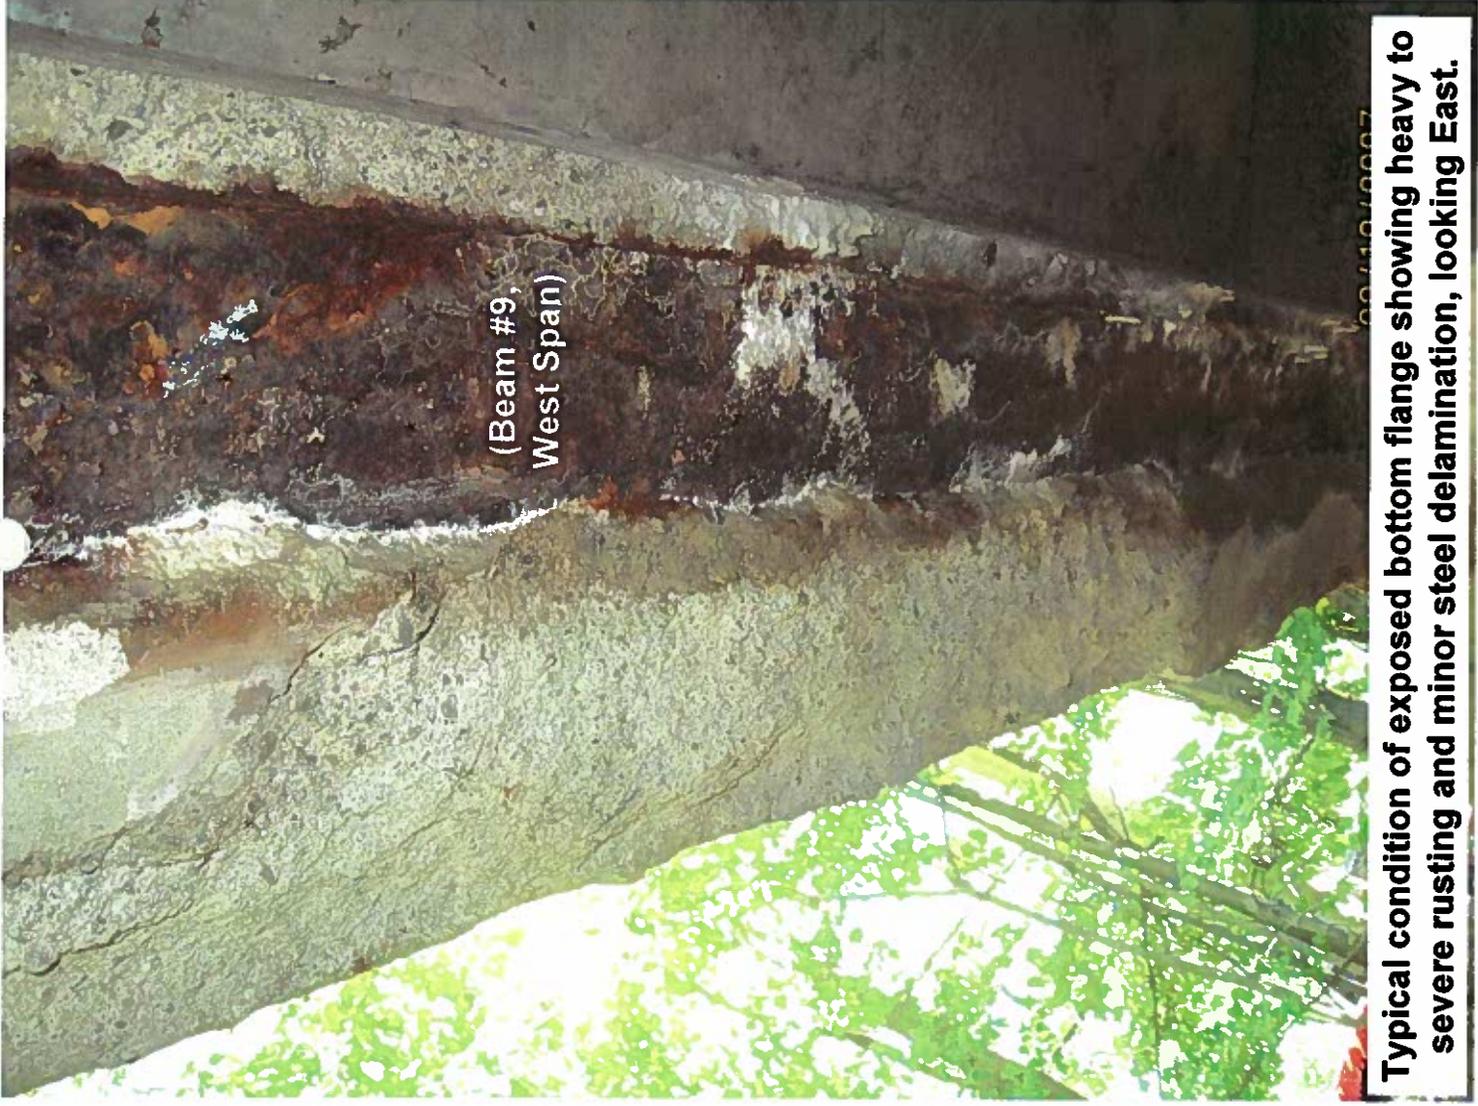
**Typical condition of exposed bottom flange showing heavy to severe rusting and minor steel delamination, looking East.**
