# PHASE I- PRELIMINARY REPORT

## Town of Acton

### Summary of Conditions and Recommendations for the Repair/Rehabilitation of Town Owned Bridges

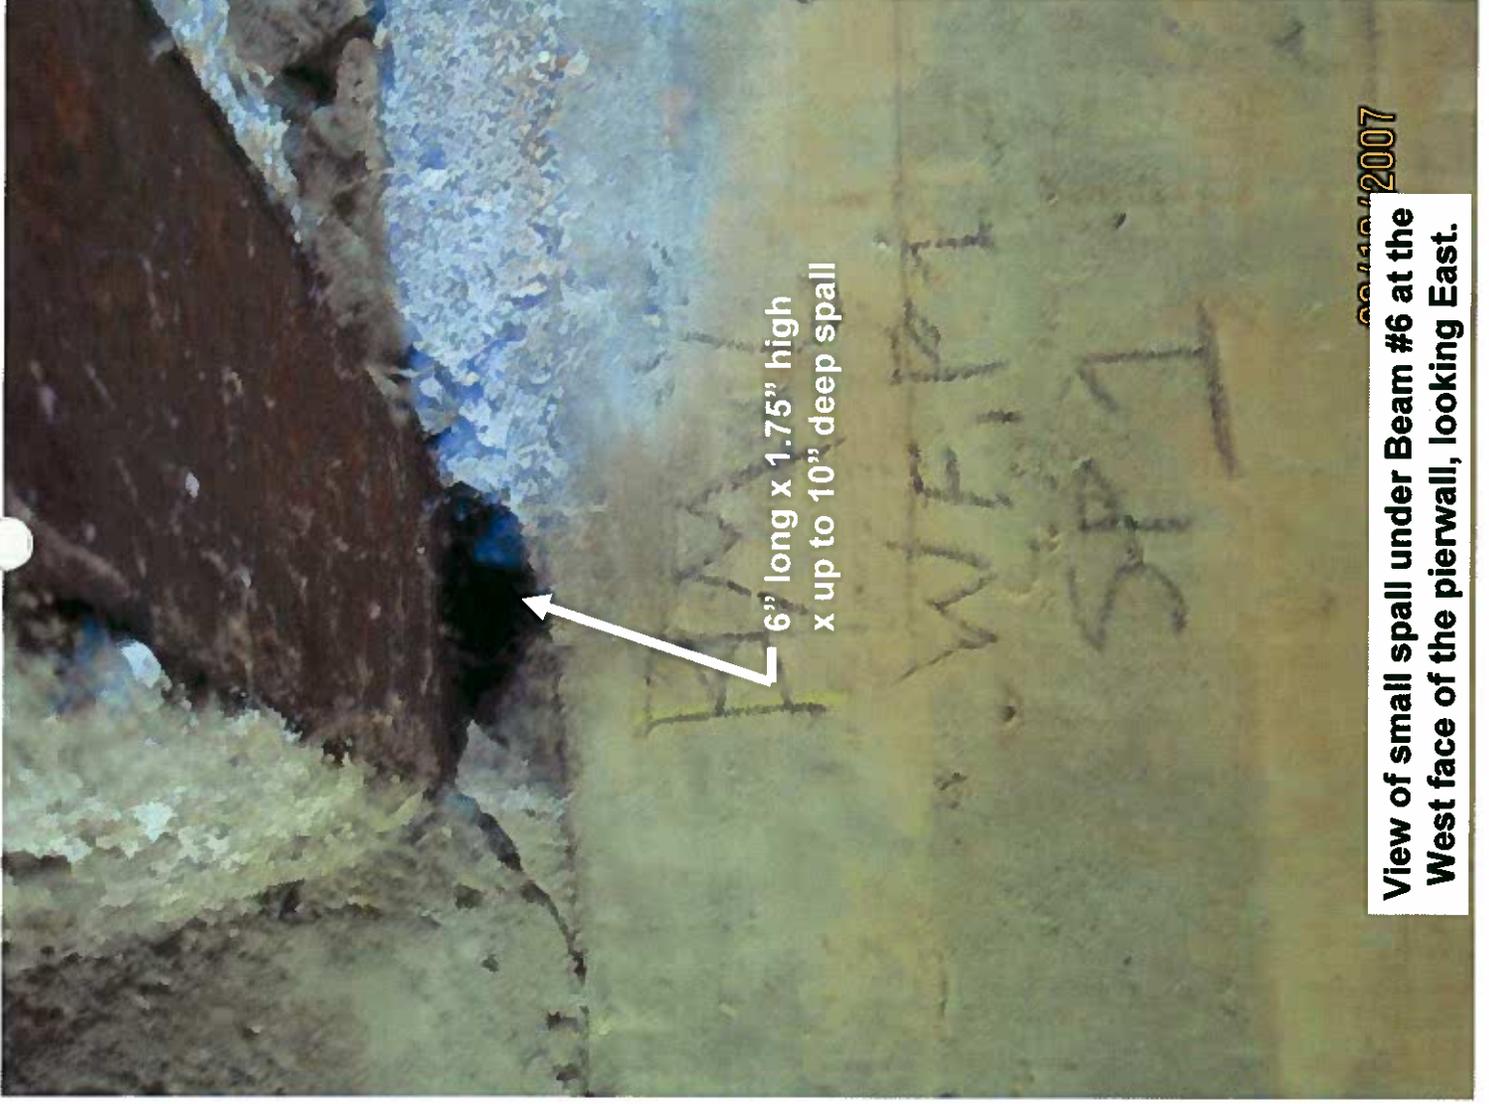
6" long x 1.75" high  
x up to 10" deep spall

View of small spall under Beam #6 at the West face of the pierwall, looking East.

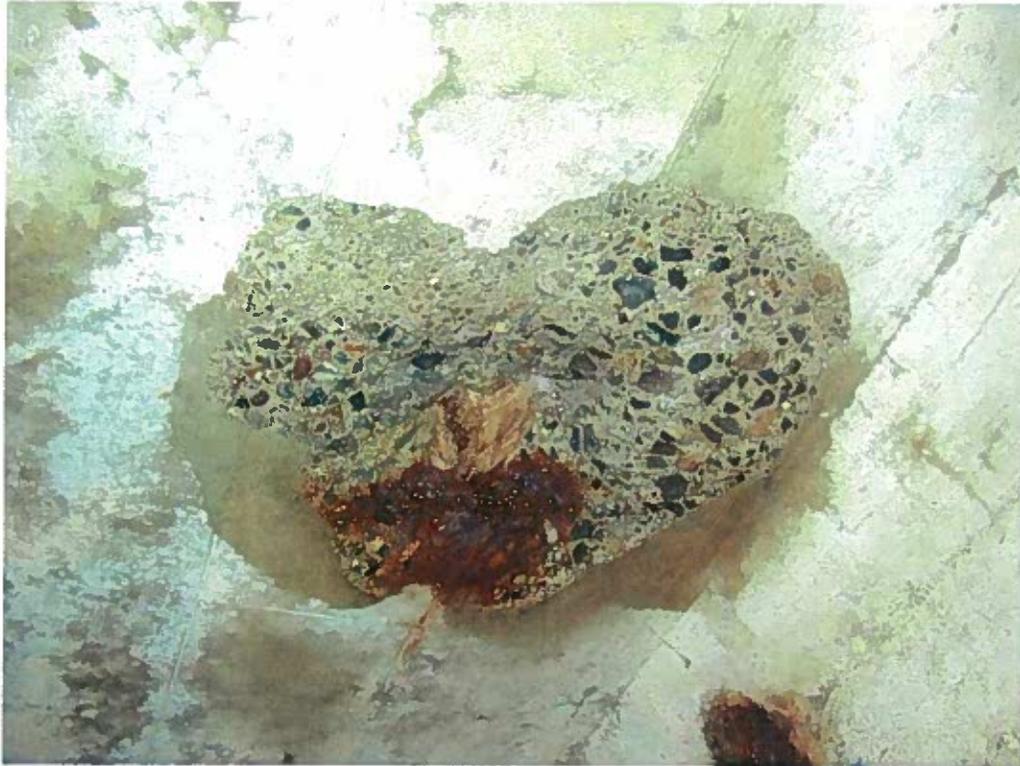
**Photo 1: Spall to the deck in bay #5.**

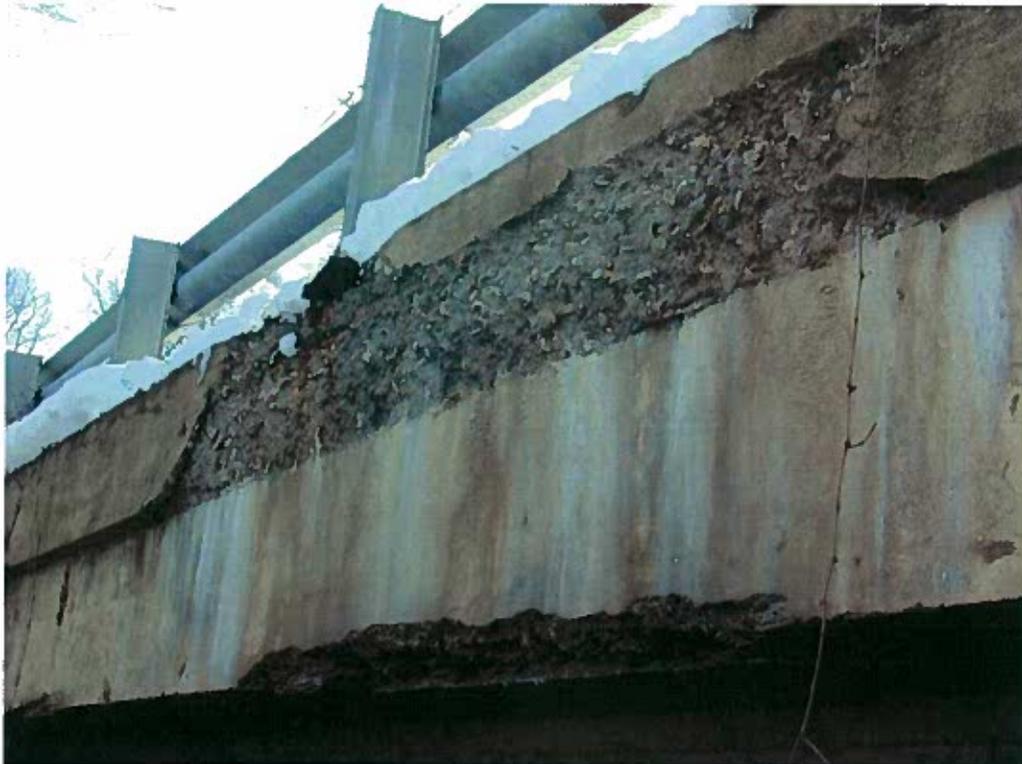
**Photo 2: Scaling to the East parapet at midspan.**

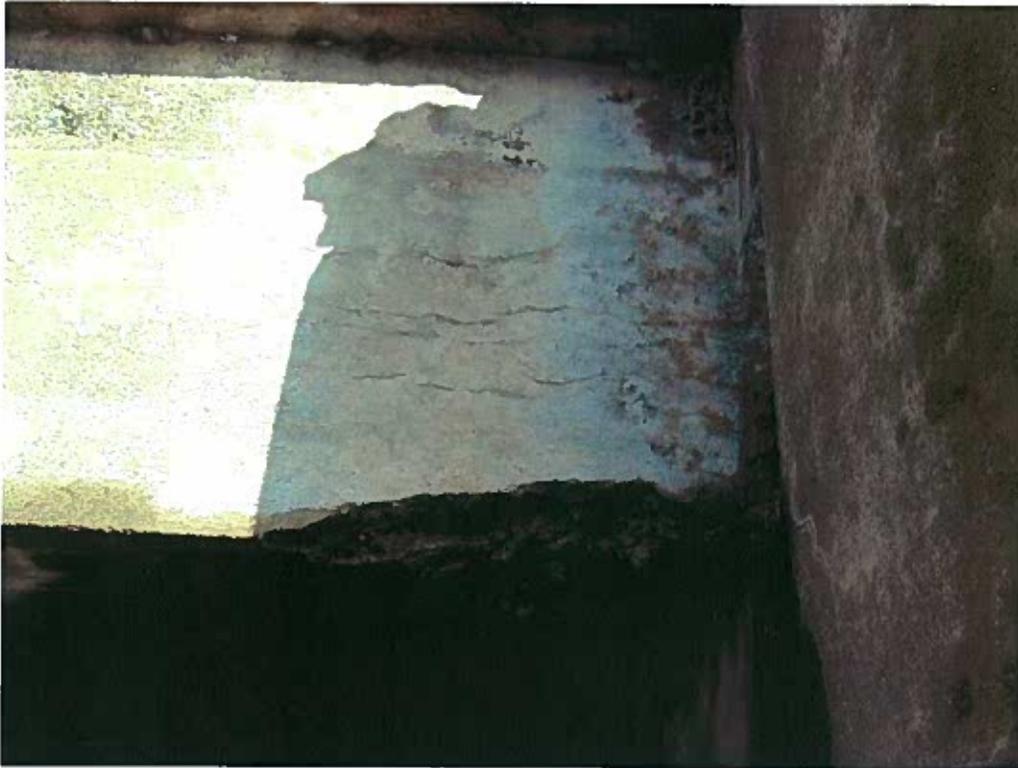
**Photo 3: Scaling and delamination cracking to the Southwest end of beam #1.**

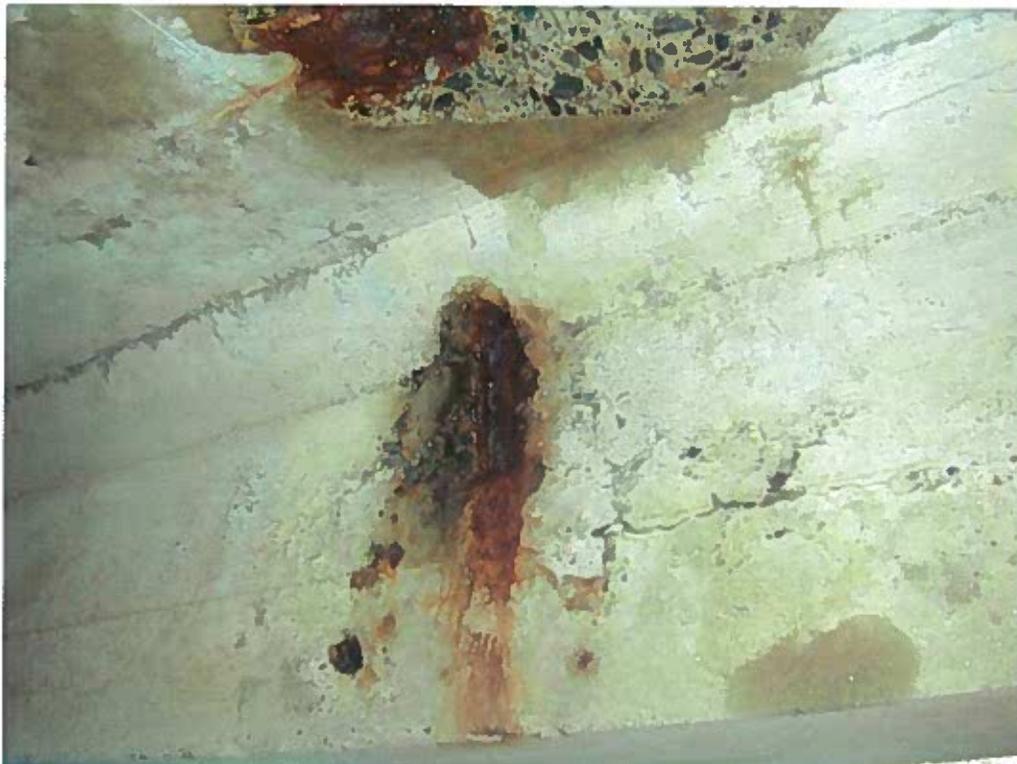
**Photo 4: Hole/spall in the West face of beam #6.**

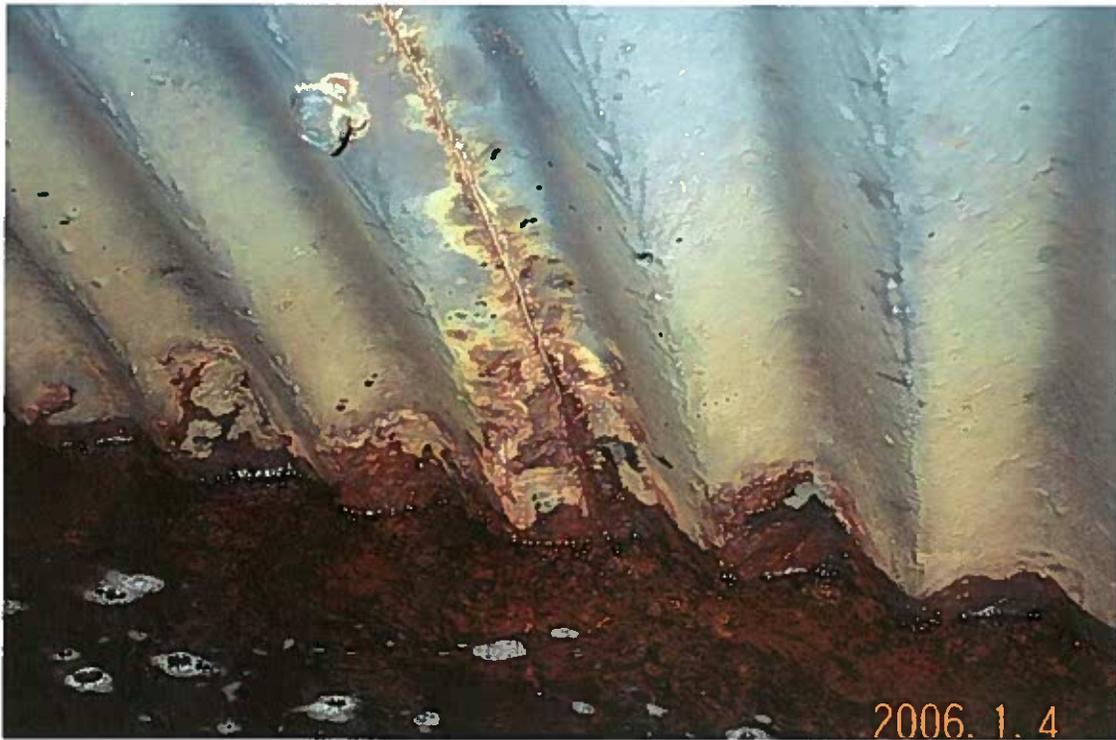
**Photo 1: Minor to moderate surface rusting of arch at the waterline.**

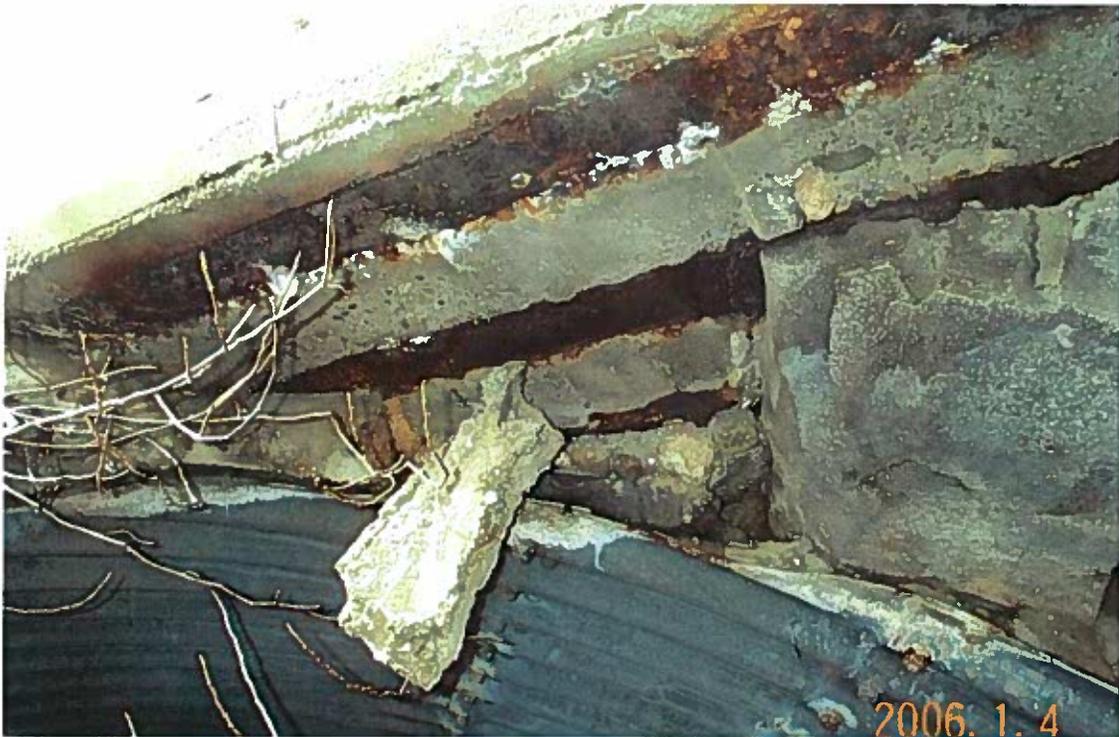
**Photo 2: Missing stones at the East keystone area.**

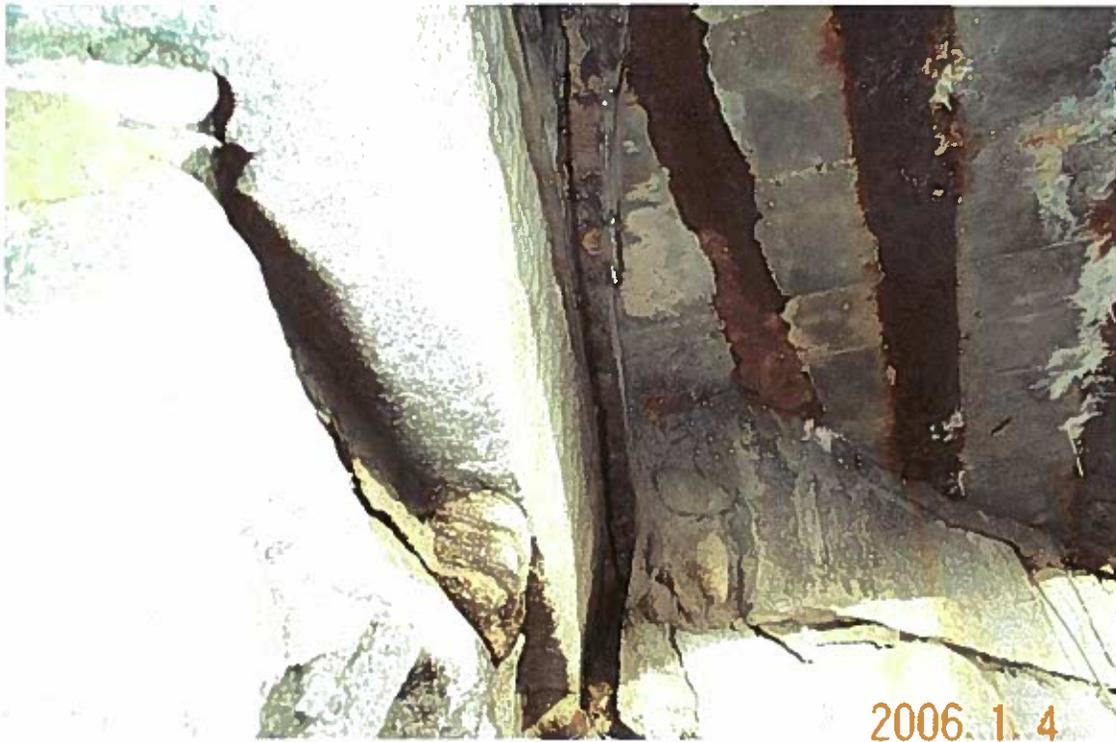
**Photo 3: Surface rusting to East stringer flanges.**

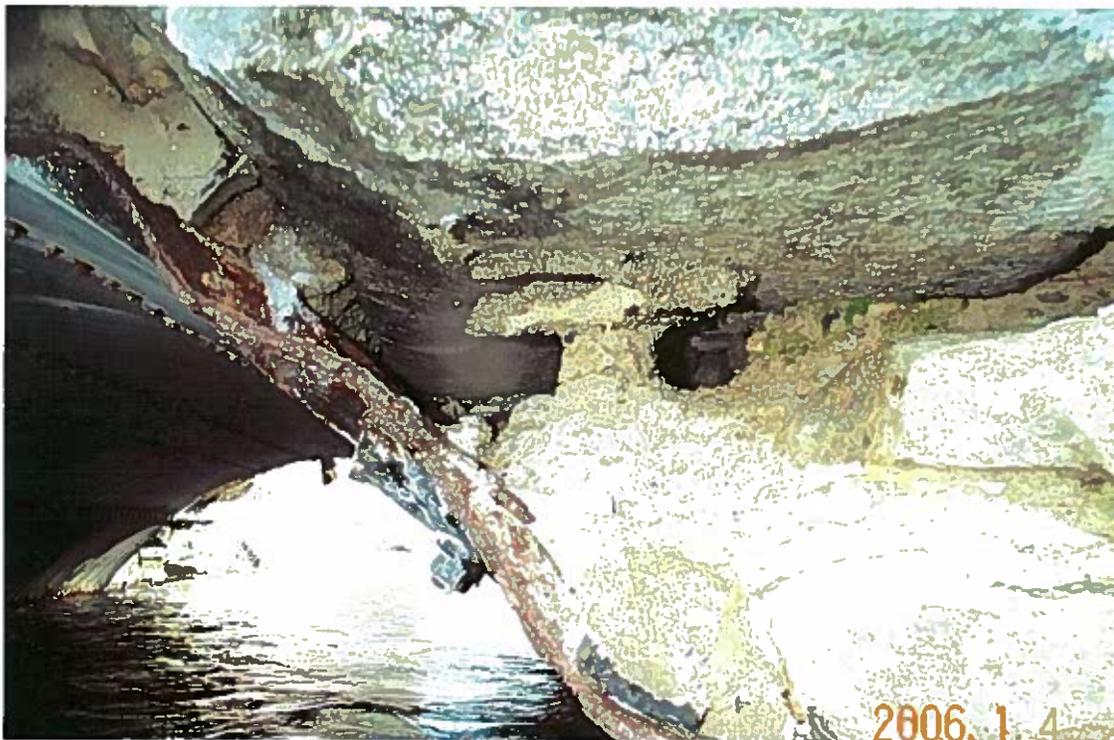
**Photo 4: Void to the Southwest spandrel wall above the arch ring.**

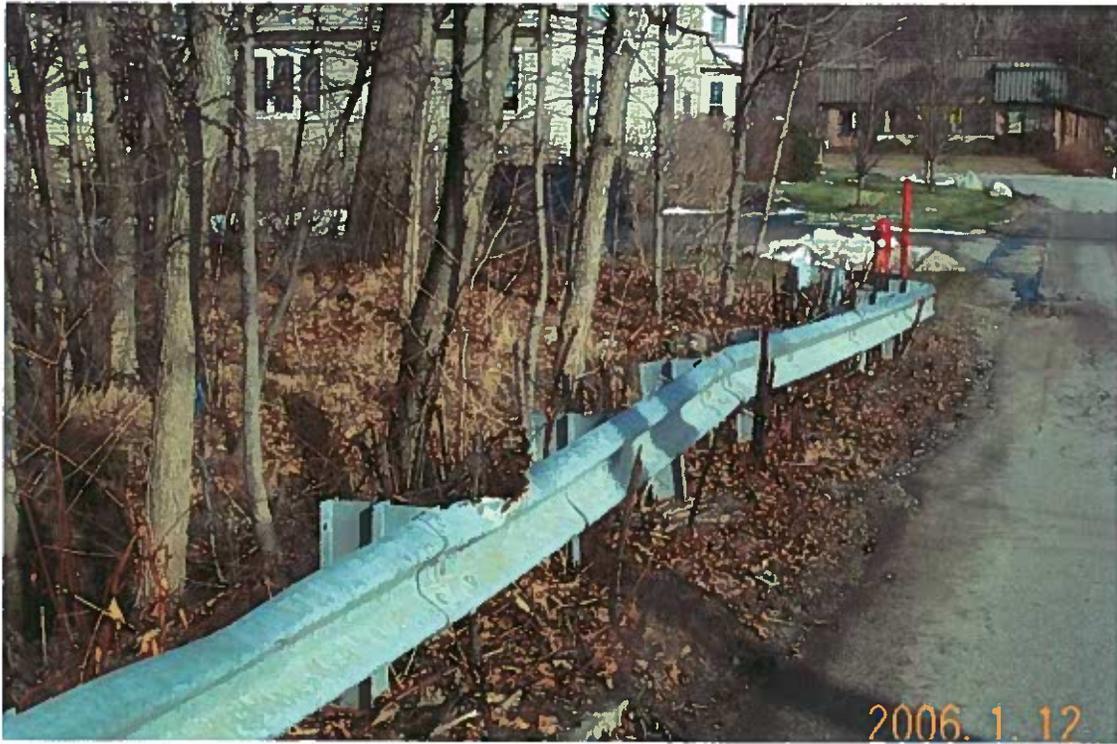
**Photo 1: Collision damage to NW approach guardrail.**

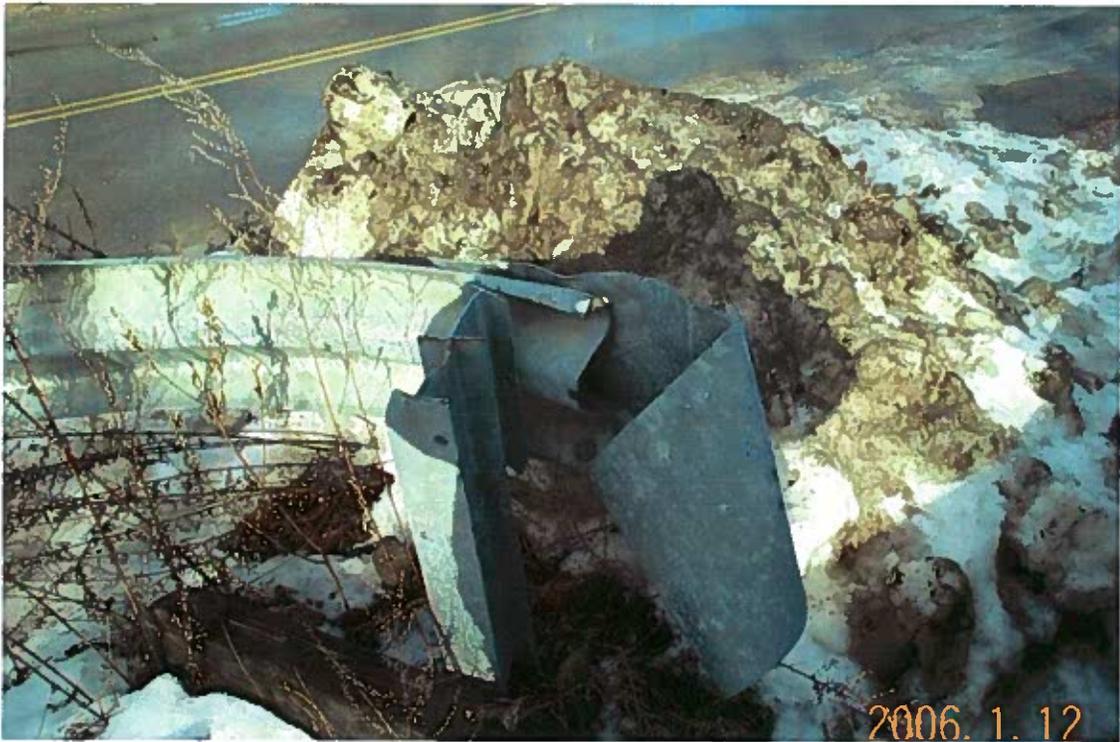
**Photo 2: Collision damage to NE terminal end.**

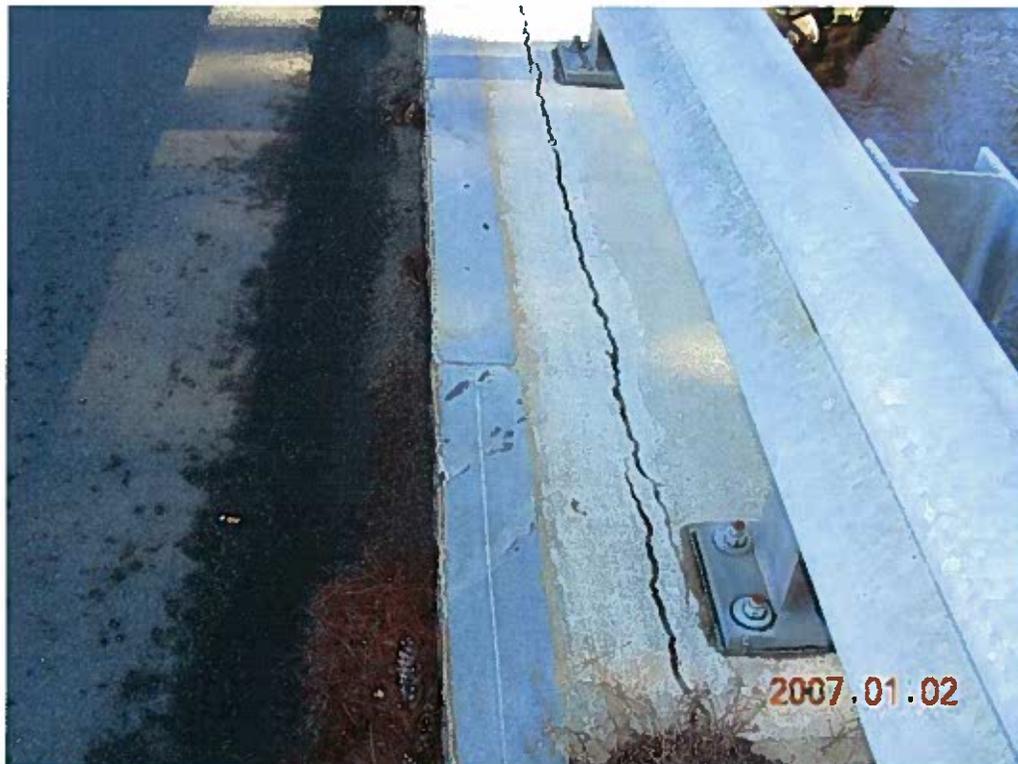
**Photo 2:** A crack 10 ft. long x up to 1/2 in. wide at the top of the South headwall.

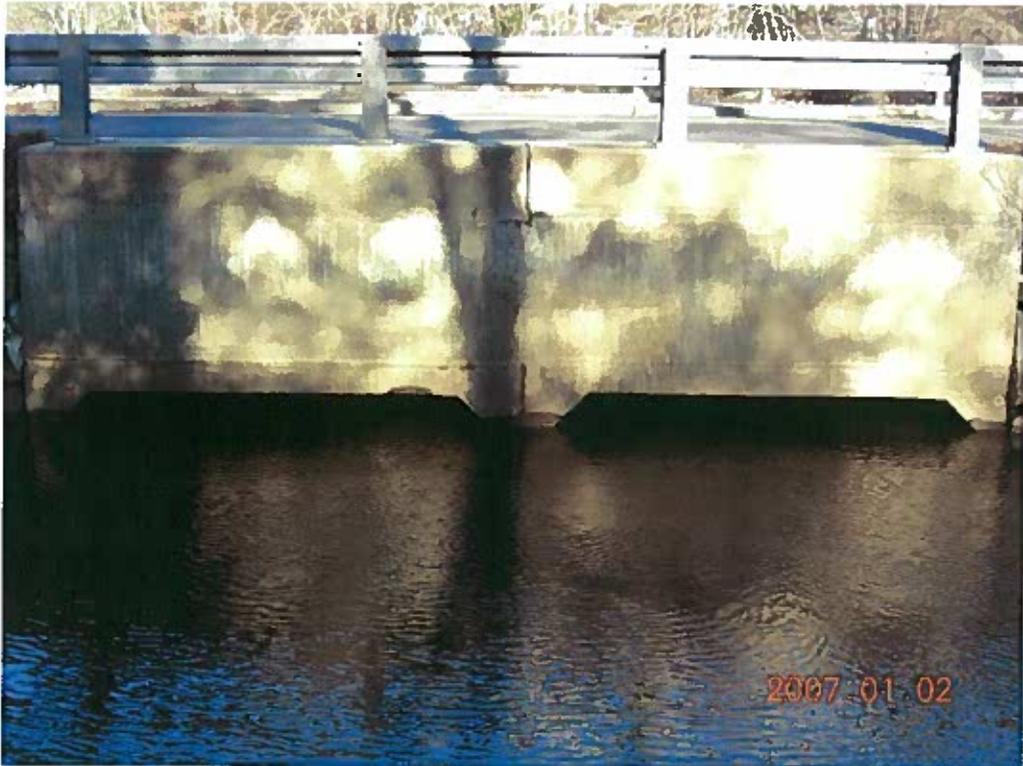
**Photo 3: Vertical hairline crack near the centerline of the South headwall.**

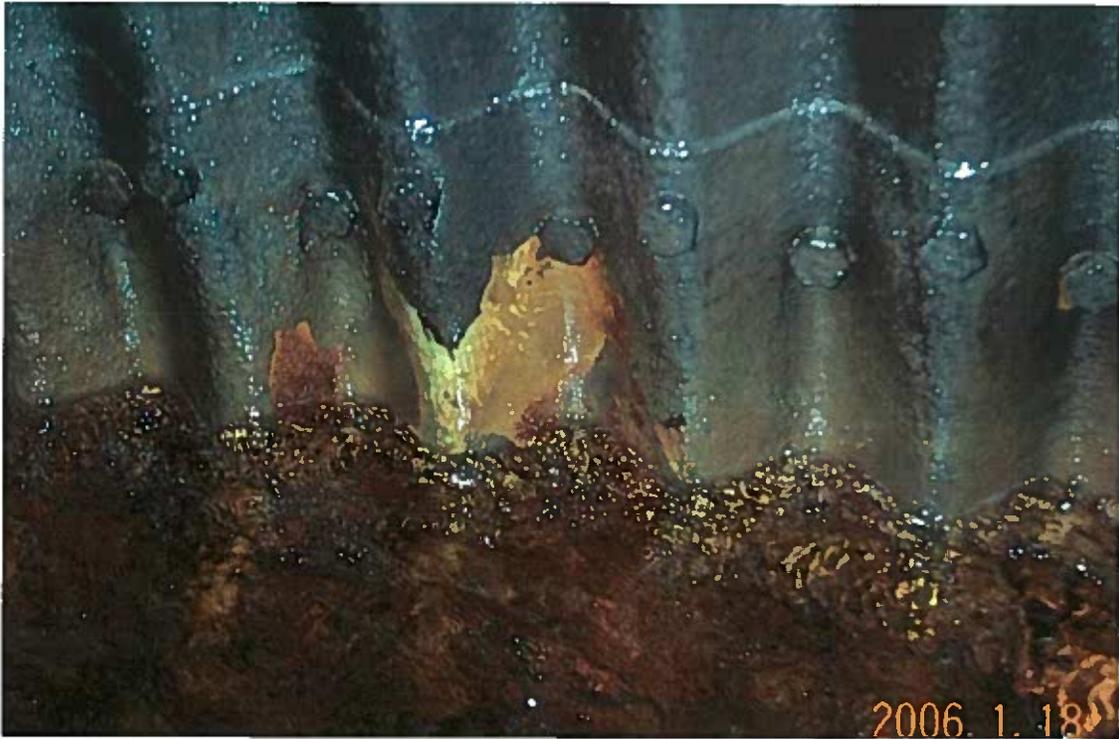
Photo 2: Surface rusting to barrel. Typical.

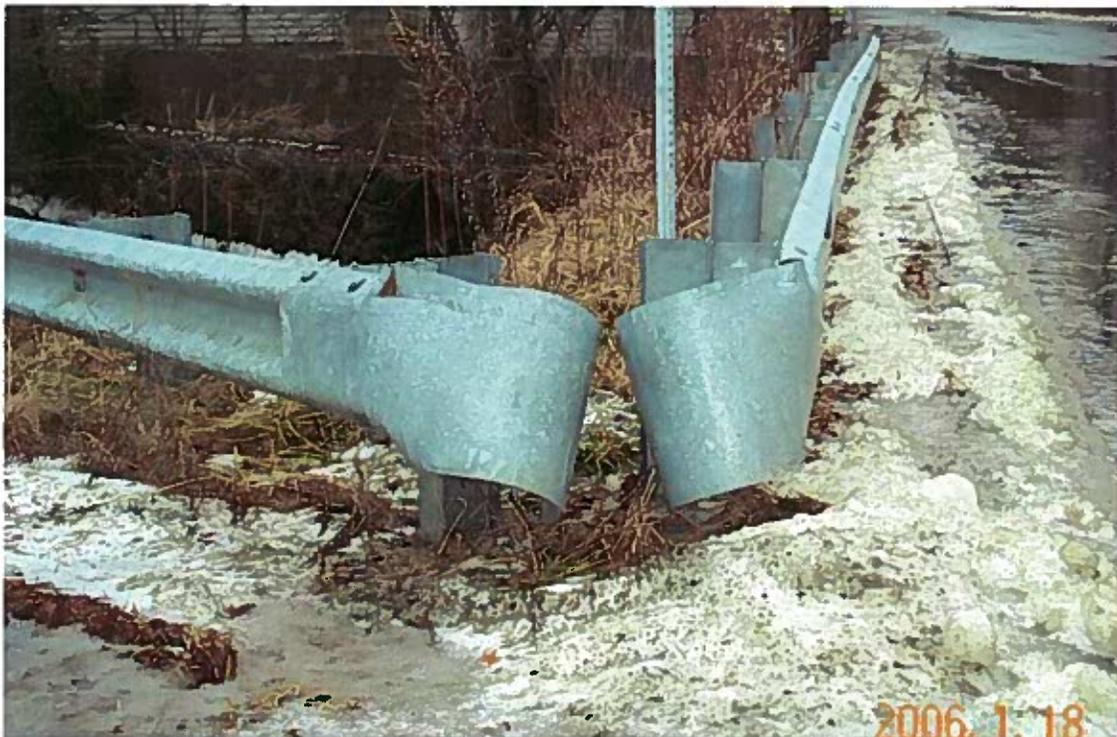
**Photo 6: Collision damage to the Southeast terminal end.**

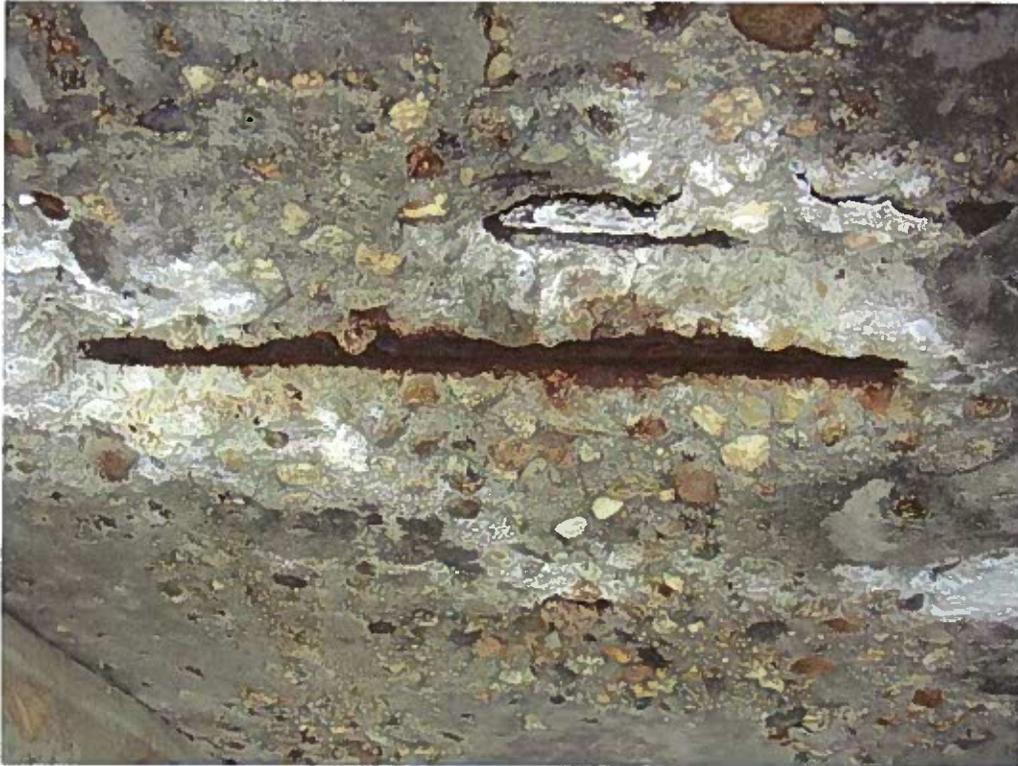
**Photo 1: Spall and honeycombing on the bottom of the utility slab near the West end of bay 1 in the West span**

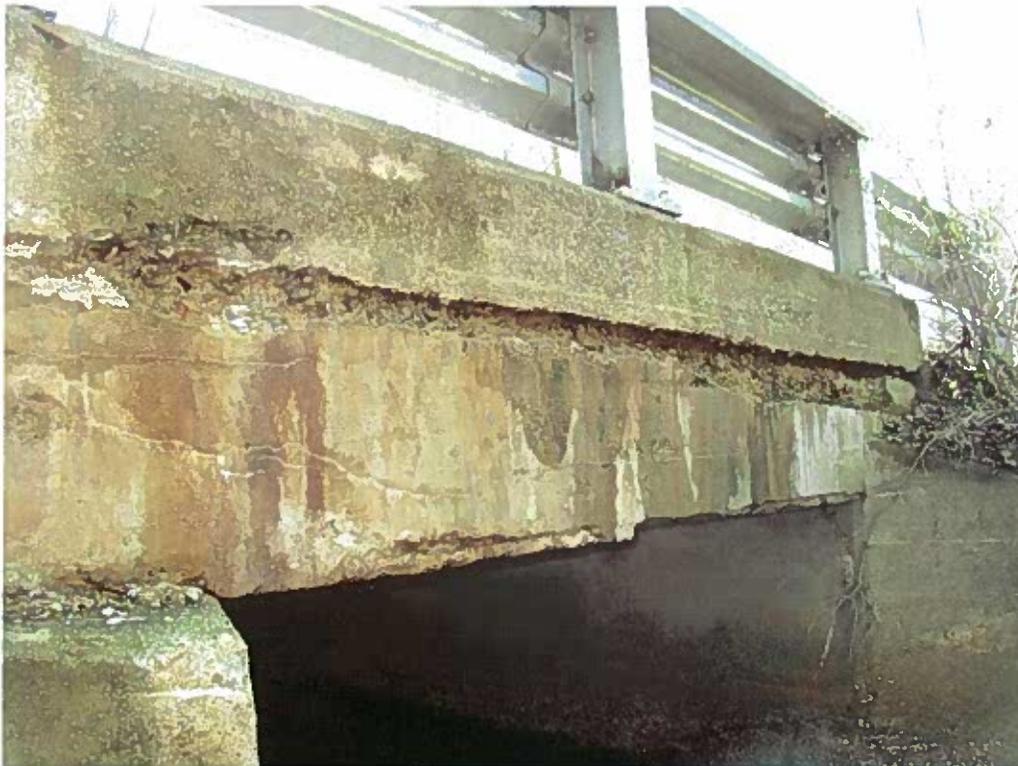
**Photo 2: Spall along the North deck slab fascia in the West span**

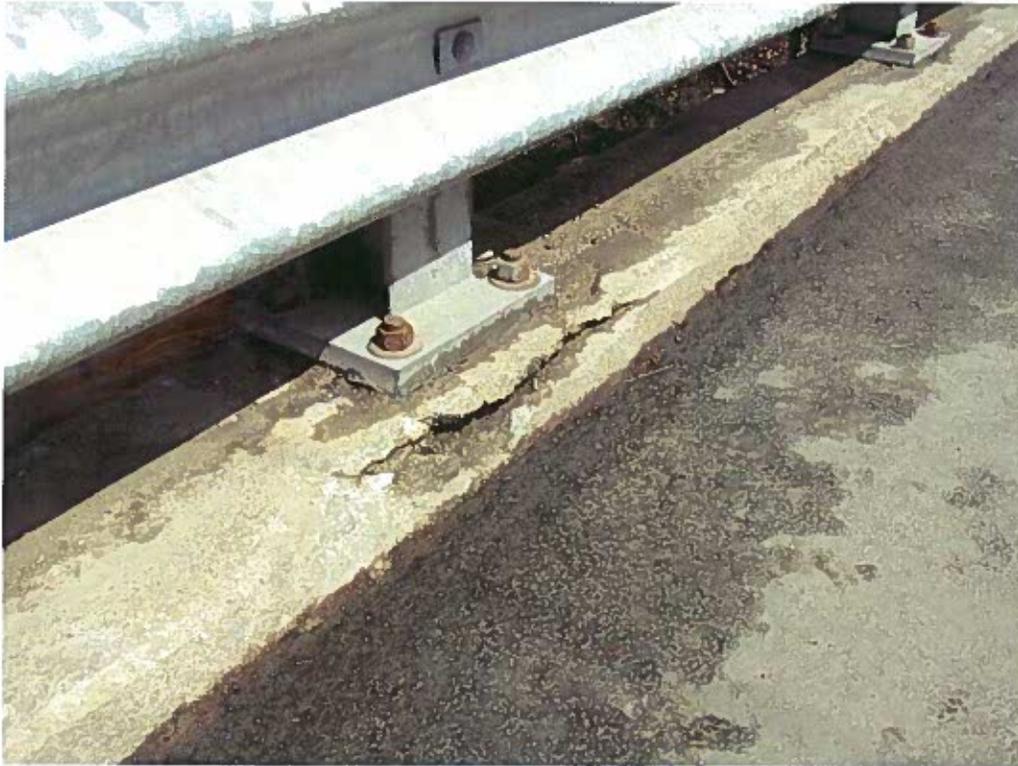
**Photo 3: Spall on the North curb**

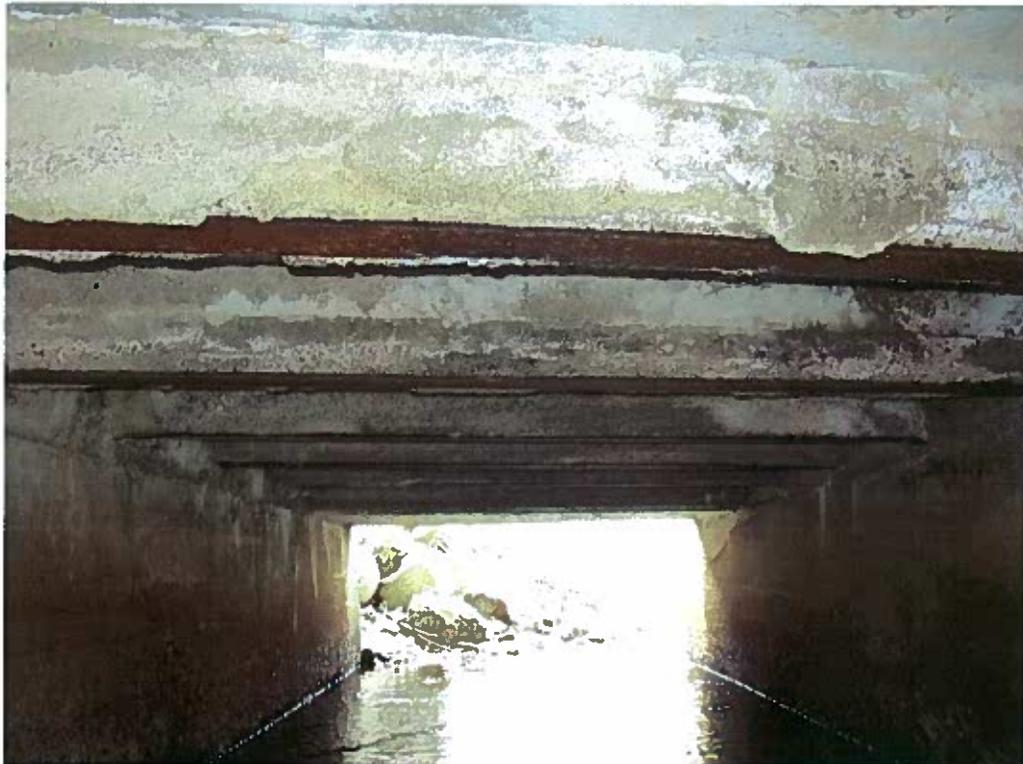
**Photo 4: Spalling of the concrete encasements in East span looking South**

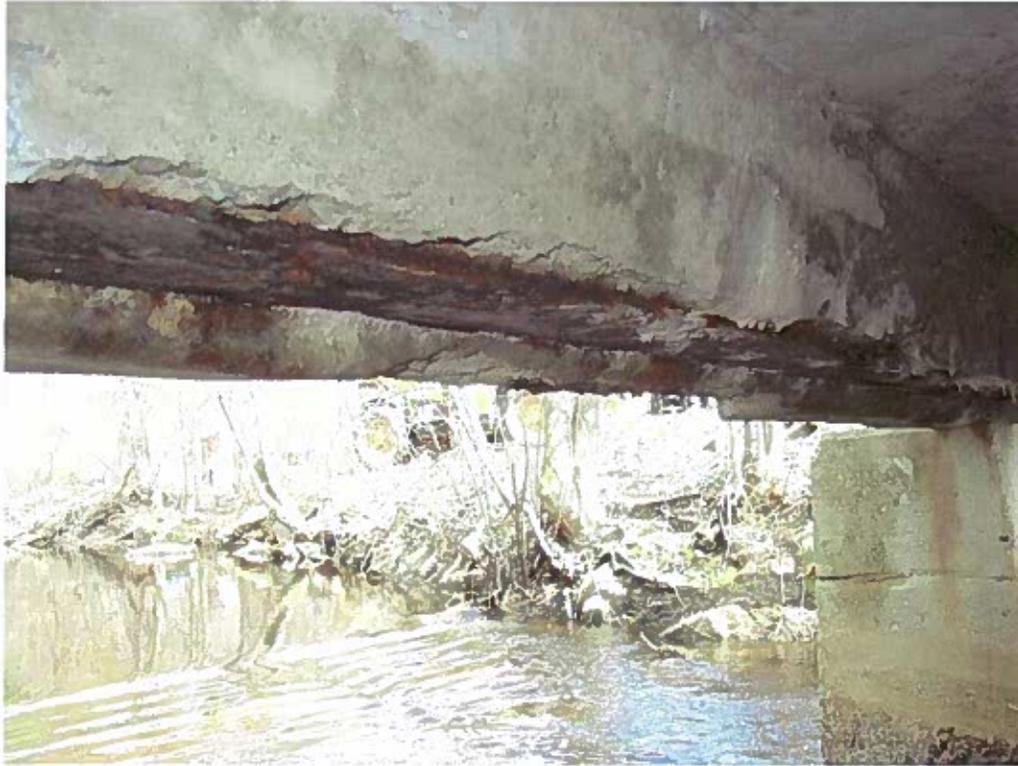
**Photo 5: Rusting and section loss to bottom flange of stringer 9 in West span**

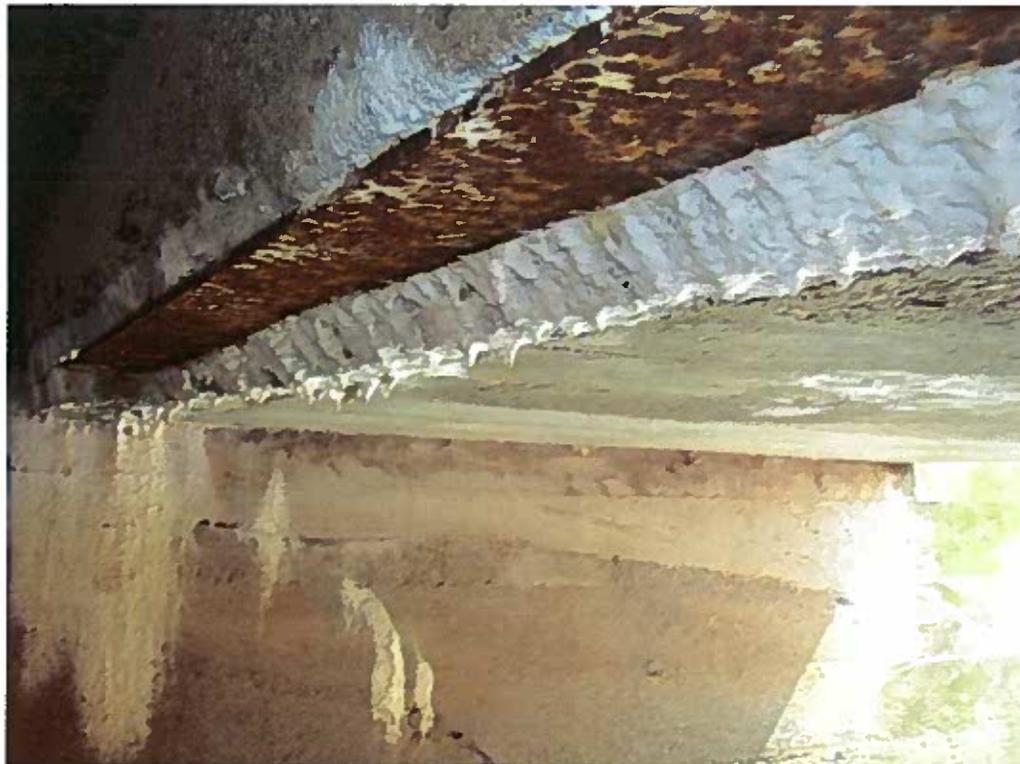
**Photo 6: Heavy efflorescence along stringer 3 in West span**

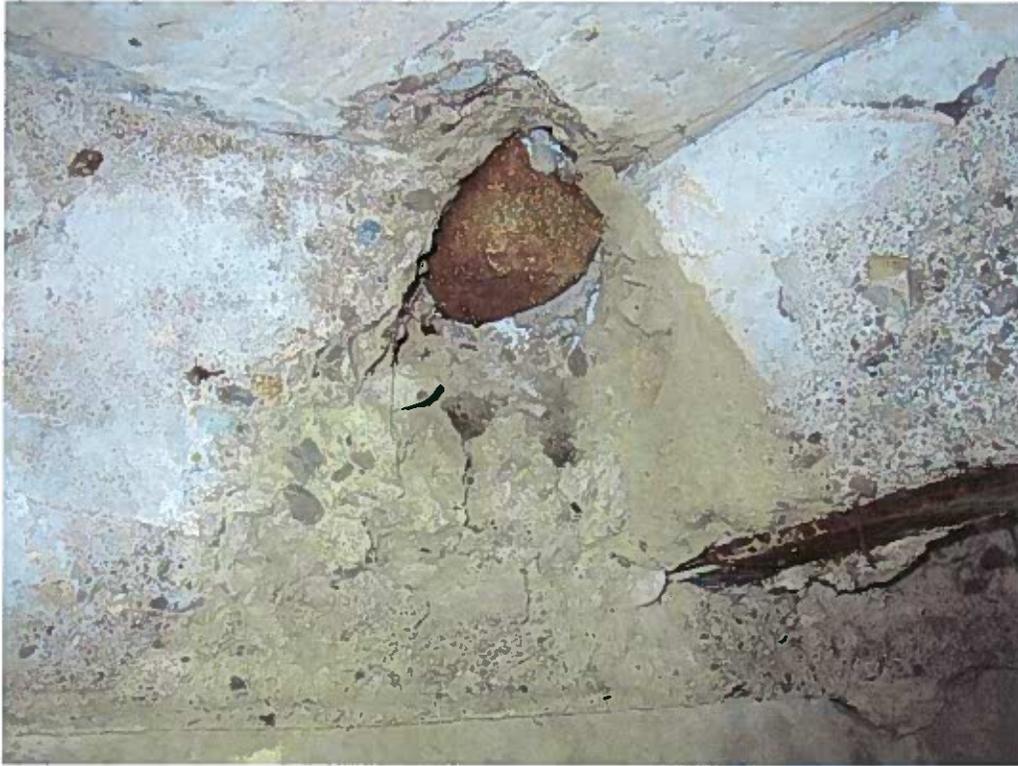
**Photo 7: Spall on East abutment adjacent to stringer 6**

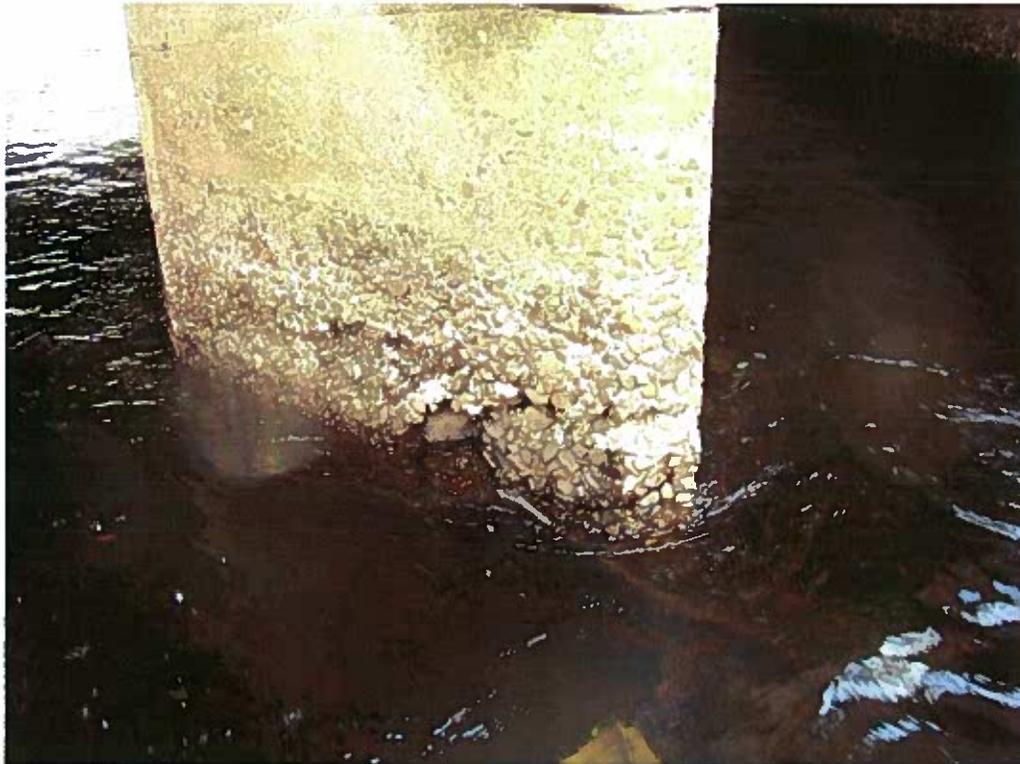
**Photo 8: Heavy abrasion to North end of pierwall**

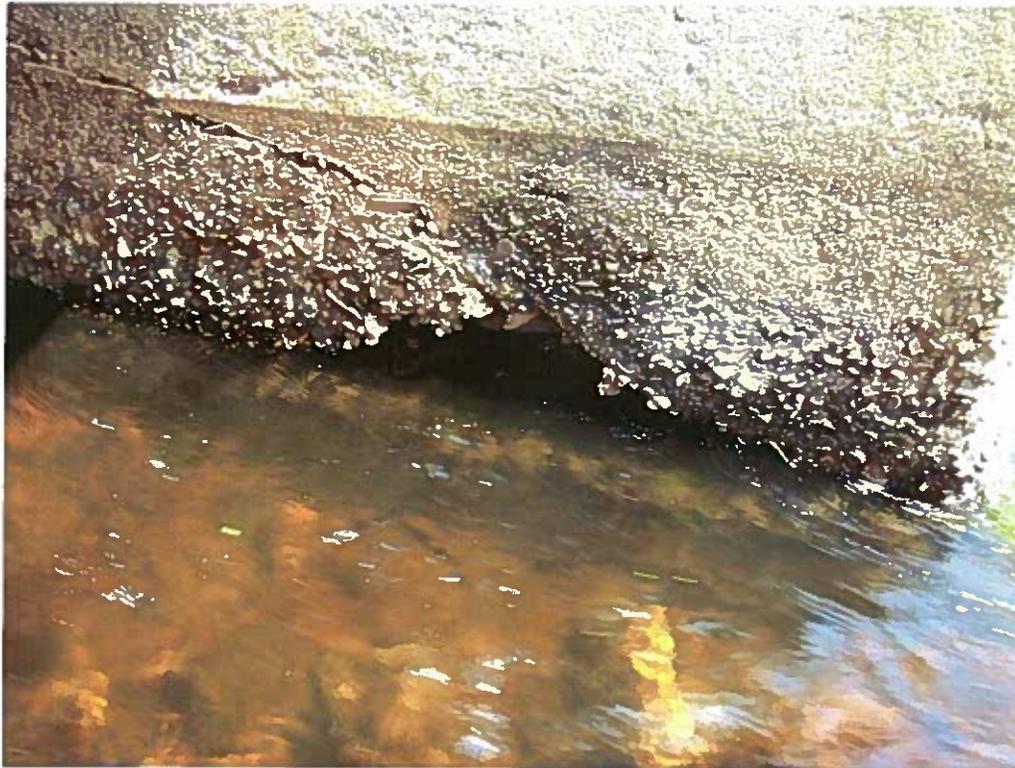
**Photo 9: Abrasion and spalling at SW corner of pierwall**

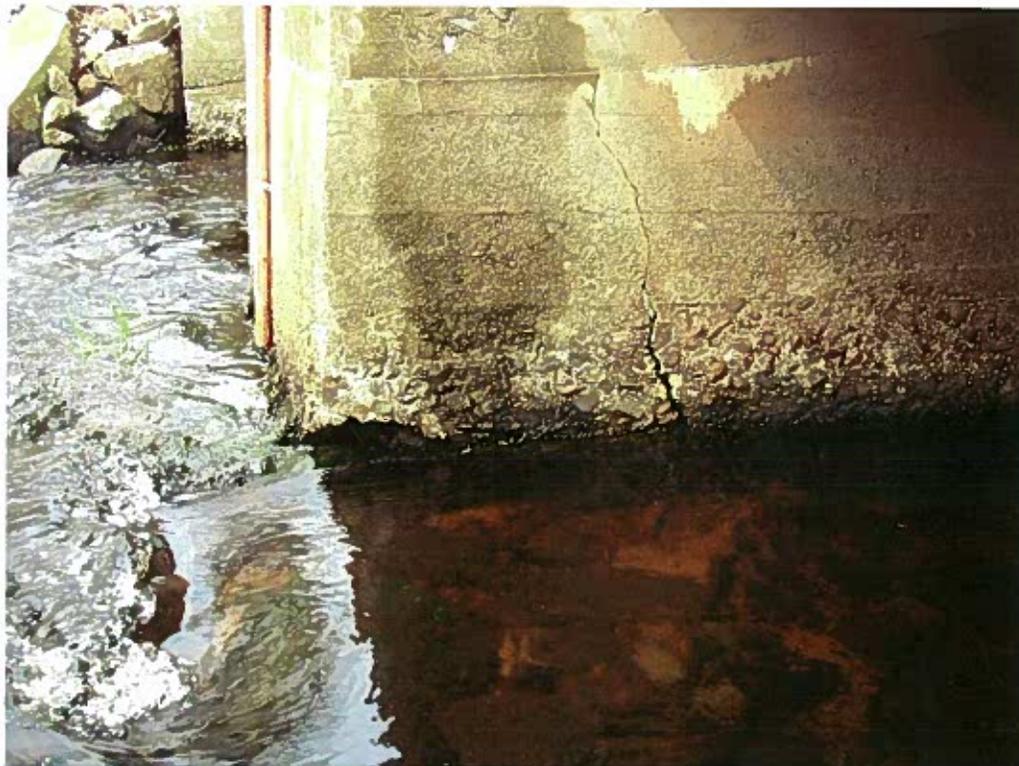
**Photo 10: Abrasion and spalling at SE corner of pierwall**

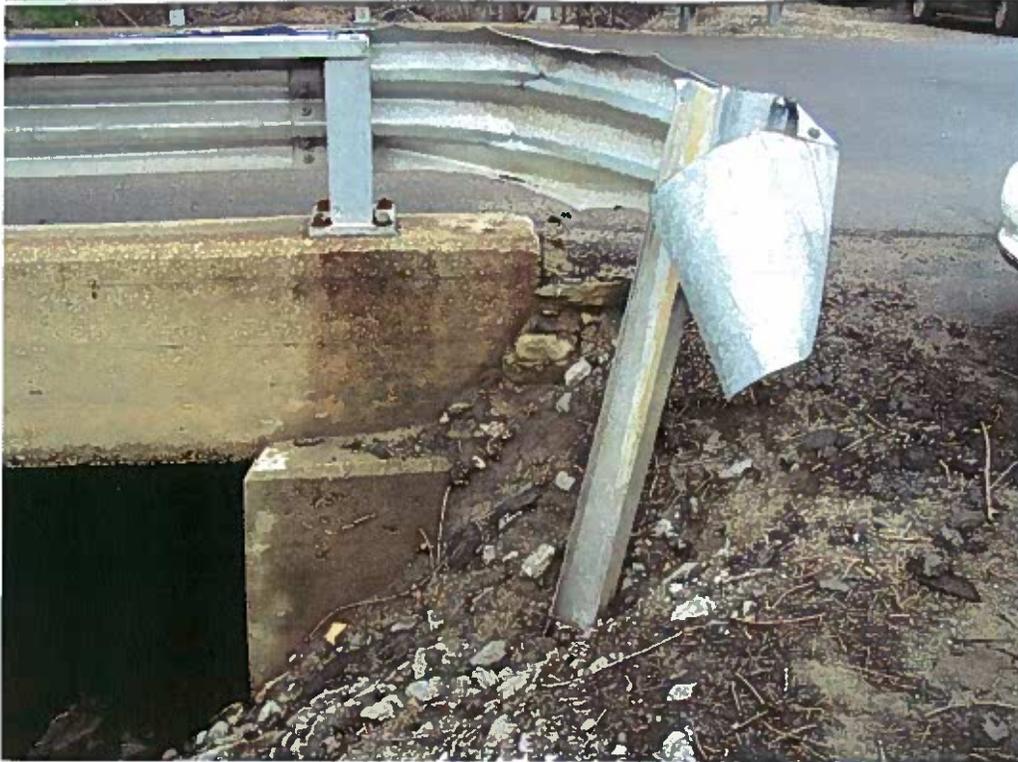
**Photo 11: Collision damage to SE approach rail end and embankment erosion**
