INTERDEPARTMENTAL COMMUNICATION

Subject: Site Plan Special Permit #1/23/2009-417 - Wetherbee Plaza Extension -
107 – 115 Great Road

We reviewed the plan entitled "As-Built Plan, 107-115 Great Road Acton, Massachusetts" dated May 7, 2010 and last revised on May 11, 2010. This plan was submitted to our office on May 11, 2010. Based on our review we have the following comments: ***Our revised comments made on May 21, 2010 have been highlighted with text that is bold and italicized. These comments are based on the As-Built Plan dated May 7, 2010 with the latest revision date of May 20, 2010 and the packet of information submitted with the letter from Acton Survey & Engineering dated May 20, 2010.***

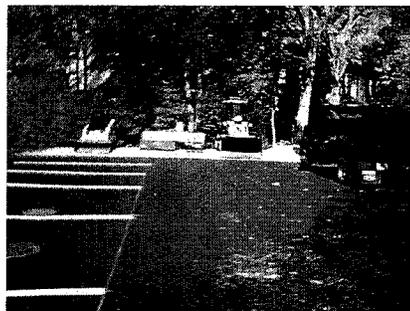
- The turnaround at the Carriage House was not constructed as shown on the plans. The applicant used crushed stone instead of pavers as proposed on the plan and the layout of the crushed stone area is different. The engineer stated in his letter dated May 7, 2010 that they substituted the pavers for crushed stone due to their limited timeframe to construct the turnaround and the potential for settlement. The No Parking sign was installed. However, there was construction equipment being stored on the crushed stone area that is obstructing the turnaround. The painted parking spaces along the Carriage House were painted in a manner that would also potentially obstruct the area for the fire truck to maneuver.

The enclosed Carriage House Pavement Diagram presents the difference between the pavement and grass pavers/trap rock areas at the Carriage House we believe that the small modifications do not inhibit vehicle turning movements. Given the time period in which the turnaround was to be constructed we believe that the use of trap rock is a better solution than grass pavers or bituminous concrete pavement. The trap rock enhances recharge. Equipment that is to be stored in the Carriage House has remained

The engineer has submitted a Parking Proof Diagram showing the 2 parking spaces that are obstructing the turnaround for the emergency vehicles could be removed. The proposed Carriage House Parking Proof Diagram dated May 19, 2010 shows that the applicant could layout their parking in a revised manner to maintain the minimum number of parking spaces. The parallel parking space shown on this diagram adjacent to the Carriage House is located in a paved area that was originally proposed as open space. The parking space is also shown to obstruct the walkway that was supposed to be located along this side of the driveway. I would defer comment to the Fire Chief as to the adequacy of the turnaround that was constructed on the site. Based on our turning templates, it seems that the turnaround needs to be extended further along the walkway as shown on the previously submitted proposed plans to allow sufficient room for the fire truck to maneuver on the crushed stone surface.
