# Conditions Assessment & Schematic Design Report

## The Asa Parlin House Acton, Massachusetts

October, 2012

menders, torrey & spencer, inc.

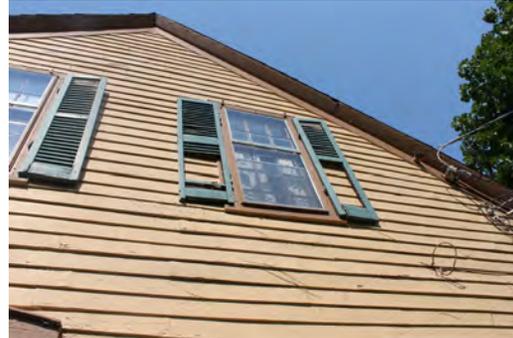
The wood clapboard siding and trim elements have areas of rot and there is widespread paint failure. Shutters on the facade are in poor condition with missing louvers. The windows exhibit deteriorated glazing and cracked panes; window operation was not tested. Vegetation overgrowth is contributing to moisture retention and damage to the clapboards, particularly at the base of the building.

Damaged shutters and worn paint finishes at the facade.

- Make structural repairs as recommended by Structures North (summarized on page 25 of this report).
- Repair, prepare, prime and repaint wood clapboards and trim elements.

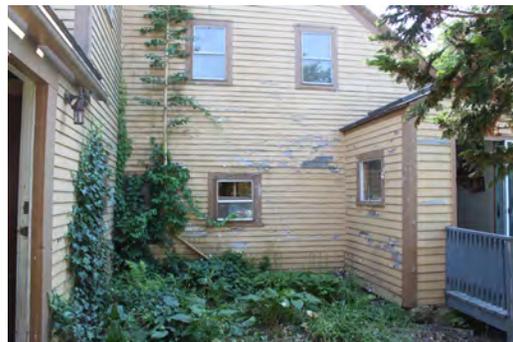
Widespread paint failure at the east elevation.

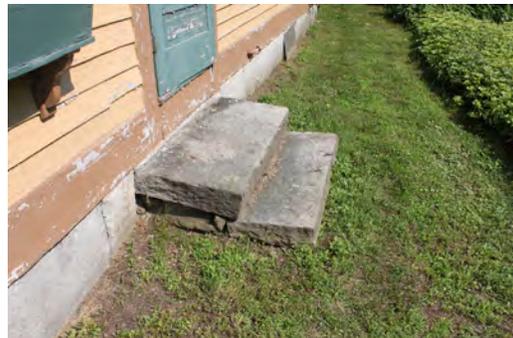
The asphalt roof shingles are in fair but serviceable condition with cupping and areas of wear. The gutters and downspouts are in fair condition but filled with debris. There is mortar failure and damaged flashing at the chimney base. The granite steps at the entry have shifted out of alignment.

Misaligned granite steps at the main entry. Worn paint finish at the clapboards, trim, door and sill.

- Repair and reglaze windows.
- Schedule roof for replacement when renovations are performed.
- Repair and clean gutters and downspouts.
- Repoint the chimney and replace flashing.
- Rebed and align the granite entry steps.
- Remove vegetation from the building.

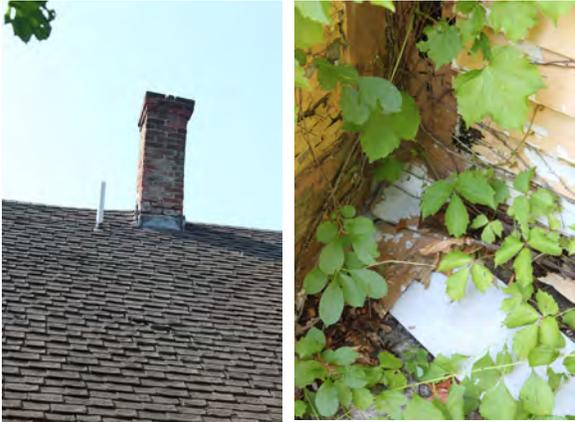
Left: aged asphalt shingles, mortar failure at the chimney.  
Right: vines damaging wood clapboards and cornerpost.

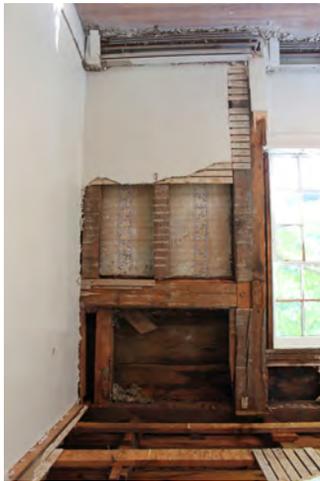
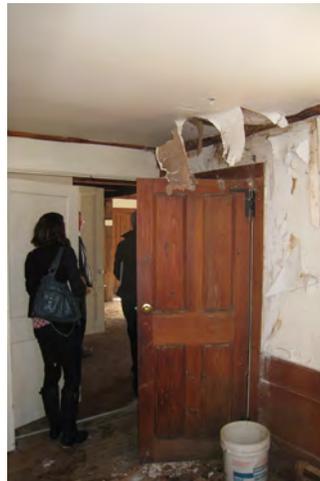
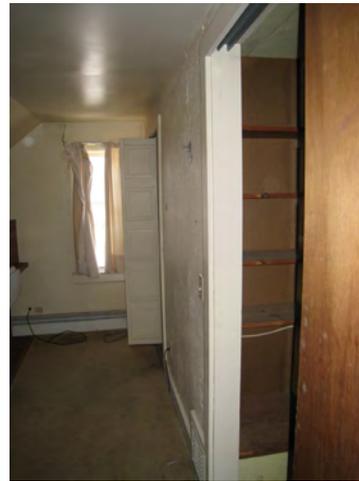
The plaster walls and ceiling show water damage throughout. Additional impact was sustained when areas of wall and flooring were selectively removed as part of the framing investigation. The plank flooring is worn. The wood wainscot, trim and doors are in good condition. The bathroom fixtures and finishes are in poor condition.

Left: framing exposed during selective demolition. Center: peeling paper at wall and ceiling. Right: second floor.

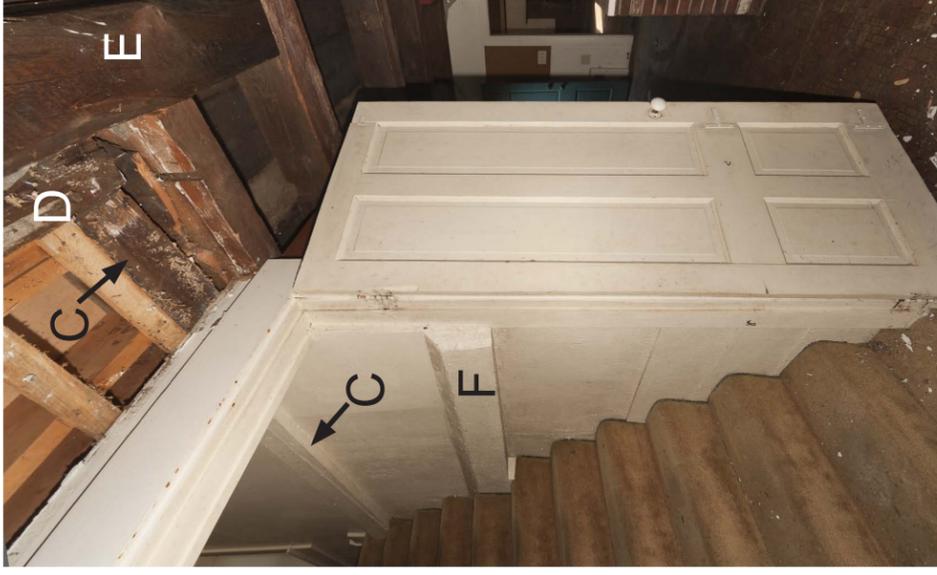
**Photo 12:** Southeast corner of the mid-19th century structure. "C" marks the east slash sawn girt. "D" marks south slash sawn girt. "E" is modern reused framing. "F" may be a continuation of the missing lower east hewn girt in room 115.

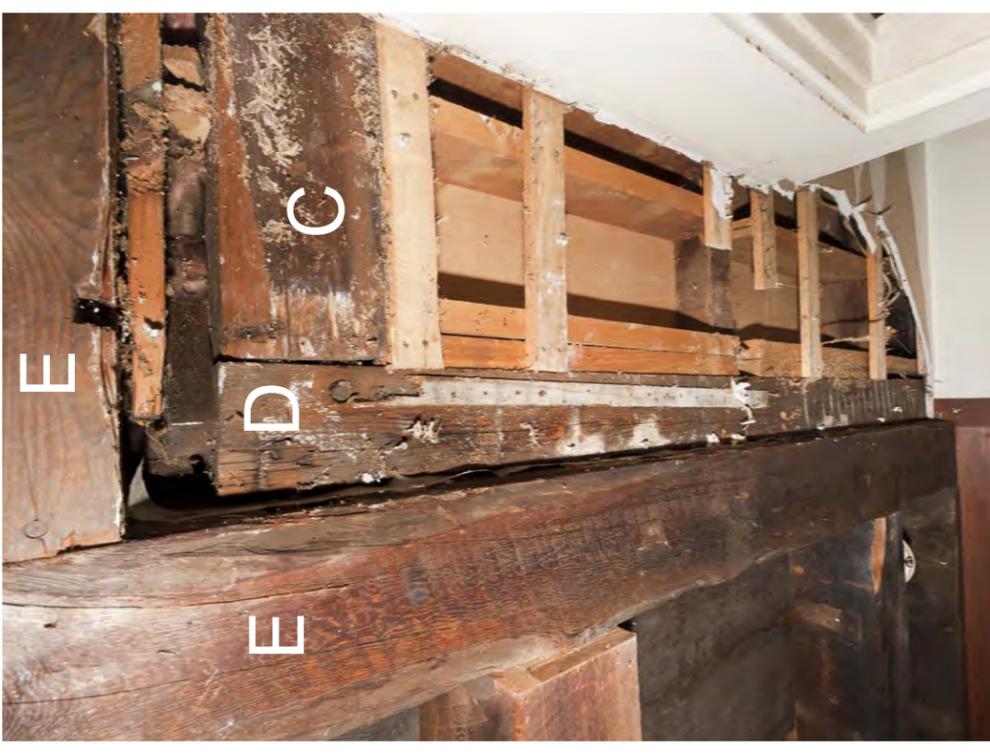
**Photo 13:** Detail of the southeast corner of the mid-19th century structure. Letters indicate members labeled in photo 12. There is no indication of a former corner post under the junction of girts C and D. Perhaps D was on top of an earlier girt that was removed when the framing at "E" was added.

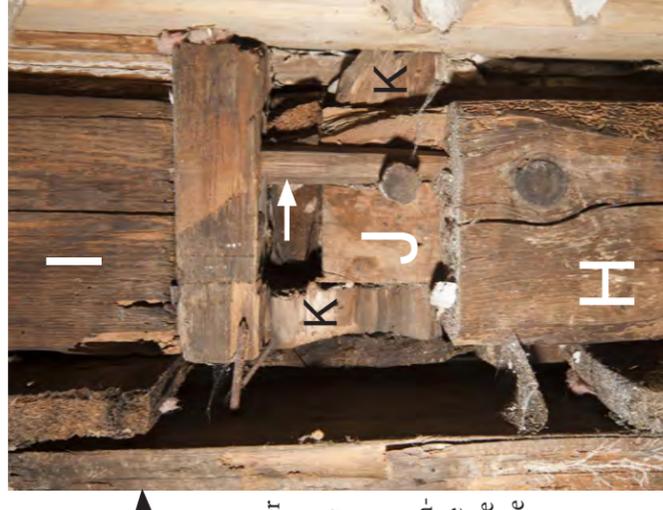
**Photo 22:** Detail of photo 20 showing the pins that secured the former girts to the top of post "H". "J" is the tenon of "H" that received a former east/west girtd, remnants of which are marked "K". White arrow points to the pin that secured the north/south girtd ("G" in photo 21) in place.
