# West Acton Baptist Church

## A. Architectural Report

June 21, 2013

## West Acton Baptist Church Building Condition Analysis

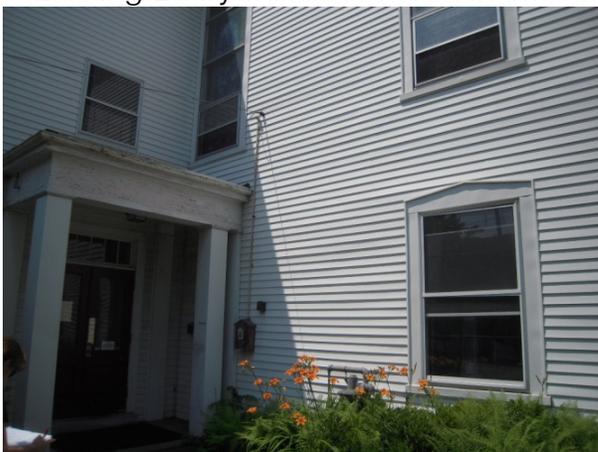
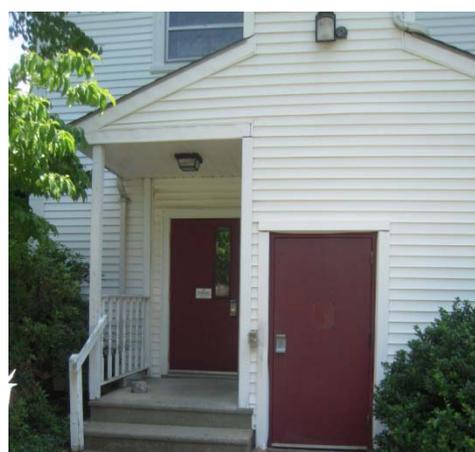
- Vinyl siding installed in the 70's is in fair condition, suggest cleaning and minor restorations
- Wood canopy and trim located around exterior doors may want to be restored and painted
- Existing Belfry will be restored in the Fall 2013

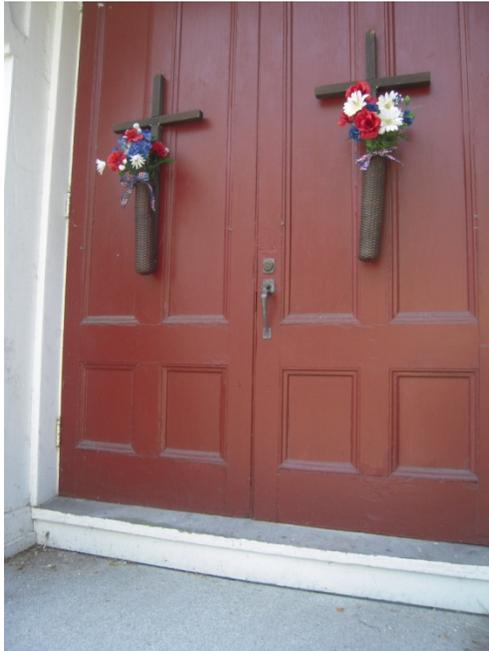
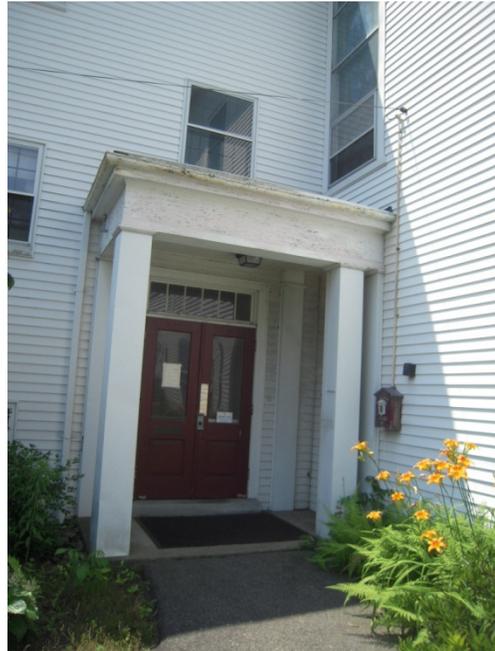
- Storm window enclosures over existing stain glass windows (operable sash for ventilation)
- Main entry wood doors appear to be the original doors, may need refurbishment and new hardware
- Wood doors on east side entry are not the proper size and may want to be replaced with accessible hardware
- Wood door on west side entry is the proper size but does not have required latch side clearance on the pull side of the door and could benefit with new compliant hardware

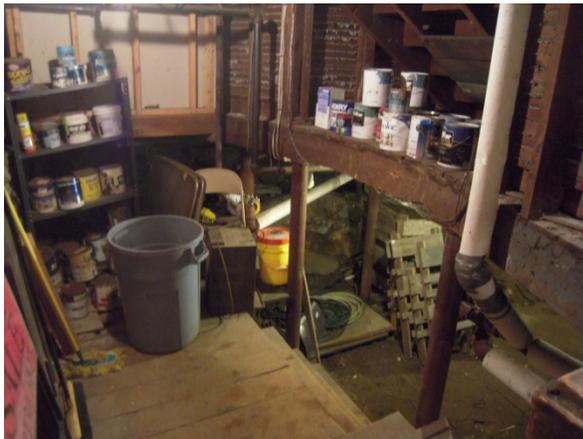
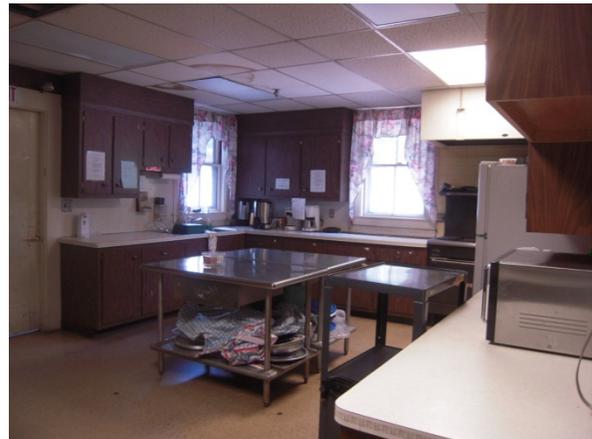
- Kitchen: Sheet flooring may need to be updated to meet current Board of Health requirements
- Basement: Partial concrete and dirt floor allows water to flow through basement at times. Installation of better sump would improve condition (or installation of a perimeter foundation drain system).

- Kitchen: existing walls have ceramic tile and wall paper. Wall paper would need to be replaced with tile or coated panels to meet current codes
- Basement: has rubble foundation walls in reasonable condition

- Kitchen: ACT ceiling is stained and not coated, Board of Health would require clean room tiles in this space if it is to be brought up to code.
- Basement: Exposed wood floor joists and no fixed lighting. Adding permanent lights would be helpful but are not required by the state building code.

- Kitchen Hood should be tested and replaced or restored as required
- Counters may need to be replaced (suggest stainless steel countertops)

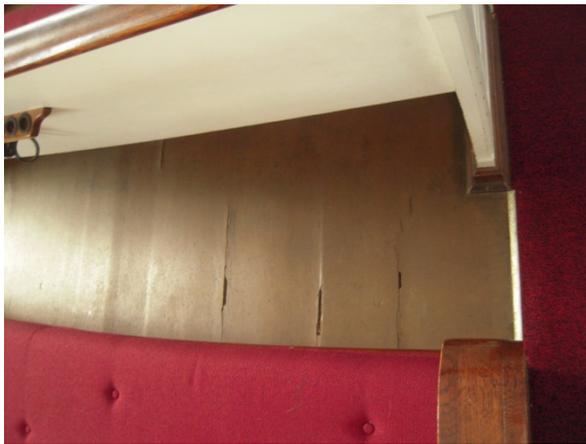
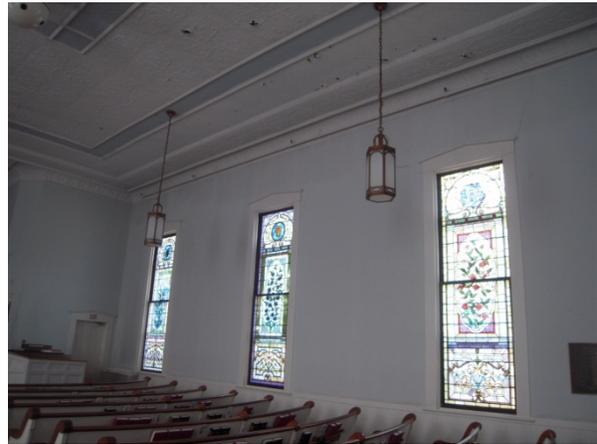
- Carpeted aisles and old linoleum flooring under pews. The wood plank floor appears to be the structural subfloor and most likely cannot be refinished as a hardwood floor if the linoleum was removed. Suggest using a new flooring system over the existing wood planks.

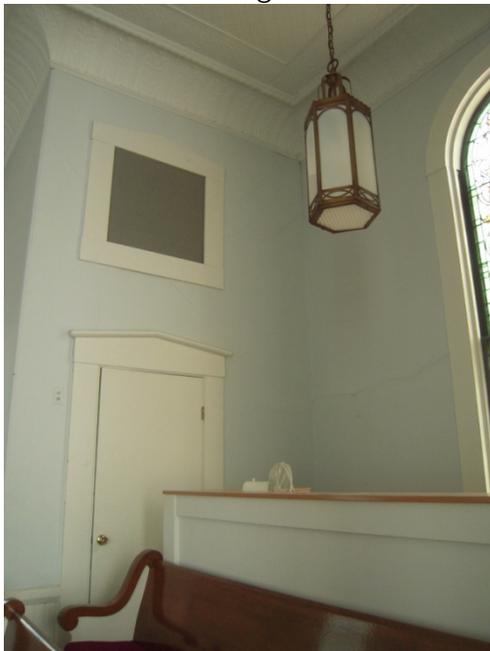
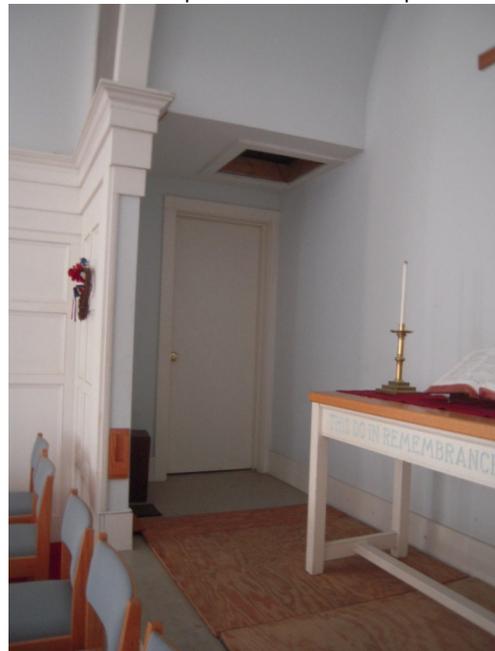
- Plaster walls in the sanctuary have stress cracks along the exterior walls, but there are no signs of leaks or water damage. Should be patched and repainted.

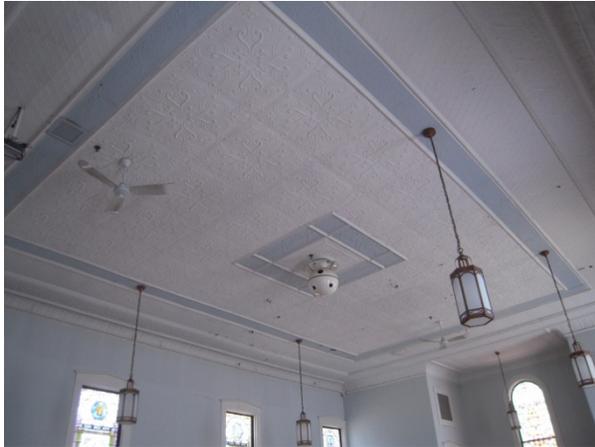
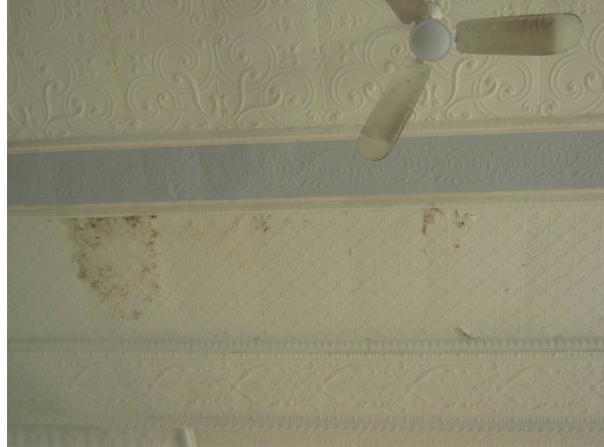
- Steel ceiling appears to be part of the original architecture. Signs of water damage are apparent in the ceiling and paint is peeling. Ceiling could be refurbished to maintain historic character

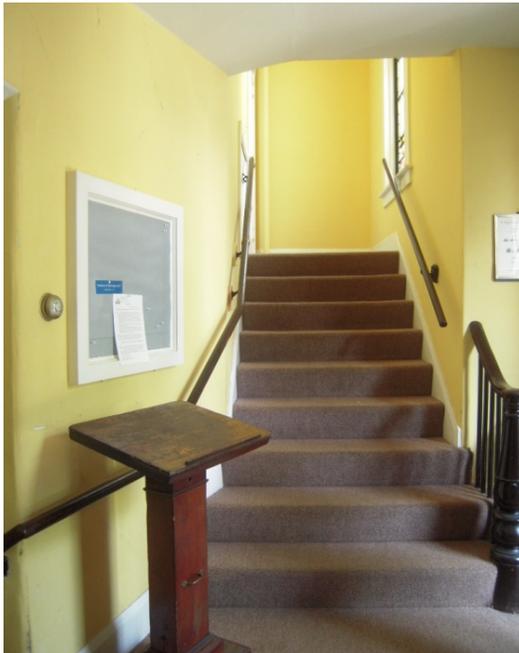
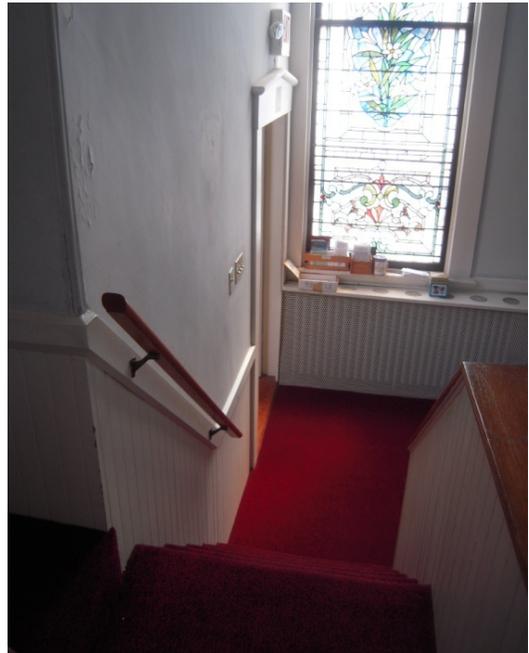
- Stairs and stair handrails do not meet current accessibility or building code requirements.
  - Stair tread height is over 7"
  - Most railings exceed 1 ½" width and are not located at least 1 ½" away from the wall
  - hand railings are not set at the proper height, some railing brackets are not properly fastened to the wall (blocking should be added and bracket should be reinstalled at the proper height)
  - Stairs do not have visual transition at bottom and top tread
  - Stairs to baptismal do not have hand rails or proper landing size at doorways
  - Railings do not extend the proper length beyond top and bottom tread

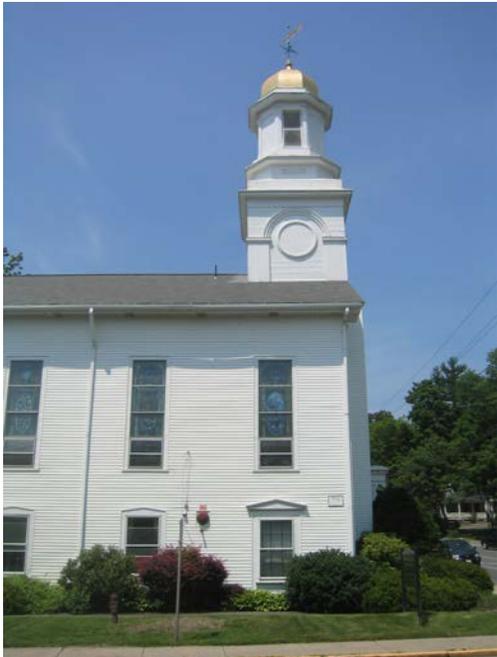
Photo No. 1: Belfry and Sanctuary Roof

2. The Belfry also appears to be relatively plumb (Photo No. 1). The aspect ratio (height to width) is relatively low. Belfry construction was briefly reviewed during the site visit. The Belfry appears to be well constructed, with rational, gravity load and lateral (wind) load systems. Reportedly, there have been some leaks and there may be areas where localized deterioration of framing members has occurred. FBRA understands that a Contractor has been retained to inspect the framing and to conduct any repairs to the roof and structure that may be required.

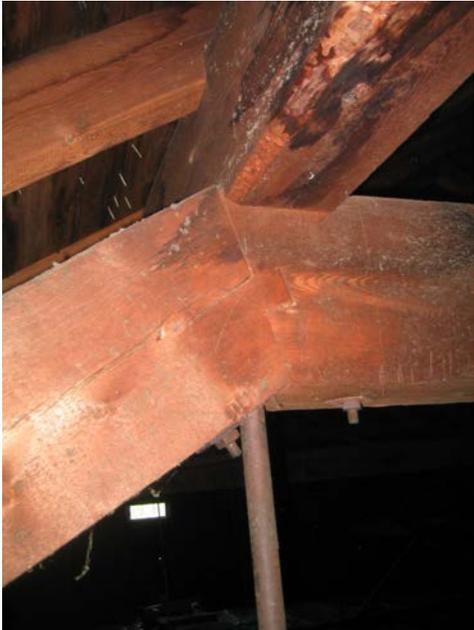
Photo No. 2: Queen Post Truss Joints

3. The condition of the trussed roof construction over the Sanctuary appears to be satisfactory. Truss joints appear tight and it does not appear that any significant out of plane movement has occurred (Photo No. 2). The capacity of the roof structure was not determined; however, it appears to be performing satisfactorily. No prominent sags or dips in the roof construction were observed from the building exterior (Photo No. 1). As the original (presumably slate) roof has been replaced by the current (lighter), asphalt shingle roof, the review of roof member anchorage is recommended.

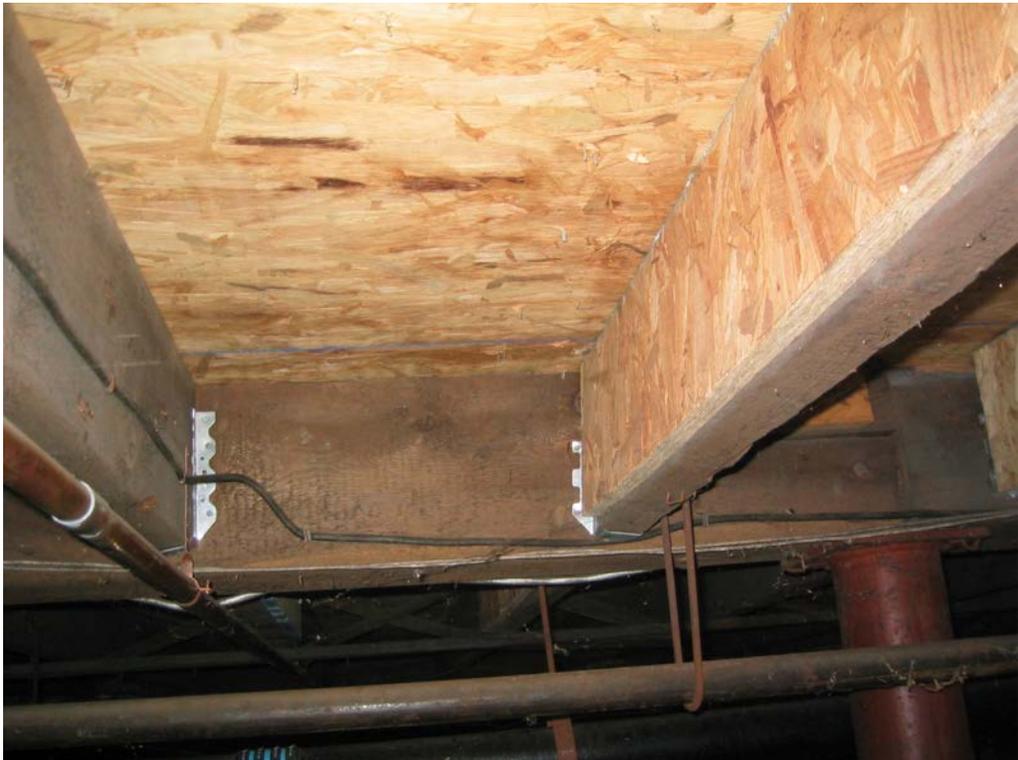
Photo No. 3: Fellowship Hall Floor – Sistered Joists, Plywood Subfloor and Added Joist Hangers

6. A number of Main Level joists in the original church have been repaired by sistering; joist hangers have also been added where splits have developed at the mortised connections to the supporting beams (a common condition for this type of construction). FBRA recommends that hangers be provided at all Main Level joist/beam connections. Similar conditions may be present at the Upper Level floor construction as well; further review is recommended (Photo No. 3).

7. Wood subflooring of the Main Level has been replaced by  $\frac{3}{4}$ " plywood in some locations; this is structurally acceptable (Photo No. 3).
8. Steel pipe columns in the Fellowship Hall, which support the Sanctuary floor above are 2 $\frac{1}{2}$ " OD and have an unbraced length of approximately 9 $\frac{1}{2}$  feet (relatively slender). The capacity of these columns is somewhat marginal, but acceptable for the fixed seating Sanctuary use (Photo No. 4).

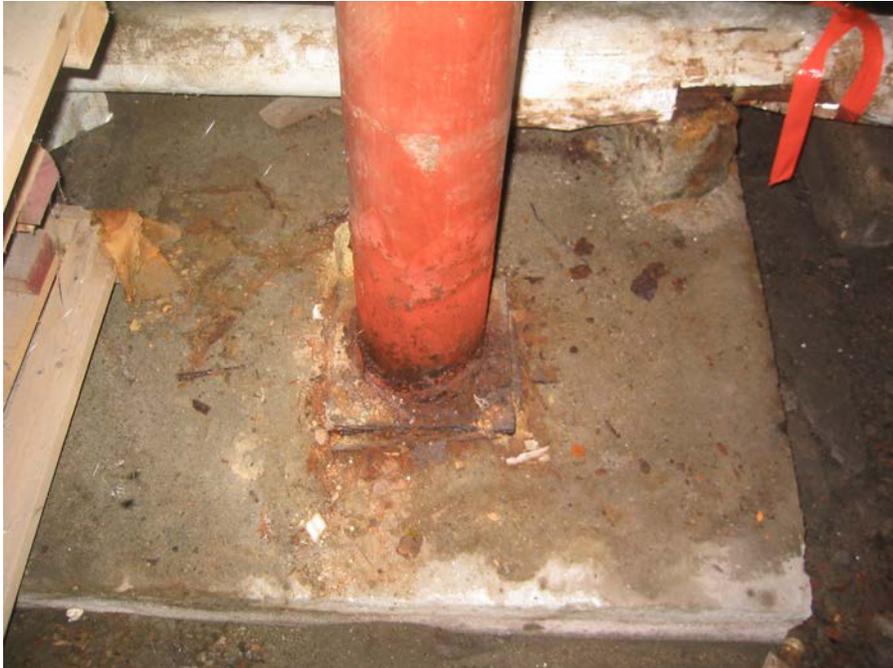
Photo No. 5: Corroded Column Base and Base Plate in Crawl Space

10. The bases/base plates of steel columns in the crawl space have corroded, due to the above-mentioned damp conditions. FBRA recommends that these areas be mechanically cleaned and evaluated to determine if there are any structural concerns (Photo No. 5).

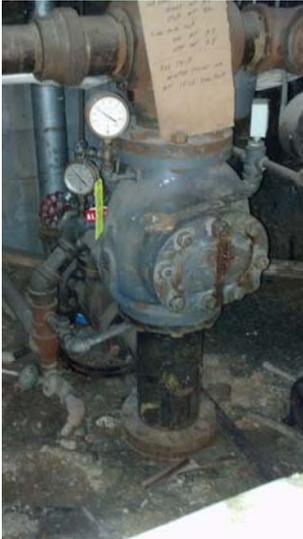
- The fire service enters the dirt floor basement from Central Street. The fire service is controlled by an exterior post indicating valve (PIV). The PIV is not monitored by the fire alarm system and does not have a padlock. The service has a check valve and 6" dry alarm valve. The service is not protected with a code required double check valve assembly.

*Fire service and dry alarm valve*

- Due to the age of the system we would recommend full replacement. This would include new double check valve assembly on incoming service, new dry type alarm valve and air compressor.
- Due to the potential of corrosion inherent in dry sprinkler systems, we would recommend use of galvanized pipe and fitting for new systems.
- All new sprinkler heads should be quick response type in accordance with NFPA 13 standard.

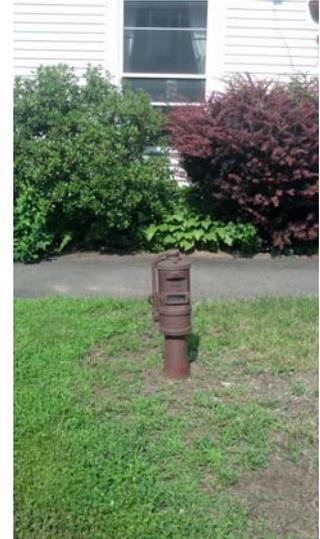
*Post indicator valve*

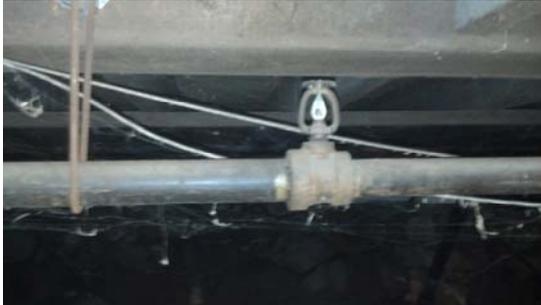
- Sprinkler piping is black steel with threaded joints. Piping is generally exposed throughout the building.
- Sprinklers are solder type, upright or vertical sidewall, heads and several show sign of corrosion.

*Basement sprinkler*

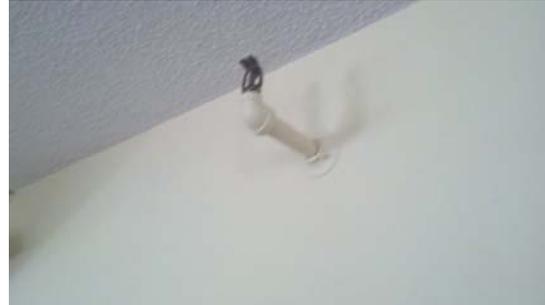
*Vertical sidewall sprinkler*

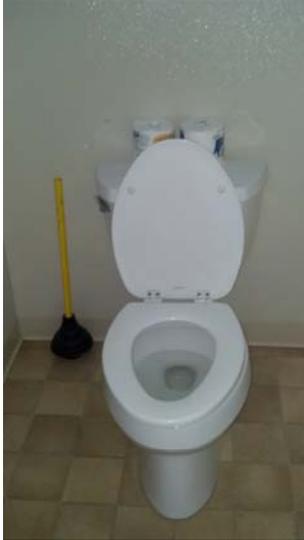
*Floor mounted tank type toilet*

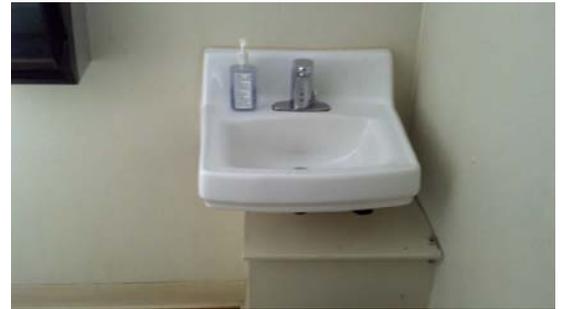
*Lavatory with sensor faucet*

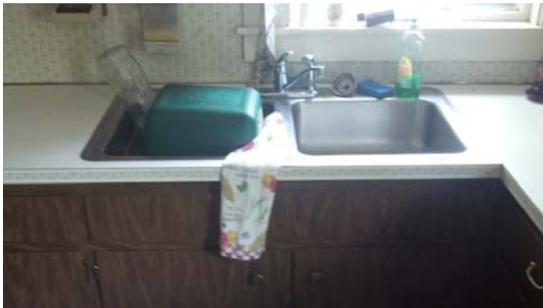
*Kitchen sink*

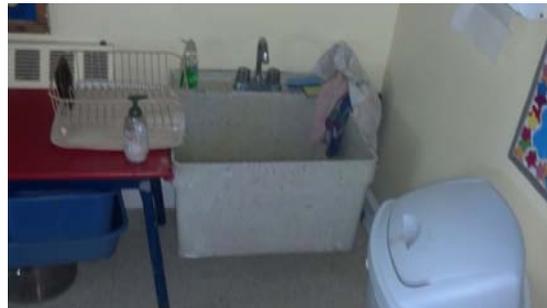
*Wall hung laundry tubs*

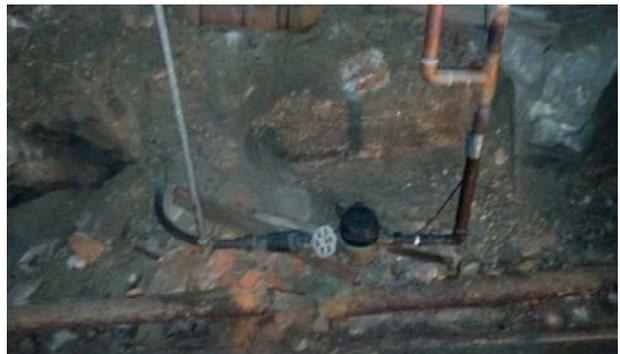
*Water service & meter*

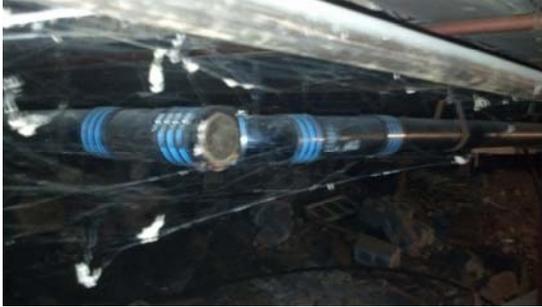
- Cast iron is used for sanitary drainage. Where visible in crawl space it appears original cast iron piping has been replaced with no-hub cast iron pipe with no-hub coupling s. The new piping connects to the existing sanitary service which exists on the west side of the crawl space.
- There is a simplex sump pump located in the crawl space. Pump discharge is thru a flex hose then galvanized pipe. Sump is not properly covered or vented.

*New no-hub cast iron*

- In general, the cast iron drainage piping can be reused even in a major renovation where adequately sized for the intended new use. Video inspection of any buried piping intended for reuse is recommended.

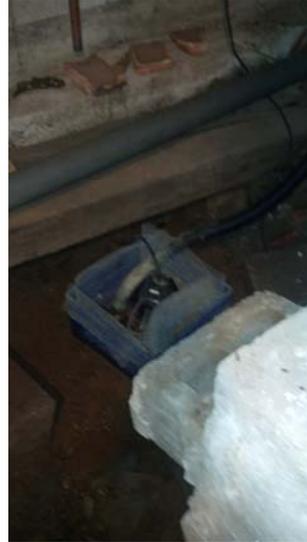
*Crawl space sump pump*

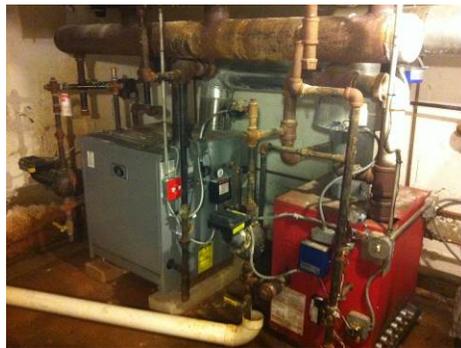
- The heating plant consists of two gas fired steam cast iron boilers. The primary boiler is of the Peerless manufacture and the backup boiler is of the HB Smith manufacture. Both boilers have fire tube style burners. All safety components appear to be installed. Both boilers appear to be in fair condition. Each boiler has a separate breeching system utilizing galvanized sheet metal. Both exit the building through the masonry chimney. Supply and return piping appears to be schedule 40 black steel and travels throughout the building feeding fin tube radiation and cast iron radiators. Condensate return travels back to the boiler room and into a duplex pump condensate receiver which feeds into the boilers. None of the piping within the boiler room is insulated. The the crawl space piping system is not completely insulated and some of the existing insulation appears worn and damaged. Throughout the building within individual rooms, insulation is utilized; however, it is unclear whether the insulation is fiberglass or asbestos. This should be tested and verified. The majority of the insulation throughout the building is in poor condition and replacement with fiberglass insulation should be considered. Combustion air for the boilers appears to be through one opening located low on one of the walls which communicates directly to the outdoors through the use of a galvanized sheet metal duct. This one opening does not appear to be sized properly and may not be code compliant.

*Steam Boilers*

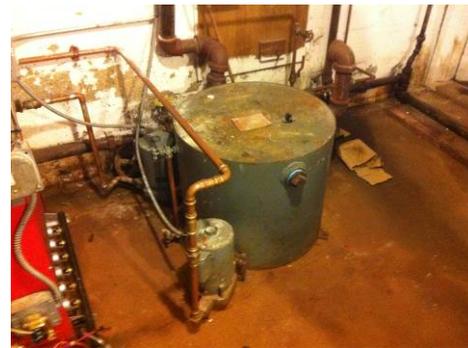
*Condensate Receiver w/ Duplex Pumps*

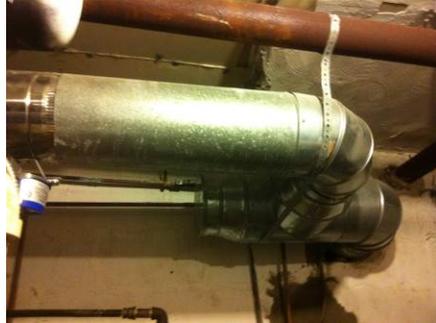
*Boiler Breeching*

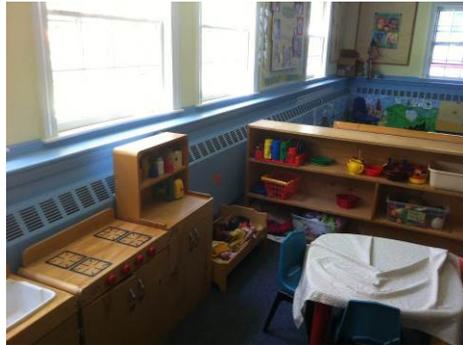
- On the lower level, fin tube radiation is utilized throughout the Nursery, Classrooms and stairwells as the main heat source. Wall-mounted thermostats are located in each space and are associated with electronic control valves located within the fin tube cover. The fin tube cover and element appeared to be in fair condition. Piping insulation was soiled and damaged in many locations.

*Typical Fin Tube Radiation*

- Provide 1-1/2" fiberglass insulation on all piping in the boiler room, crawl space, and within each space. An insulation cover should be provided in spaces where the piping system is exposed to prevent damage to the insulation.

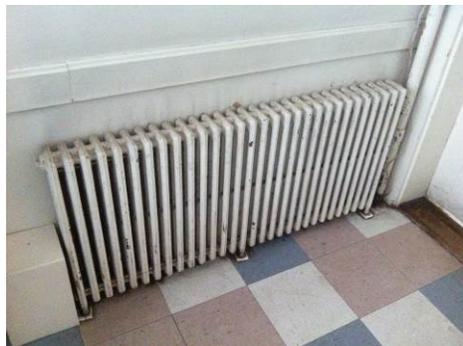
- On the main level, fin tube radiation is utilized throughout the offices, classrooms and bathrooms as the main heat source. Within the Fellowship Hall, storage and lower entry, cast iron radiators are utilized as the main heat source. Wall-mounted thermostats are located in each space and are associated with electronic control valves located within the fin tube cover or adjacent to the cast iron radiators. The fin tube cover and element appear to be in fair condition. The cast iron radiators appear to be in fair condition; however, consideration should be given to removal and replacement with fin tube radiation for a more even heat distribution within the space. Piping insulation was soiled and damaged in many locations. Custom wooden boxes were made to conceal the control valves associated the cast iron radiators in the Fellowship Hall. These boxes are not fastened down and could potentially allow damage to be done to the already antiquated control valves.

*Typical Cast Iron Radiator*

- Areas utilizing cast iron radiators should be upgraded to fin tube radiation. This would provide a more even heat distribution throughout the space and allow exterior infiltration to be captured at the wall.

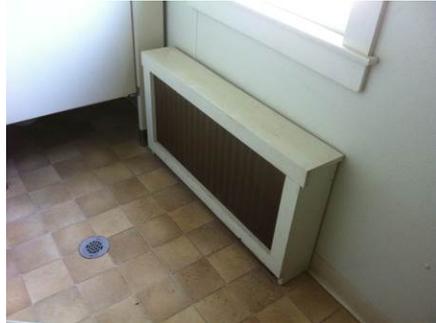
*Typical Bathroom Radiator*

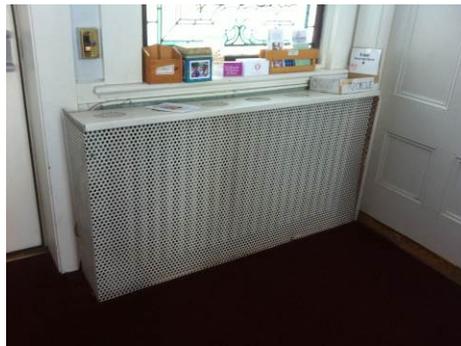
- On the upper level, fin tube radiation is utilized throughout classrooms and stairwells as the main heat source. In the sanctuary cast iron radiators, which are concealed with a perforated metal casing, are utilized as the main heat source. Wall-mounted thermostats are located in each space which are associated with electronic control valves located within the fin tube cover or adjacent to the cast iron radiators. The fin tube cover and element appeared to be in fair condition. The cast iron radiators appeared to be in fair condition; however, consideration should be given to removal and replacement with fin tube radiation for a more even heat distribution within the space. There was no piping insulation on any of the heating piping on this level.

*Typical Sanctuary Radiator*

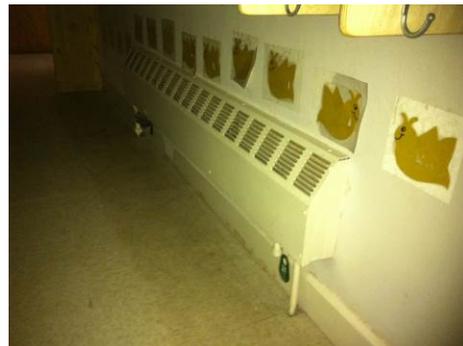
*Typical Fin Tube Radiation*

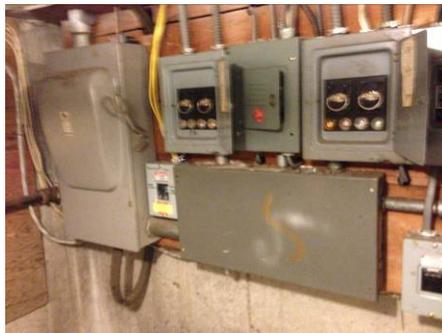
- An overhead service lateral feeds the existing electrical service equipment located in the basement. The service entrance cable runs through the crawl space and terminates on a 200 amp, 120/240 volt fused switch. The main electrical service equipment is rated at 200 amps, 120/240 volt, 1 phase, 4 wire. The service equipment is in poor condition. The equipment is manufactured by Murray.

*Main Switch*

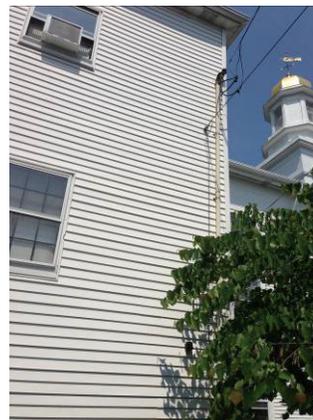
*Overhead Service Lateral*

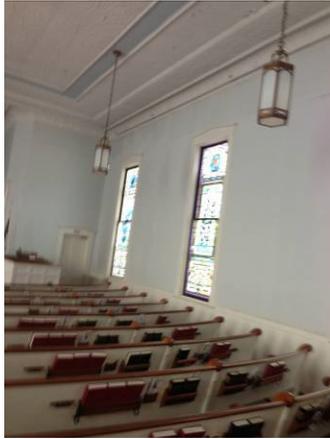
- The sanctuary has switch controls for decorative lanterns. The light level appears low.

*Worship Area Lighting*

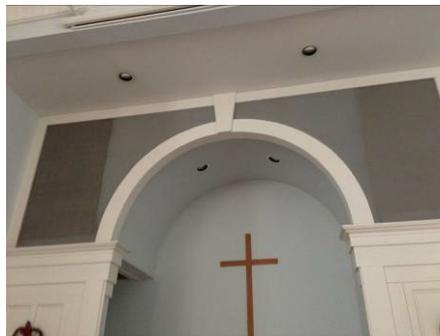
*Spot Lighting at Alter*

- There are spot lights serving the alter. The lighting is in fair condition.

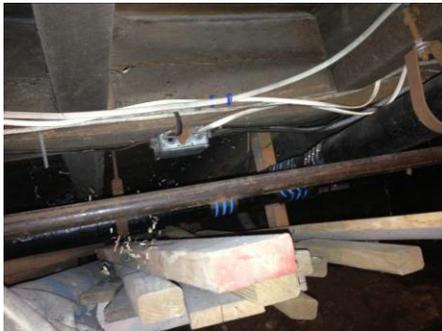
*Romex Wiring*

- The existing wiring consists of conduit, BX cable, Romex and cloth insulated cables and should be replaced. Romex is not allowed as a wiring method in places of assembly.
- Kitchen receptacles are not ground fault type.
- Light switches in worship area are in mounted at 58 1/2 inches the max height by ADA is 48 inches.

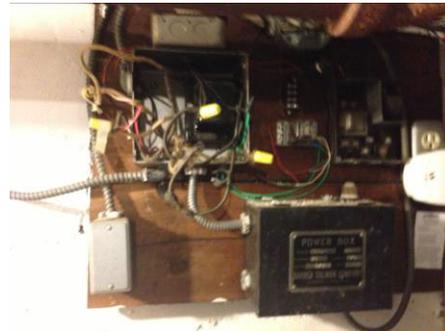
*Open Junction Boxes*

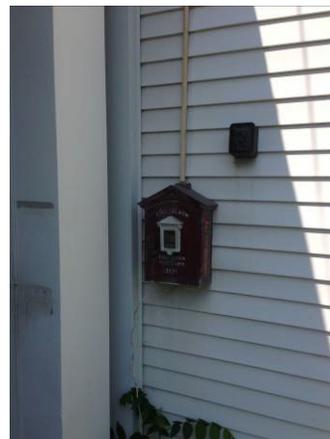
*Master Box*
