Variance Number: 11 110

RE: **Exchange Hall
2 School Street
Acton**

**ACCESSIBILITY REVIEW
EXCHANGE HALL
2 SCHOOL STREET
ACTON, MA 01720**

**OWNER INTENT AND VARIANCE REQUEST
EXCHANGE HALL
2 SCHOOL STREET
ACTON, MA 01720**

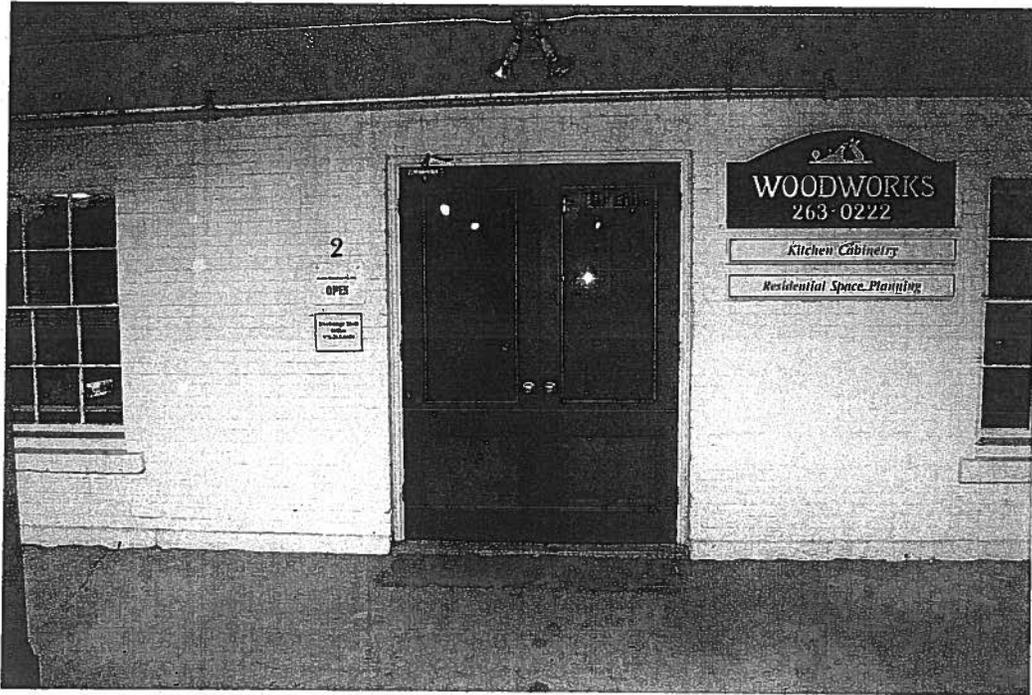
Photo No. 1

- A. Entrance/exit at door number 001, leading to an accessible route, does not comply with Section 29.2 LEVEL CHANGES. There is a 1 1/2" drop from the door threshold to the concrete walkway immediately outside of the entrance/exit. To be brought into compliance with 29.2, the walkway immediately outside the entrance shall have a change in level no greater than 1/2", with a 1:2 beveled edge, which requires the walkway to be raised approximately 1" with no more than a 2% slope for a distance of 60" from the face of the building (See Photo No. 1).

- B. Entry door number 001 does not comply with Section 26.00 DOORS AND DOORWAYS. Unit is an original 5'-0" double door unit with manual type flush-bolts and door knobs, and a coordinating original double storm door unit with manual type flush-bolts and door knobs. Neither of the door units comply with Sections 26.4, 26.5 and 26.11. The set of doors does not comply with Section 26.7 (See Photo Nos. 1 & 2).

- A. Entrance/exit at door number 001, leading to an accessible route, does not comply with Section 29.2 LEVEL CHANGES. There is a 1 1/2" drop from the door threshold to the concrete walkway immediately outside of the entrance/exit. To be brought into compliance with 29.2, the walkway immediately outside the entrance shall have a change in level no greater than 1/2", with a 1:2 beveled edge, which requires the walkway to be raised approximately 1" with no more than a 2% slope for a distance of 60" from the face of the building (See Photo No. 1). *Owner requests a variance to provide a tapered 6" wide hardwood threshold beveled to a 1:4 (25%) slope immediately outside the door in lieu of raising the entire walkway. The walkway is concrete, which means to properly raise the slope from 1 1/2" down to 0", the walkway would need to be completely cut and removed and new concrete installed. The Owner asserts that bringing this entrance into full compliance with 521 CMR is impracticable as it would result in excessive and unreasonable costs without a substantially more beneficial result than the above proposed alternate.*

- B. Entry door number 001 does not comply with Section 26.00 DOORS AND DOORWAYS. Unit is an original 5'-0" double door unit with manual type flush-bolts and door knobs, and a coordinating original double storm door unit with manual type flush-bolts and door knobs. Neither of the door units comply with Sections 26.4, 26.5 and 26.11. The set of doors does not comply with Section 26.7 (See Photo Nos. 1 & 2). *Owner requests a variance for full compliance with 521 CMR, as the door and storm doors are original and matching units. The Owner asserts that when the business is open the manual flush-bolts will be disengaged, allowing both leaves to*

swing freely. The Owner proposes to provide lever-type handles to comply with Section 26.11.1.

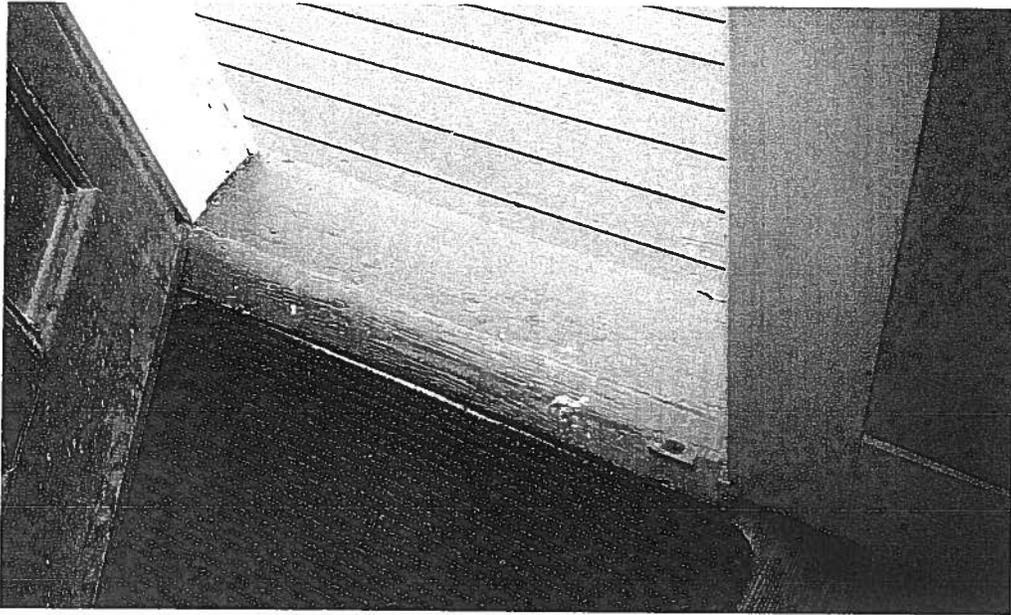
Photo No. 3

- A. Entrance at door number 107, leading to an accessible route., does not comply with Section 29.2 LEVEL CHANGES. There is a 1 1/4" drop from the door threshold to the floor immediately inside the entrance/exit (See Photo No. 3).

- A. Entrance at door number 107, leading to an accessible route., does not comply with Section 29.2 LEVEL CHANGES. There is a 1 1/4" drop from the door threshold to the floor immediately inside the entrance/exit (See Photo No. 3). *The Owner requests a variance for full compliance with 521 CMR, as the accessible route immediately outside the entrance/exit is a compliant 1/4" threshold. The Owner proposes to provide a tapered 5" wide hardwood threshold beveled to a 1:4 (25%) slope immediately inside the door. The Owner asserts that bringing this entrance into full compliance with 521 CMR is impracticable as it would result in excessive and unreasonable costs without a substantially more beneficial result than the above proposed alternate.*

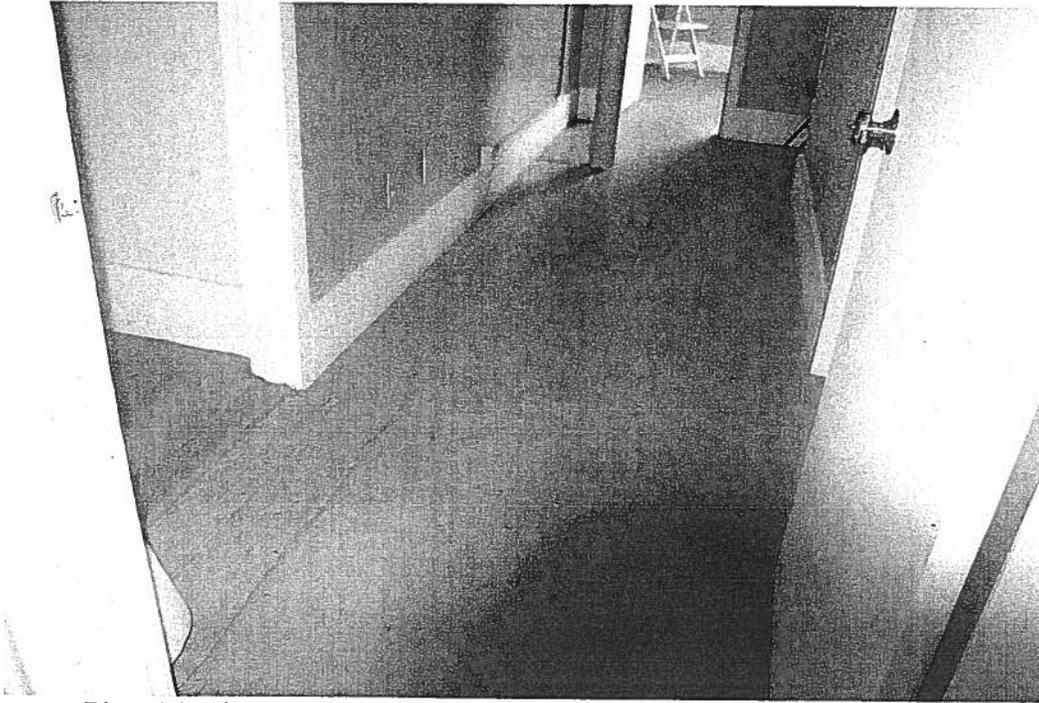
Photo No. 5

- G. Due to the difference in new hardwood flooring and original flooring, the floor drops approximately 3/4" at door number 207 from the Victorian room to the back hall, steps up again in the hall between doors numbered 206 and 215 and down again entering the hall in front of the kitchen. This condition does not comply with Section 29.2 LEVEL CHANGES (See Photo No. 5).

- G. Due to the difference in new hardwood flooring and original flooring, the floor drops approximately 3/4" at door number 207 from the Victorian room to the back hall, steps up again in the hall between doors numbered 206 and 215 and down again entering the hall in front of the kitchen. This condition does not comply with Section 29.2 LEVEL CHANGES (See Photo No. 5). *The Owner request a variance for full compliance with 521 CMR. The Owner proposes to provide a tapered 5" wide hardwood threshold beveled to a 1:10 (10%) slope at the level change.*

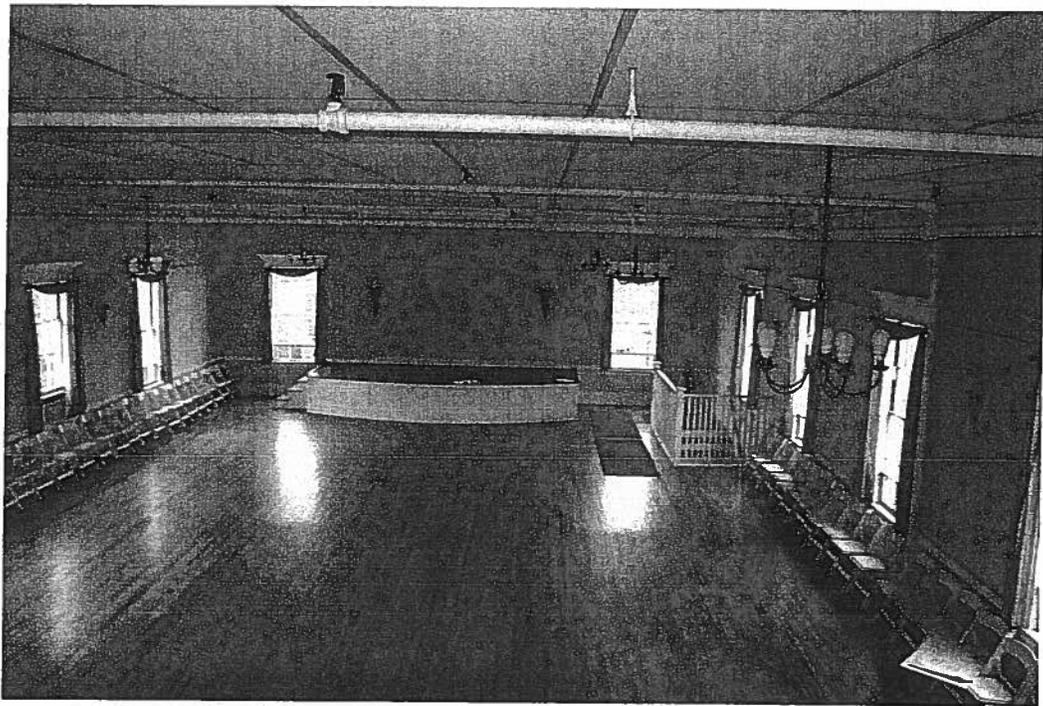
Photo No. 6

- A. The stage is approximately 2'-8" above the finish floor, which does not comply with Section 14.6 ACCESS TO PERFORMING AREAS. (See Photo No. 6)
- B. The toilet room on the west side of the building does not comply with Section 30.00 PUBLIC TOILET ROOMS. Door number 305 leading into the room has a clear opening of 2'-6 1/4", which does not comply with Section 26.00 DOORS AND DOORWAYS. The water closet is in a stall which is less than 3'-0" wide, which does not comply with Section 30.6 TOILET STALLS (See Photo No. 7). The water closet does not comply with Section 30.7 WATER CLOSETS. The sink does not comply with Section 30.9 SINK (See Photo No. 8). There are no grab bars, which does not comply with Section 30.8 GRAB BARS.

- A. The stage is approximately 2'-8" above the finish floor, which does not comply with Section 14.6 ACCESS TO PERFORMING AREAS. (See Photo No. 6) *The Owner requests a variance for compliance with 521 CMR. The Owner asserts that creating a ramp for access to the stage would be technically infeasible because of the height of the stage and the amount of ramp required to create access.*

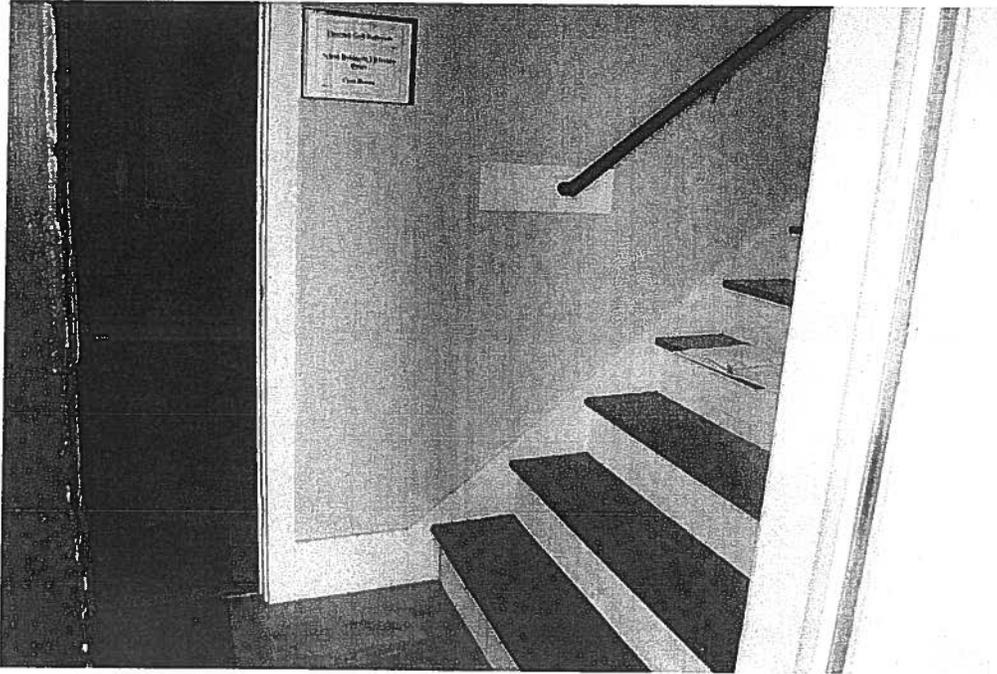
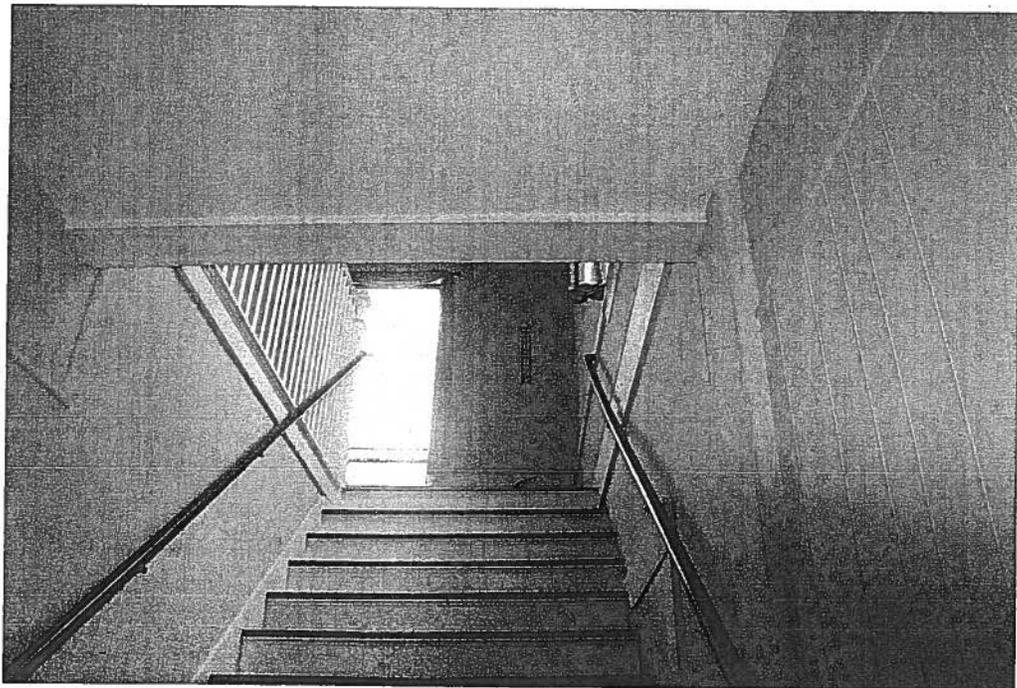
- i. Nosings are traditional bullnose with scotia molding below, which do not comply with Section 27.3 NOSINGS, requiring sloped risers or angled nosings with angle no less than 60 degrees from the horizontal.
- ii. Handrails do not comply with Section 27.4 HANDRAILS. Handrail on East side of stair is approximately 2'-8 1/2" above the stair nosings, which does not comply with Section 27.4.2. Handrails on both sides do not extend at the bottom of the stair run as far as space permits, which does not comply with Section 27.4.3 Extensions. Handrail on West side does not extend beyond the top riser, parallel to floor, which does not comply with Section 27.4.3 Extensions. Handrails on both sides have zero clearance from the floor edge and other trim projections, which does not comply with Section 27.4.7 Clearance (See Photo Nos. 9 & 10).

- i. Nosings are traditional bullnose with scotia molding below, which do not comply with Section 27.3 NOSINGS, requiring sloped risers or angled nosings with angle no less than 60 degrees from the horizontal. *The Owner requests a variance for full compliance with Section 27.3. While the nosings are not a smooth 60 degree angle, the scotia molding does mitigate the abruptness of the underside of the nosings.*

- ii. Handrails do not comply with Section 27.4 HANDRAILS. Handrail on East side of stair is approximately 2'-8 1/2" above the stair nosings, which does not comply with Section 27.4.2. Handrails on both sides do not extend at the bottom of the stair run as far as space permits, which does not comply with Section 27.4.3 Extensions. Handrail on West side does not extend beyond the top riser, parallel to floor, which does not comply with Section 27.4.3 Extensions. Handrails on both sides have zero clearance from the floor edge and other trim projections, which does not comply with Section 27.4.7 Clearance (See Photo No. 8). *The Owner proposes to replace handrails on both sides to be compliant with 521 CMR, correcting the height, providing required clearance and providing required extensions as far as space permits.*

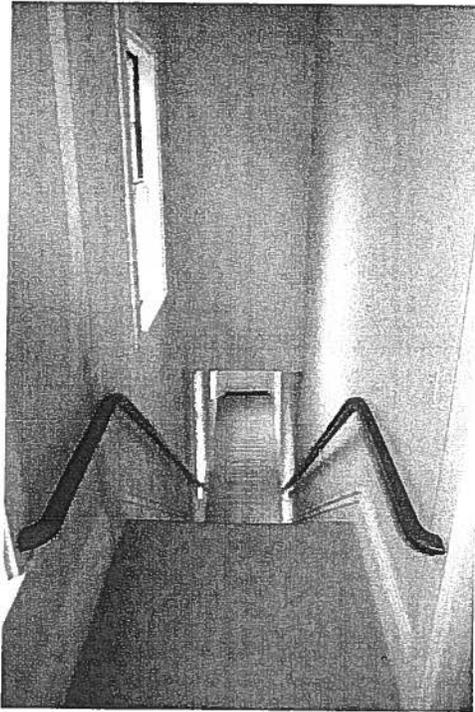
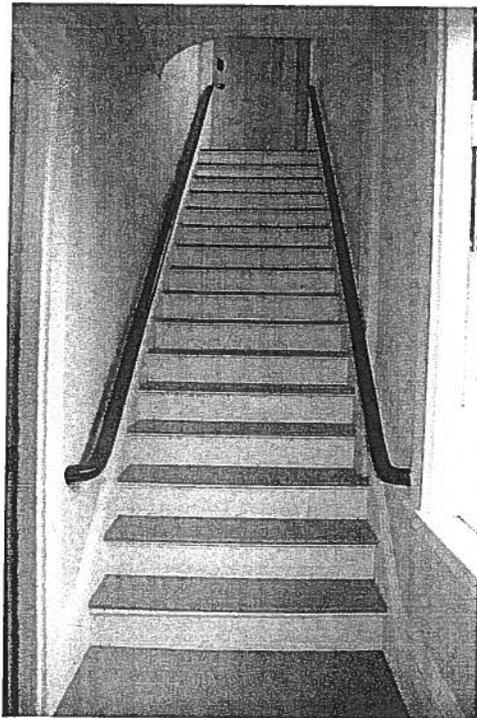
- i. Nosings are traditional bullnose with scotia molding below, which do not comply with Section 27.3 NOSINGS, requiring sloped risers or angled nosings with angle no less than 60 degrees from the horizontal.
- ii. Handrails do not comply with Section 27.4 HANDRAILS. The outside diameter of handrails on both sides is 2 3/4" in the long direction of the oval, which does not comply with Section 27.4.4 Size. Handrails on both sides have zero clearance from the floor edge and other trim projections, which does not comply with Section 27.4.7 Clearance (See Photo Nos. 11 & 12).

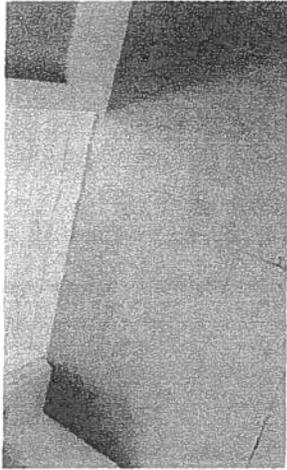
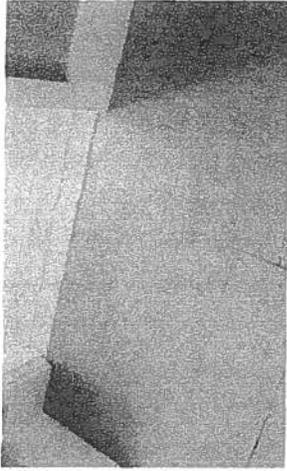
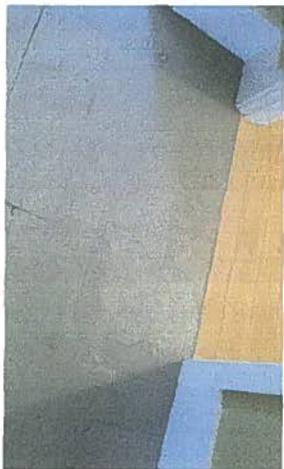
Door 207 #P1

- D. Door number 204 leading into the bridal suite has a clear opening of 2'-6", which does not comply with Section 26.00 DOORS AND DOORWAYS.
- E. Door number 207 has an approximately 1" high threshold, which does not comply with Section 26.10 THRESHOLDS.

- E. Door number 207 has an approximately 1" high threshold, which does not comply with Section 26.10 THRESHOLDS. *The Owner proposes to install new hardwood flooring over original flooring to bring the floor level to the east of this door up to the same level as the floor level to the west.*

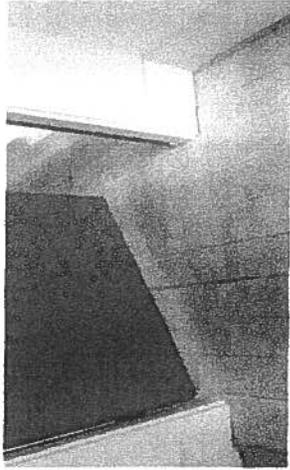
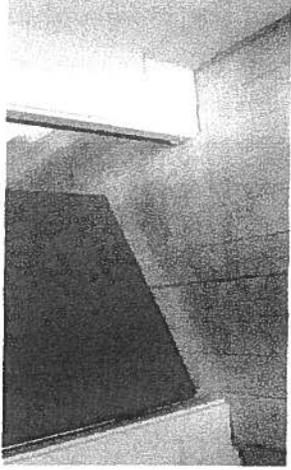
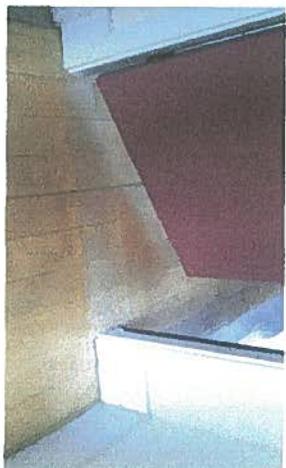
Door 208 #P2

- F. Door number 208 has an approximately 3/4" high threshold, which does not comply with Section 26.10 THRESHOLDS. Door swings into the waiting room away from the wall, which creates less than 18" for the pull side clearance, which does not comply with Section 26.6.3.

- F. Door number 208 has an approximately 3/4" high threshold, which does not comply with Section 26.10 THRESHOLDS. Door swings into the waiting room away from the wall, which creates less than 18" for the pull side clearance, which does not comply with Section 26.6.3. *The Owner proposes to remove the high threshold and reverse the door swing to bring the door opening into compliance.*
