**NAGOG POND DAM
ACTON, MASSACHUSETTS**

**UNDERWATER INSPECTION
OF THE
RAW WATER INTAKE SUPPLY LINE**

APRIL 11, 2012

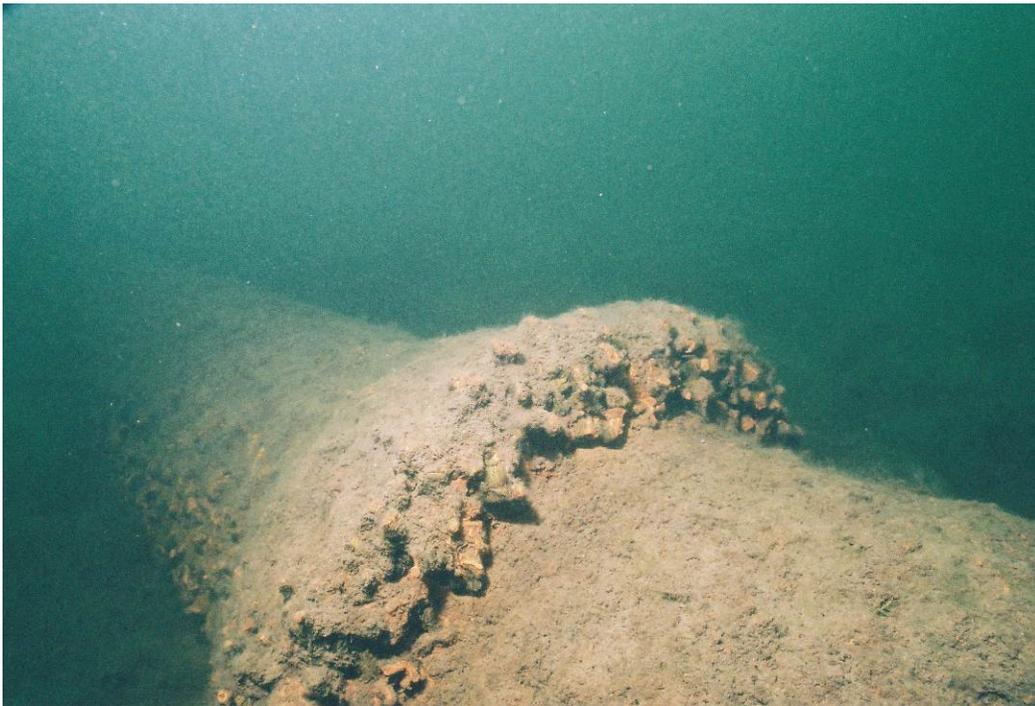
This section of pipeline was generally visible and covers an area from and adjacent to the island (situated at the center of the pond) to the end. The pipeline protrudes out of a bank of sand and rock which extends from the Island to the Easterly shore. The pipeline appears heavily rusted but intact and without observable cracks or broken sections. The pipeline is supported off the bottom of the pond by previously described wooden posts topped with cross timbers and bottom wedges holding the pipe on center. The posts and timbers appear heavily weathered and grainy with reduced X section from deterioration. The height of the wooden pipe supports varies with the elevation off the bottom. Discussion with the Town engineer detailed a previous inspection in which some settling of the pipe supports was noted. This could not be determined during this inspection effort because the as-built elevation of the pipeline was not known. The pipeline joints do not appear to have rotated or moved recently and the pipeline is currently bearing on all wooden pipe supports. Generally, the pipeline passes over a deeper area from the bank, into a shallower area for 50 to 100 lf, changes direction or elevation and back into a deeper area to the end. During this direction or elevation change, the greatest pipe joint angle was noted, the joint appeared intact and without leakage. (note photograph following)

Photograph showing typical exposed pipe joint

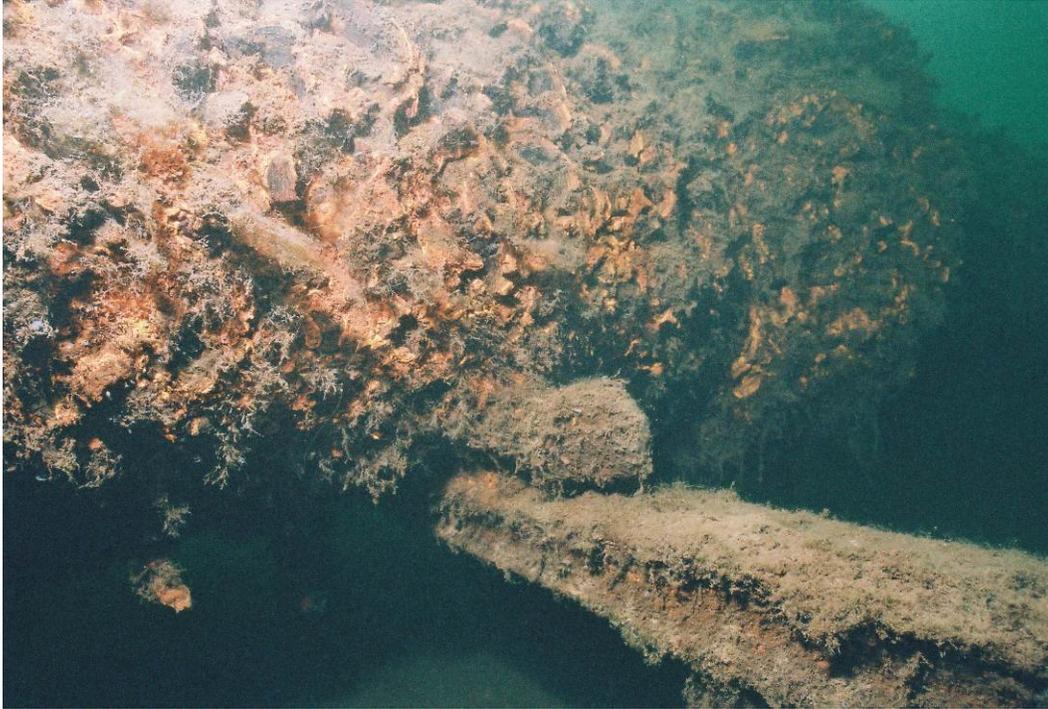
Photograph showing pipeline resting on wooden support

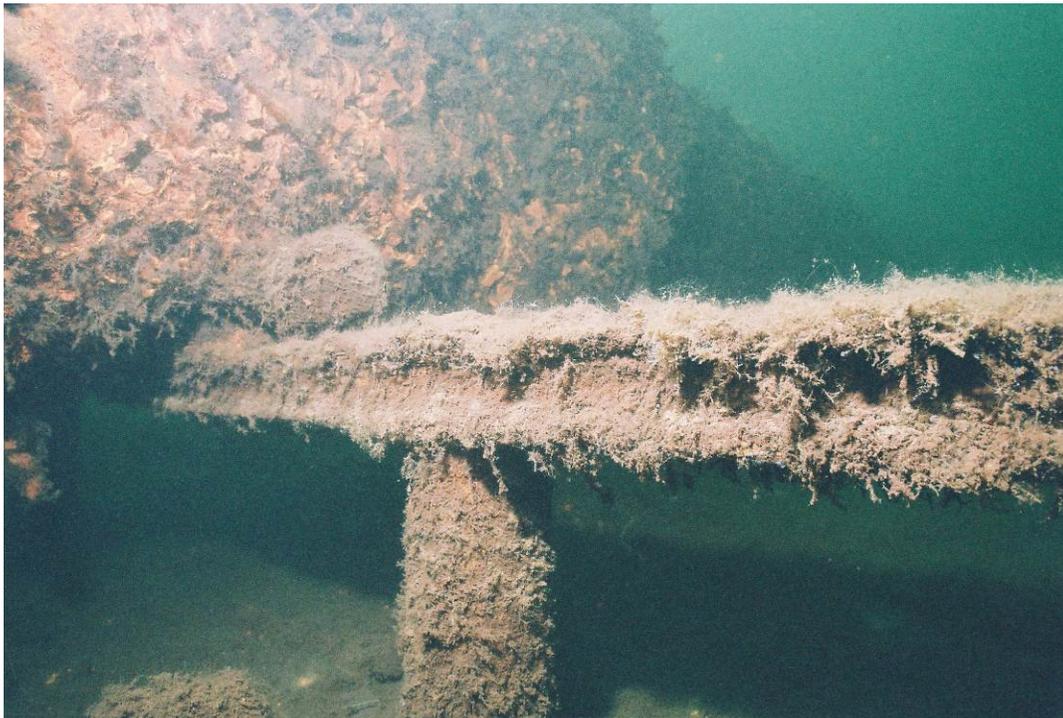
**Photograph showing pipeline resting on wooden support, pipeline changing
Elevation into deeper area showing more extreme joint angle**

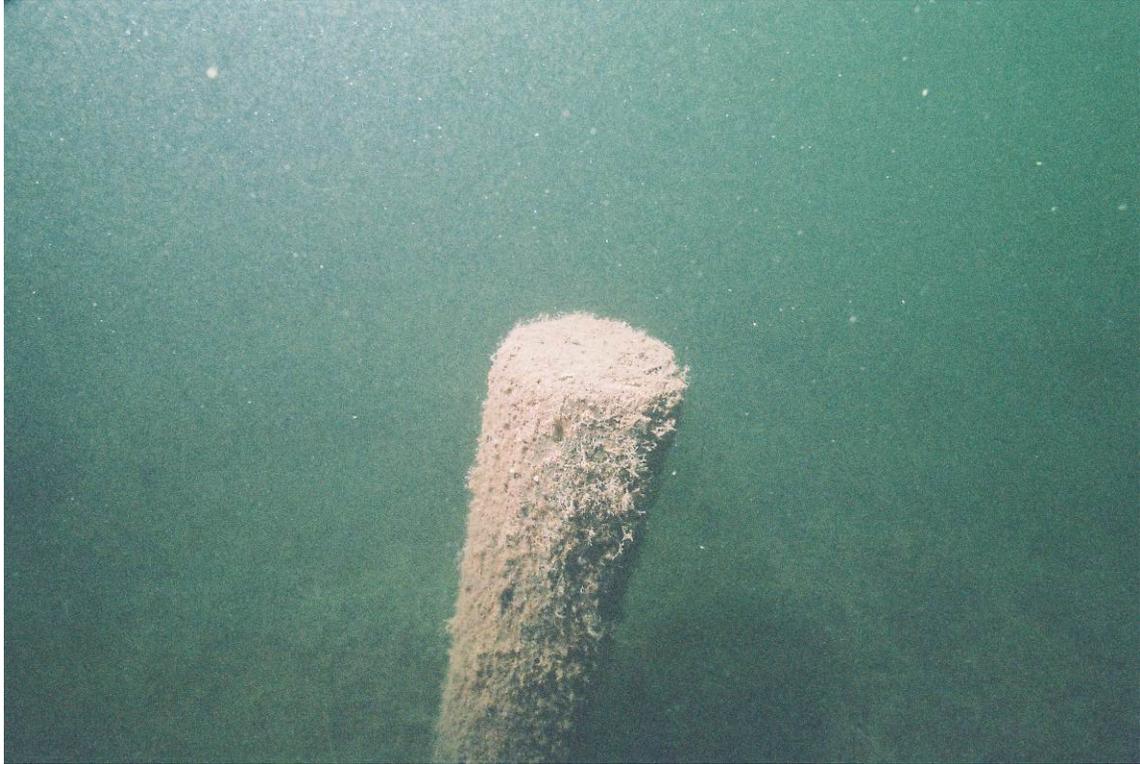
Photograph showing top of posts visible in area where pipe is covered with silt

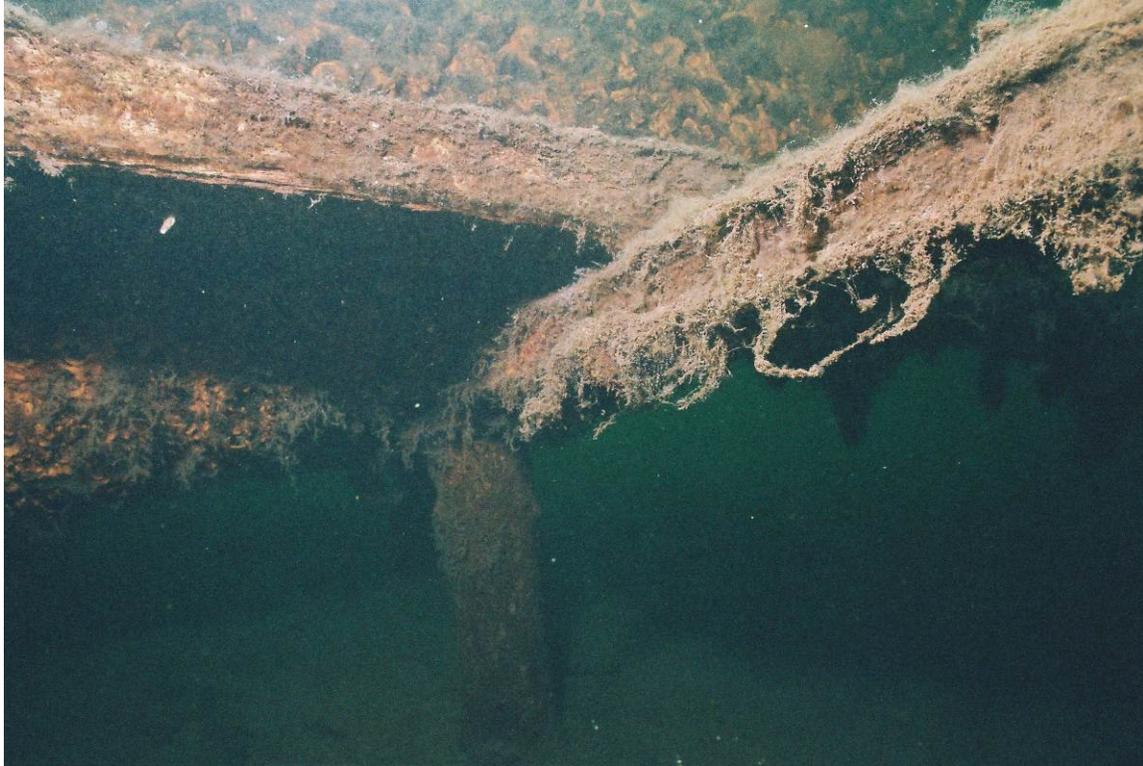
Photograph showing pipeline support arrangement near end of pipeline

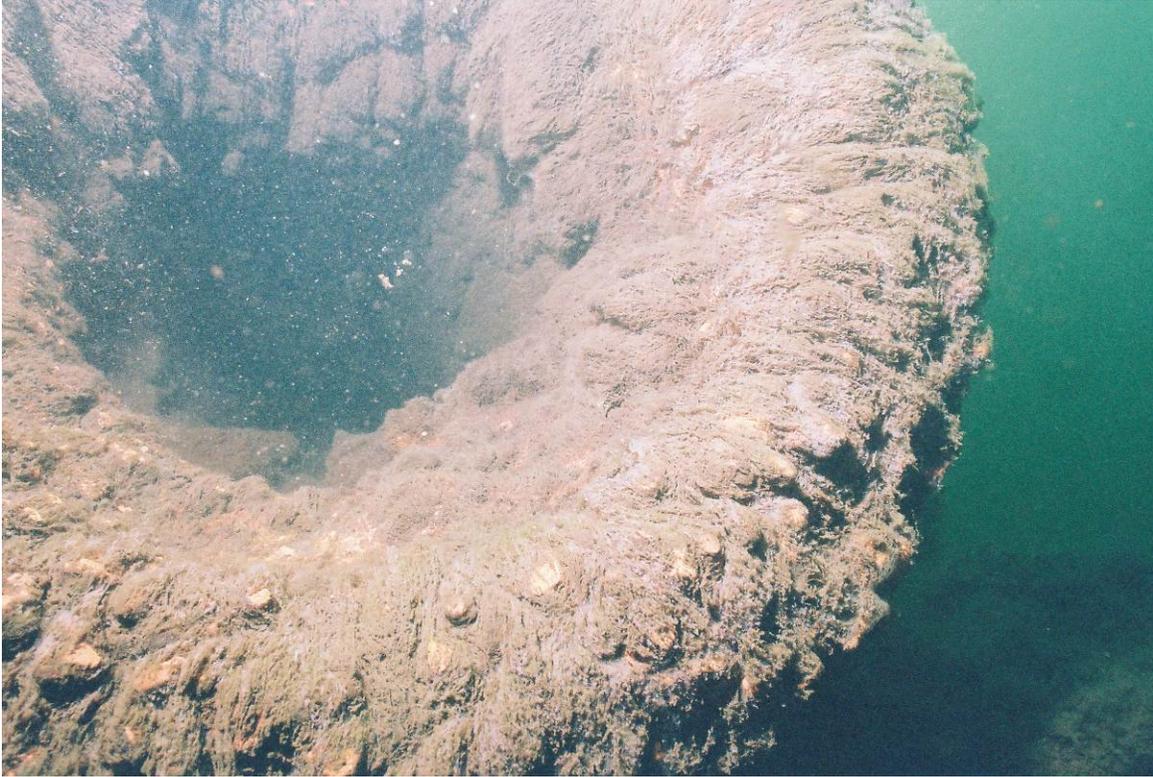
The pipeline terminates at a bell end which has a greatly reduced inner diameter (approximately 12 inches) from rust and deterioration (Note photographs following). Directly in front of the end of the pipe is a concrete or stone block pad laid on a wooden platform. The blocks were covered with a layer of soft silt approximately ½ to 1 inch deep. The blocks appear flat and intact but irregular in shape and very weathered (Note following photographs and figure 3).

Photograph showing inside end of pipeline with reduced diameter

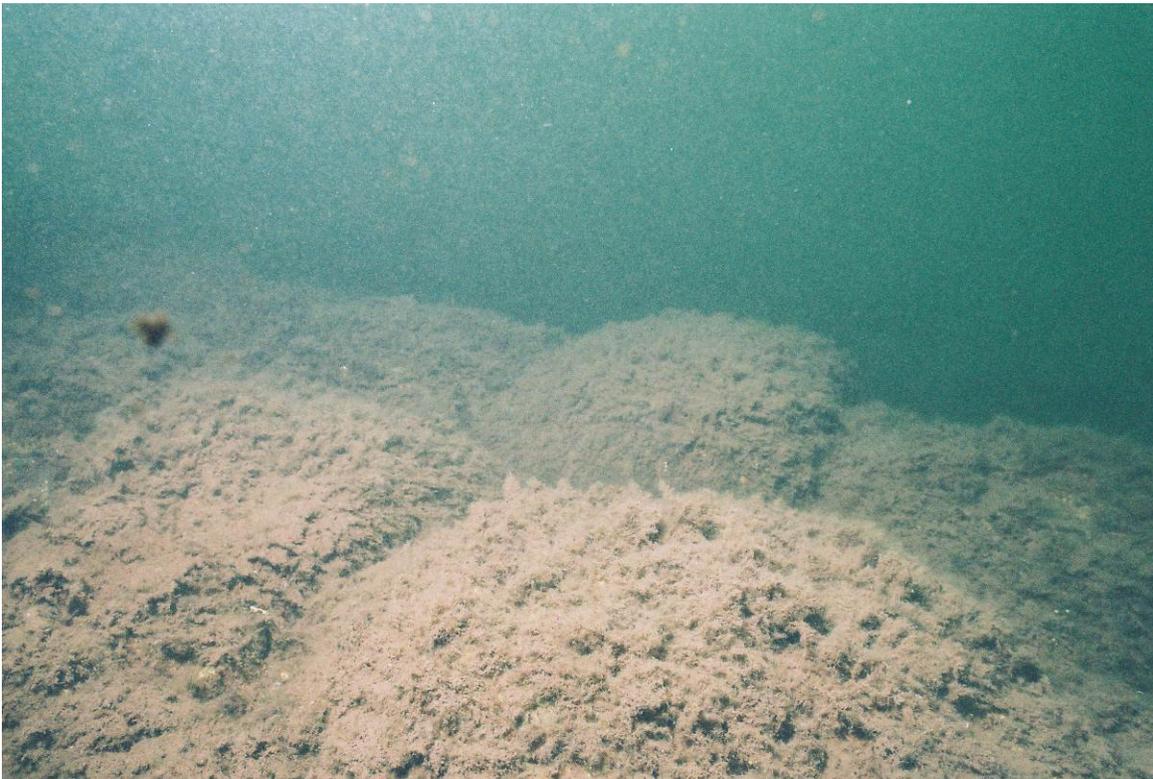
Photograph showing scour pad blocks at end of pipeline

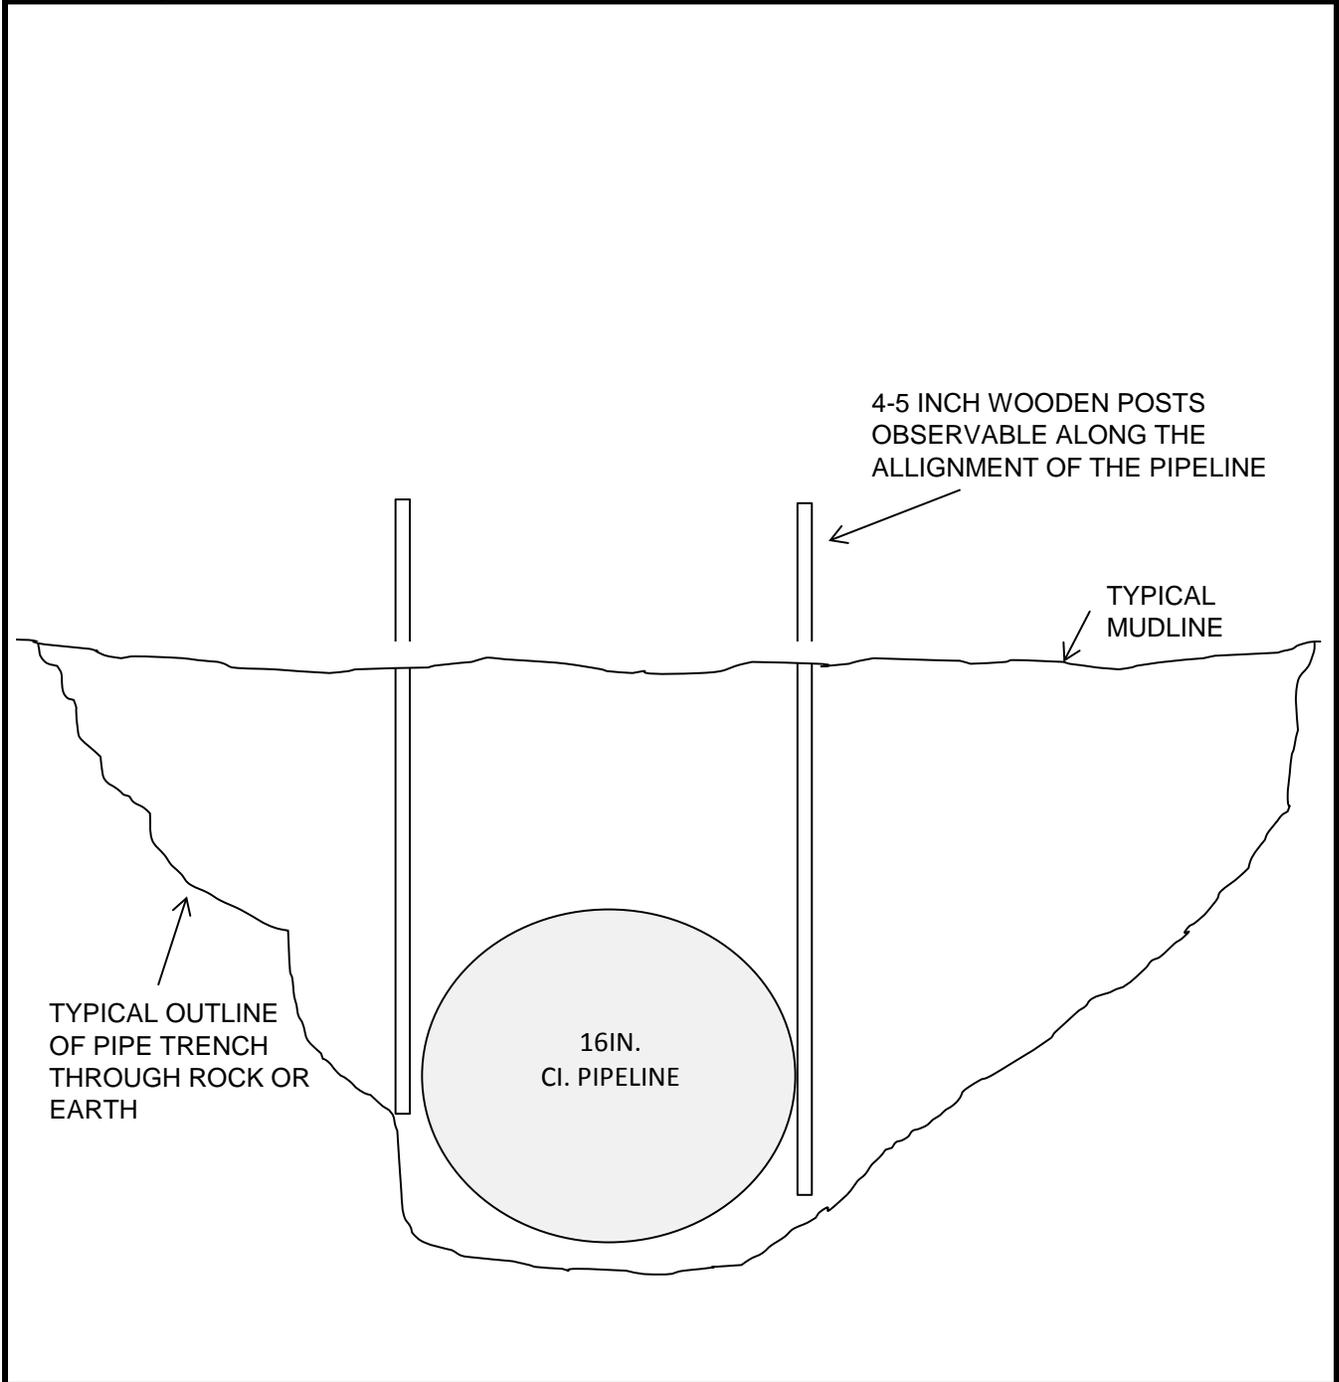
NAGOG POND
FIGURE 1
DETAIL OF POSTS VISIBLE
VISIBLE ALONG ALIGNMENT OF PIPELINE
CROSS SECTION

The general alignment of the pipeline was followed by swimming a trench cut in stone for the first approximately 200-300lf. The pipeline was covered with silt and not visible in the trench. Some effort was made to hand dig through the silt and uncover the pipeline. The silt proved to be too deep to be uncovered practically for the work scope of this project. At approximately 200lf out (engineer to confirm), a short section of pipeline was visible along with an adjacent open ended section (see photograph No. 1). This is believed to be a secondary outlet controlled by a gate in the gatehouse or an as-built means to drain the pond during construction. Within the trench, the top sections of 4-5 inch diameter wooden posts could be seen on either side of the pipeline path. These posts may have been used to align the pipeline within the trench. At approximately 400lf to approximately 1000lf, the trench and much of the pipeline was not visible. The alignment was followed by swimming post to post (See figure 1 for cross section and detail).
