BRIDGE NO. A-02-008 (RIVER STREET OVER FORT POND BROOK AT CARRIAGE DRIVE)

Summary of Existing Conditions:

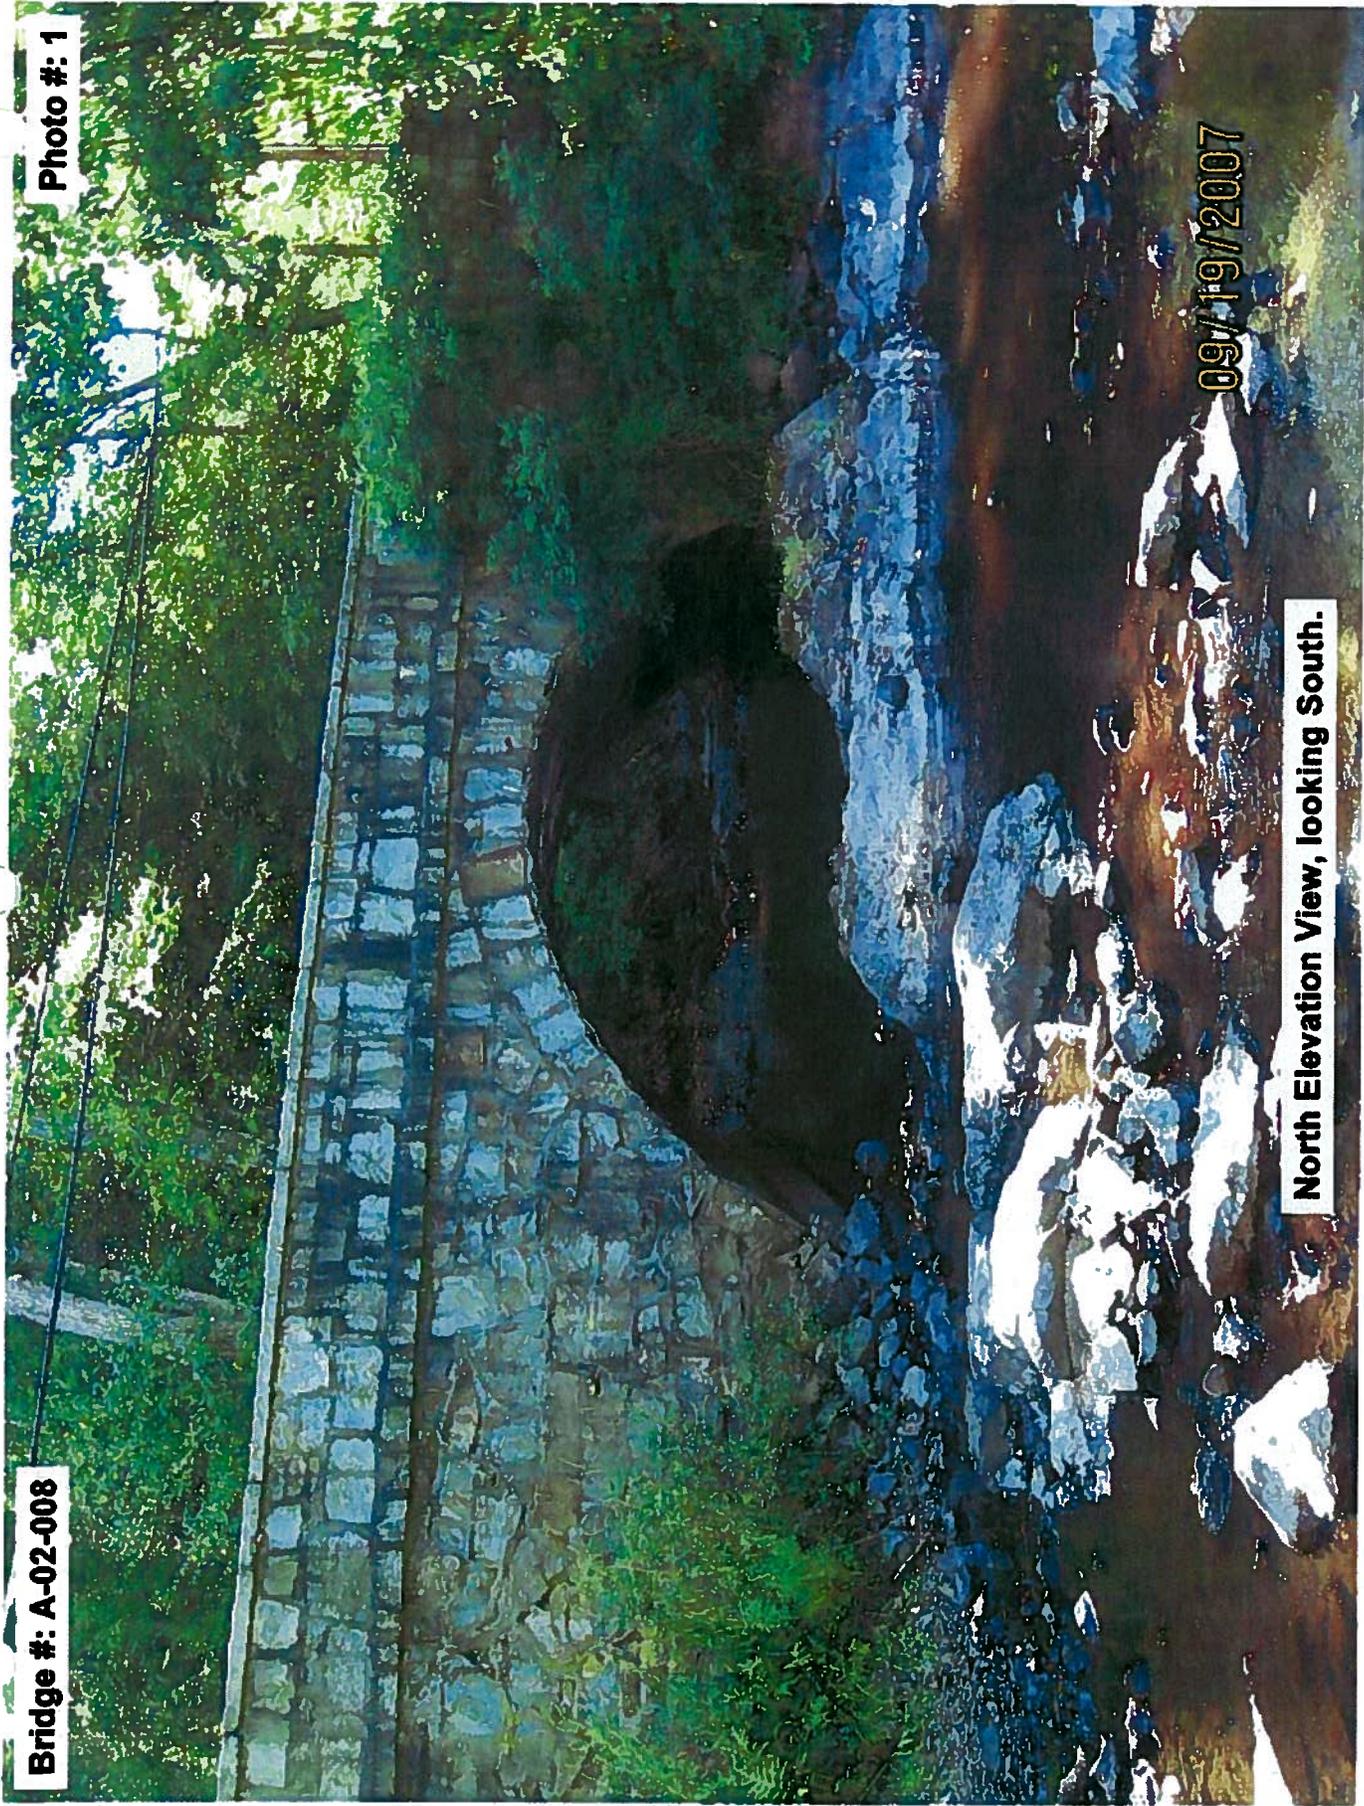
Photo #: 1

The River Street Bridge over Fort Pond Brook is a single span corrugated steel arch deck structure that was built in 1937 (see Sketches & Photos #1 & #2). River Street, at the bridge, is oriented West and East over the Fort Pond Brook which flows South to North.

North Elevation View, looking South.

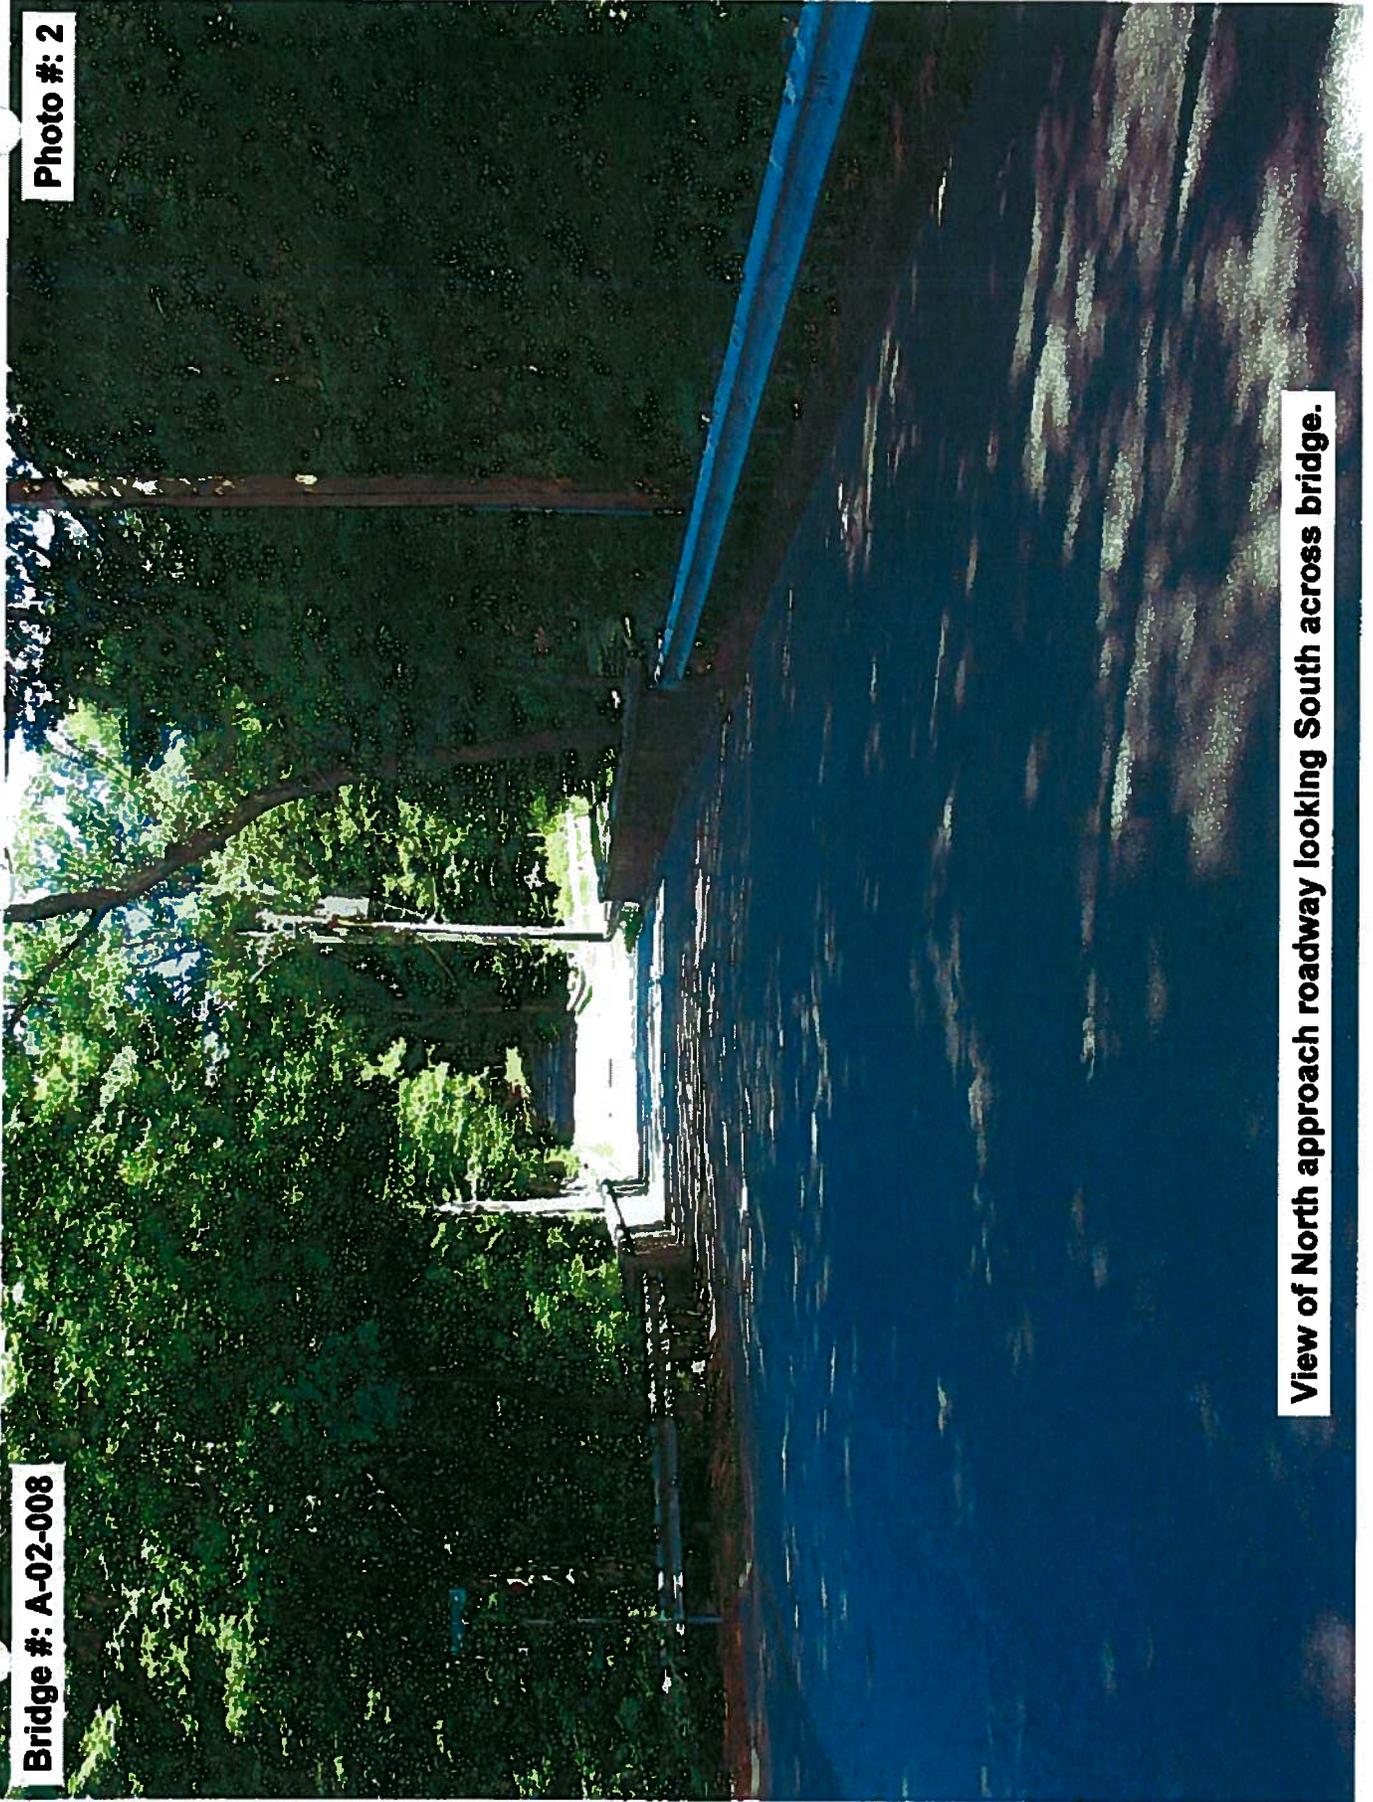
Photo #: 2

View of North approach roadway looking South across bridge.

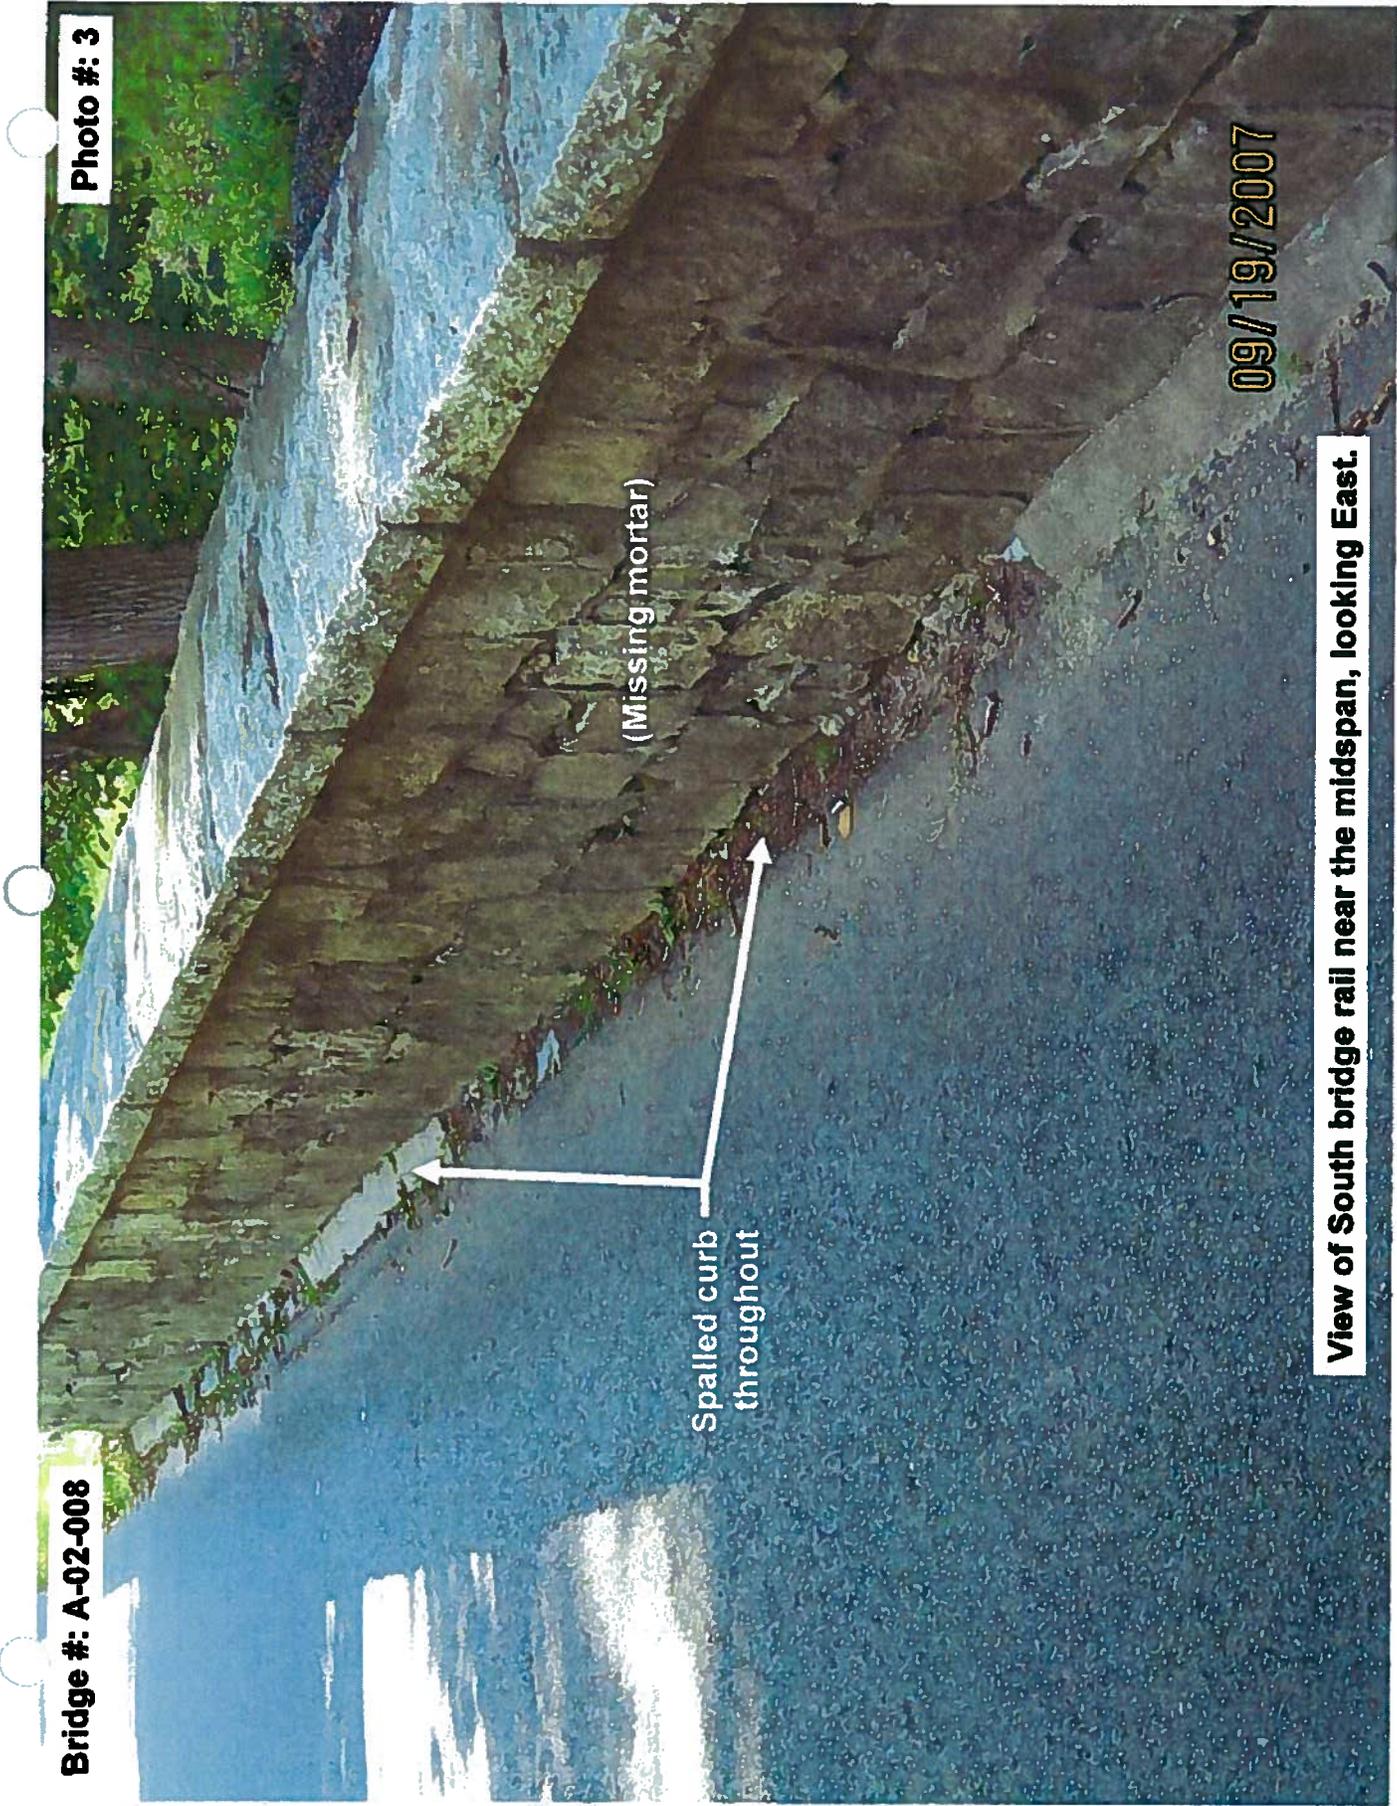
Photo #: 3

Element	Deficiency	Reference Photo(s)
Wearing Surface	<ul style="list-style-type: none"> • Hairline to narrow random cracks throughout • Light vegetation growth along curbs • Beveled curb is spalled throughout 	3

(Missing mortar)

Spalled curb
throughout

View of South bridge rail near the midspan, looking East.

Element & Location		Deficiency	Repair Needed	Priority
#1	Top of bridge	Beveled curb spalling along bridge rail	Remove beveled curb and replace with asphalt berm	Low

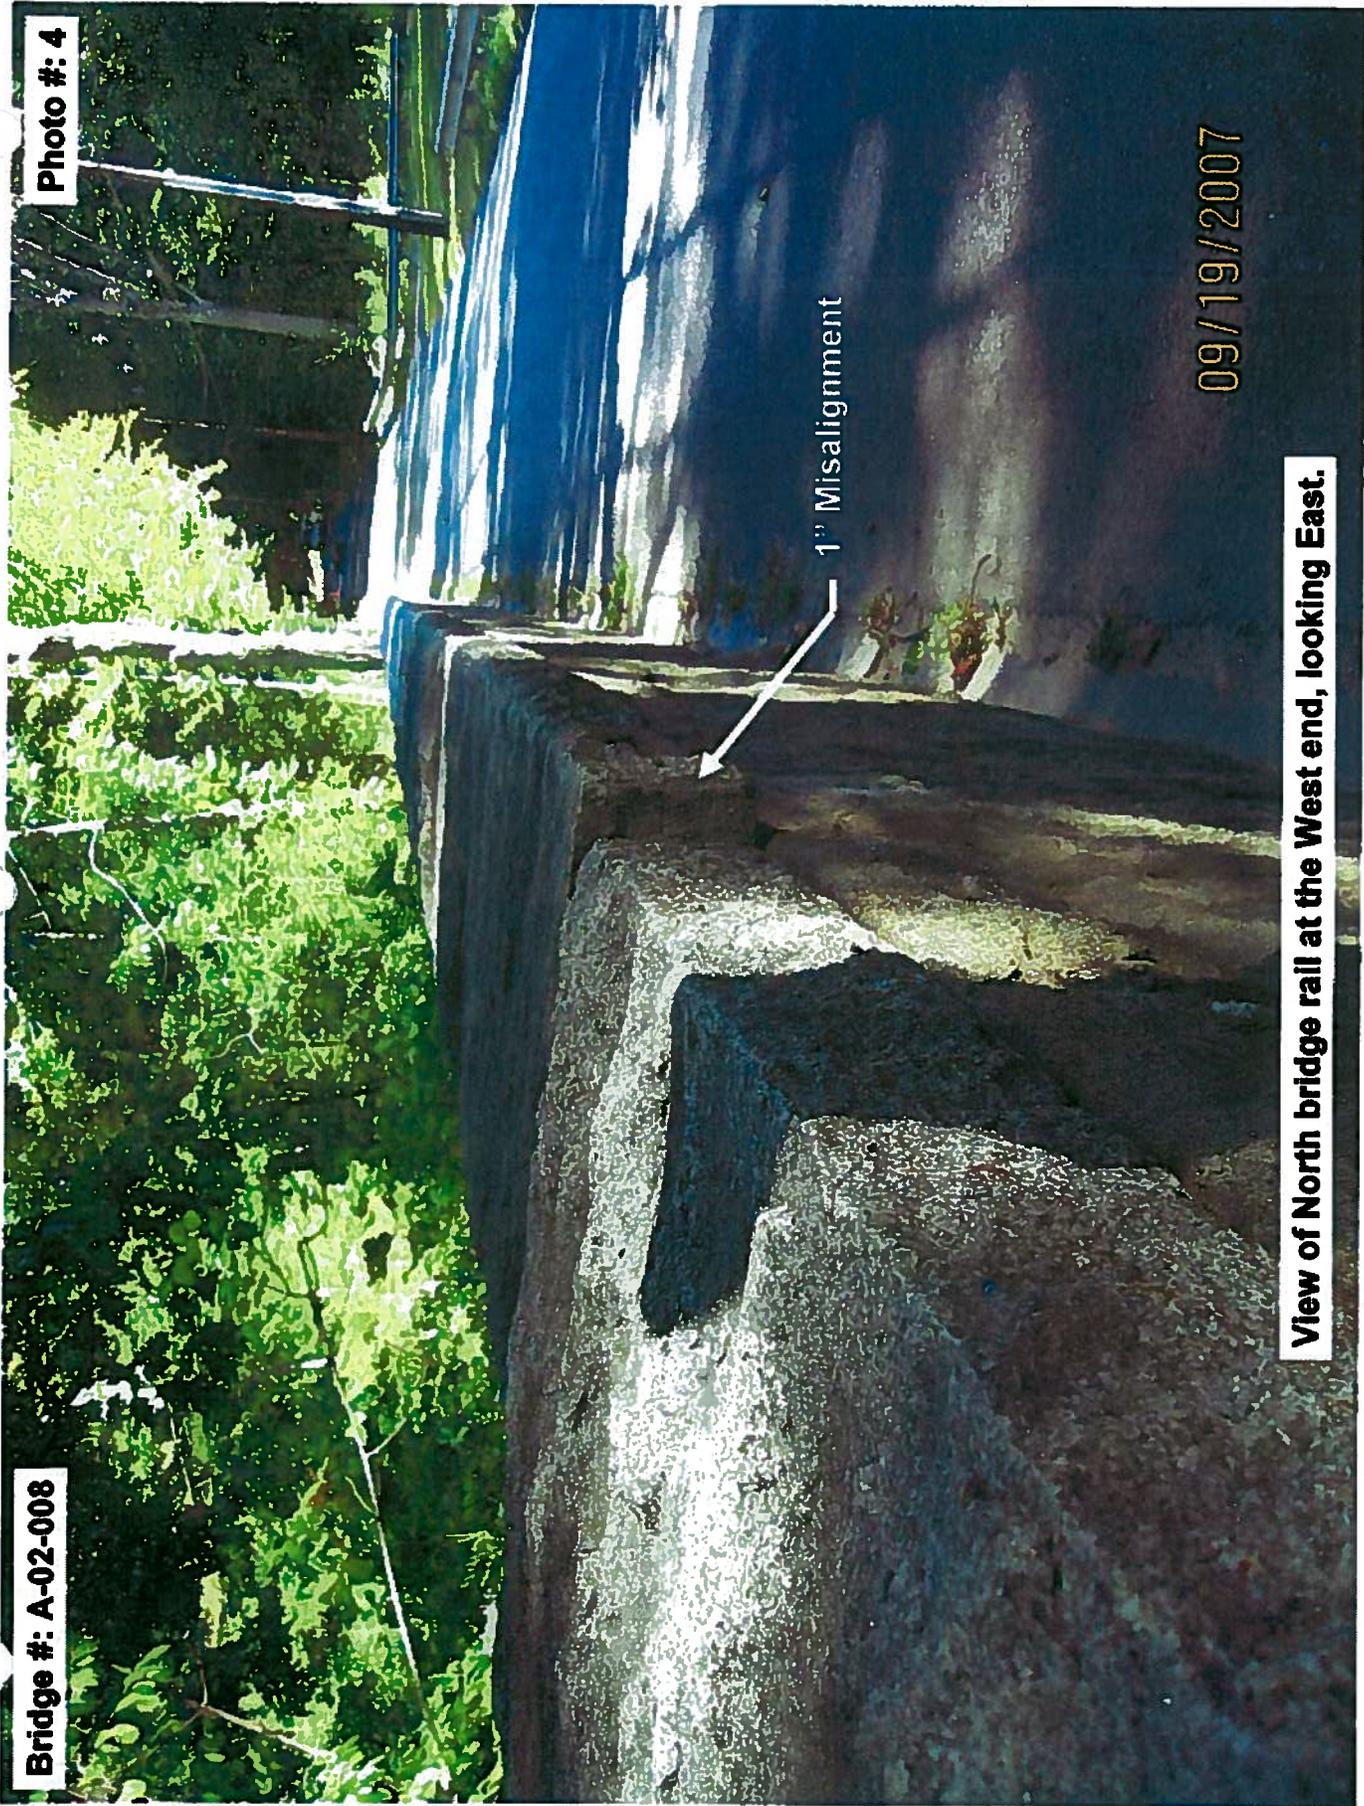
Photo #: 4

1" Misalignment

View of North bridge rail at the West end, looking East.

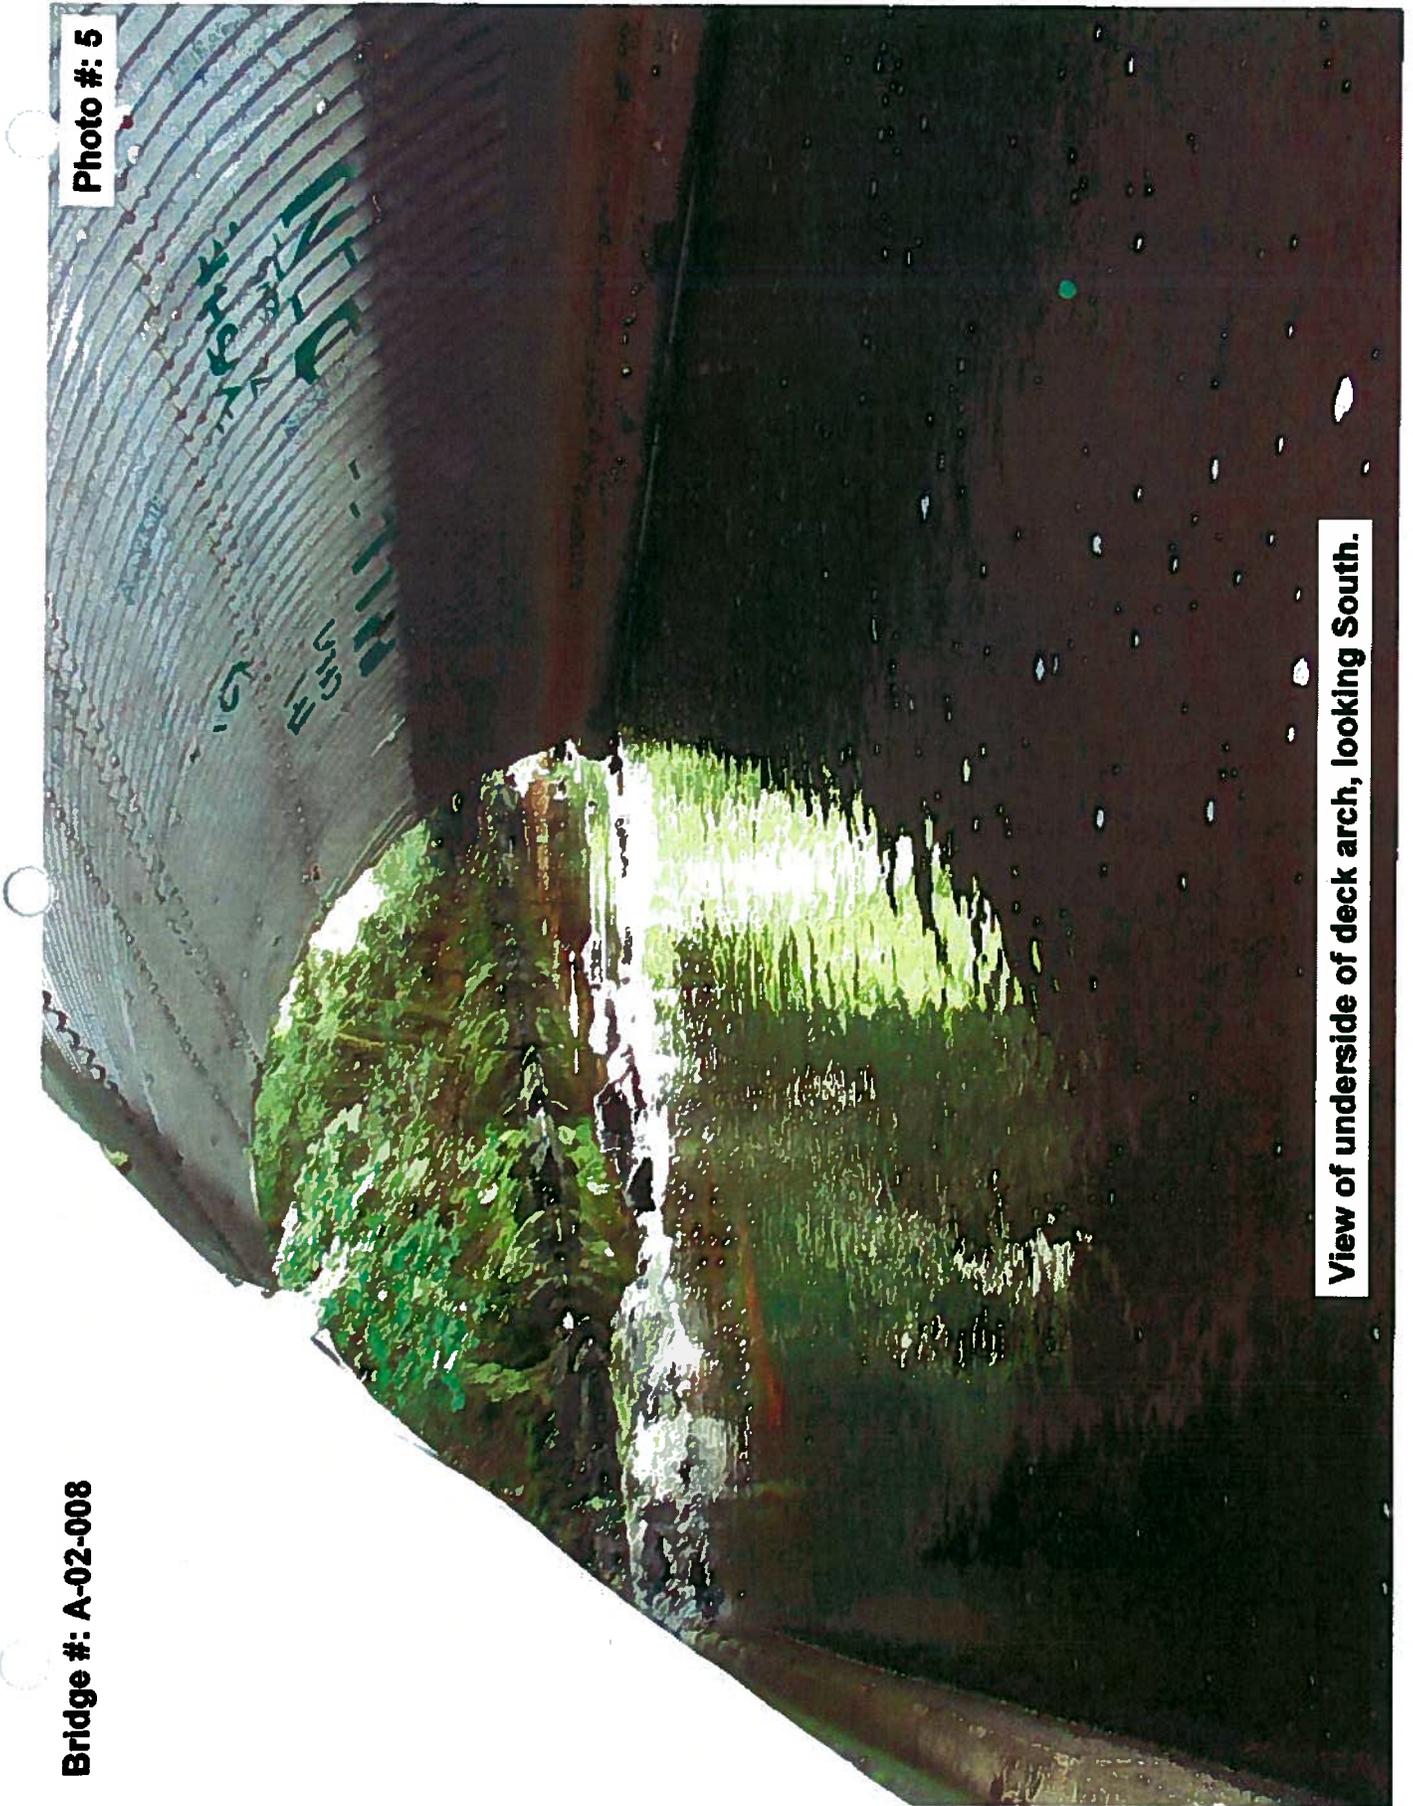
Photo #: 5

View of underside of deck arch, looking South.

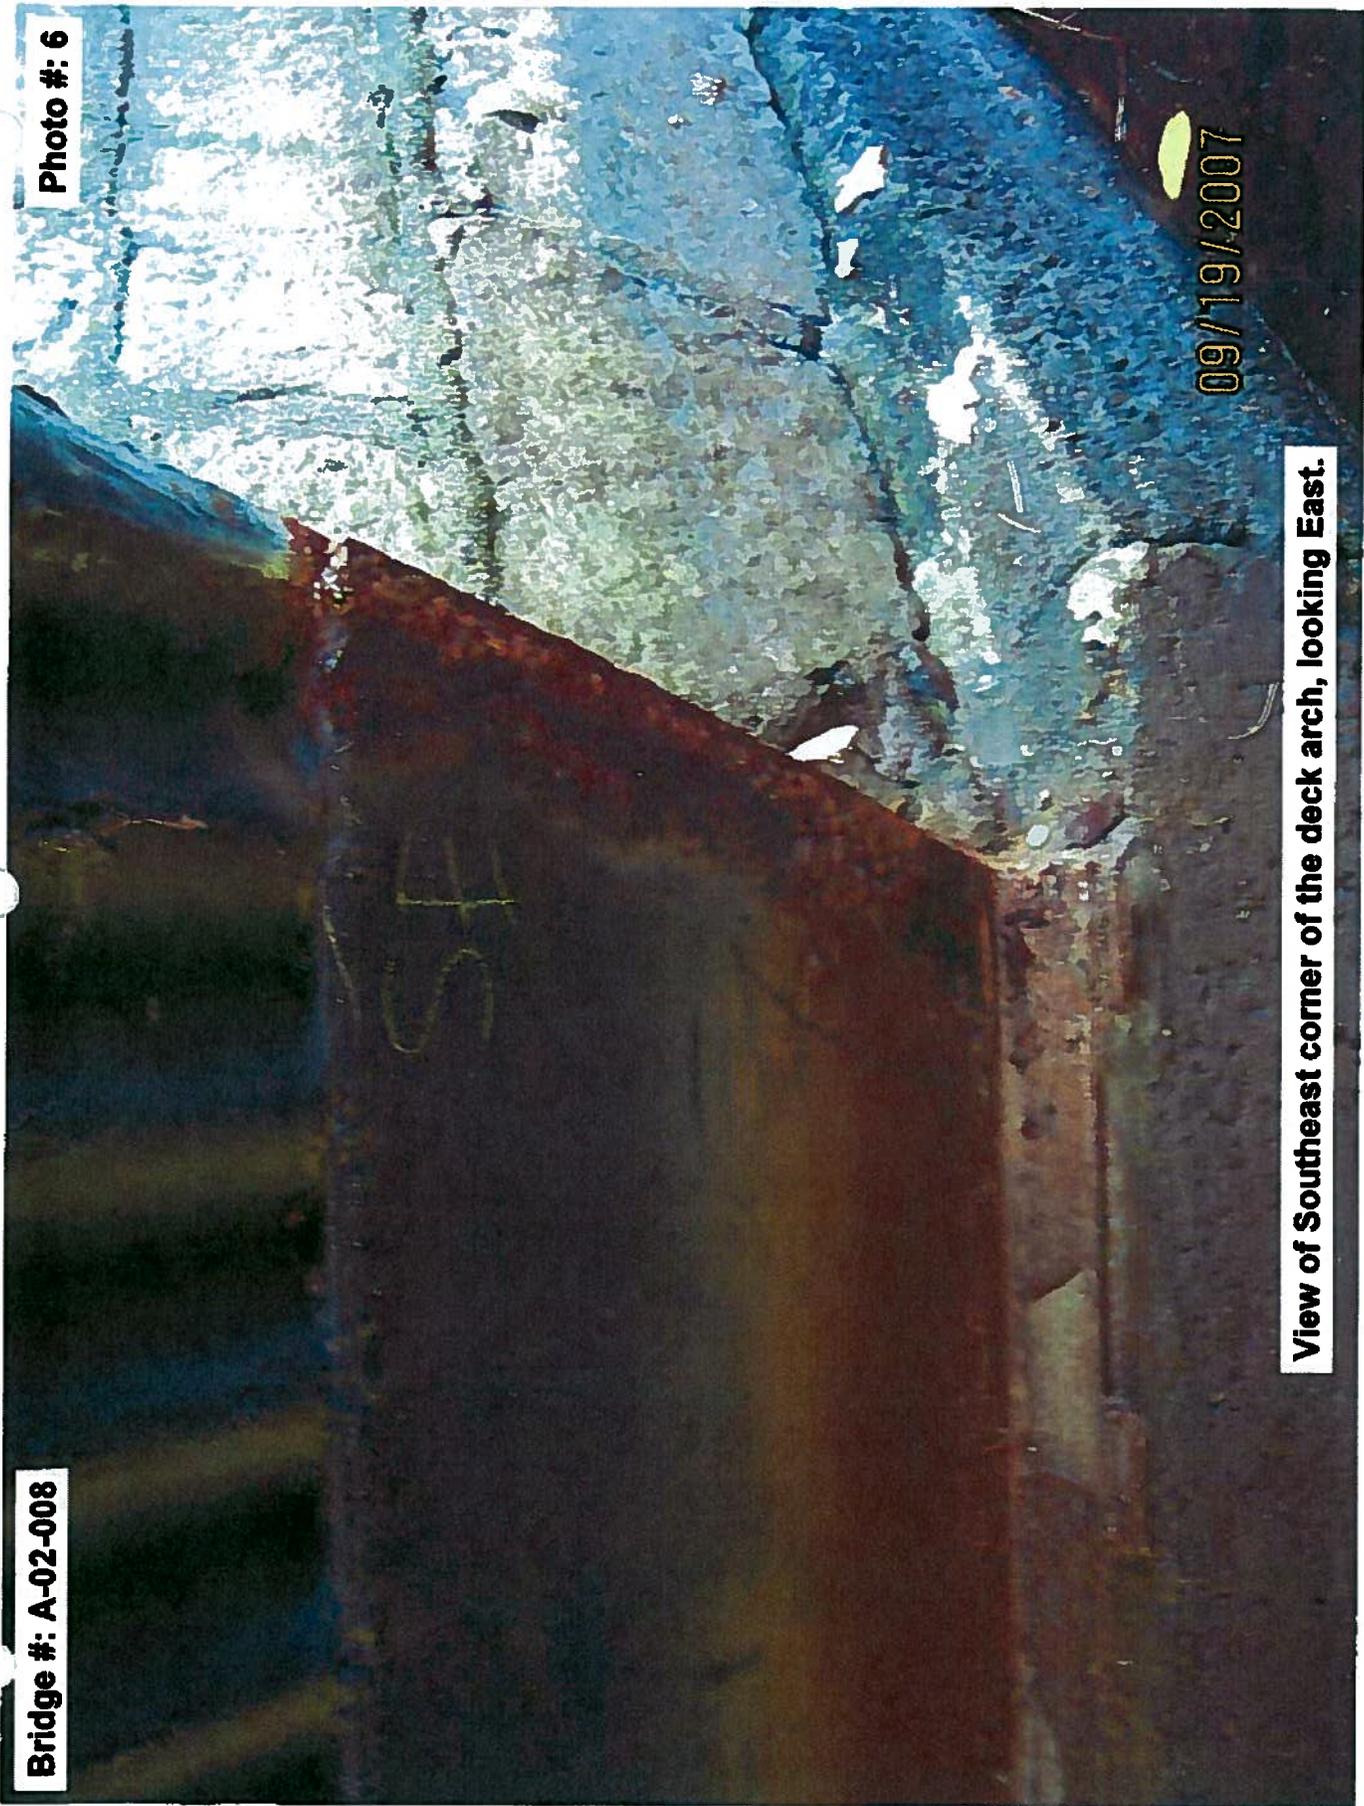
Photo #: 6

View of Southeast corner of the deck arch, looking East.

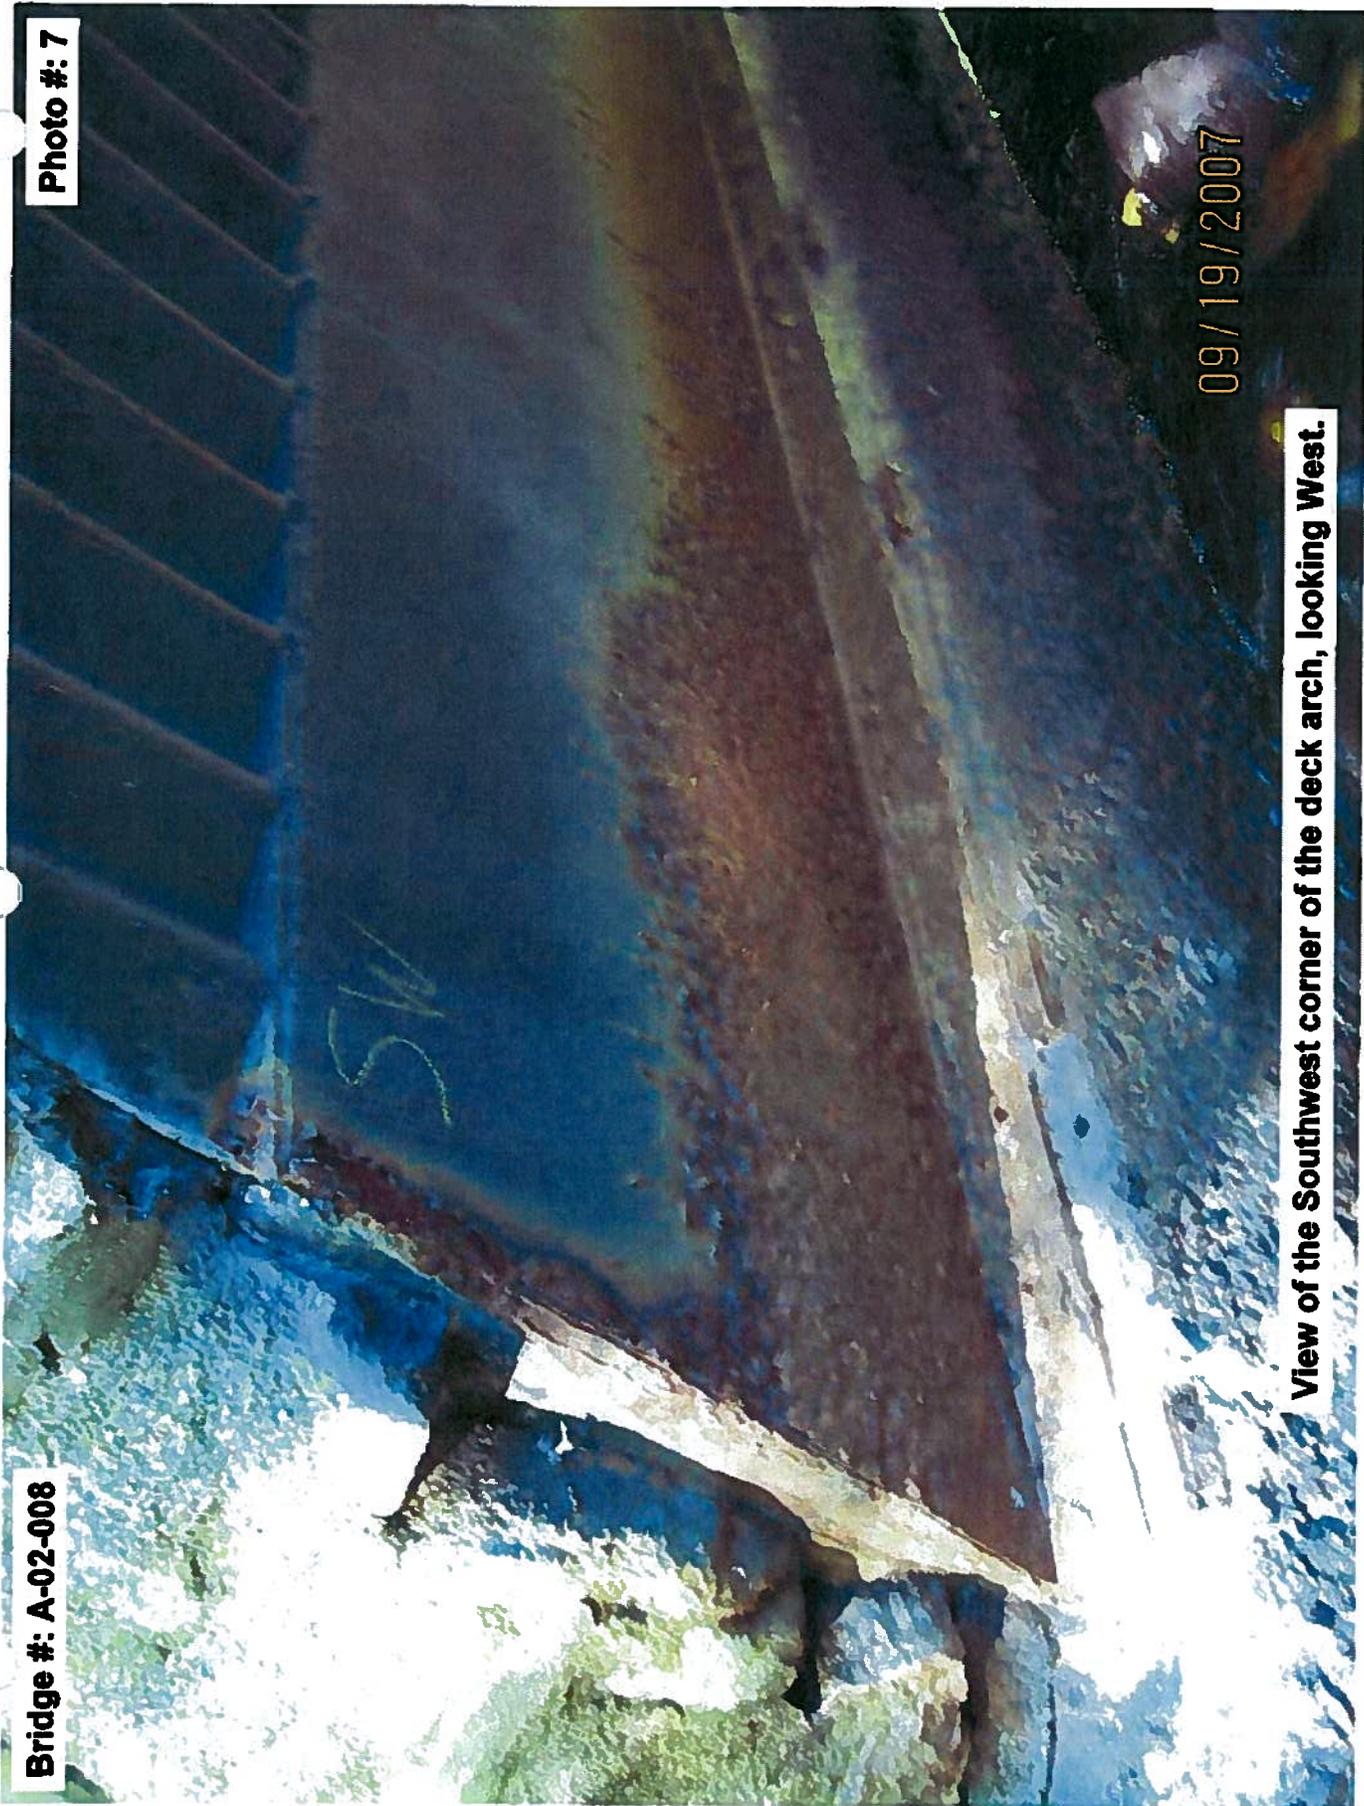
Photo #: 7

View of the Southwest corner of the deck arch, looking West.

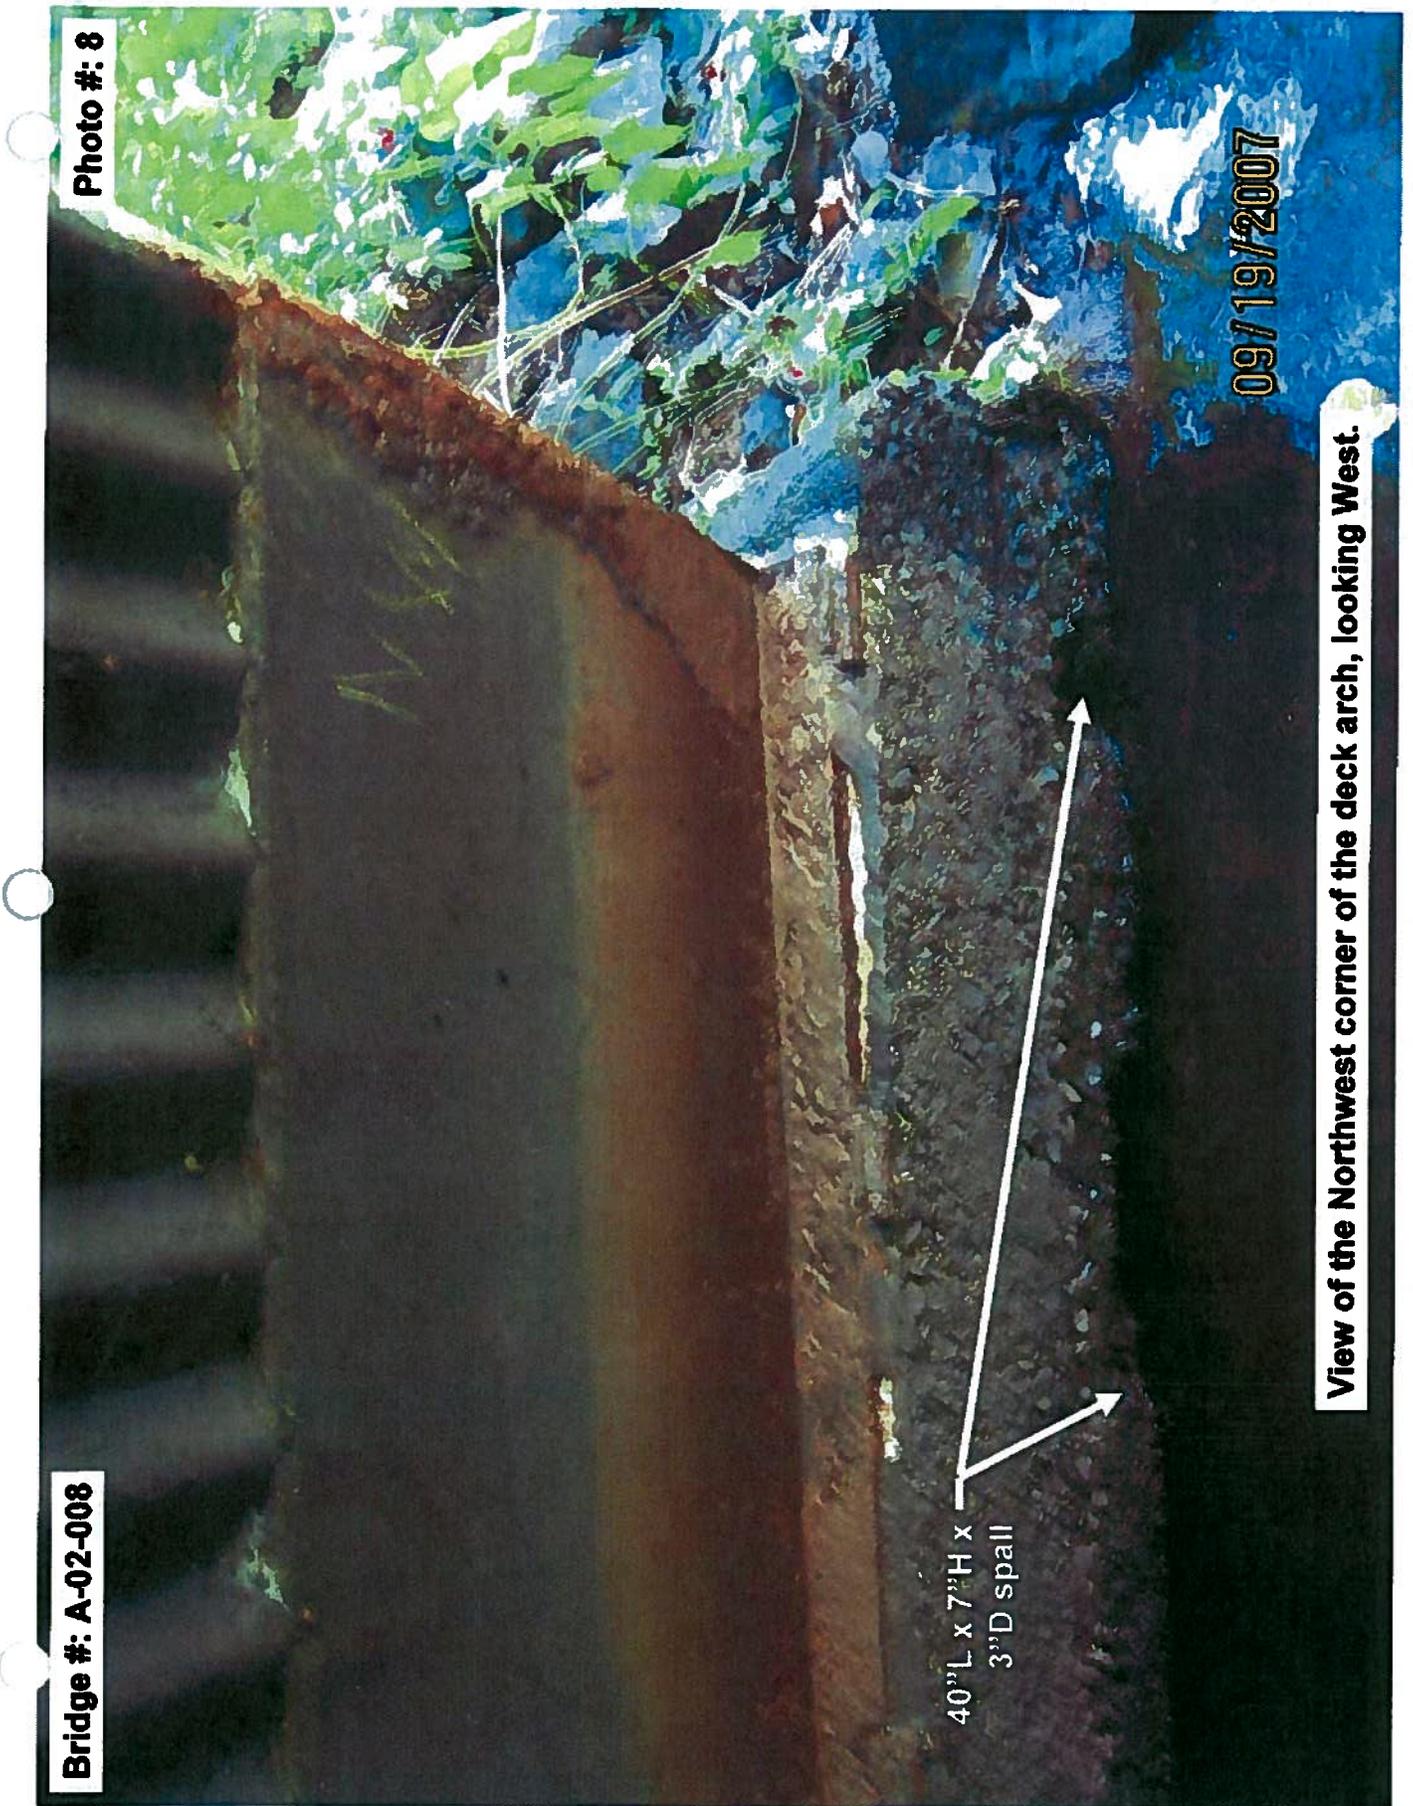
Photo #: 8

Element	Deficiency	Reference Photo(s)
Abutment Breastwalls	<ul style="list-style-type: none"> Moderate to heavy scaling (waterline abrasion) throughout Spall at the Northwest corner that measures 40"L x 7"H x 3"D (at waterline) Minor aggradation at Southeast corner of bridge 	8
Wingwalls	<ul style="list-style-type: none"> Numerous hairline to narrow random cracks in mortar and minor separation between stones 	9
	<ul style="list-style-type: none"> Large voids in Southeast wingwall along bottom and random small voids between stones Area of missing mortar near East end of Northeast wingwall that measures 8'-0"W x 4'-0"H 	10

40" L x 7" H x
3" D spall

View of the Northwest corner of the deck arch, looking West.

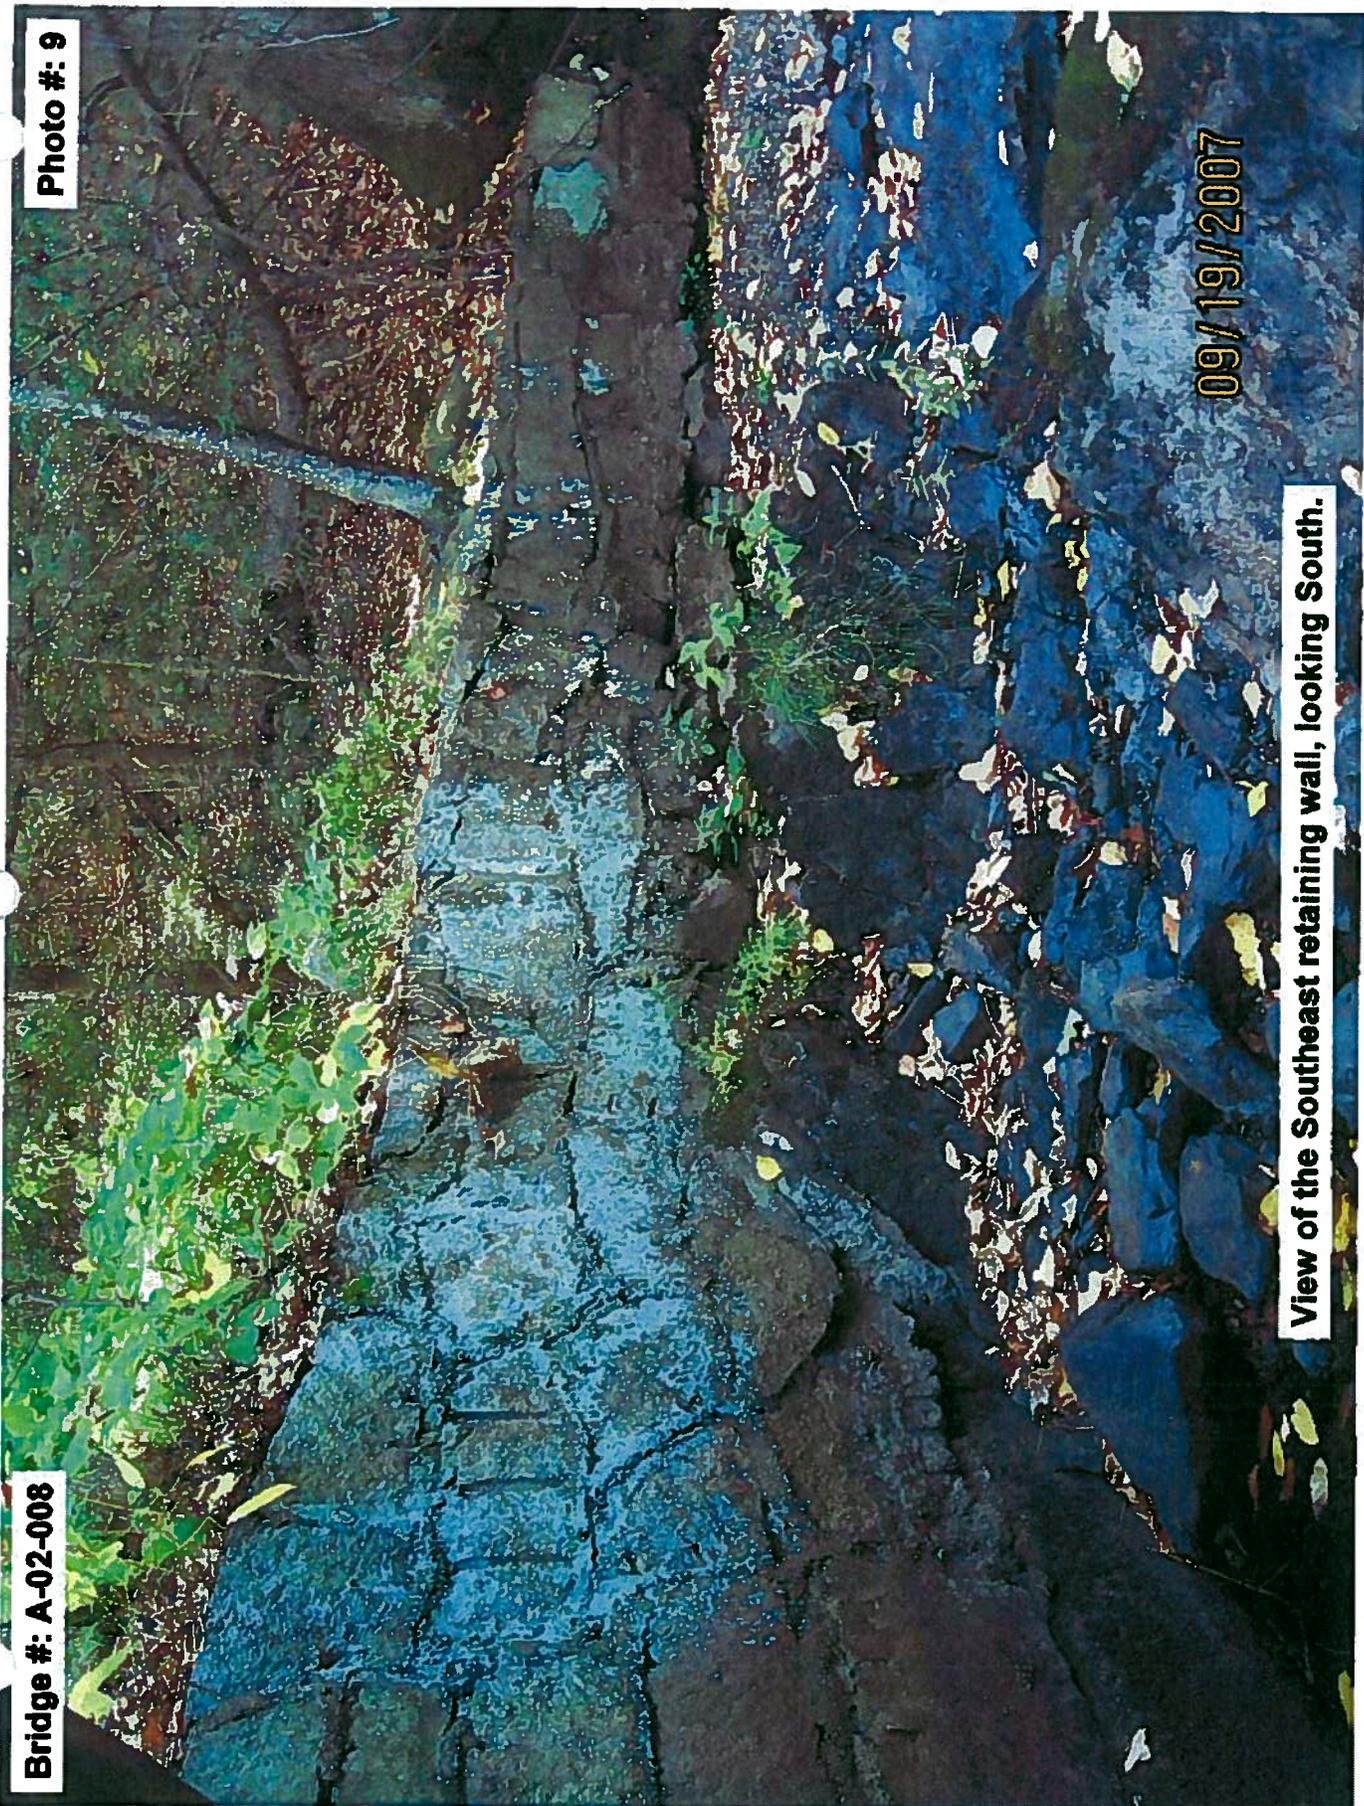
Photo #: 9

View of the Southeast retaining wall, looking South.
