BRIDGE NO. A-02-008 (RIVER STREET OVER FORT POND BROOK AT CARRIAGE DRIVE)

Summary of Existing Conditions:

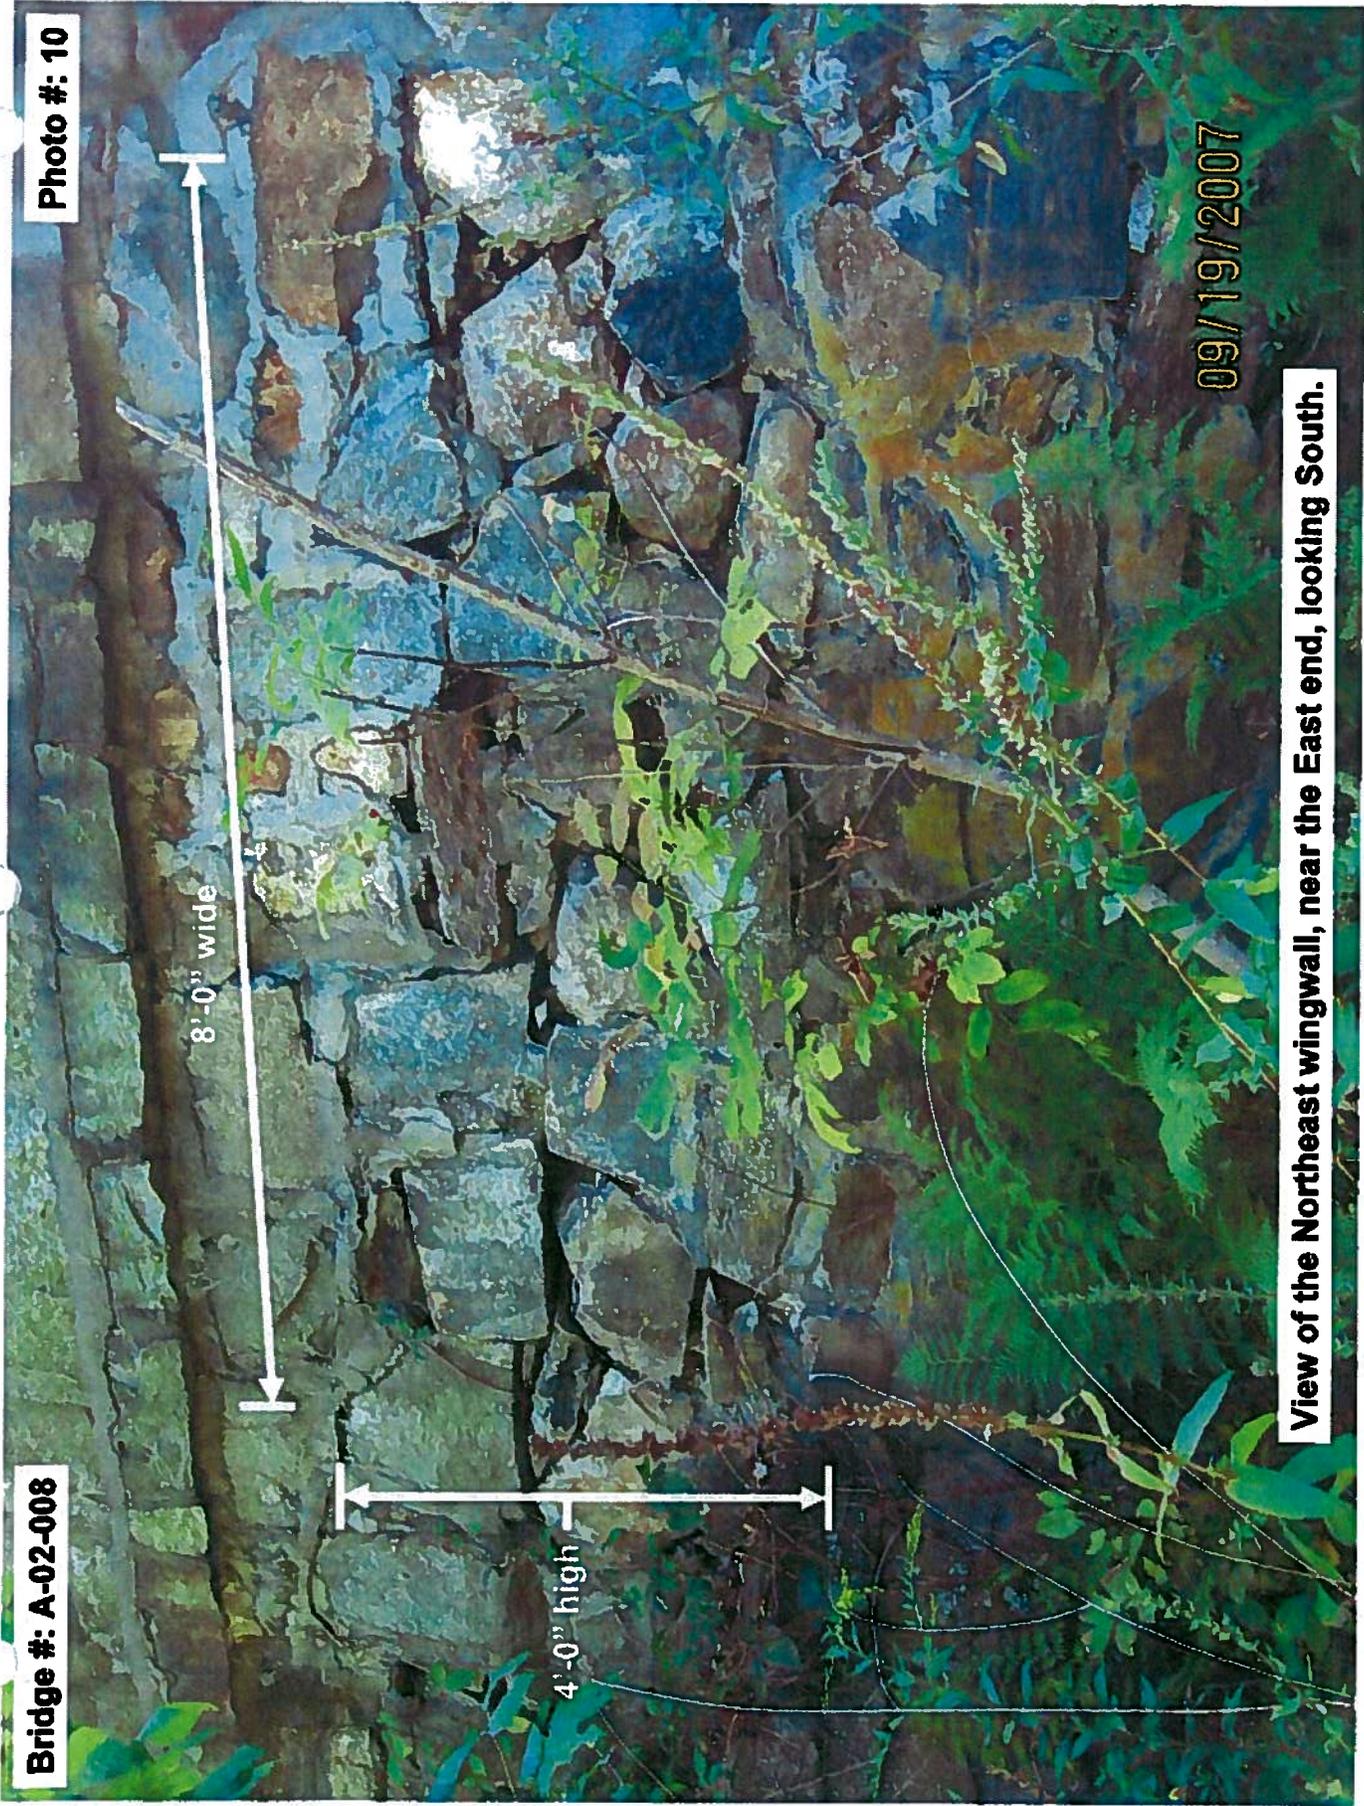
Photo #: 10

8'-0" wide

4'-0" high

View of the Northeast wingwall, near the East end, looking South.
