**BRIDGE NO. A-02-020 (RIVER STREET OVER FORT POND BROOK AT MERRIAM LANE)**

**Bridge Description and Orientation:**

The River Street Bridge over Fort Pond Brook is a twin corrugated steel pipe culvert that was built in 1981 (see Sketches & Photos #1, #2 & #3). River Street, at the bridge, is oriented West and East over the Fort Pond Brook which flows North to South. The pipe culverts are labeled West and East.

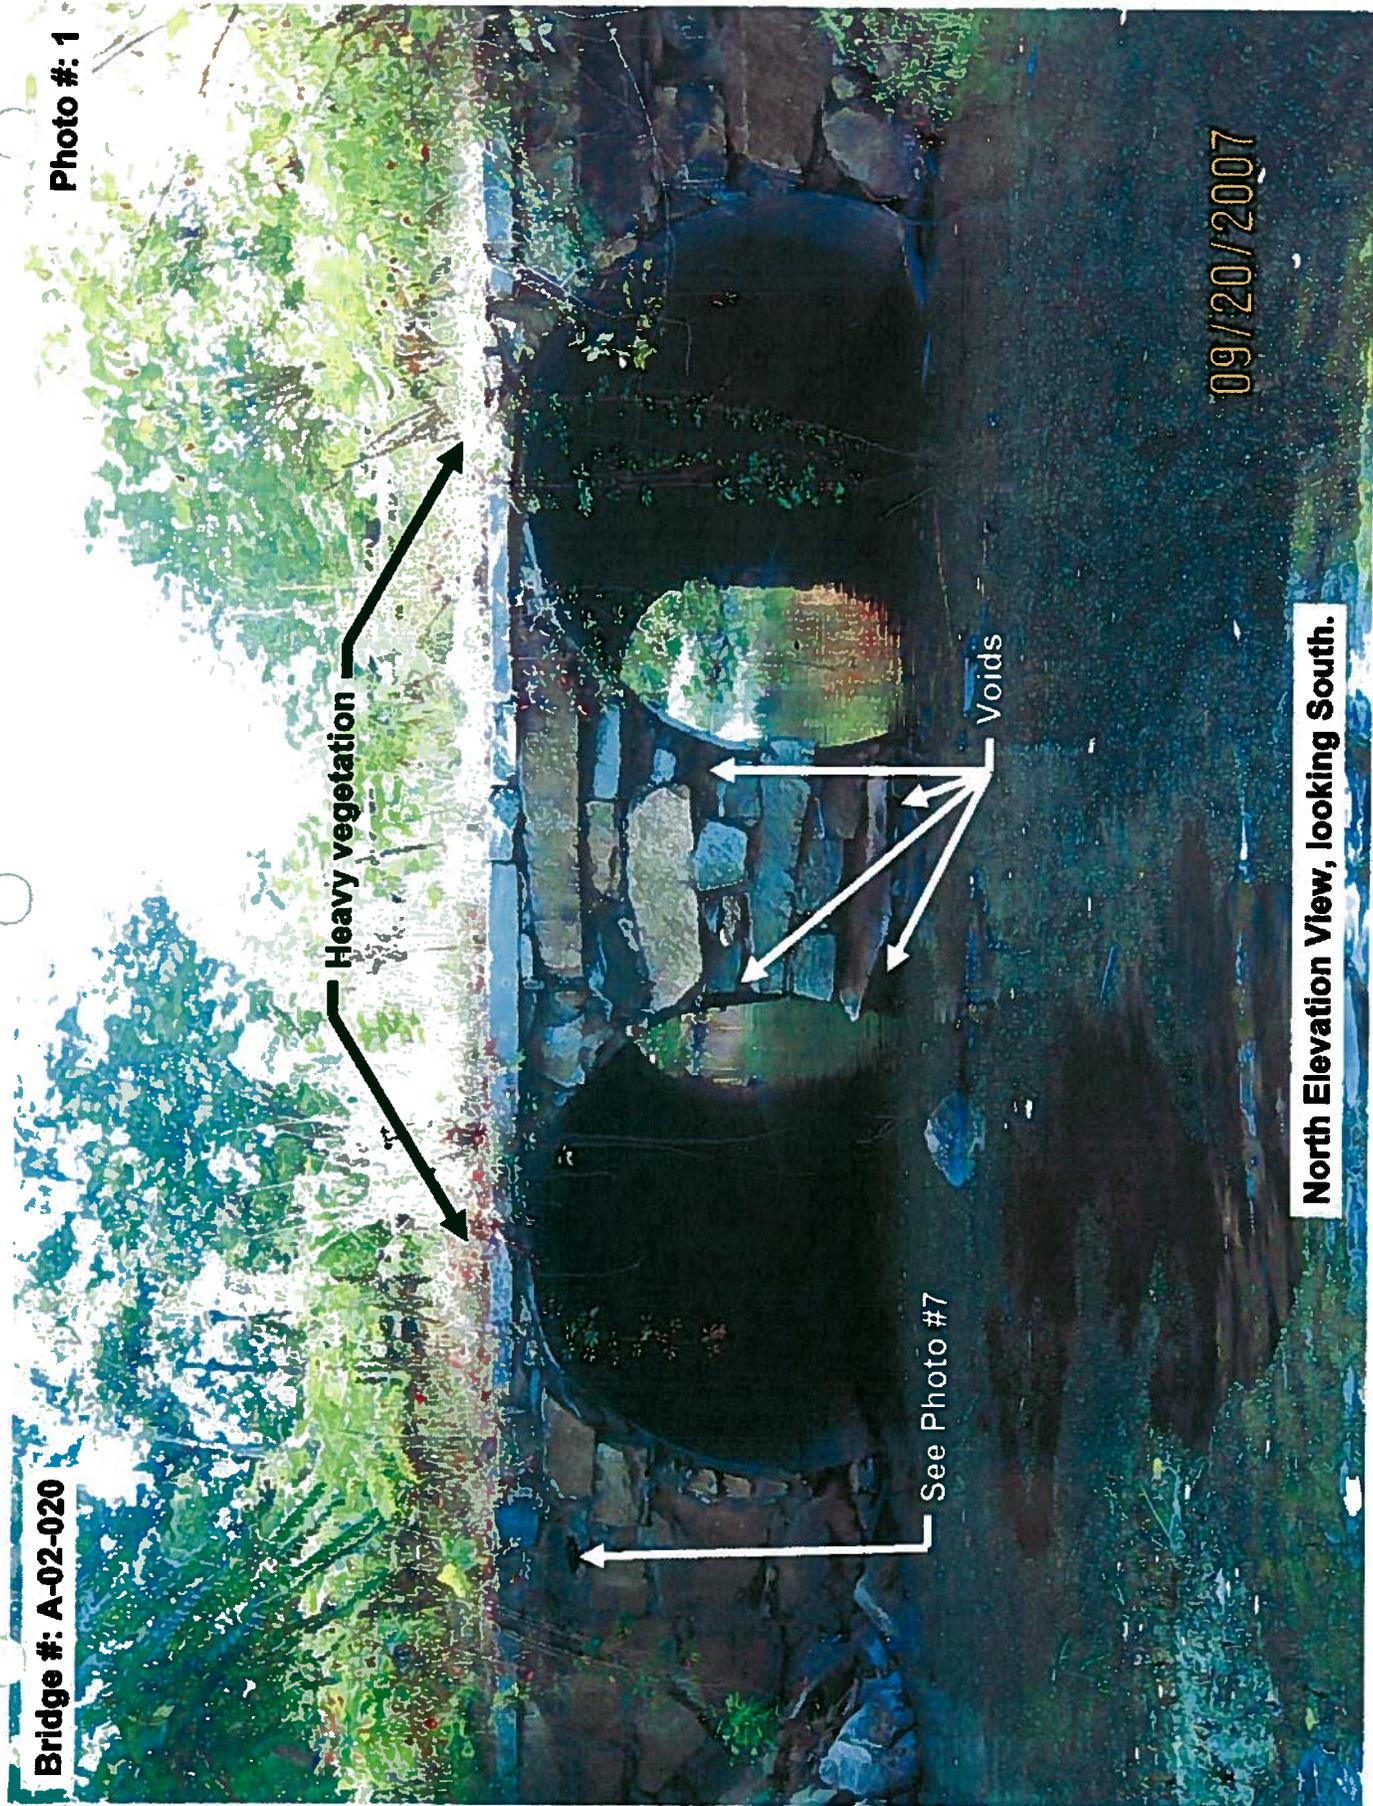
Photo #: 1

Element	Deficiency	Reference Photo(s)
Debris	<ul style="list-style-type: none"> <li>• Moderate to heavy accumulation of debris (tree limbs) at the upstream face of both pipe culverts</li> <li>• Minor scour at the upstream (North) end</li> <li>• Moderate to heavy aggradation at the South end of both pipe culverts</li> </ul>	1

Heavy vegetation

See Photo #7

Voids

North Elevation View, looking South.

#10	Upstream face of both pipe culverts	Debris	Remove debris from channel	Moderate

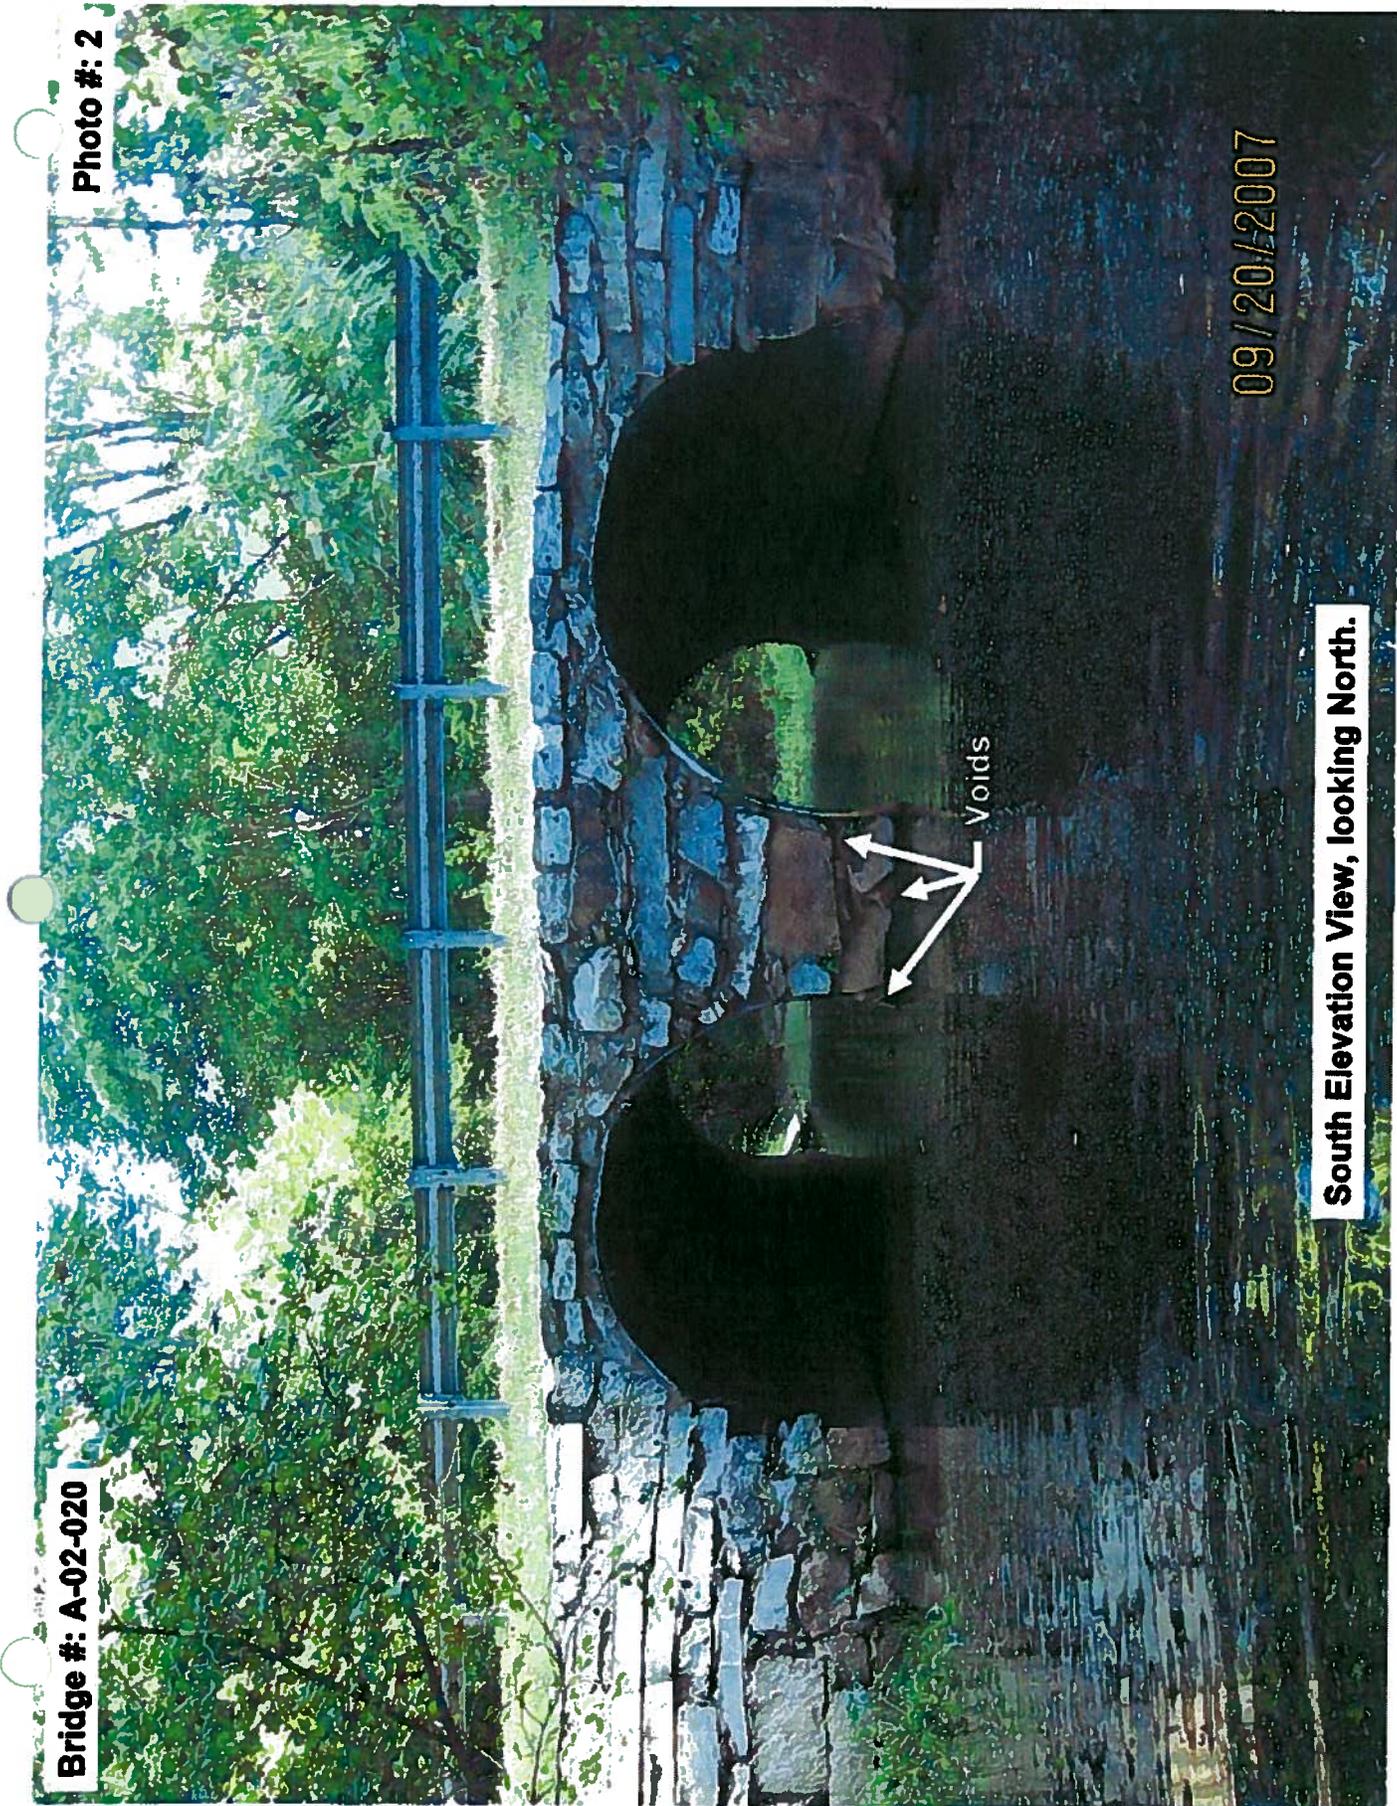
Photo #: 2

North Headwall	<ul style="list-style-type: none"> <li>• Random hairline to narrow cracks in the mortar and separation of the mortar between stones as well as loose stones throughout</li> <li>• Void at the West face of the West pipe culvert that measures up to 12"H x 6"W x 8" of penetration</li> <li>• Void between the Northeast wingwall and the East face of the East pipe culvert that measures 7"H x 8"W x greater than 12'-0" of penetration</li> <li>• Top of the North headwall shows medium to wide reflective cracks in the mortar between the cap stones with areas of missing pointing and protective coat</li> <li>• Random voids all around the edges of the pipes</li> </ul>	1
South Headwall	<ul style="list-style-type: none"> <li>• Random hairline to narrow cracks and separation of the mortar between stones as well as loose stones throughout</li> <li>• Top of the South headwall shows medium to wide reflective cracks in the cap stones with areas of missing pointing and protective coat</li> <li>• Numerous voids all around the edges of the pipes</li> </ul>	2

Voids

South Elevation View, looking North.

#7	North headwalls around pipes	Voids	Fill holes/voids with concrete	High
#8	South headwalls around pipes	Voids	Fill holes/voids with concrete	High
#9	Wingwalls	Cracks in mortar and random voids	Fill any voids and repoint stone masonry as needed	Low

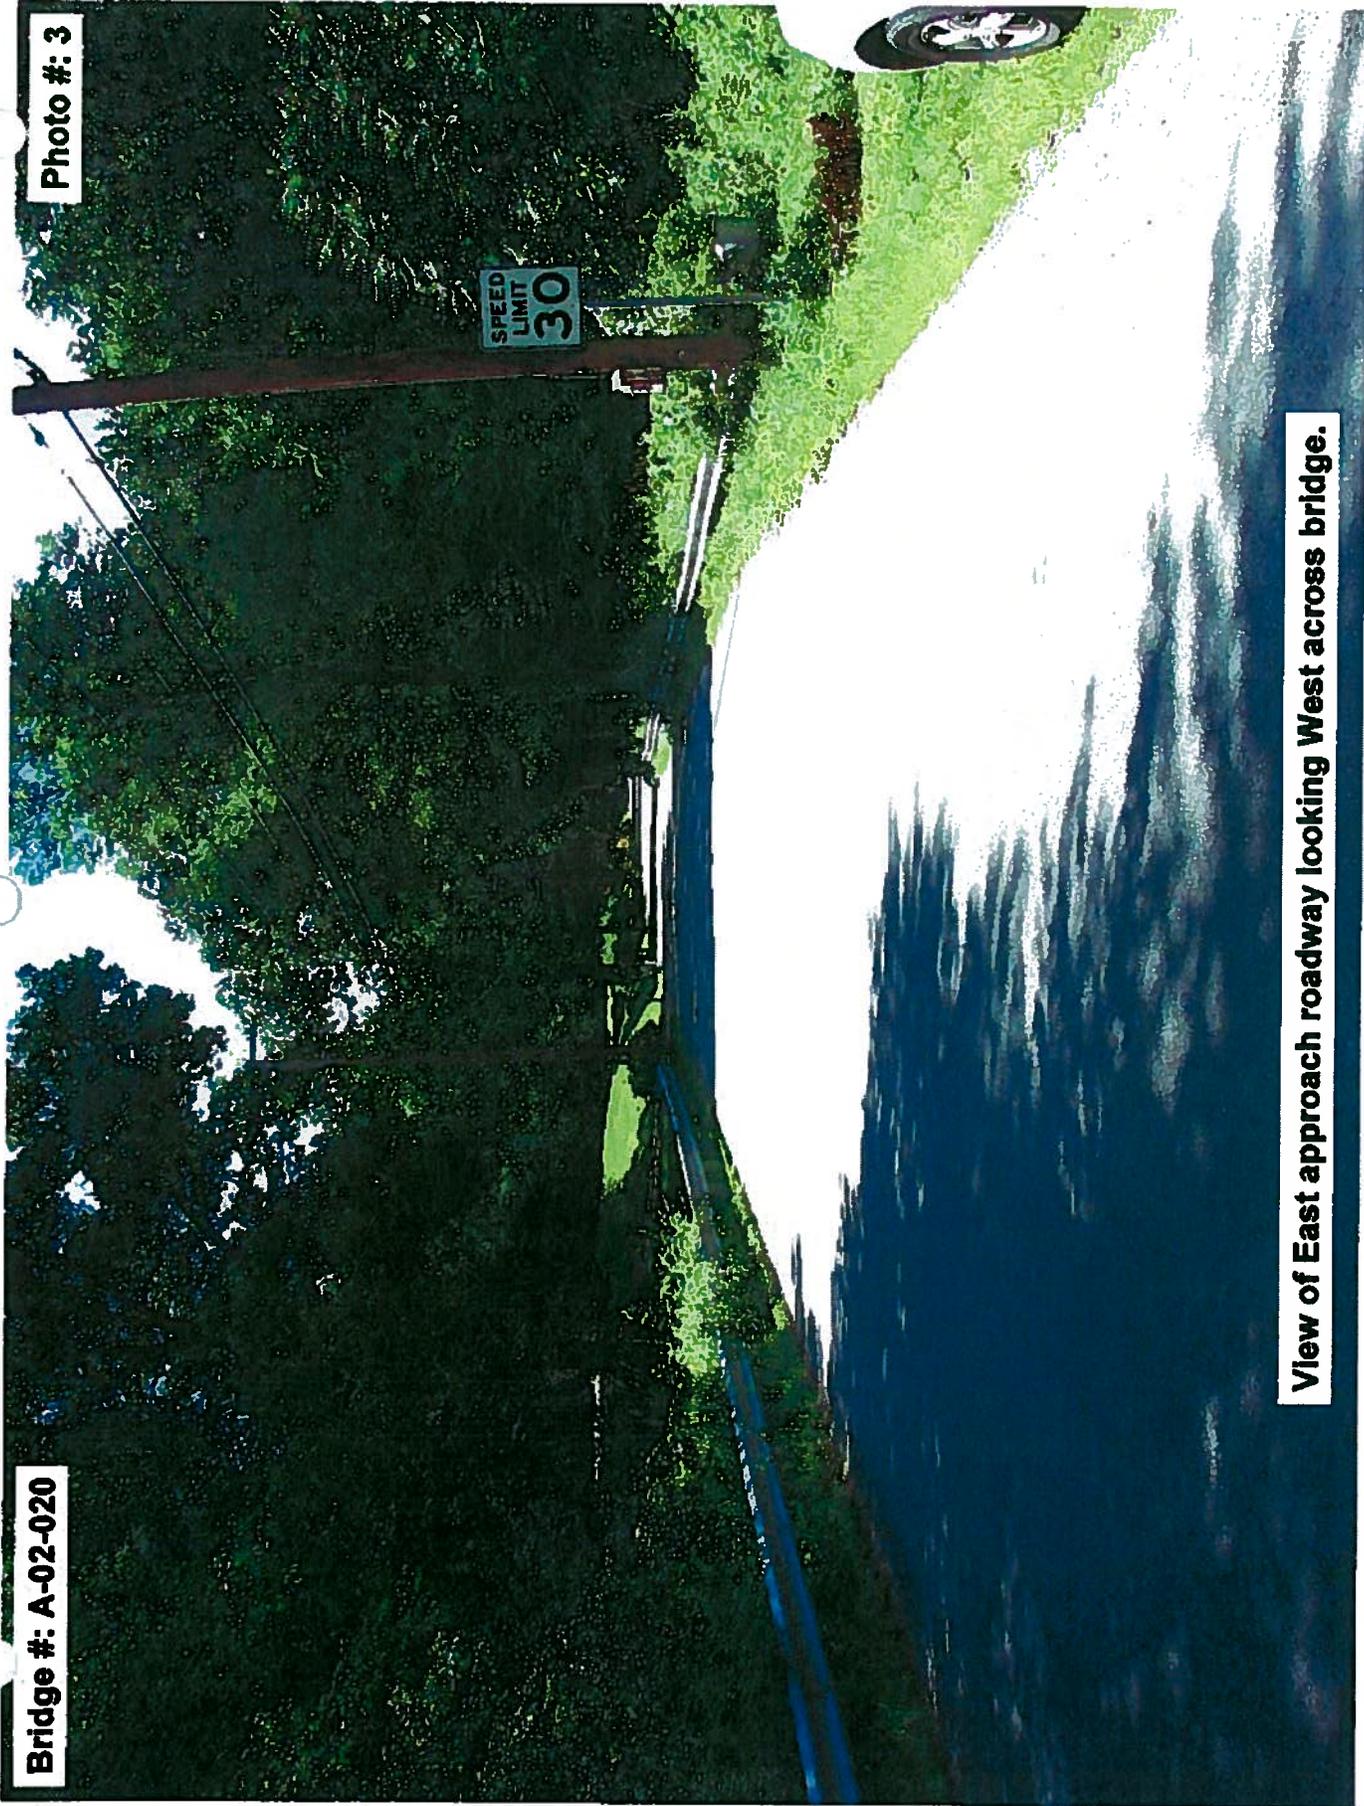
Photo #: 3

View of East approach roadway looking West across bridge.

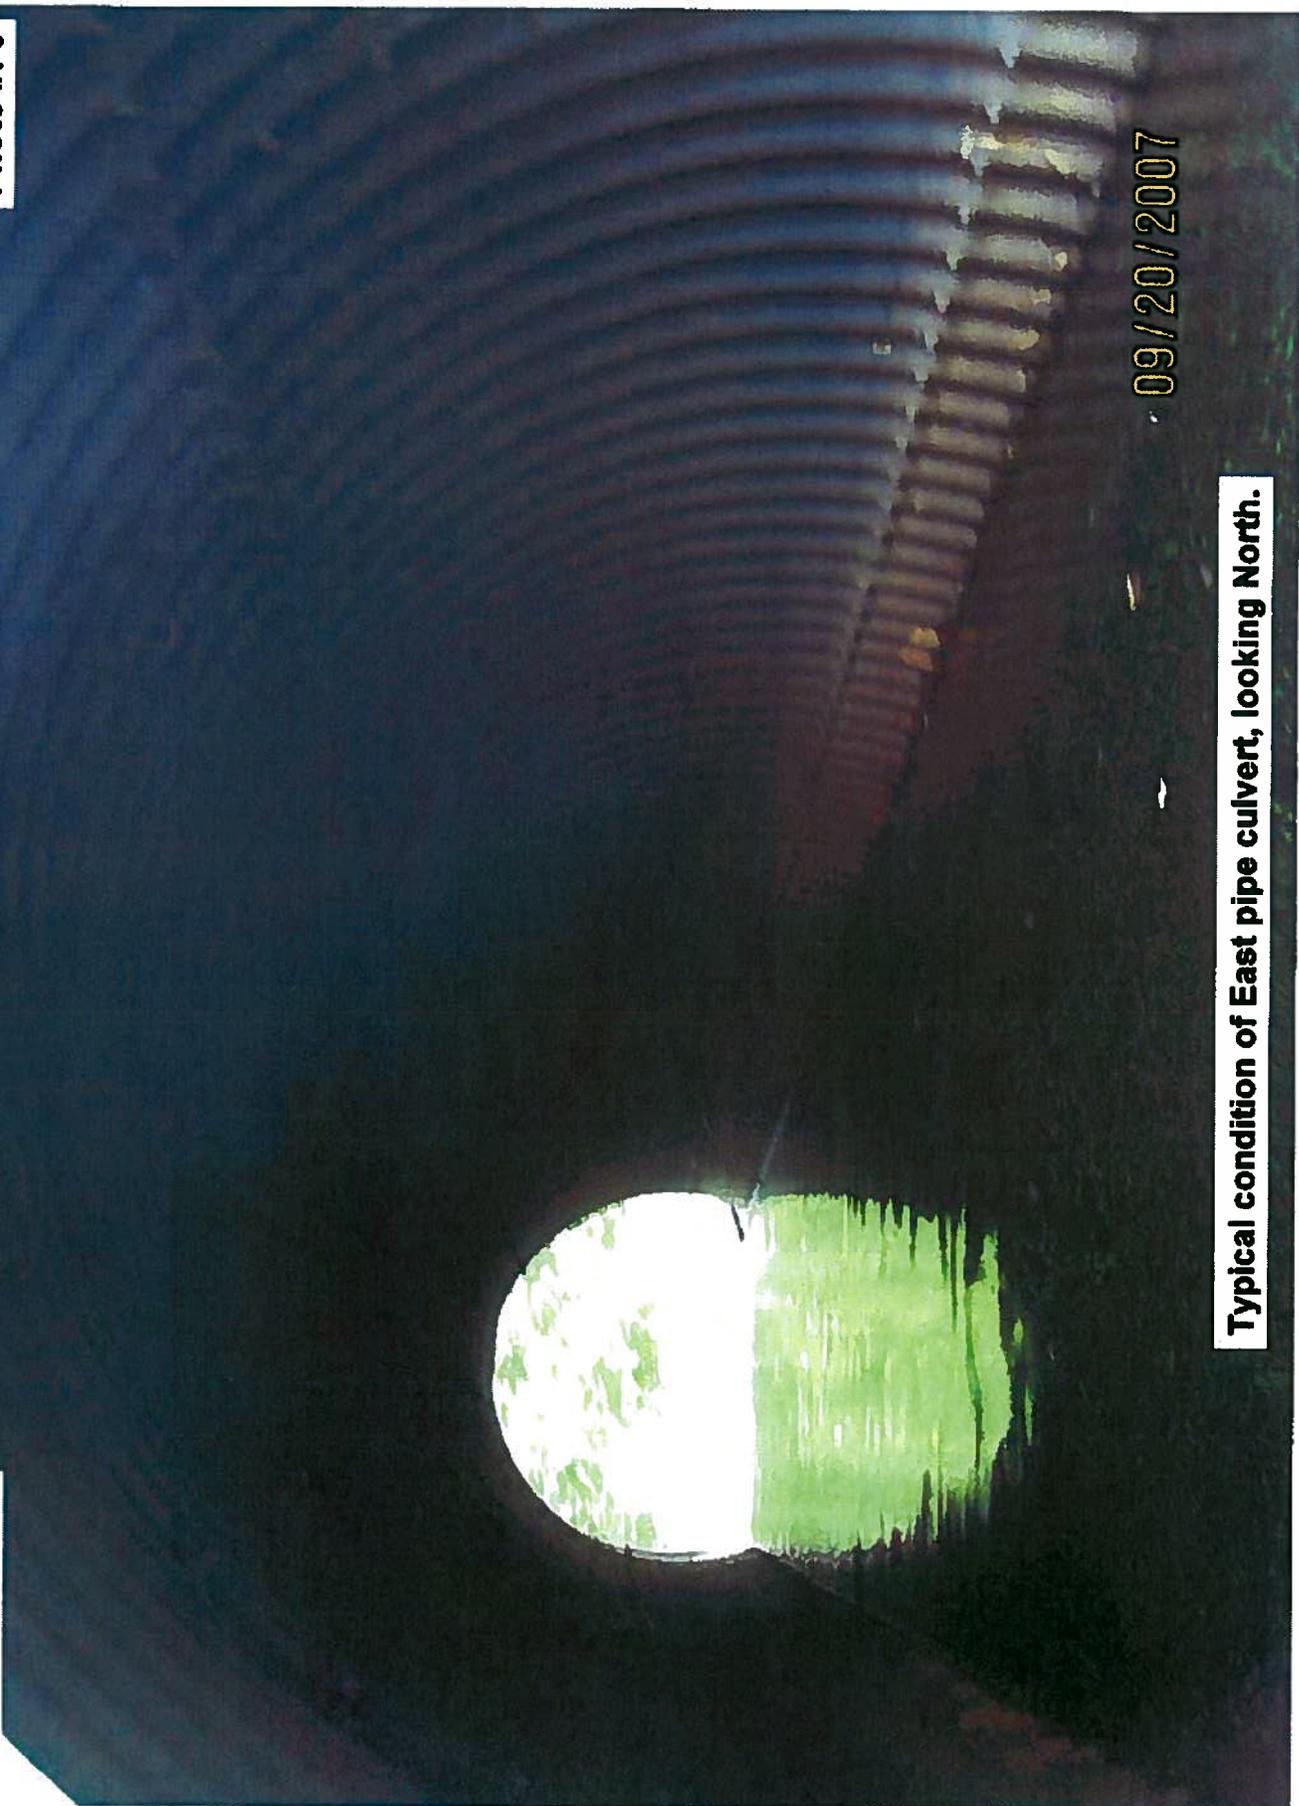
Photo #: 5

Typical condition of East pipe culvert, looking North.

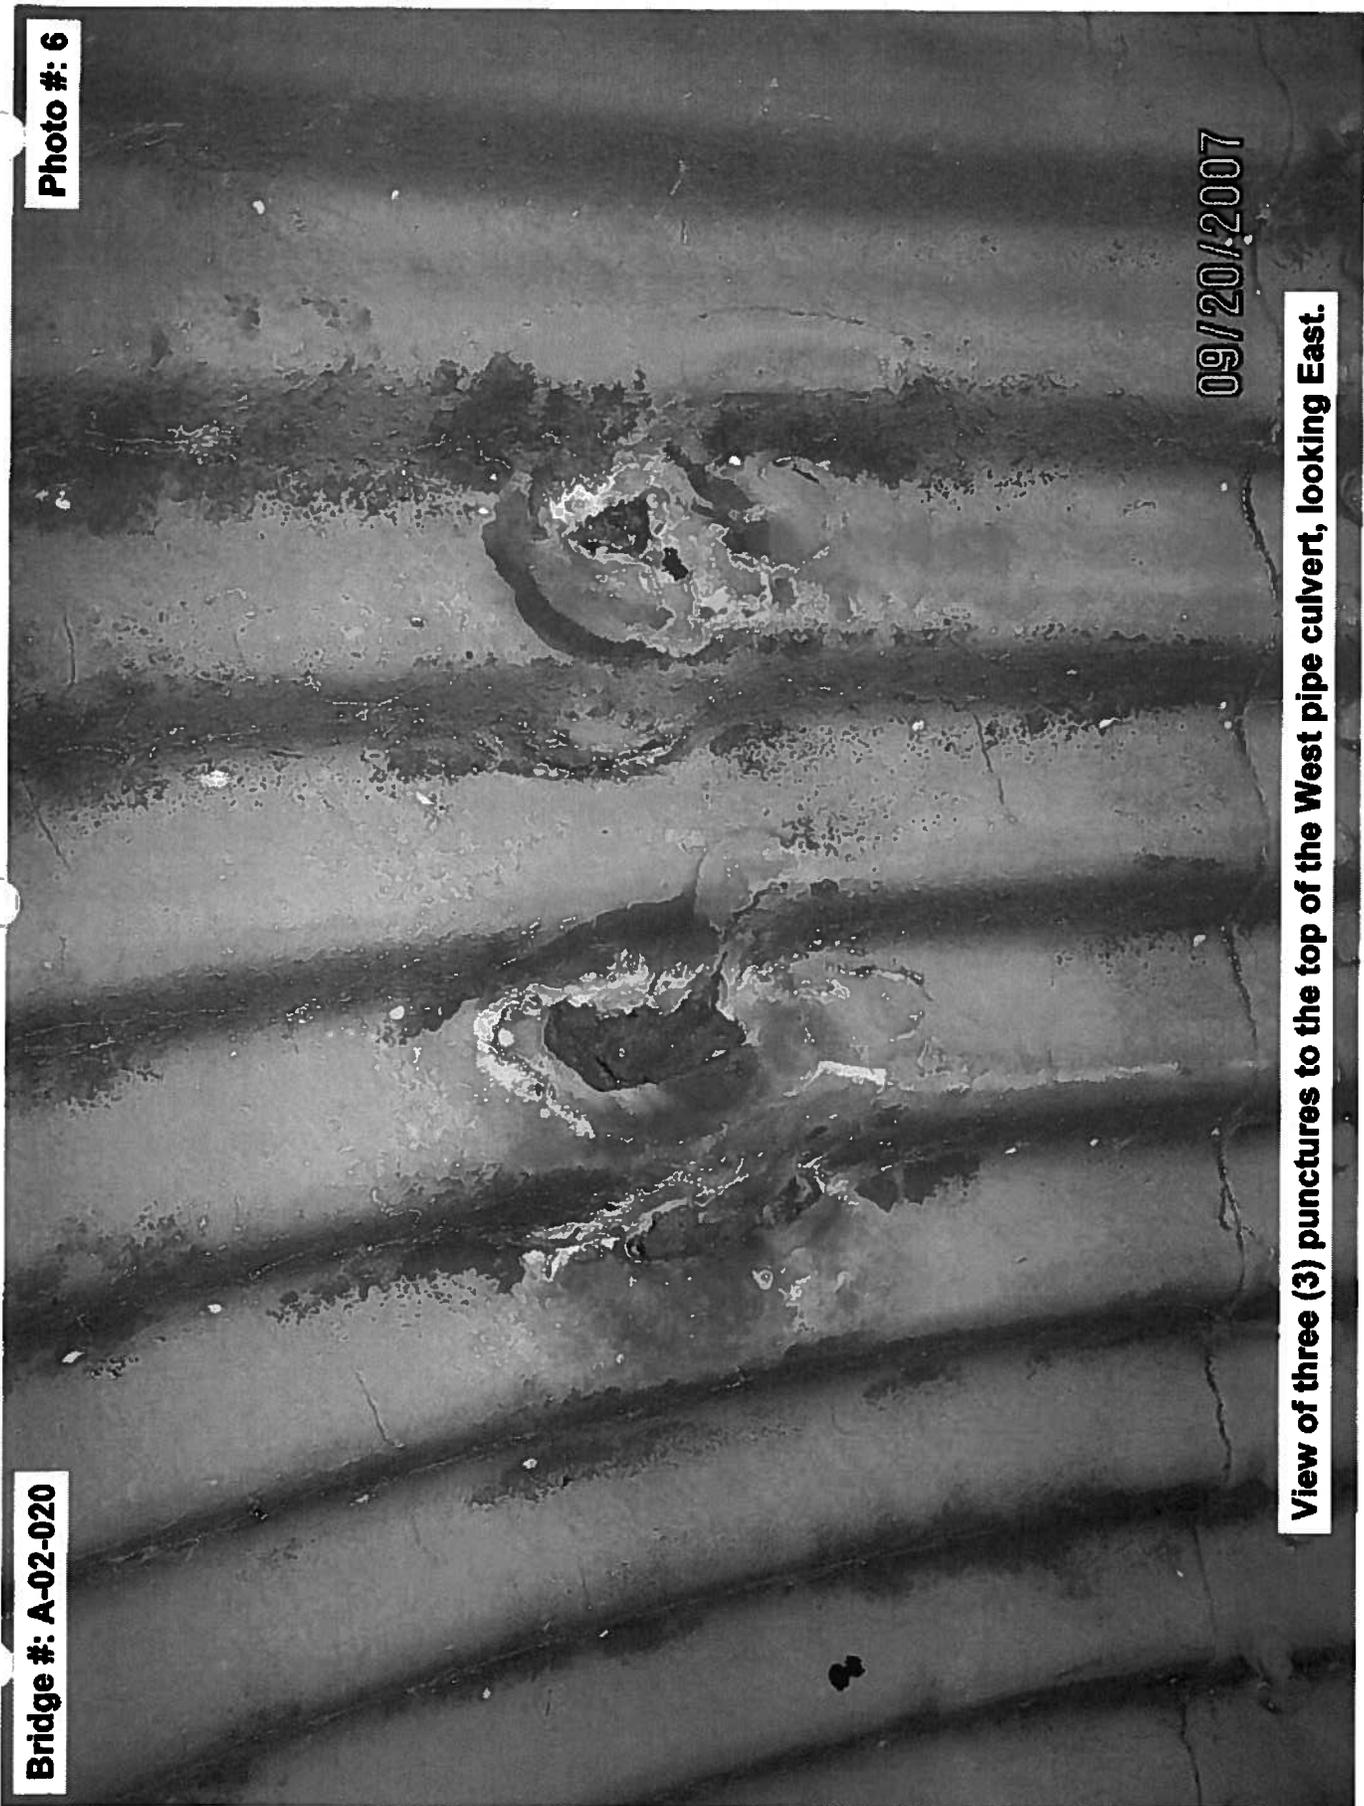
Photo #: 6

View of three (3) punctures to the top of the West pipe culvert, looking East.

#3	Top of West pipe culvert	Three punctures from guard rail installation	Weld repair plate	Moderate
#4	Top of East pipe culvert	Two punctures from guardrail installation	Weld repair plate	Moderate

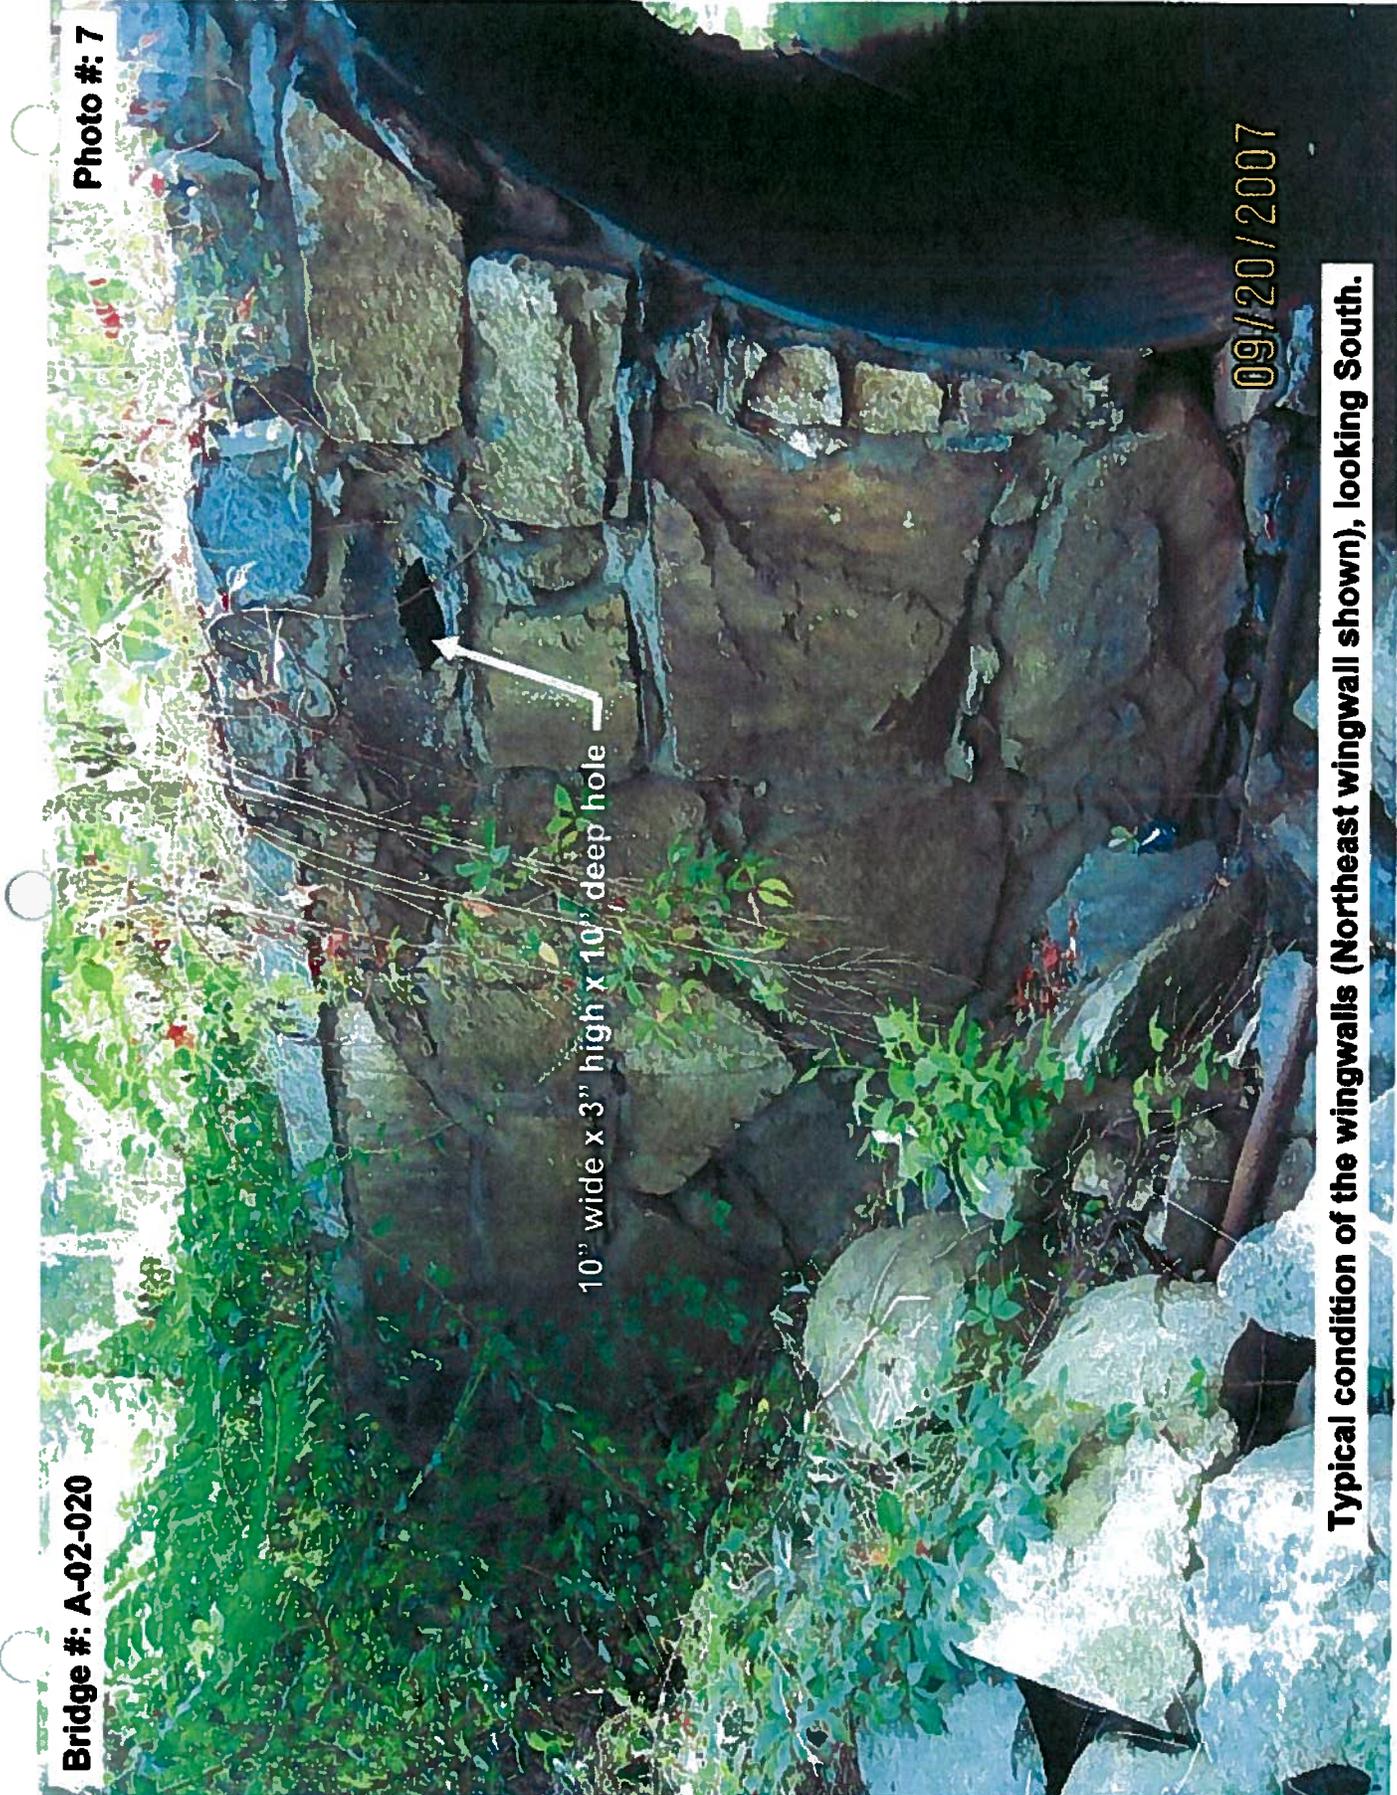
Photo #: 7

Element	Deficiency	Reference Photo(s)
Wingwalls	<ul style="list-style-type: none"> <li>• Random narrow cracks in mortar</li> <li>• Random voids and missing mortar at the West pipe culvert of the Northwest wingwall</li> <li>• Random cracks in the mortar and a missing stone near the top of the Northeast wingwall that measures 10"W x 3"H x 10"D</li> <li>• Random minor voids throughout the Southwest wingwall with light vegetation growth near the base</li> </ul>	7

10" wide x 3" high x 10" deep hole

Typical condition of the wingwalls (Northeast wingwall shown), looking South.
