III. RECOMMENDATIONS OF REPAIRS TO TOWN OWNED BRIDGES

CITY/TOWN ACTON	B.I.N. 255	BR. DEPT. NO. A-02-008	8.-STRUCTURE NO. A02008-255-MUN-NBI	INSPECTION DATE DEC 5, 2005
---------------------------	----------------------	----------------------------------	---	---------------------------------------

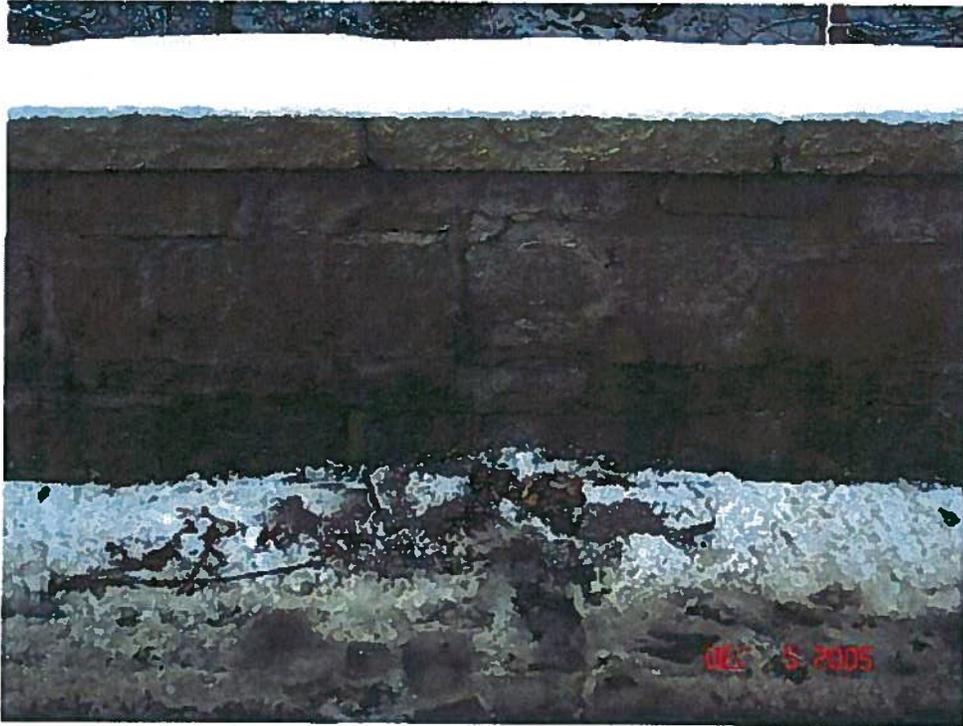
The curbs consist of beveled mortar which is on top of the spandrel wall cap stone. There are a few spot locations where this mortar has broken off exposing the spandrel wall cap stone primarily on the south side. (See Photo 1.) During the day of inspection the edge of roadway on both sides had a covering of snow that hid the curb area. Where the snow cover was removed and the curb was exposed the condition was observed to be similar to that reported in 2003. Therefore the curb reveals reported in 2003 have been carried forward.

Photo 1: South curb center span.

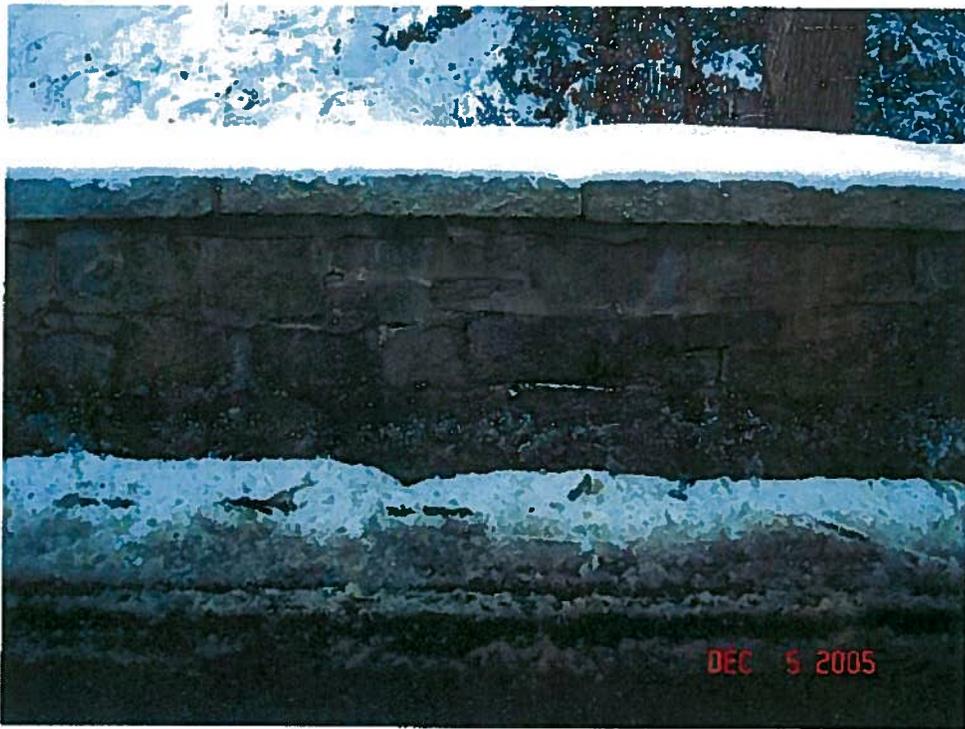
Photo 2: South bridge rail, southeast quadrant.

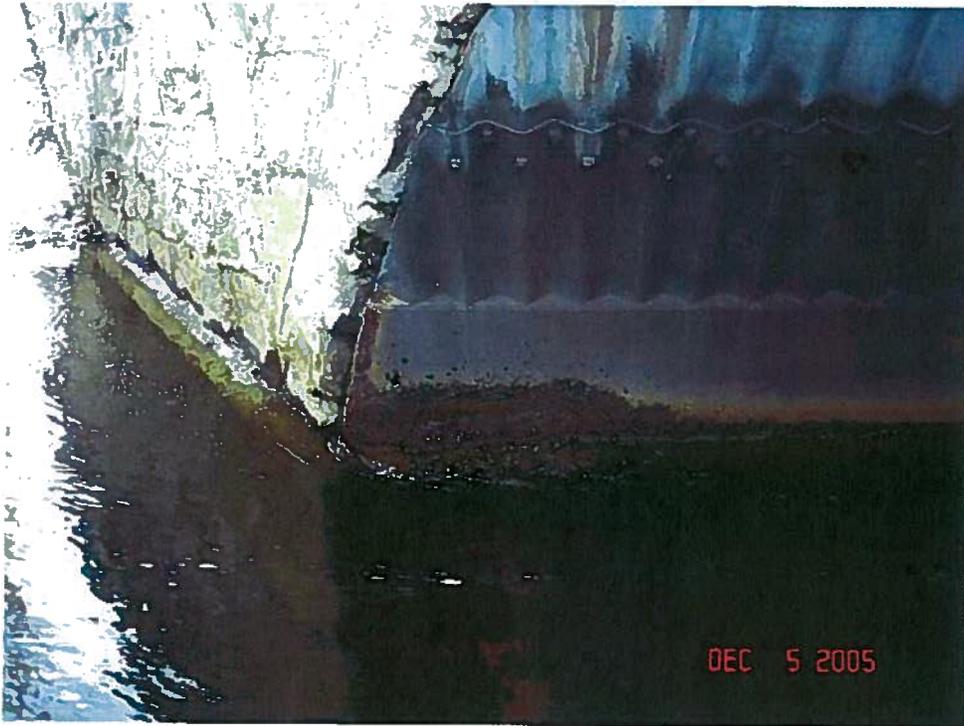
On the west side in the center of the barrel there is a bow of 1 to 2 in. above the spring line. The steel seat plate for the corrugated plate arch is rusted at the southeast, southwest and northwest quadrants. (See Photo 3.)

Photo 3: Southwest end of barrel.

SELLS recommends that the corrugated steel deck arch and lower connection plates be cleaned and coated with a new protective coating, particularly at the lower ends where the steel plate meets the concrete abutments. Based on the recommended repairs, the preliminary construction cost estimate to accomplish this work is approximately **\$41,000**.

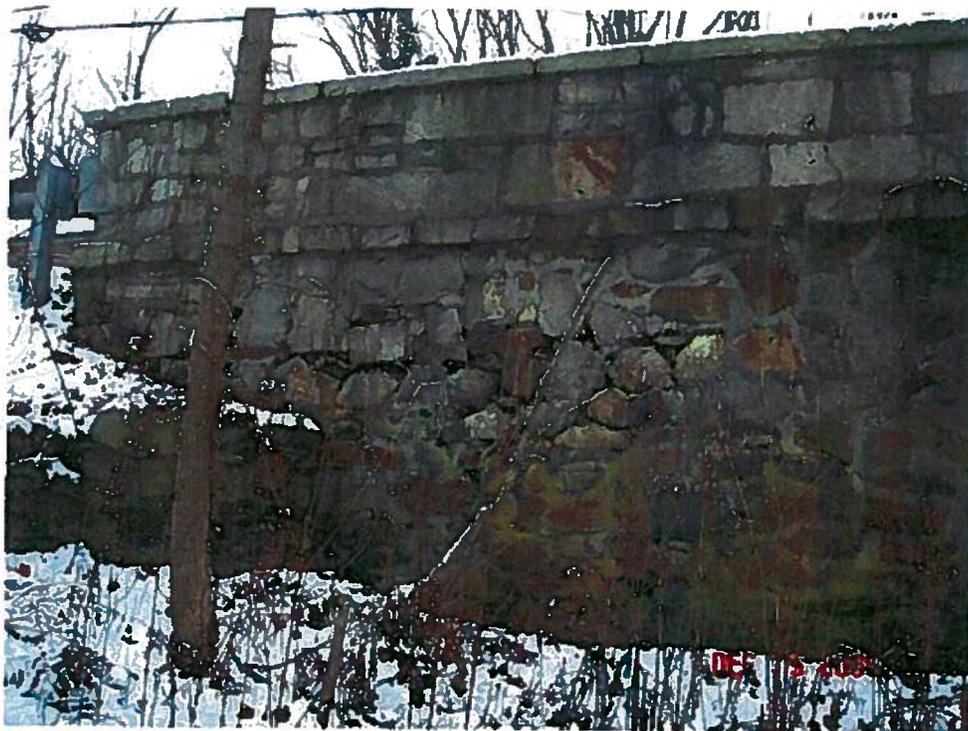
There is an 8 ft. wide and 4 ft. tall area with missing mortar in the northeast wingwall. The voids in the mortar were found to be approximately 1 ft. deep. (See Photo 4.)

Photo 4: Northeast wingwall.

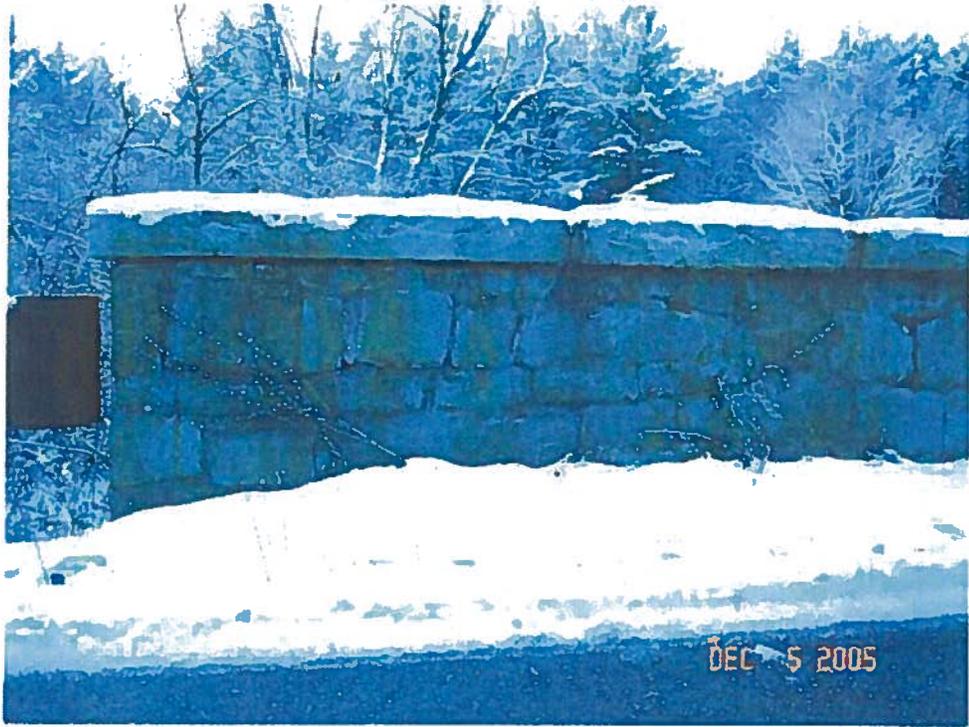
The north and south bridge rails are made up of random laid up stone mortar with a stone cap. The mortar condition is good. Both have vertical and horizontal cracks in the mortar joints. The cracks are typically 1/8 to 1/4 in. in width. (See Photo 1.) The south bridge rail has a 1 in. wide crack located 16 ft. east of the west end. (See Photo 2.) No through cracks in stones were observed adjacent to or part of the vertical or horizontal cracks. The cap stone in each quadrant is losing mortar at the ends of the headwalls. Some of the cap stone joints are open.

Photo 1: Northeast bridge rail.

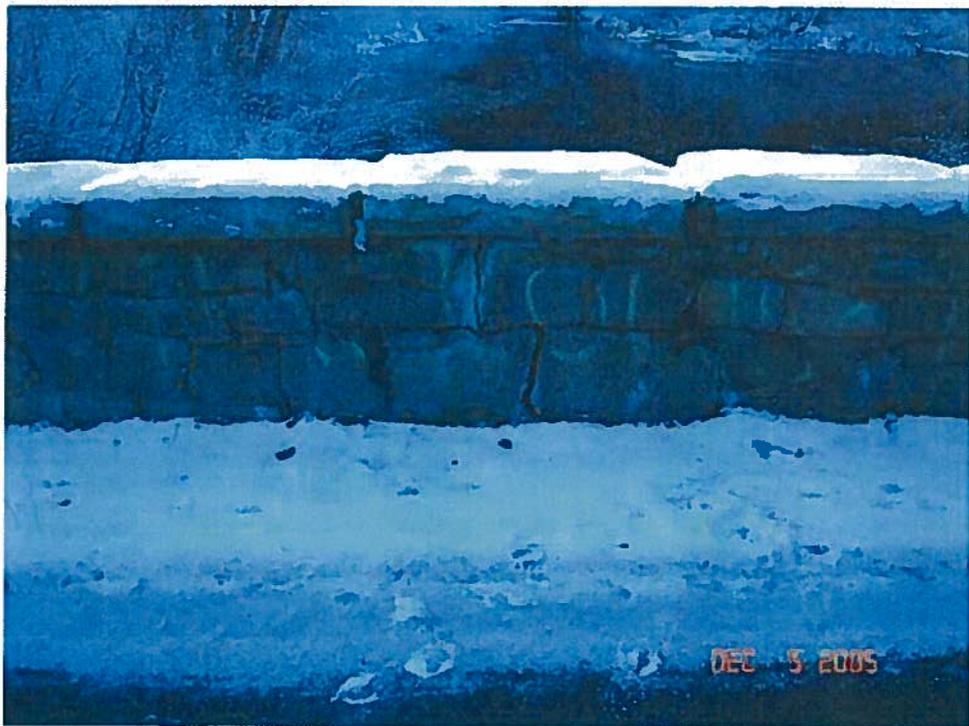
Photo 2: South bridge rail center span.

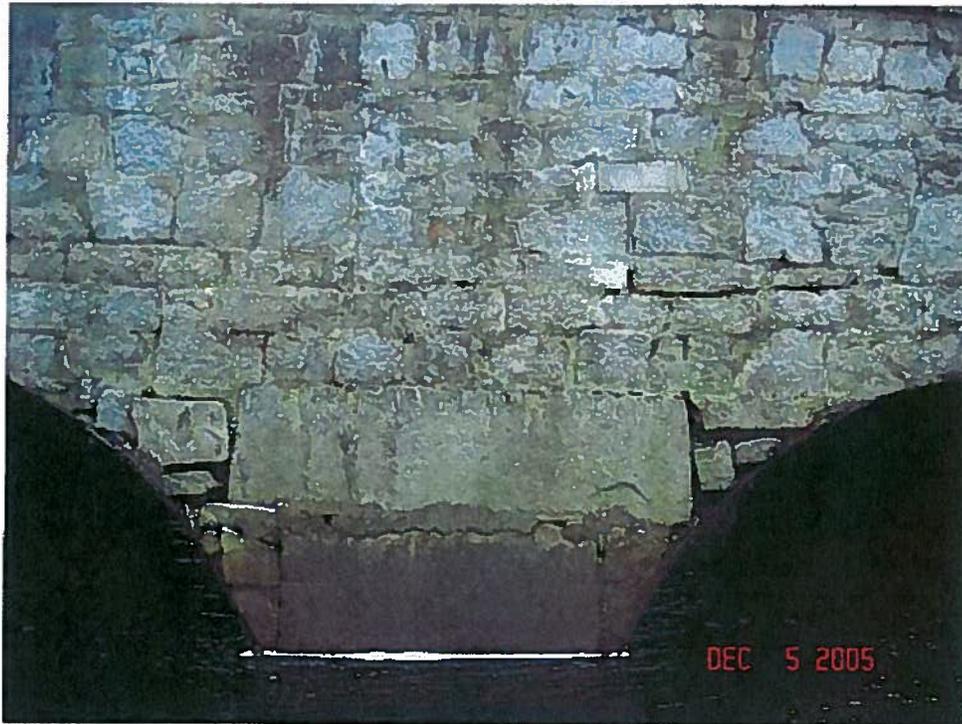
The north headwall has two areas where the mortar between the masonry blocks is missing. The first area is located at 10:00 o'clock facing south on culvert 1 and measures 26 in. wide and 26 in. tall. The second is at 2:00 o'clock facing south on culvert 2 and measures 24 in. wide and 40 in. tall. The voids in these two areas were up to 1 ft. deep. (See Photo 3.) There is a hairline to narrow crack in the mortar joints between the stones located in the center between the culverts extending vertically from the cap stone to the first area mentioned above. There is an area with efflorescence staining extending from the west headwall end to above the center of culvert 1 from the street level down.

Photo 3: North headwall.

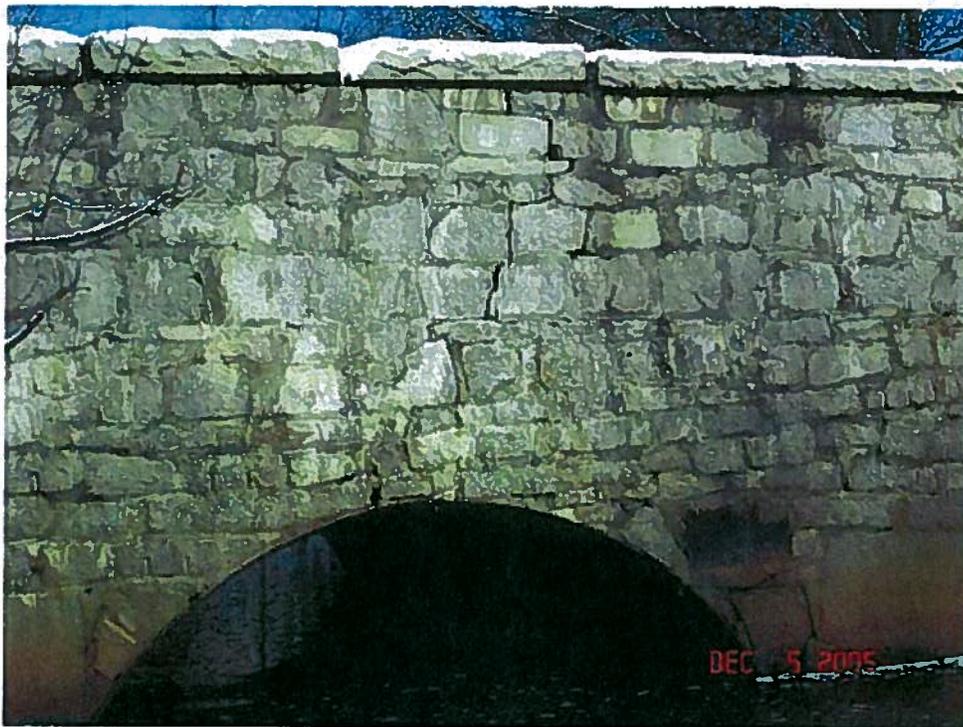
were measured to be up to 30 in. deep. There are areas of hairline surface efflorescence in the mortar joints below the street surface in the south headwall primarily on the east side of culvert 2. There is a wide crack in the mortar joints located above culvert 1 and extending vertically from the cap stone to the keystone area. (See Photo 4.)

Photo 4: South end of culvert 1.

SELLS recommends that the steel corrugated pipe arch culverts be cleaned and coated with a new protective coating. Also, voids between the headwalls and pipe arches shall be filled to prevent the infiltration of water behind the pipe arches. Lastly, the stone masonry bridge rail and headwalls shall be repointed to fill the large gaps in the mortar. Based on the recommended repairs, the preliminary construction cost estimate to accomplish this work is approximately **\$92,000**.

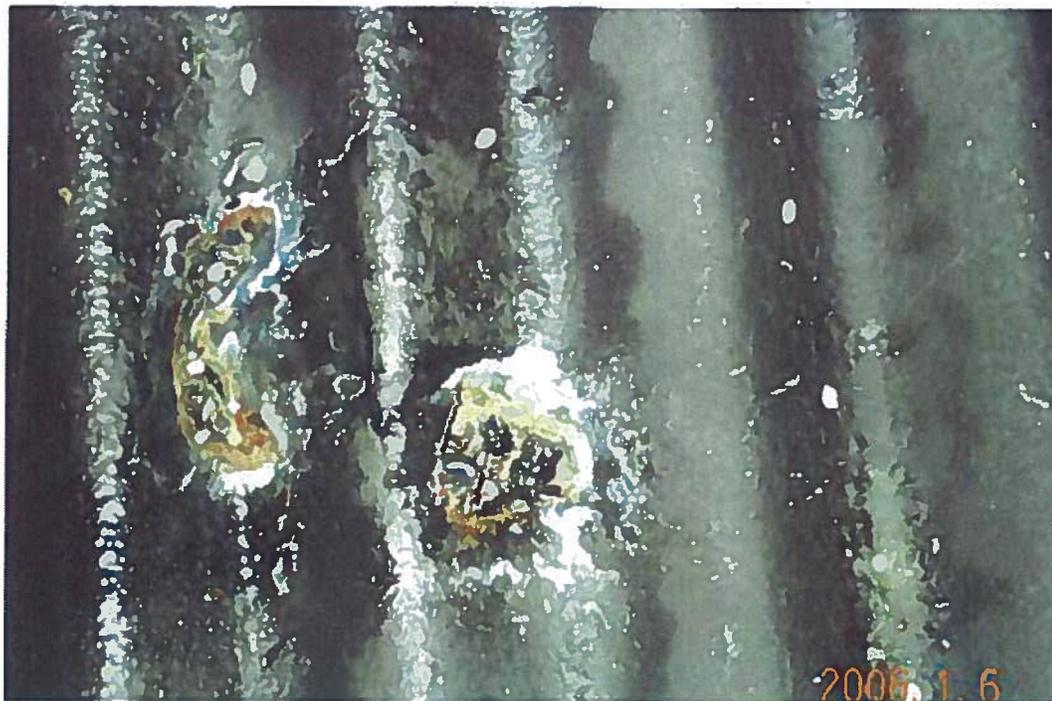
Photo 1: Two small holes to S barrel, typical of three small holes in N barrel.

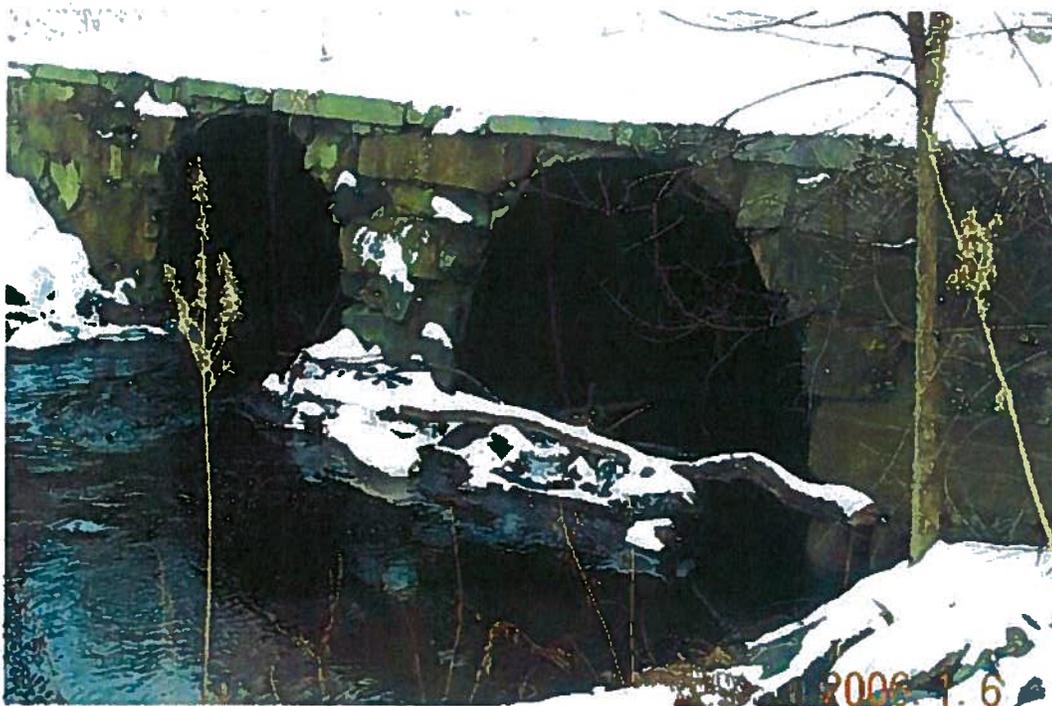
Photo 2: Debris at upstream side of W culvert barrel.

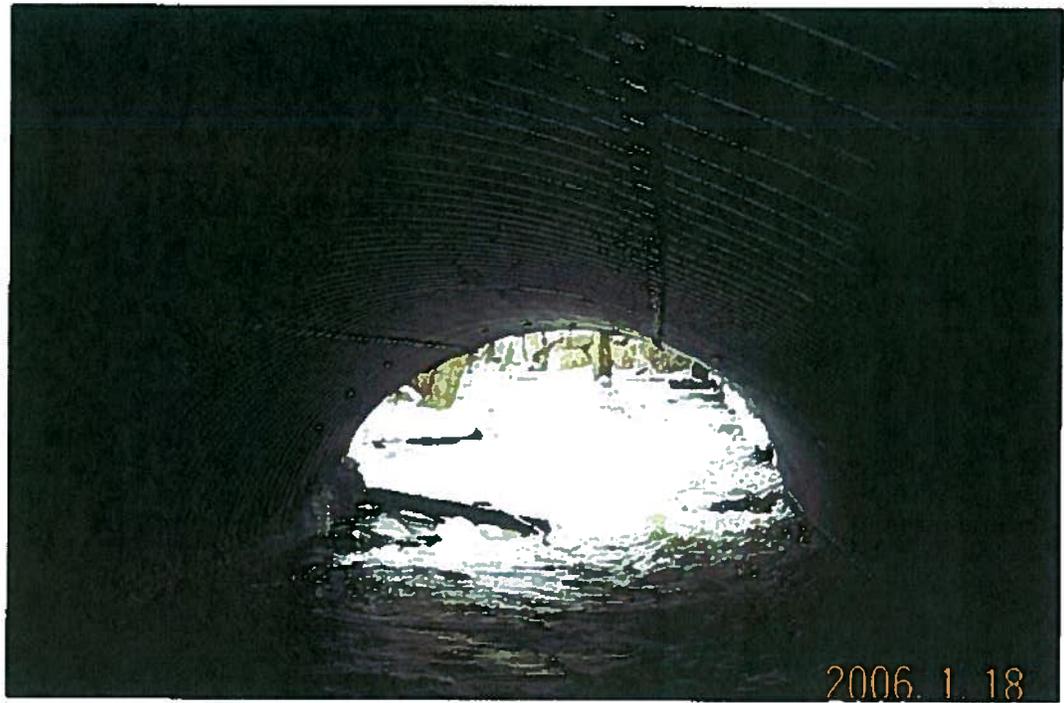
Photo 1: Barrel #1 (West).

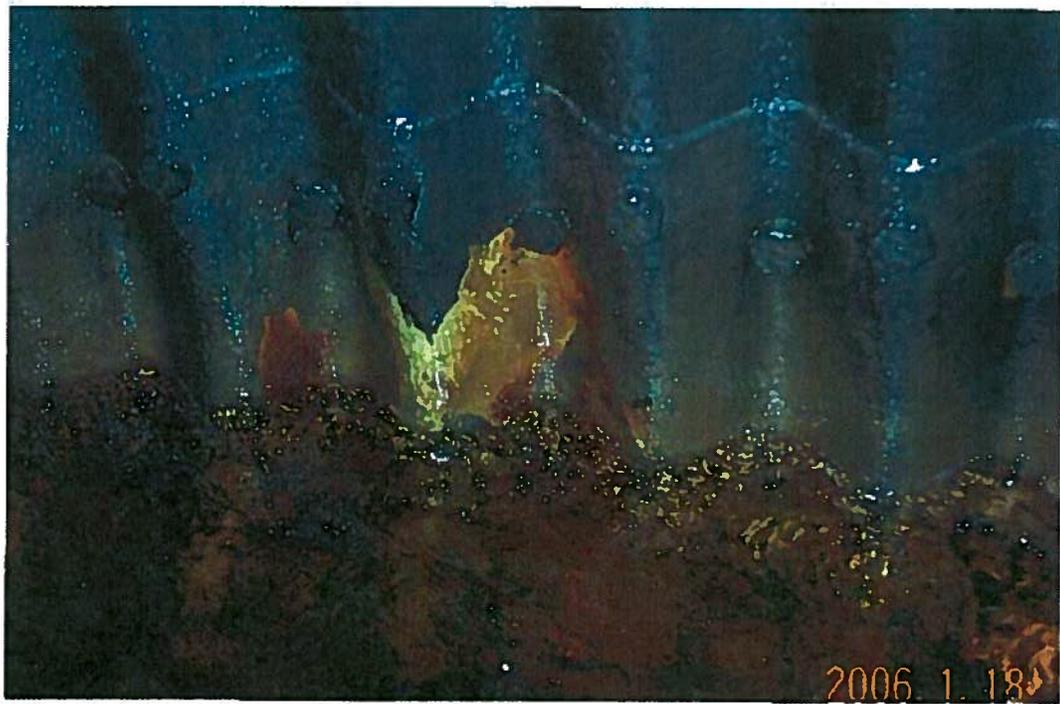
Photo 2: Surface rusting to barrel. Typical.

SELLS recommends that the steel corrugated pipe arch culverts be cleaned and coated with a new protective coating. Also, voids between the headwalls and pipe arches shall be filled to prevent the infiltration of water behind the pipe arches. Riprap shall also be placed at the culvert ends to prevent undermining and the failed section of the Southwest wingwall should be rebuilt. Based on the recommended repairs, the preliminary construction cost estimate to accomplish this work is approximately \$74,000.

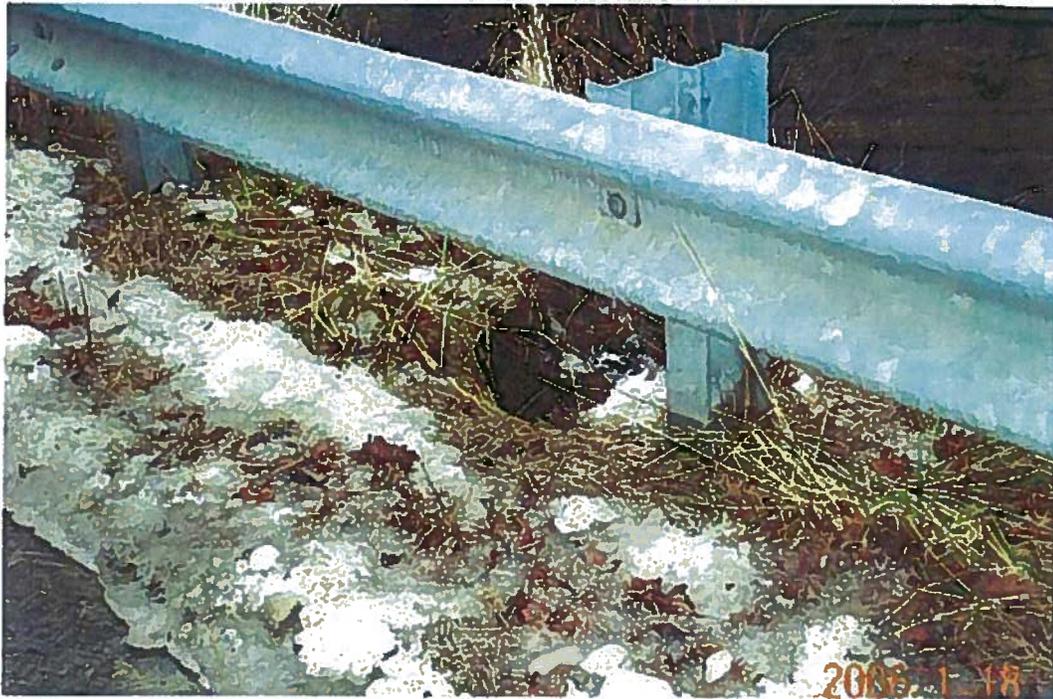
Photo 3: Sinkhole above barrel #2. South end.

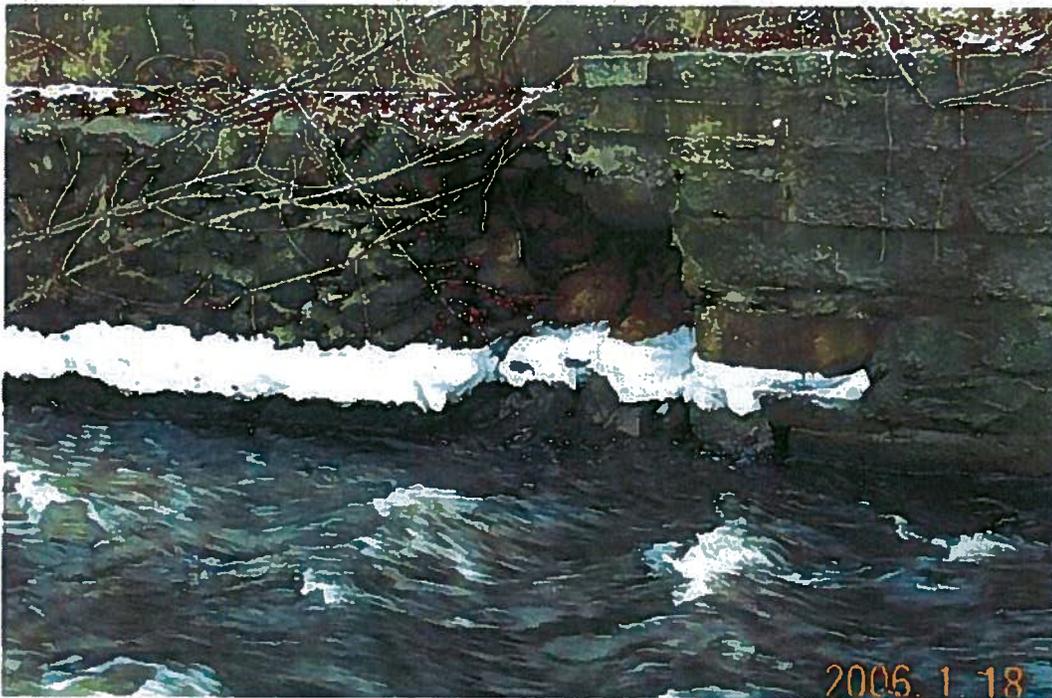
Photo 4: Collapse to the Southwest channel wall.

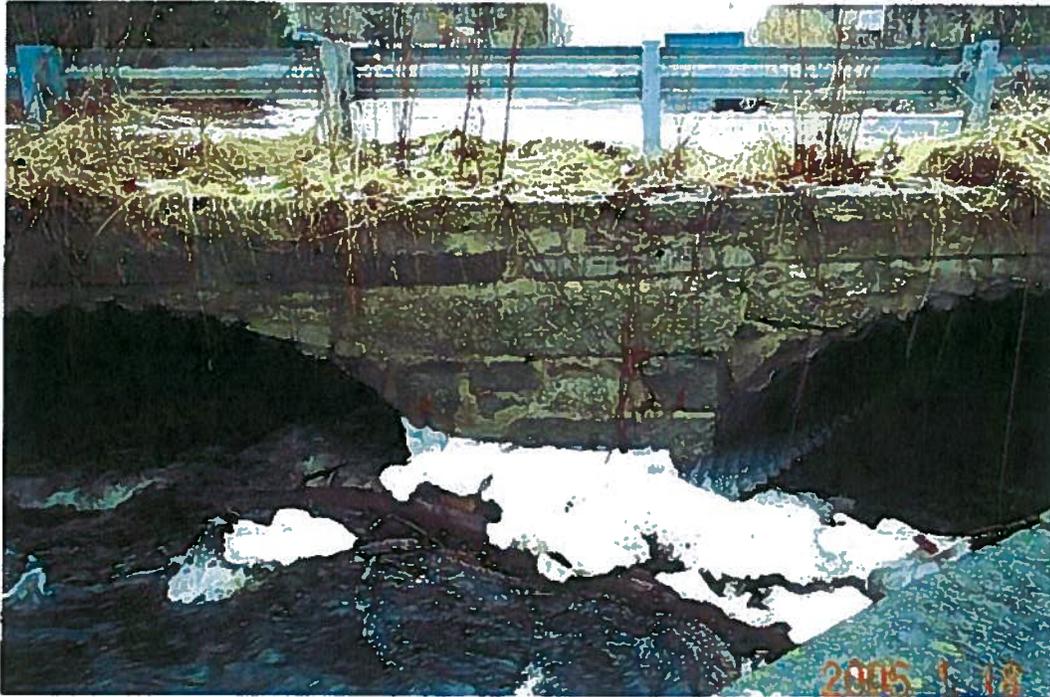
Photo 5: Debris across both barrels at the upstream end.

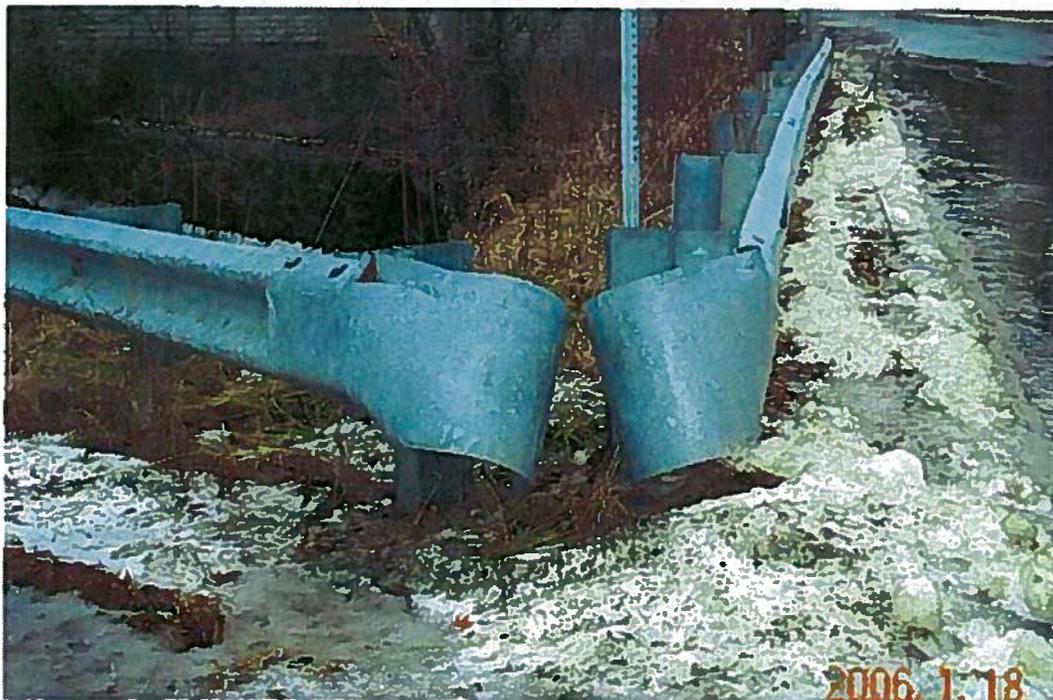
Photo 6: Collision damage to the Southeast terminal end.

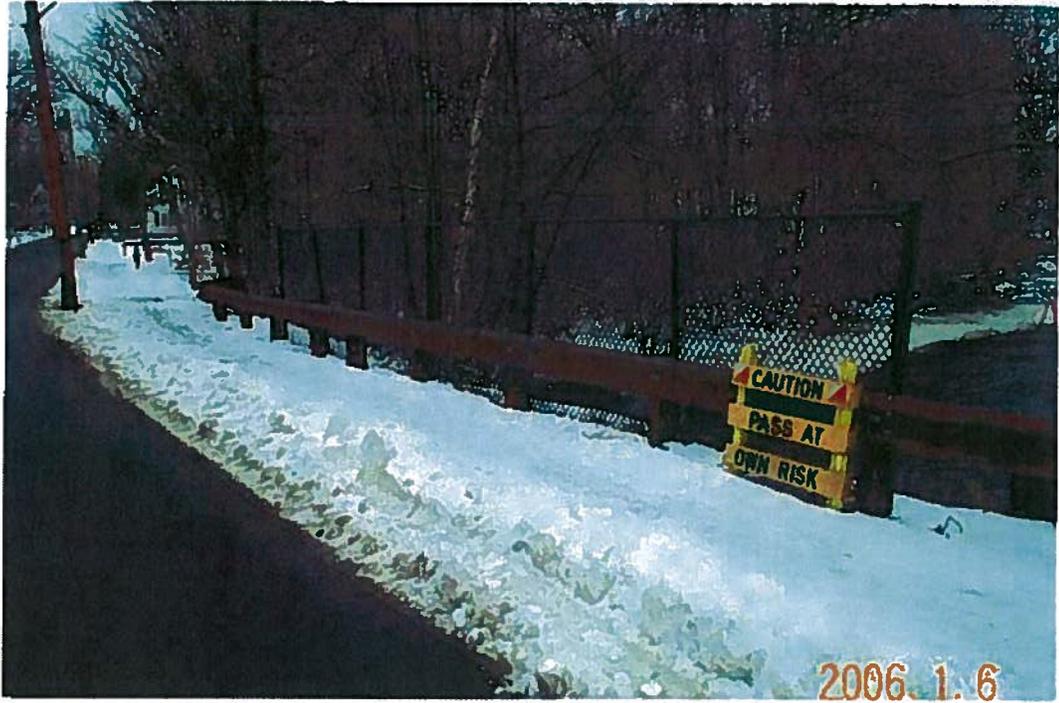
Photo 1: Chain link pedestrian barricade at E side of culvert (sidewalk side)
