*MINUTEMAN REGIONAL VOCATIONAL TECHNICAL HIGH SCHOOL - GRADES 9 THROUGH 12; APPROX. 820 STUDENTS*

EVALUATION OF EXISTING FACILITIES  
MINUTEMAN REGIONAL CAREER & TECHNICAL HIGH SCHOOL  
758 MARRETT ROAD • LEXINGTON, MA 02421

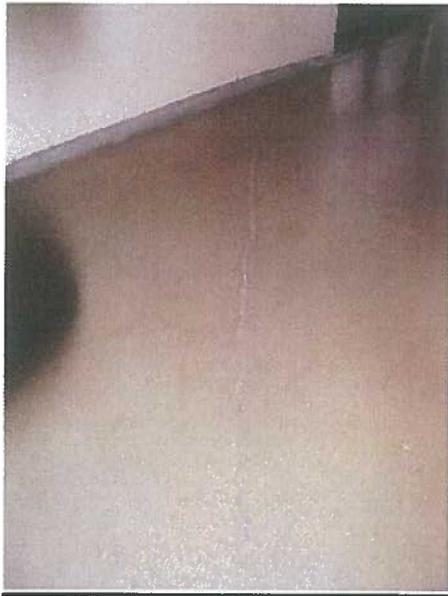
PHOTO #1: The photo above shows one of the many cracks in the first floor concrete slab on-grade. It is located in one of the stair towers where cracks of this type were prevalent.

**COMMENT FOR ITEM NO. 1:** The cracks in the first floor concrete slab on-grade appear to have occurred as the result of several circumstances. The majority of the cracks appear to be shrinkage-type cracks. Several of them appear to be settlement cracks, including the cracks that appear to continue into the foundation walls. These settlement-type cracks were found in several stairwells throughout the building. In general, the cracks in the first floor concrete slab on-grade are not a serious structural concern, and do not pose a life/safety issue. The cracks do however, reduce the usefulness/serviceability of the floor, and pose a potential tripping hazard.

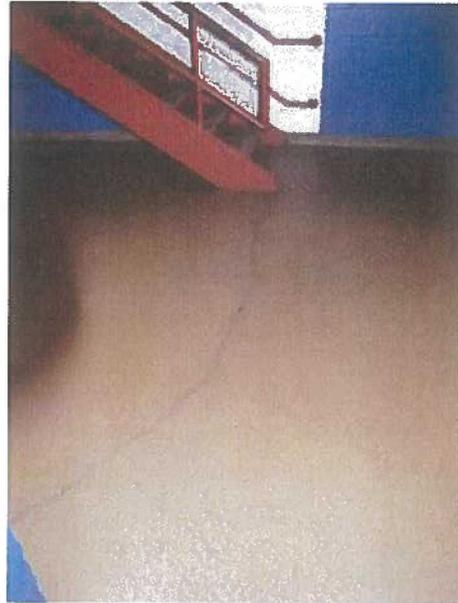
PHOTO #4: The photo above shows another of the many cracks in the first floor concrete slab on-grade in a stairwell.

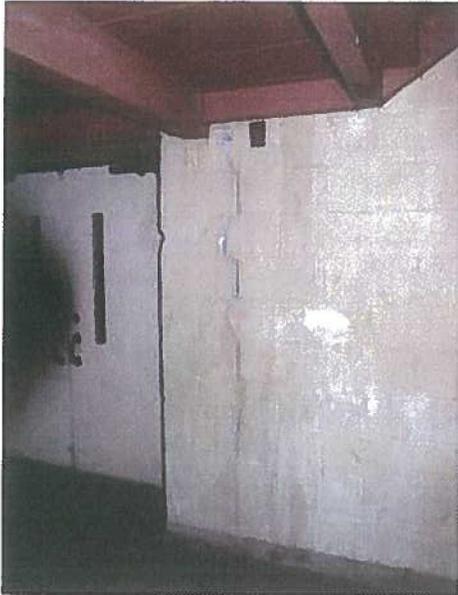
**PHOTO #5:** The photo above shows one of the many cracks in the masonry block walls of the stair towers.

**COMMENT FOR ITEM NO. 2:** Many of the most significant cracks in the masonry block walls of the stairwells and the widening of the masonry control joints appear to be the result of settlement of the supporting foundation walls. Several of the smaller cracks in the stairwell masonry blocks appear to occur where the concrete blocks were cut to surround supporting steel columns. Cracking of the masonry block walls may also have been caused by water infiltration into the building envelope. Further investigation is recommended.

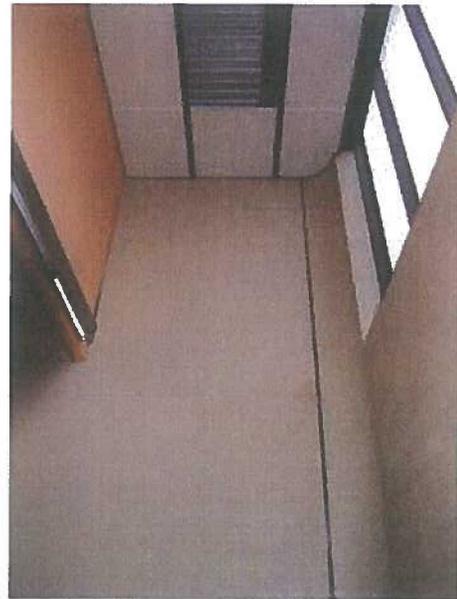
**PHOTO #7:** The photo above shows cracking at the top of the masonry block wall in one of the stair towers, and the enlarged control joint in this masonry wall.

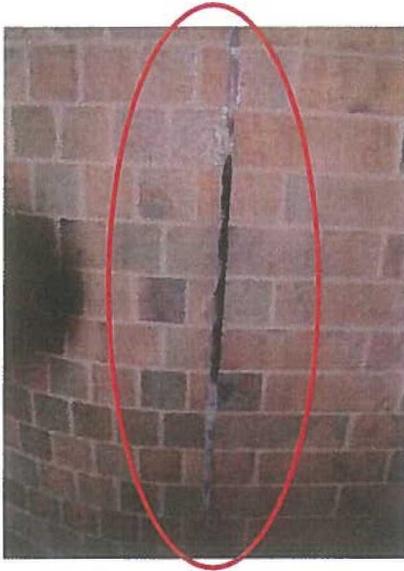
**PHOTO #8:** This photo shows one location where the joint sealant for the exterior brick veneer has failed.

**COMMENT FOR ITEM NO. 3:** The failure of the joint sealant for the exterior wall brick veneer control joints may be allowing water to enter into the building envelope; this water may be further damaging the building structure. A program of repair and maintenance for the exterior wall joint sealants should be instituted to prevent further damage to the building structure and finishes.

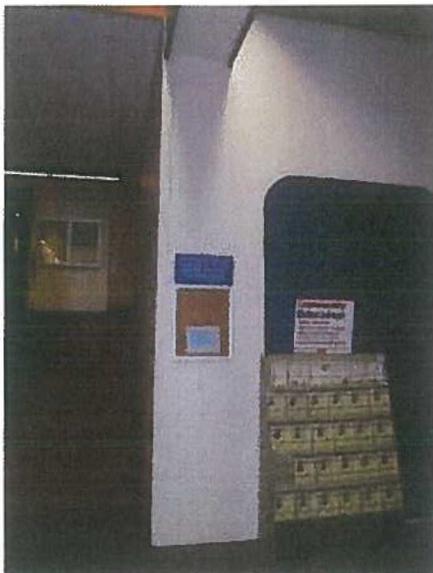
**PHOTO #10:** The photo above shows another of the isolated cracks in the interior masonry block walls found throughout the school.

**COMMENT FOR ITEM NO. 4:** Many of the cracks in the interior masonry block walls appear to be minor in nature. In several instances, these cracks appear to occur where the concrete blocks were modified to accommodate the building columns. In other cases, the cracks appear to be caused by minor movements of the building superstructure. Further investigation is recommended.

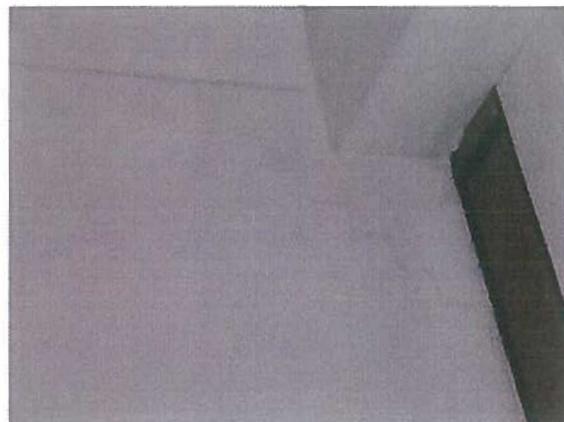
**PHOTO #9:** This photo shows one of the several cracks in the interior masonry block walls.

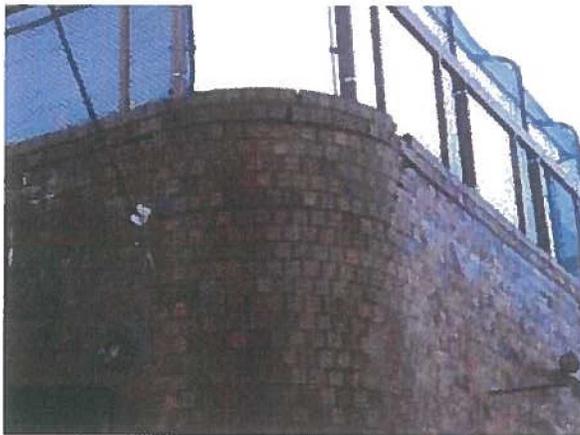
PHOTO #11: Above represents the significant displacement and cracking of the brick veneer on the south and west exterior walls of the school's Boiler Room building.

**COMMENT FOR ITEM NO. 5:** These exterior brick veneer walls will require partial reconstruction and repair. Waterproofing measures will be required to prevent water from infiltrating into the walls and penetrating the building envelope.

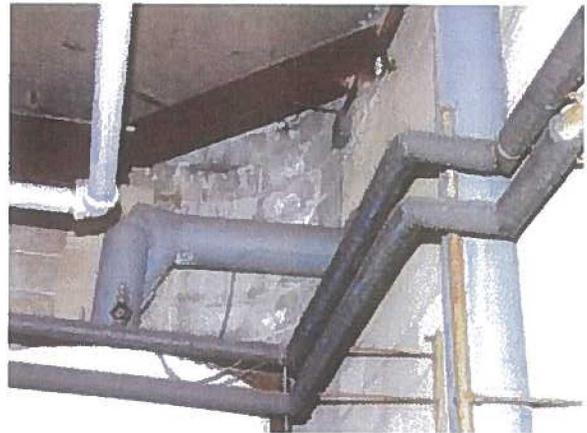
PHOTO #13: This photo shows the water infiltration inside the Boiler Room Building and the minor corrosion of the roof framing members.

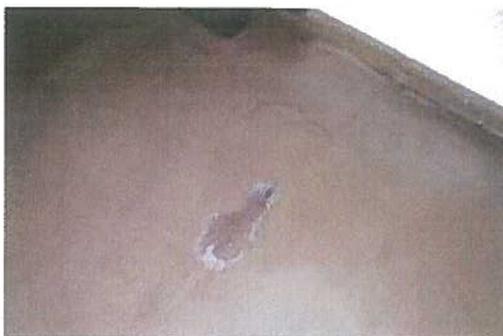
PHOTO #14: This photo shows one location where the concrete floor in the Natatorium has cracked and spalled.

**COMMENT FOR ITEM NO. 6:** The cracks and spalls in the concrete floor of the Natatorium should be repaired with specialty concrete repair products to prevent further deterioration of the concrete floor.

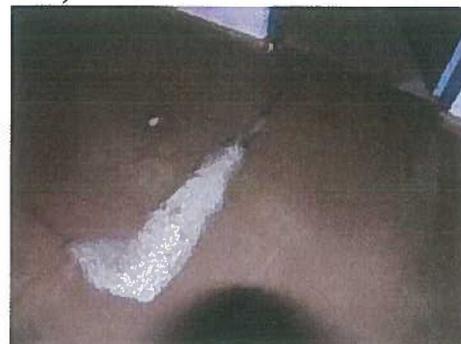
PHOTO #15: This is another of the cracks & spalls in the concrete floor of the Natatorium.

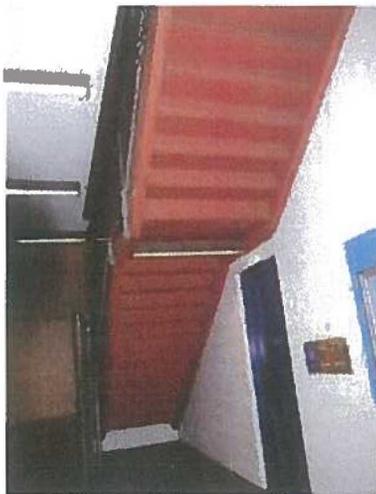
**PHOTO #16:** This photo shows one of the stairways that reportedly vibrate vigorously when in use. Notice the long span of steel channel stringer that supports the outboard side of the stairs.

**COMMENT FOR ITEM A:** The steel channel stringers that support the outboard side of the stairs have a relatively long span for the depth of the channel. Further investigation and analysis of the stairway is recommended.

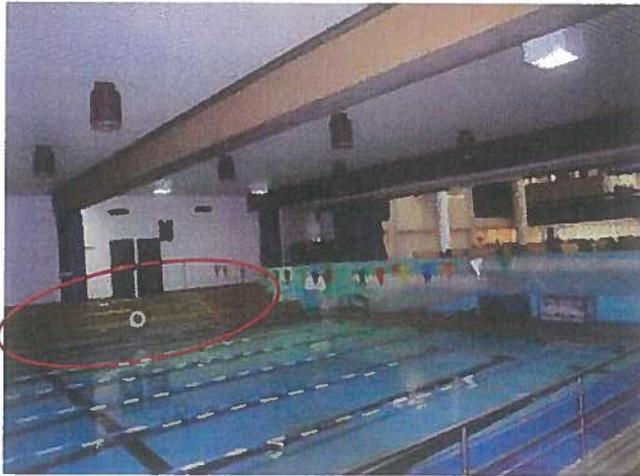
**PHOTO #17:** This photo shows the structural concrete bleachers alongside the swimming pool that are reportedly deteriorated below. In addition, this photo shows that the Gymnasium floor structure above the Natatorium is concealed behind the ceiling of the Natatorium.

**COMMENT FOR ITEM B:** The reported deterioration of the underside of the structural concrete bleachers should be investigated further. Natatoriums can create an extremely corrosive environment (high humidity and chlorine forming hydrochloric acid) if the ventilation and dehumidification systems are not working properly. Although no evidence of structural distress of the Gymnasium floor structure above the Natatorium was observed by the Field Engineer, inspection of the existing condition of the Gymnasium floor structure is recommended.

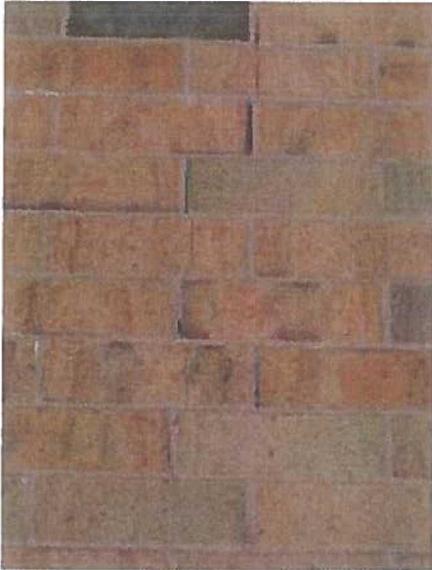
PHOTO #18: This photo shows one of the several cracks in the exterior brick walls located above the roof of the school building

**COMMENT FOR ITEM C:** The cause(s) of the brick cracking and vertical brick displacement for the screen walls located above the main roof of the school building will require further investigation.

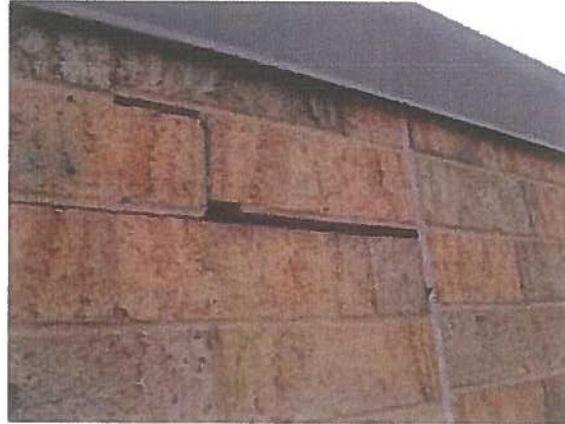
PHOTO #20: This photo shows the vertical displacement of one of the exterior brick walls located above the main roof of the school building.

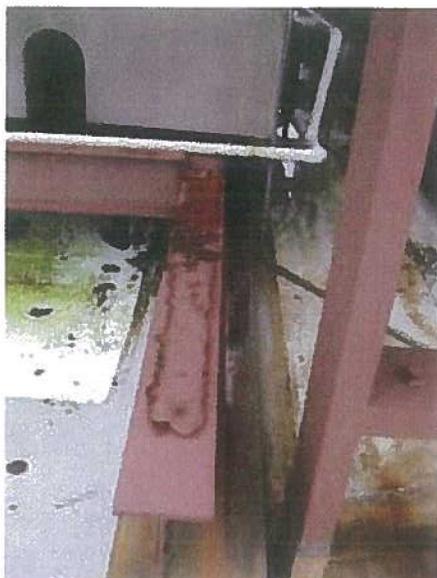
PHOTO #21: This photo depicts the corrosion of the steel frame supporting an HVAC roof top unit above the main roof of the school building.

**COMMENT FOR ITEM D:** The extent of the corrosion of the steel framing members should be investigated further. If the corrosion is minimal, then proper surface preparation and painting of the steel framing members will be required to prevent further deterioration.

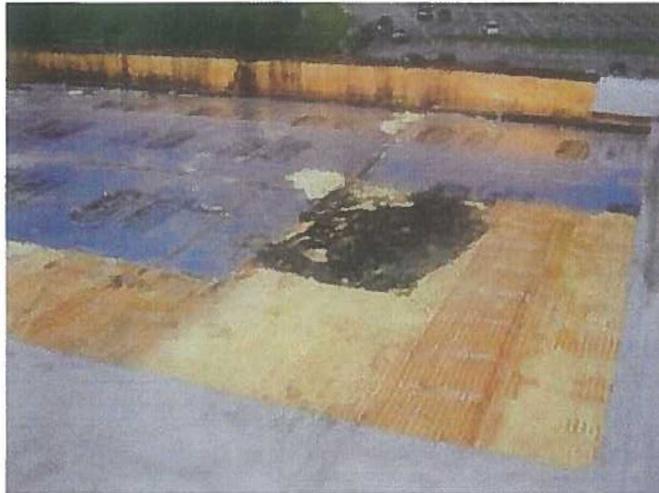
The original built up roof was replaced in 1985 with a PVC roof membrane system. The roof consists of PVC membrane, set atop a 2 ½" Rigid insulation, set on a vapor barrier on the warm-on-winter side and this entire system is fastened to 4 ½" pitched light weight concrete on 1 ½" metal deck. Complaints were made of the constant need of repairs. The roof has been a problem for many years and has been patched on multiple occasions. The last repairs were done during the summer of 2008 when it was discovered that there was water infiltration, the water soaked the insulation and diminished its R-value.

Our recommendation is that the roof and the skylights be replaced.

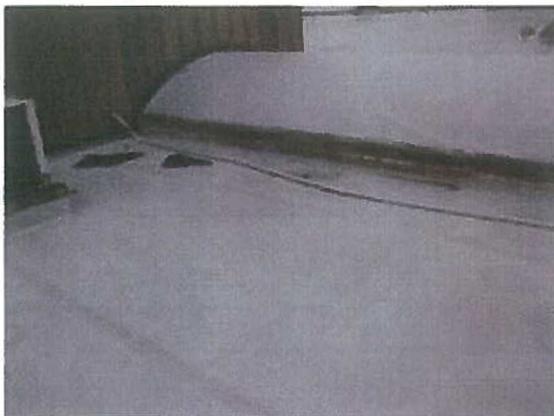
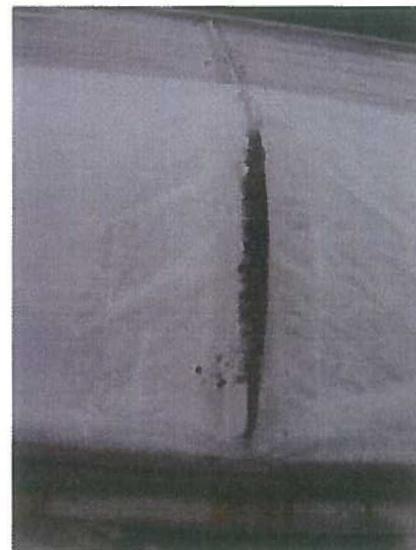
The number of skylights and the number of penetrations for roof accessories will always be a source of repairs. The skylights are failing and most are covered with transparent tarps fastened to their curbs.

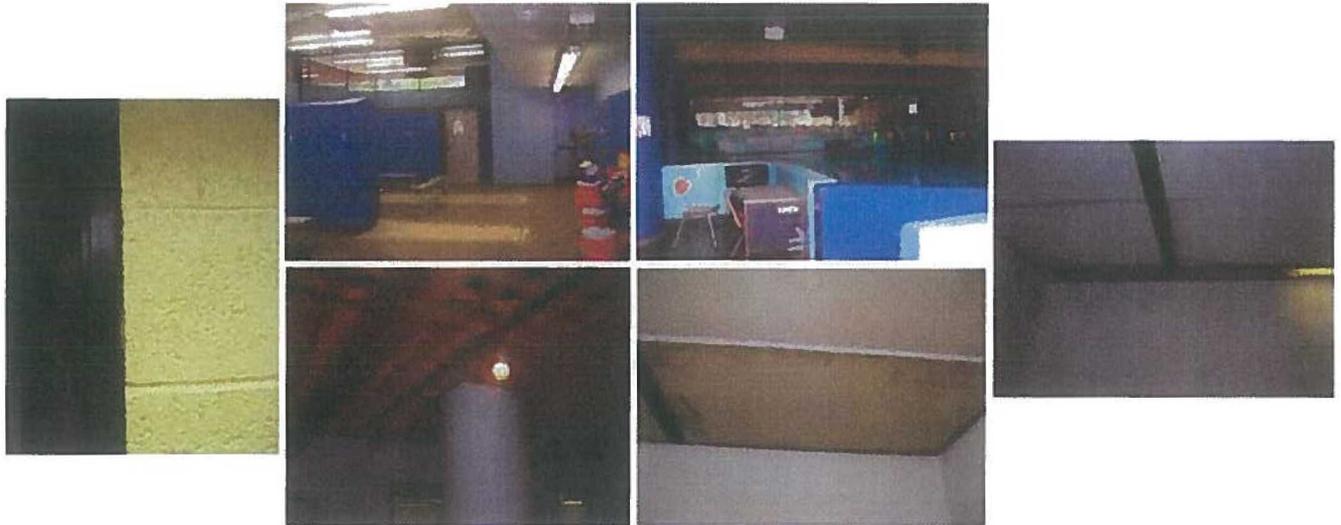
The typical ceiling system found throughout Minuteman, which is from the original construction, consists of a lay-in type of acoustical panel system that runs continuously from space to space. Water staining is prevalent throughout the ceiling system due to the roof system failures that the facility has experienced. Some spaces have updated the ceilings by inlaying ACT and additional intermediate cross grids into the original panel track. The restaurant on the mall level has an open wooded grid trellis system which is open to the typical ceiling above and is in great shape. Plaster ceilings exist in corridors, toilet rooms and locker rooms of Area A. The plaster ceilings have staining and are flaking in some areas the previously got wet.

Our recommendations are to replace finishes that do not meet flame-spread ratings.
