➤ **Field Assessment of Existing Structures**

## Field Assessment of Existing Structures

The existing structures are located in the Town of Concord, Massachusetts along a proposed 25-mile Bruce Freeman rail trail between Lowell and Framingham along the former Lowell Secondary Track right-of-way of the Old Colony Railroad. Vanasse Hangen Brustlin, Inc. (VHB) was requested to visually inspect the condition of the existing structures and prepare a conceptual study and preliminary cost estimate.

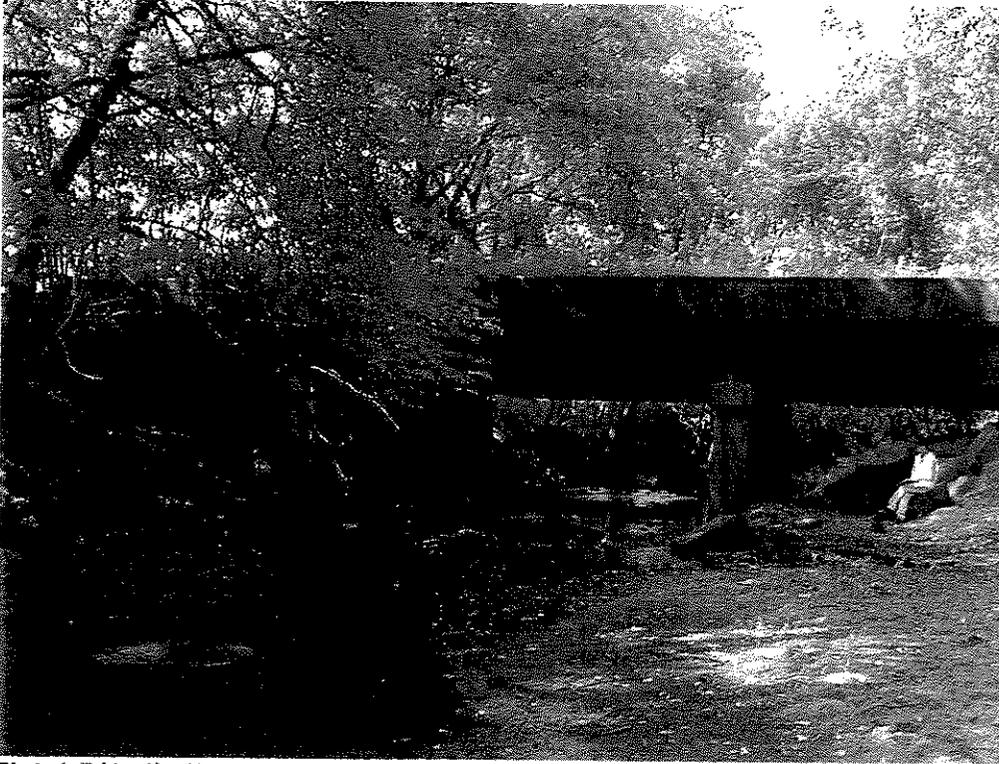
Photo 1: Bridge No. 13.86 over Nashoba Brook

The steel girders are in overall good condition with light to moderate rust. All the timber ties are deteriorated.

The granite stone abutments are in good to fair condition with tight joints.

The proposed superstructure consists of 7 ¾" cast-in-place concrete deck supported on two existing steel girders. The bridge width will consist of the 14'-0" trail, and a 1' concrete curb topped with a timber railing at each side. See Sketch 1 for the proposed typical section. To accommodate torsional rigidity of the girder due to the excessive overhang of 5'-3", a diagonal bracing will be attached to the outside face of the girder. See plans for the proposed typical section.

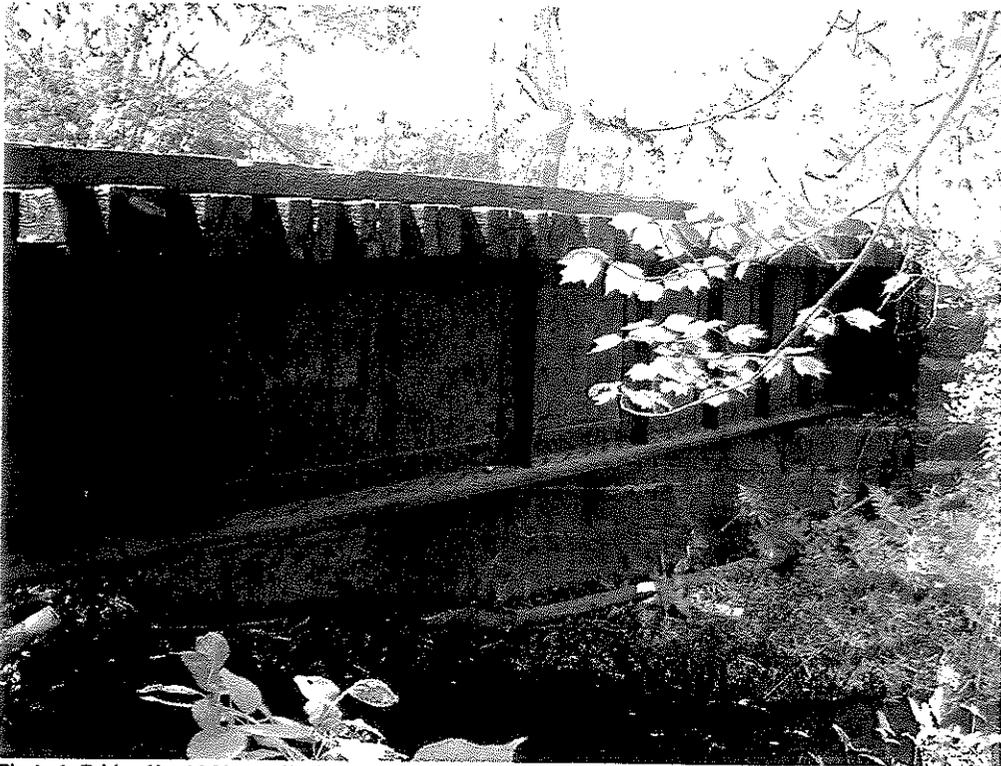
Photo 2: Bridge No. 14.81 over Nashoba Brook

The steel girders are in overall fair condition with moderate rust. The steel bearing plates and anchor bolts exhibit moderate rust with extensive section losses at some of the anchor bolts for the fascia girders (Photo 5). The exposed concrete surface exhibits moderate weathering with scaling and minor spalls. Top of deck exhibits heavy vegetation growing within the gravel fill below the three abandoned tracks.

The existing concrete deck will be used to support a 14' wide trail along one side of the bridge. A timber railing will be installed on the existing concrete barrier on the outside face and a built-up proposed barrier on the inside face. Existing vegetation will be cleared along the entire bridge. One existing track will be removed to accommodate the proposed trail and interior barrier. For the proposed trail section, it is anticipated that the top of the deck may require concrete patch repair once the fills are removed. A waterproofing membrane will be installed and backfilled up to the wearing surface to provide water-tightness for the deck. See plans for the proposed typical section.

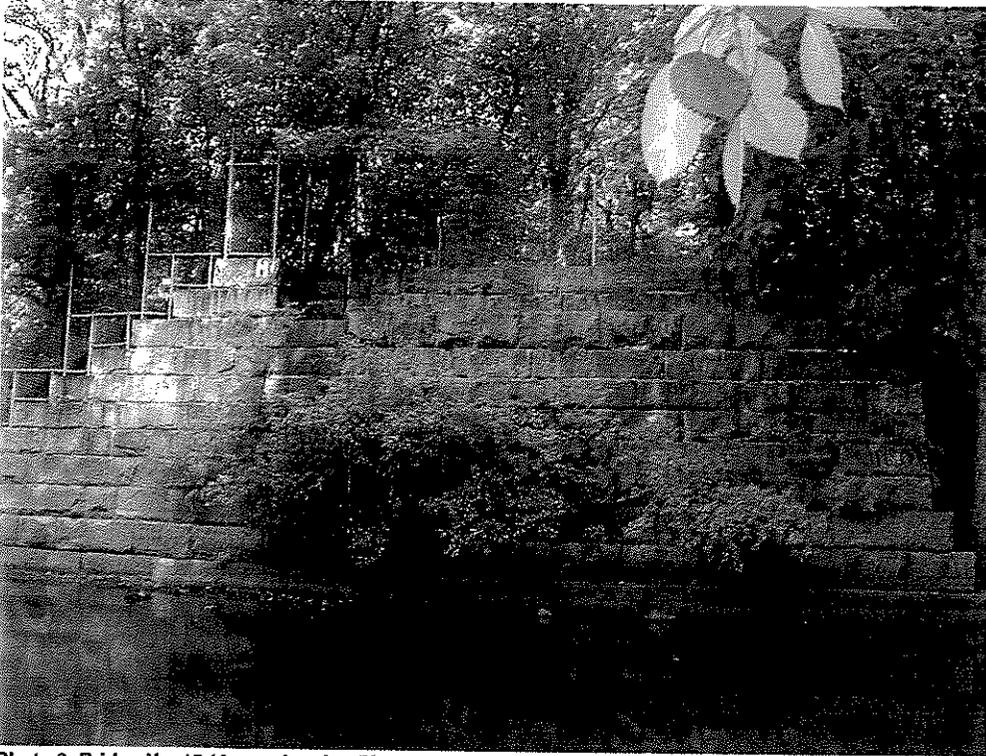
**Photo 3: Bridge No. 15.16 over Assabet River**

The granite stone abutments are in fair condition with some loose mortar joints, in particular near the water line. There is no sign of settlement or tipping along both abutments.

The proposed superstructure consists of 7 ¾" cast-in-place concrete deck supported on three proposed steel rolled W30 stringers spaced at 6'-0" on center to replace the superstructure that was previously removed. The bridge width consists of the 14'-0" trail, and a 1' concrete curb topped with a timber railing at each side. See plans for the proposed typical section.

For the granite abutments, the loose mortared joints should be repointed.

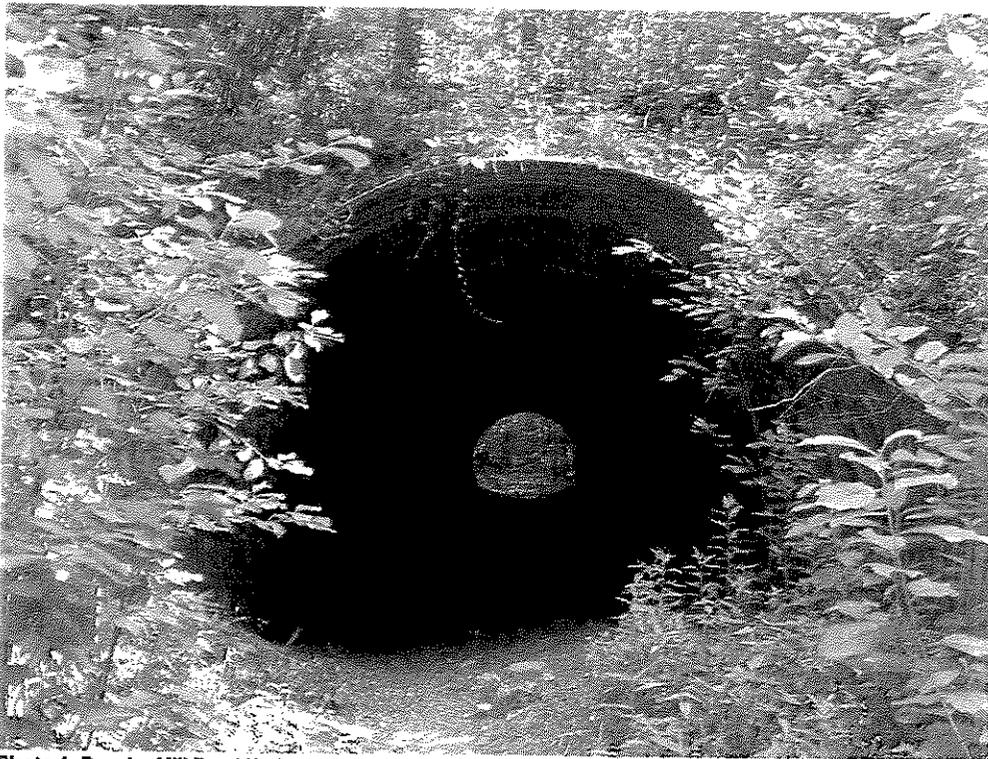
**Photo 4: Powder Mill Road Underpass**

The CMP underpass appears to be in fair condition.

The CMP underpass poses several design concerns for the purposes rail trail including:

- Insufficient vertical and horizontal clearance.
- Dark and narrow corridor provides an unsafe environment to trail users.
- CMP flared edges at the opening present a safety hazard.

It is recommended that the CMP be replaced with a pre-cast concrete box culvert with flared wingwalls at both ends. The horizontal and vertical clearance will be a

minimum of 14'-0" high and 10'-0" wide, respectively. Culvert drainage and lighting are recommended.

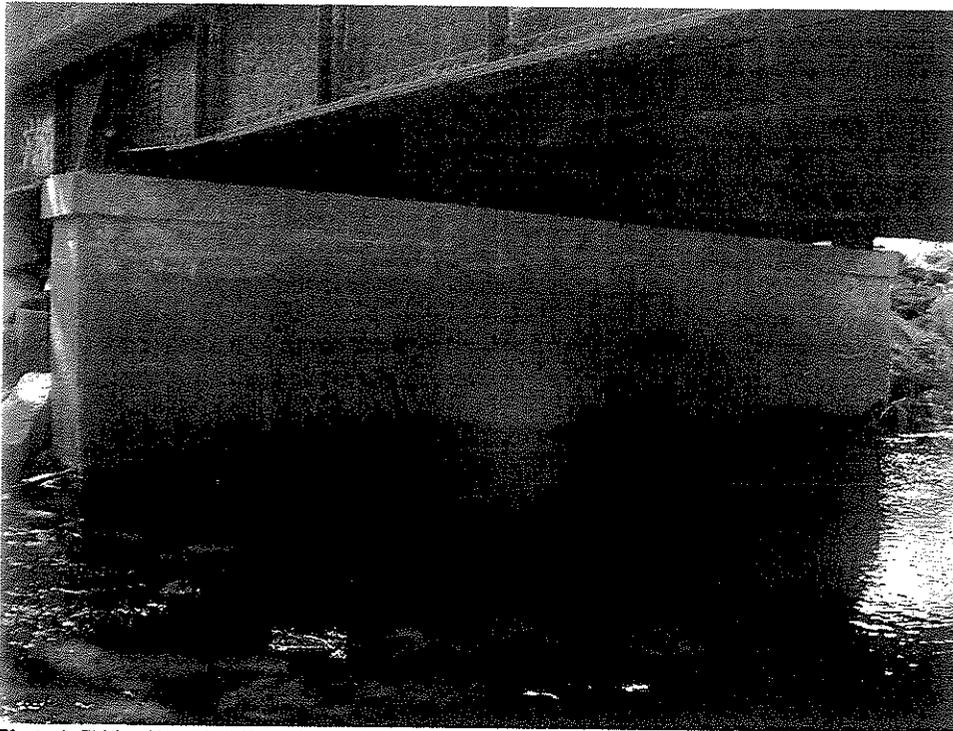
The granite abutments are in fair to good condition with some loose mortar joints along the base. The concrete wall piers are in fair to poor condition with deep voids along the waterline caused by scouring from the river flow (Photo 6). There is no sign of settlement or tipping along the wall pier.

Photo 6: Bridge No. 14.81 Wall Pier voids and Scour

For the pier stems, it is recommended that the voids at the pier base be filled with concrete. A countermeasure such as dumped riprap should be provided to prevent further scouring.
