# MESA PROJECT REVIEW CHECKLIST

Brook Street over Nashoba Brook – Bridge #A-02-009

# PHASE I- PRELIMINARY REPORT

### Summary of Conditions and Recommendations for the Repair/Rehabilitation of Town Owned Bridges

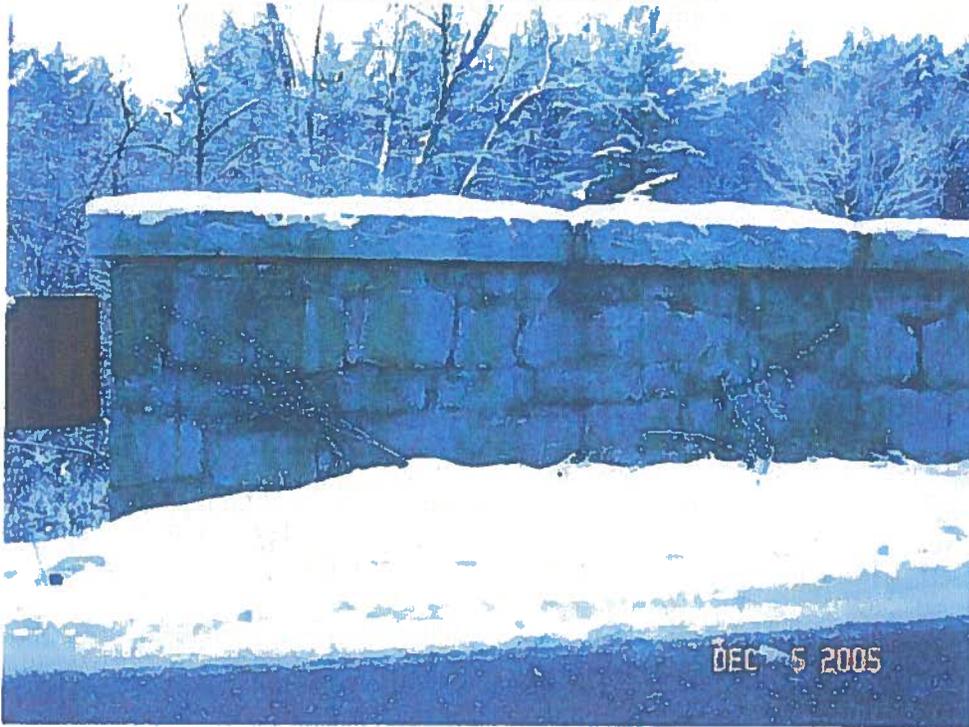
**Photo 1: Northeast bridge rail.**

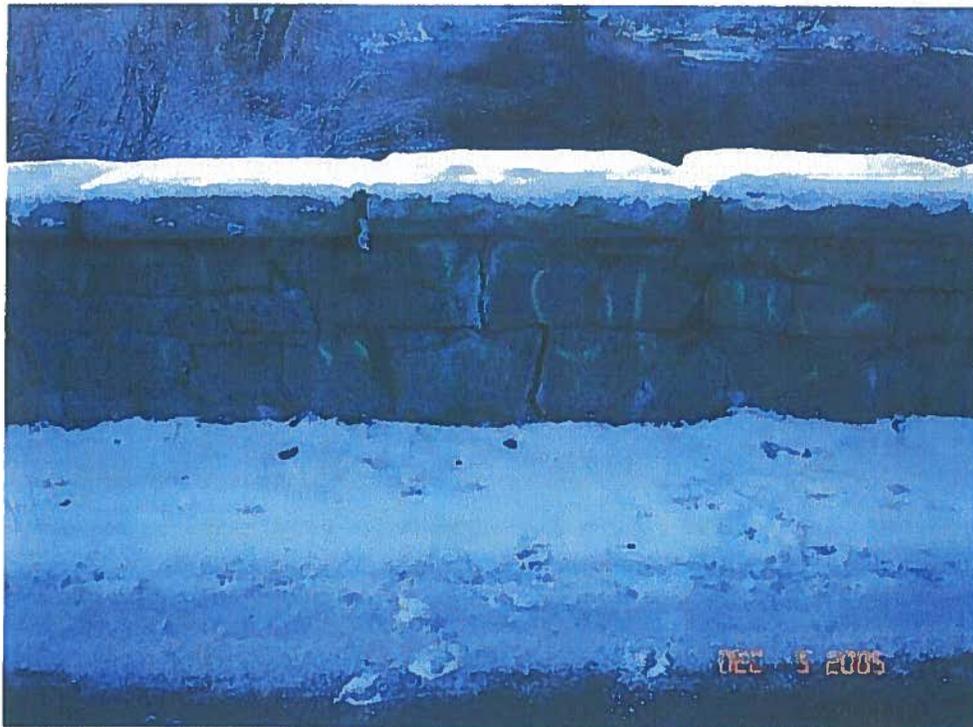
**Photo 2: South bridge rail center span.**

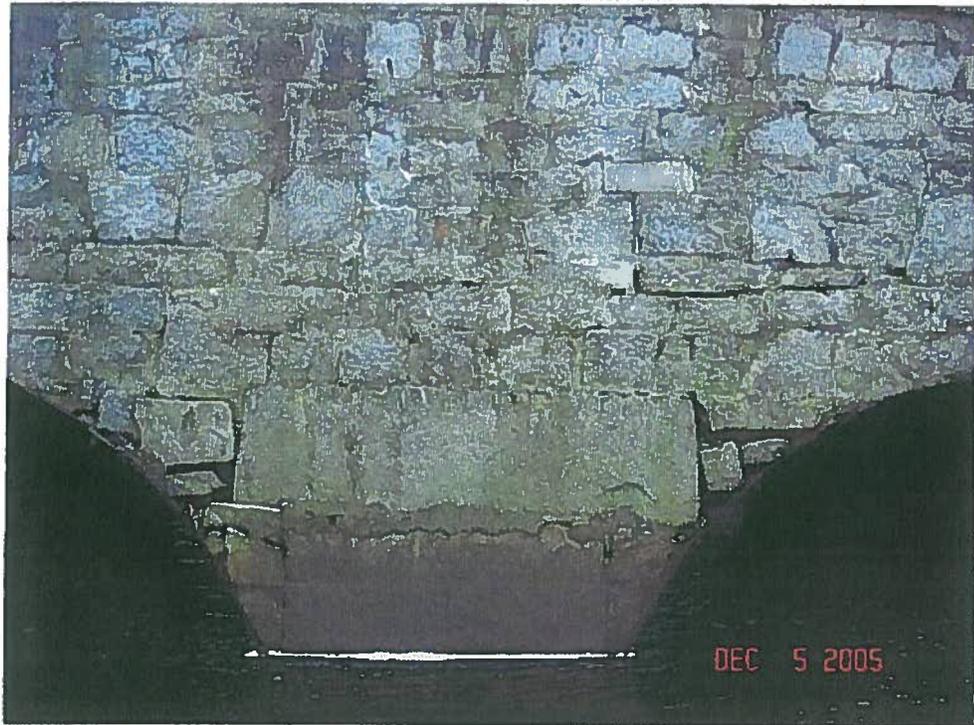
Photo 3: North headwall.

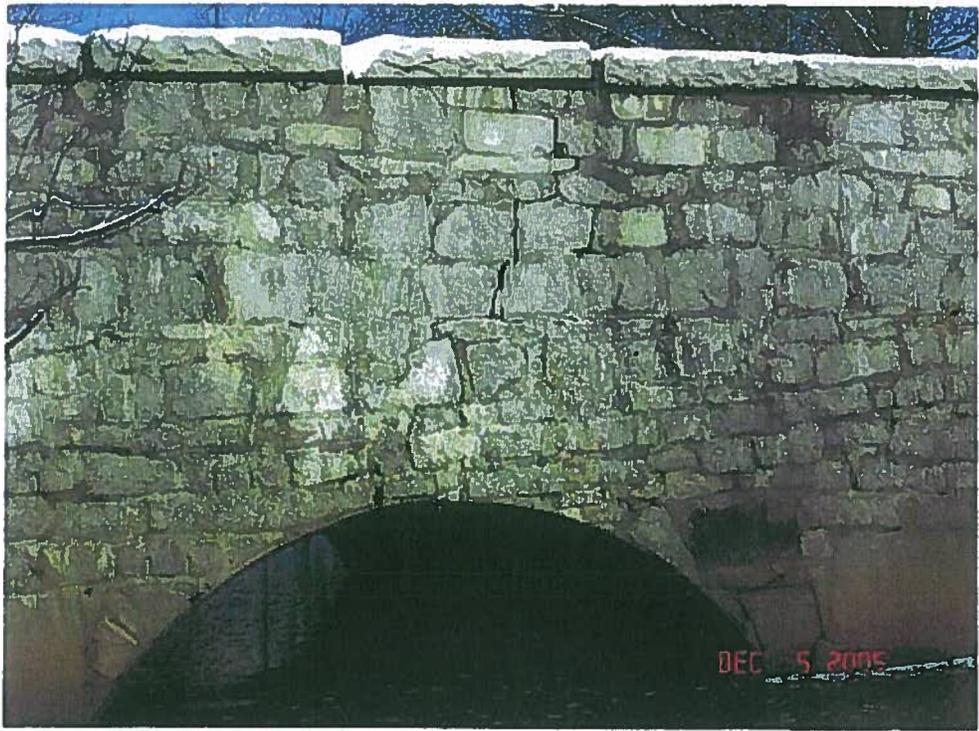
were measured to be up to 30 in. deep. There are areas of hairline surface efflorescence in the mortar joints below the street surface in the south headwall primarily on the east side of culvert 2. There is a wide crack in the mortar joints located above culvert 1 and extending vertically from the cap stone to the keystone area. (See Photo 4.)

Photo 4: South end of culvert 1.
