MassDOT Bruce Freeman Rail Trail Phase 2A (DOT Project #604532)

MassDEP File No. 085-1149

Acton Order of Conditions Environmental Monitoring Report

Date of Inspection: July 27, 2016

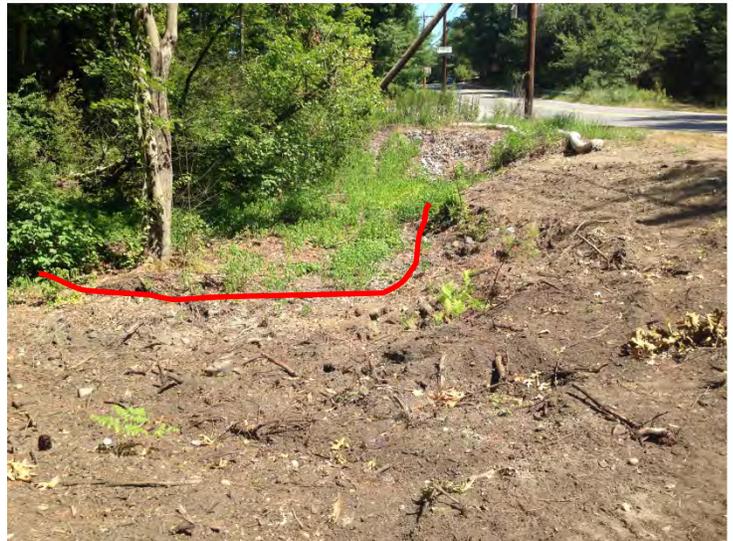
Area on southeast side of Route 27 (Station 48) where additional erosion controls are recommended along the toe of slope. Red line is approximate wetland boundary. Additional erosion controls should tie into existing controls.

- Recommend that additional perimeter erosion controls be installed on toe of slope just south of Route 27 crossing (Station 48) on east side of trail to protect the adjacent wetlands from exposed soil on slope. These erosion controls were not on plan drawings, but should be installed given current conditions.

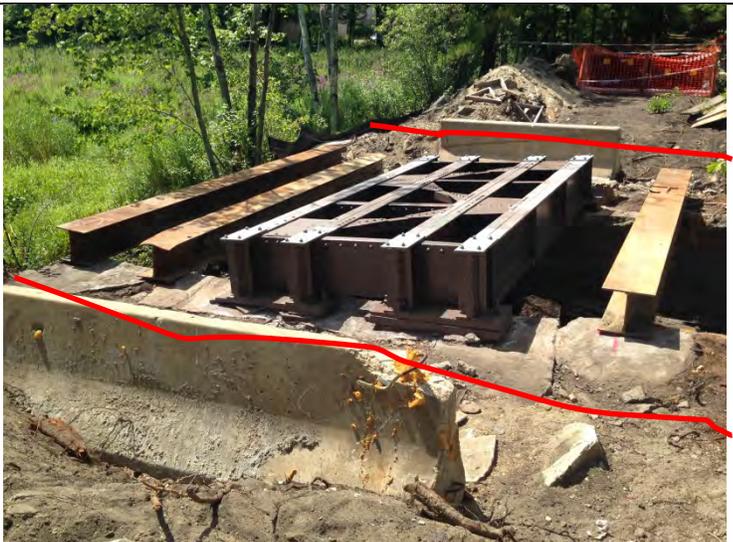
Bridge crossing near Station 58. Red lines approximately shows where additional erosion controls are recommended on both sides of bridge.

- On areas at all bridge crossings, recommend that erosion controls be installed to stop sediment from coming off the trail into the resource area directly below the bridge (i.e. erosion controls laterally across the trail) (see photos). SPS could move controls during day and return to complete erosion control barrier at the end of each workday. These controls are not shown on permit drawings, but are recommended in addition. Suggested movable erosion controls are weed-free straw wattles or strawbales.

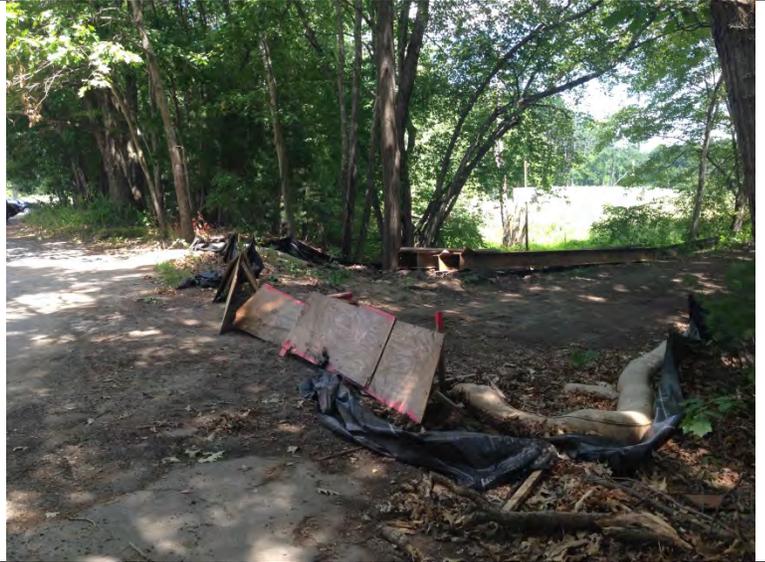
Turtle barrier at Sportsman's Club Road intersection where repairs are needed.

- Temporary perimeter erosion controls should be repaired generally in the work area near the Route 2A intersection, mostly restapling or replacing silt fence (see photo).
- In general, recommend that turtle control barriers (plywood) be augmented with a secondary control behind the barrier to make full ground contact (e.g. sand bag, straw wattle). The plywood barriers do not make full contact with the ground, leaving as much as a 2" gap due to uneven ground conditions. Thus, for small turtles, the plywood may not be an effective barrier alone.
- For the turtle control barrier at Sportsman's Club Road, the controls around the barrier should be repaired to restore its function (see photo).
- The turtle control barrier near Station 225 where I did not see any activity in area. I replaced barrier.
- Dried waste concrete should be removed near Station 144 bridge crossing, south side.

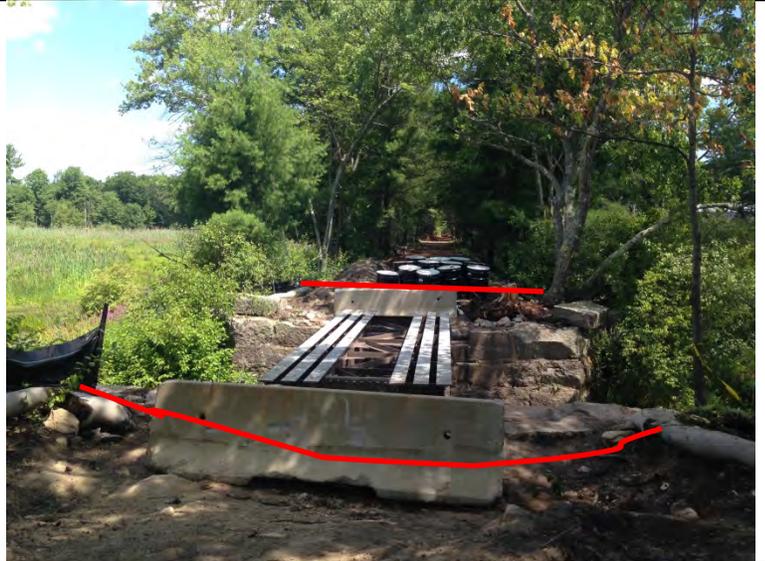
Bridge at Station 66 where additional erosion controls are recommended across trail and red lines show approximate locations.

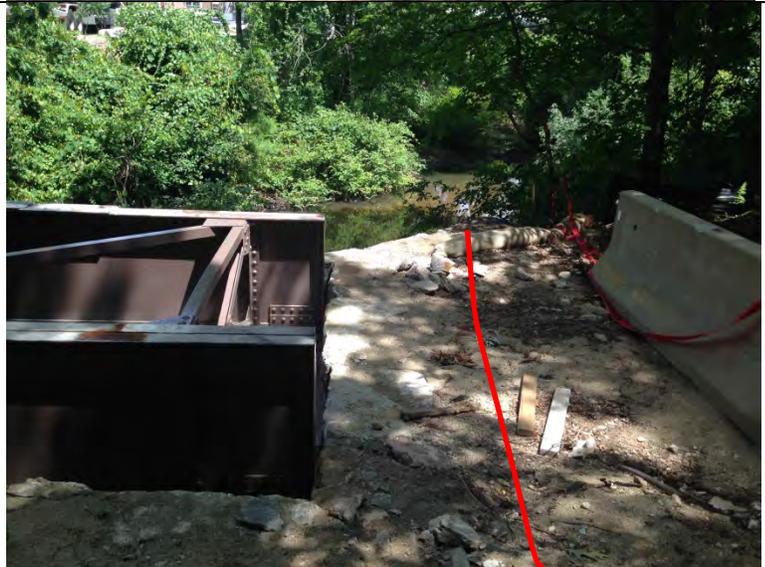
South end of bridge rehabilitation near Station 254 and red line shows approximate location on south side where additional controls are recommended. Additional controls also recommended on north side of bridge (not depicted).

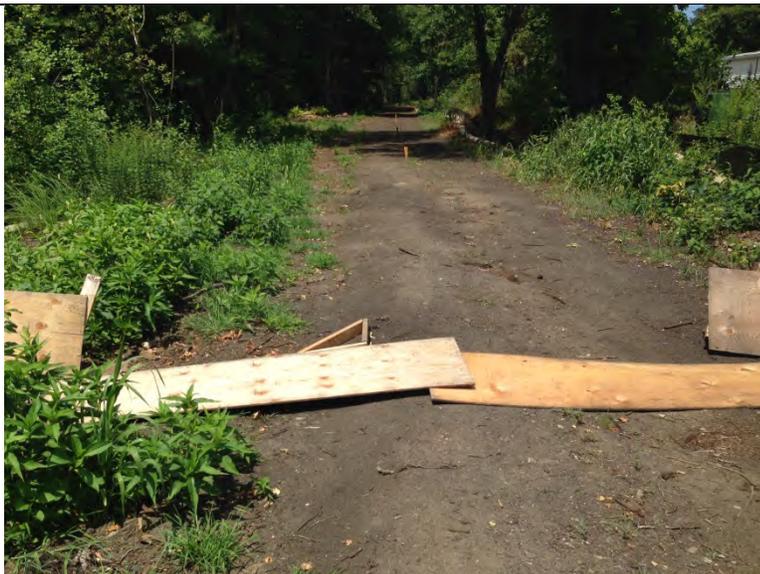
Turtle protection area barrier down at Station 225. I replaced barrier.

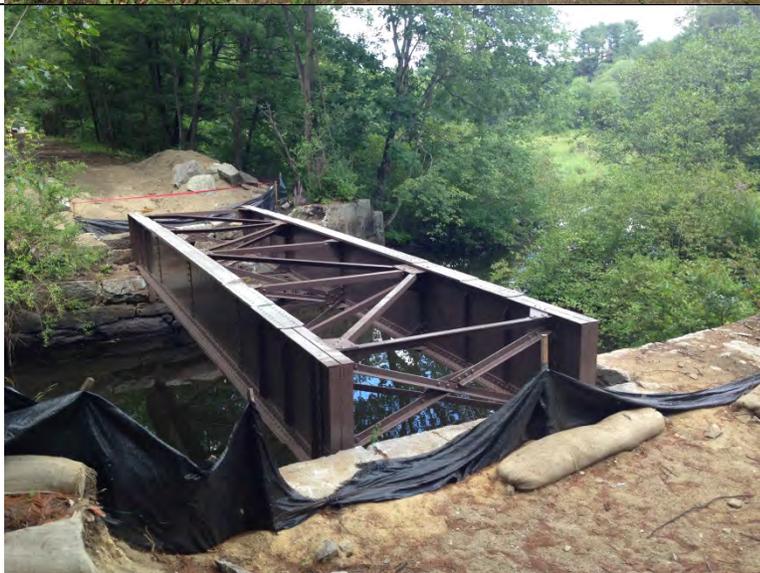
There are erosion controls laterally across trail on both sides of bridge near Station 204. Recommend using straw wattles or strawbales instead of silt fence here to make moving controls easier where working in area.

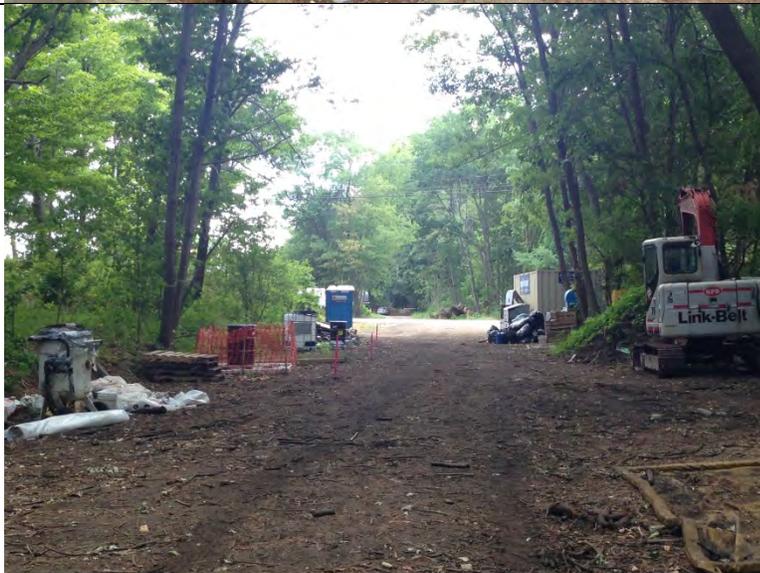
Equipment laydown and storage area just north of Concord Avenue intersection. Area is in 200 foot Riverfront Area and 100 foot buffer zone.

- ◆ Equipment staging areas have remained unchanged since last inspection with the reasoning cited as a lack of convenient locations (e.g. near road crossings) that are outside the 100 buffer zone (See OOC Condition #10). The equipment staging areas do appear contained, with fuels and lubricants stored in job boxes or other closed containers that are labelled. The major equipment staging are still near road crossings at Concord Avenue and Route 2A and also across from 1000 Main Street Acton.

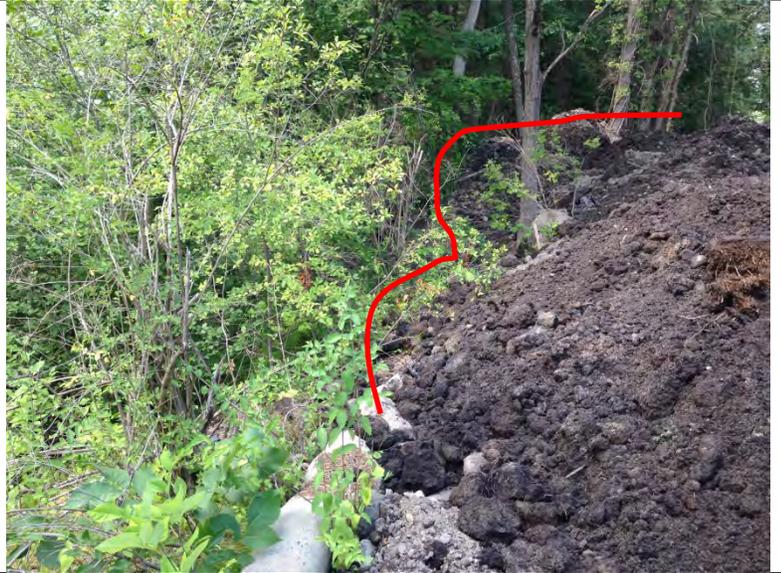
Erosion controls on west side of trail near Station 179 that have been overcome by temporary soil stockpile. Red shows approximate location of additional erosion controls needed.

- SPS has temporarily stockpiled soil near Station 179 that was excavated from wetlands on the opposite side of the Route 2A for the bridge crossing. Some sections of this stockpile are outside the perimeter erosion controls. These stockpiles should be removed as soon as possible, but at minimum, additional erosion controls should be put on the south side nearest the wetland adjacent to the stockpiles to avoid

sediment migrating into adjacent wetlands.

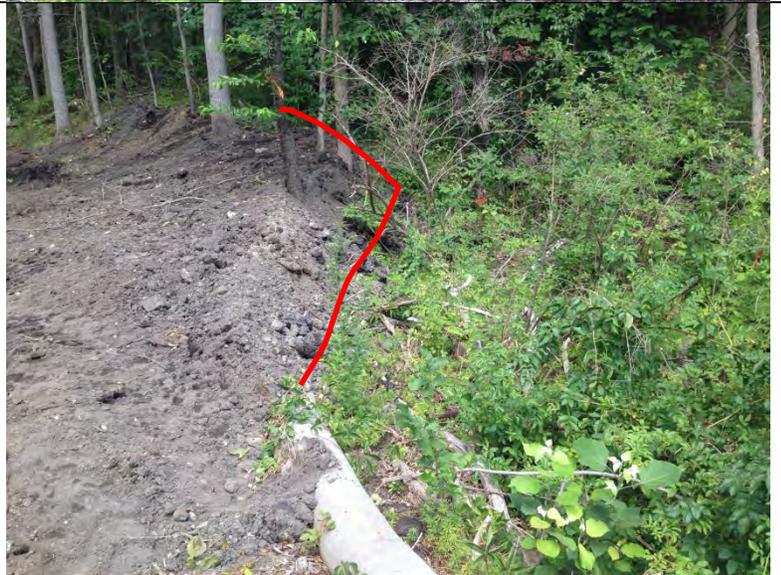
East side of trail near Station 179 where soil stockpile has overcome perimeter erosion controls. Approximate additional control location shown in red that are needed.

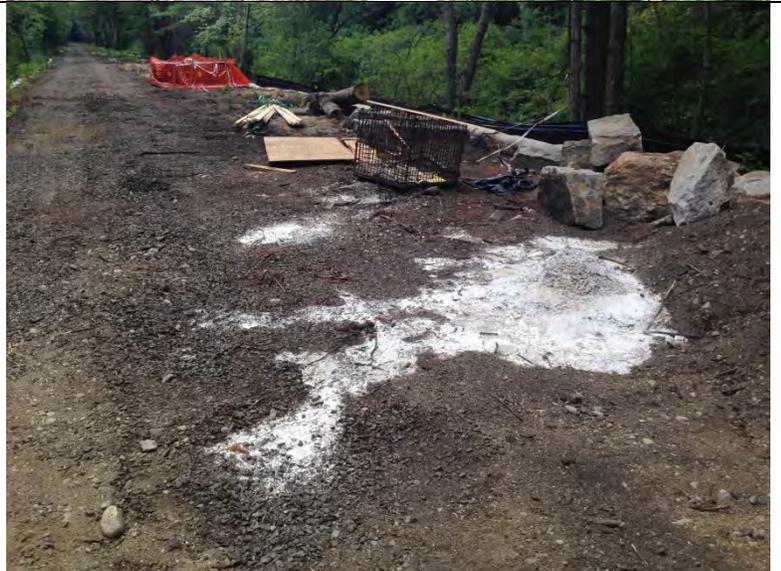
Dried waste concrete that should be removed on south side of Station 144 bridge crossing.

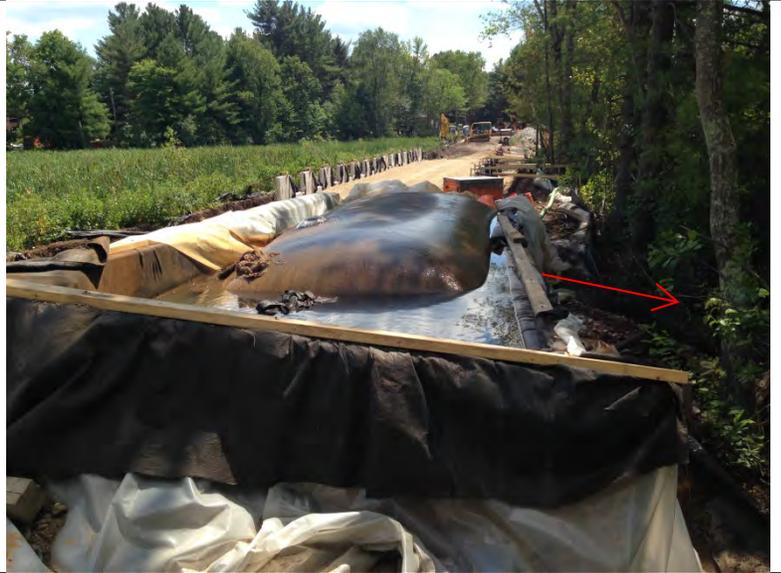
Dewatering basin near Station 160 that consists of filter bag and secondary containment of jersey barrier overlaid with geotextile fabric. The filtered, clean water was discharged back to the wetland in a controlled manner. Discharge direction is shown in red. Area dewatered was the excavation for the Route 2A bridge abutment to the north.

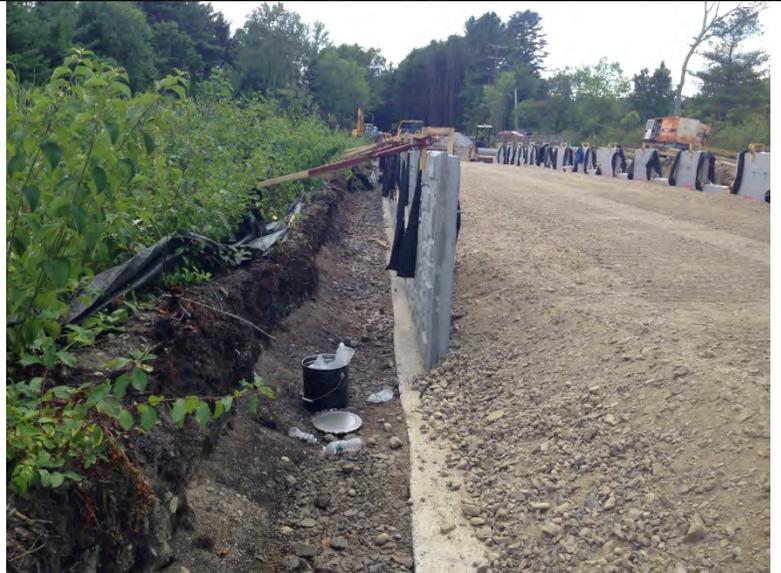
View north of retaining wall work of west side of trail near Station 167. Silt fence and other perimeter erosion controls should be repaired in this area.

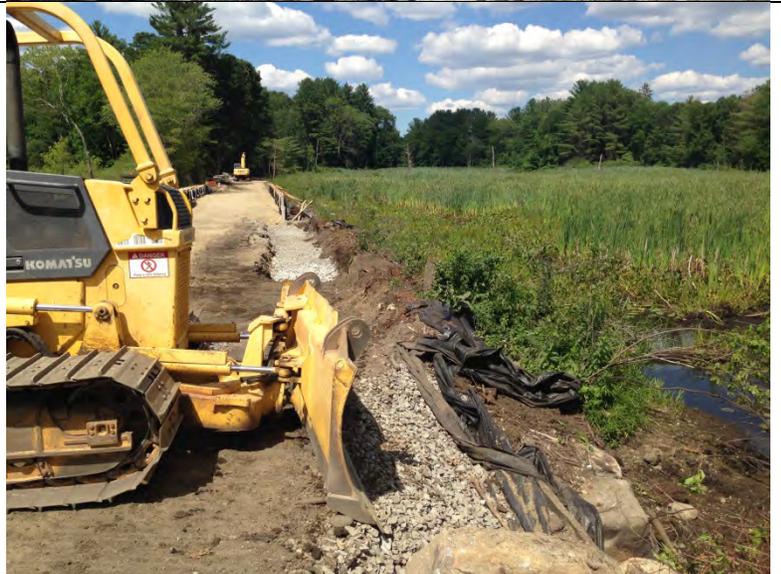
Another view north near Station 166 on east side of trail near Route 2A intersection where silt fence and other perimeter erosion controls should be replaced.
