REQUEST FOR QUALIFICATIONS
ASA PARLIN HOUSE – SCHEMATIC DESIGN
2/7/2012 12 4/4/2011 18F

The purpose of this Request for Qualifications is to establish a pool of qualified firms, one of which will be chosen to work with the Town, to produce schematic design drawings of the Asa Parlin House (17 Woodbury Lane).

November 20, 1998 DRAFT
Revised January 7, 1999

3.0 CONDITION ASSESSMENT AND TREATMENT 4

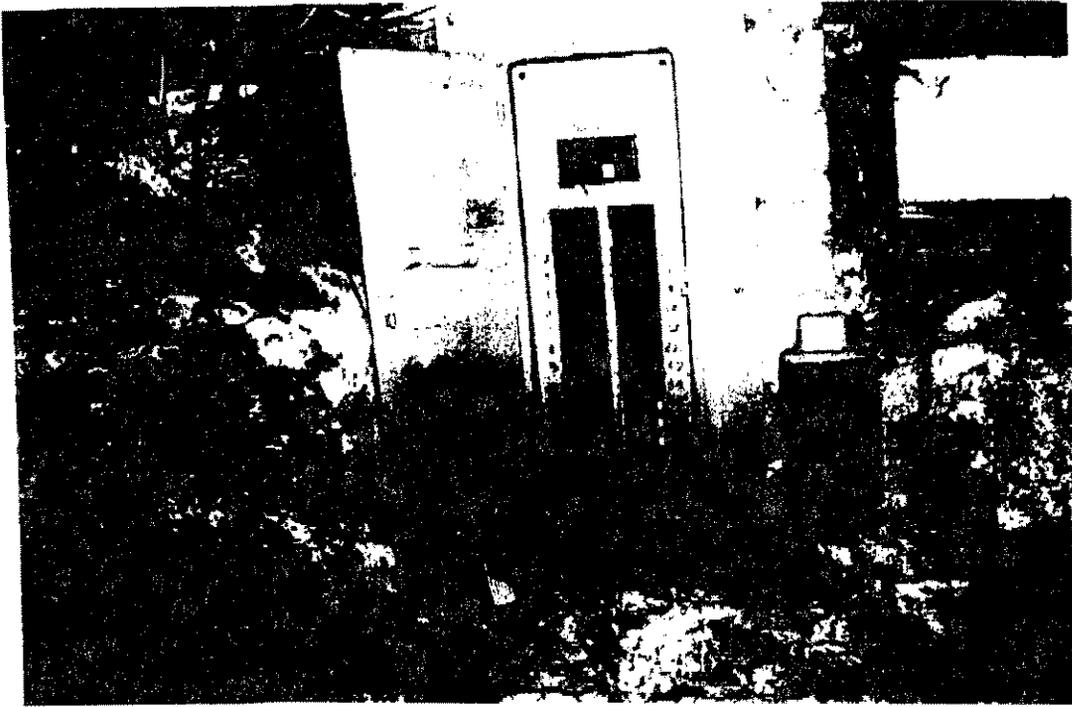
FIGURE 1

Cable television and telephone enter the building in the front as the power does. The service entrances are poorly done and subject to water intrusion as the electric service is. Some of the cable TV wiring runs outside the building and enters through a drilled hole

in the exterior wall. This arrangement will allow water and cold air to enter the building.
