Town of Acton - Health Department

NARA Water Quality Testing - 2004

Acton's Streams

Acton Shoreline Survey Spring 1998

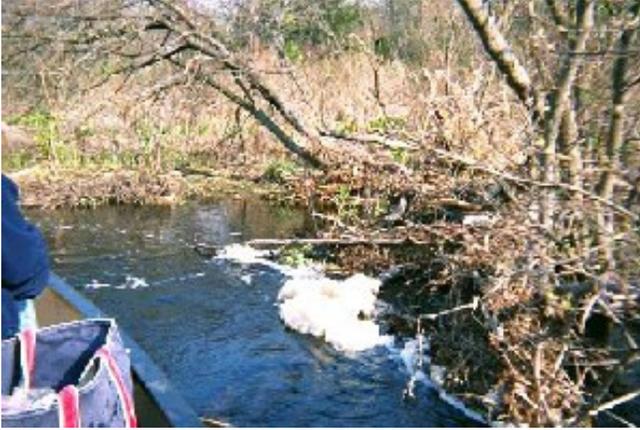
Foam: Foam observed by canoer on Fort Pond Brook, FP2

The overall character of the Brook was good, however a foam-like substance did appear at the water surface. The foam is an off-white color and was observed to be more than 6 inches in height where it became trapped in vegetation in the current along the surveyed area. The foam did not break up after agitation with a twig.

Therefore further testing of the stream isn't necessary. The stream's overall condition appears good. A trash cleanup and distribution of information to homeowners about best stream-side practices are in order.

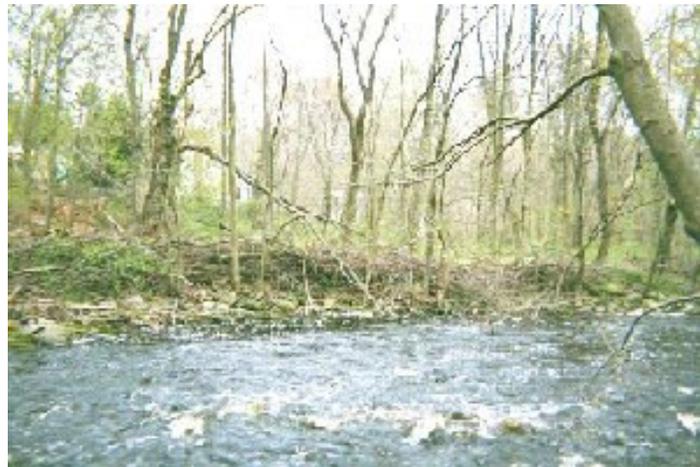
Buffer/Yard Waste/Runoff concerns: Brush piled along streambank, FP4

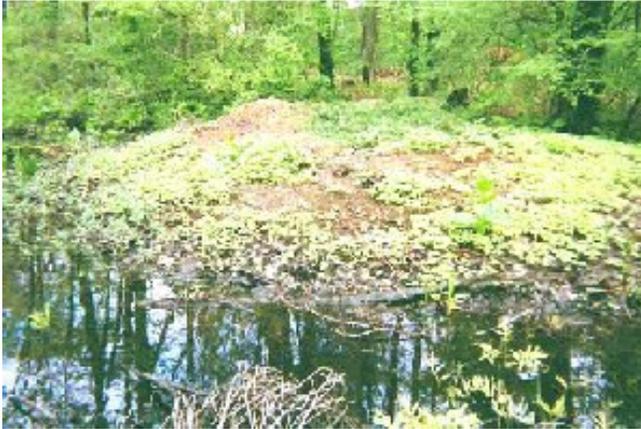
Buffer/Yard Waste/Runoff concerns: Grass clippings on bank of Fort Pond Brook, FP7. Grass clippings, brush, and leaves piled along the streams' edge, or near storm drains, "fertilize" the water.

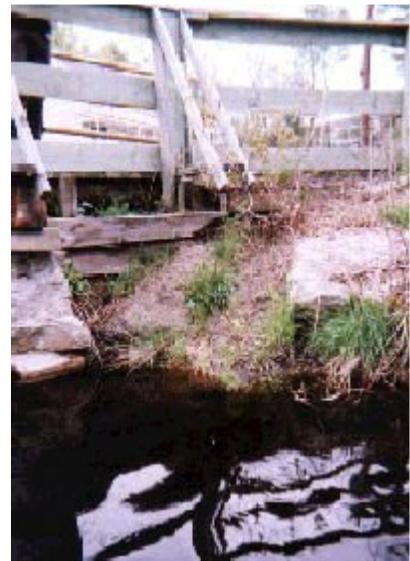
Buffer/Yard Waste/Runoff concerns: Sediment eroding into brook, next to bridge at Rte. 111, FP7

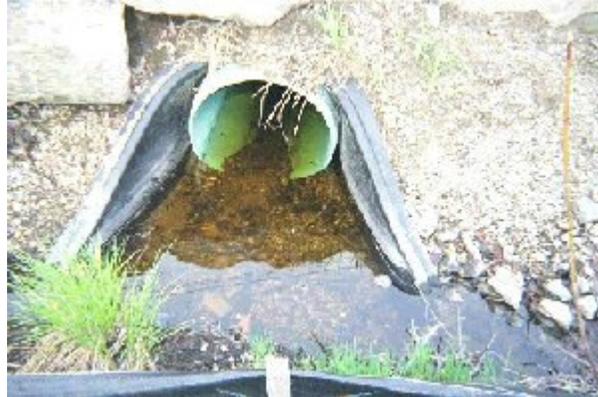
Pipes and culverts needing follow-up: Small amount of silt in new culvert, FP9

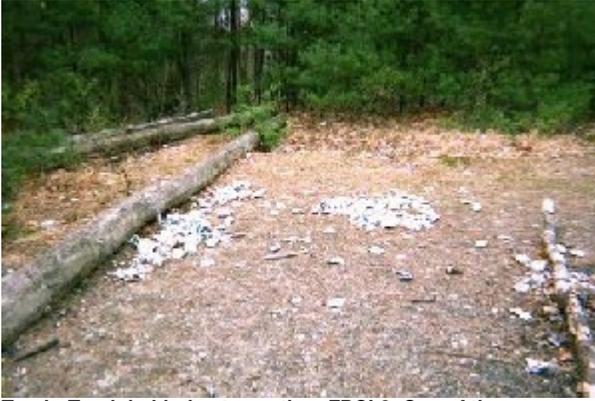
Trash: Trash behind auto auction, FPCL2. One of the stream areas [cleaned up by the Acton Stream Teams on September 12, 1998.](#)

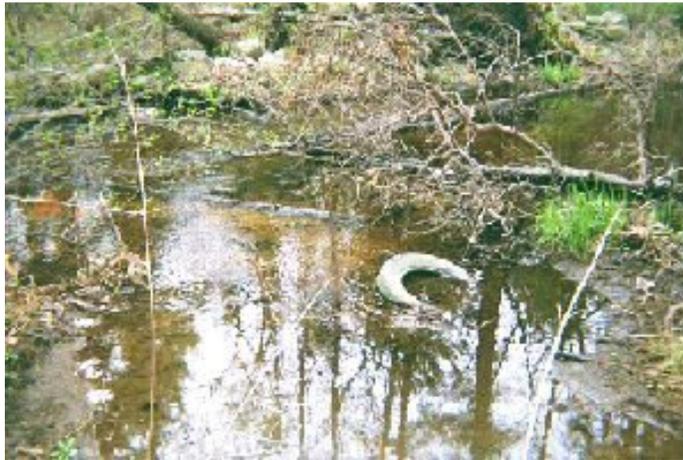
Trash: Tire in tributary to Coles Brook, FPCL2

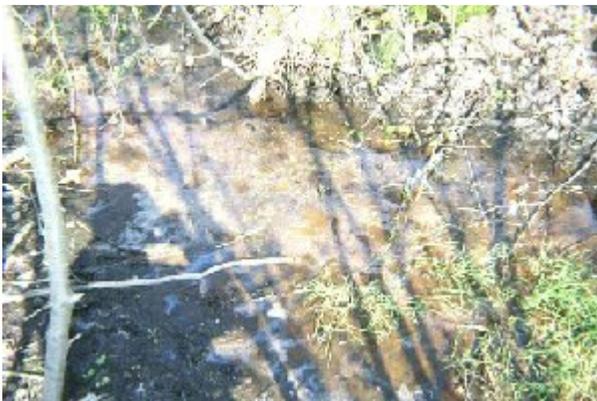
Sheens on the water, from runoff?: FPGR1. Whatever the rain washes from our roads, yards, and driveways eventually ends up in a stream.

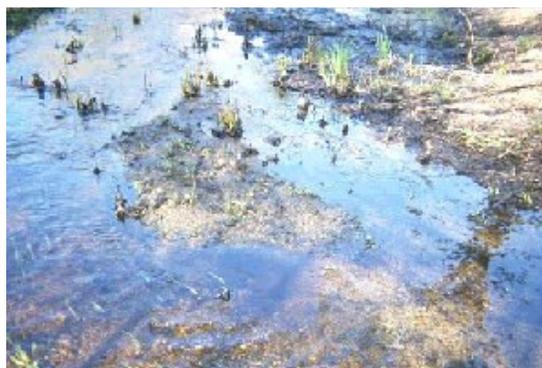
Buffer/Yard Waste/Runoff concerns: Road sand in brook,

sand from Hayward Road culvert area, FPGR1

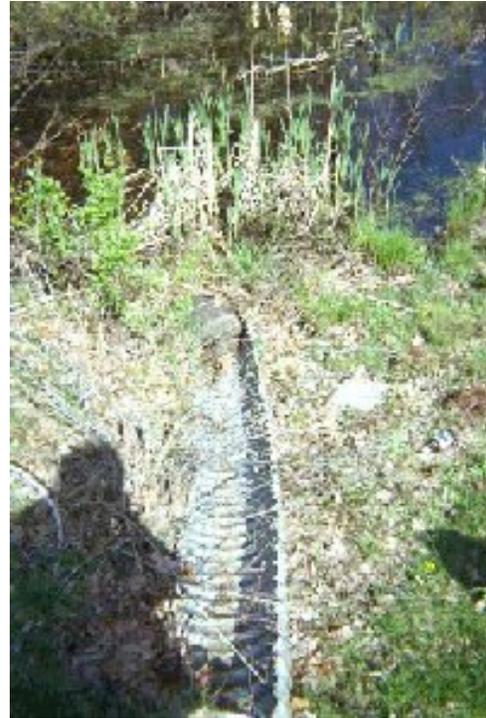
Pipes and culverts needing follow-up: 12" corrugated steel pipe leading from catch basin on Hayward Road into Grassy Brook, end of pipe plugged with sand, FPGR1

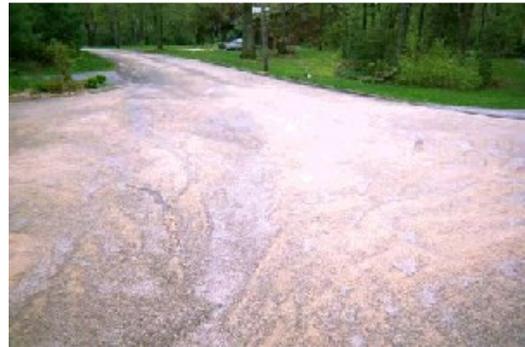
Buffer/Yard Waste/Runoff concerns: Sand being washed from road towards Pratt's Brook, FPPR1

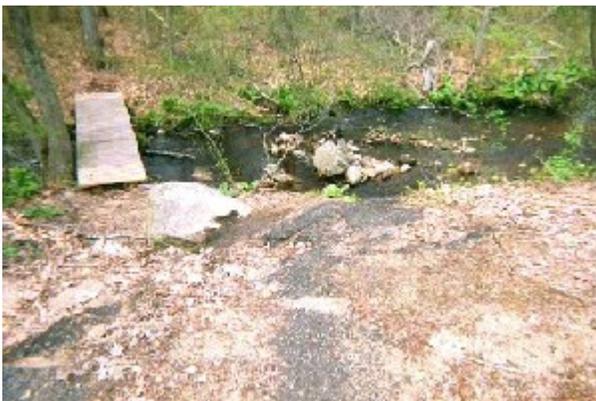
Buffer/Yard Waste/Runoff concerns: Rain water washes sand (and oil etc. from the road?) into Pratt's Brook, FPPR1

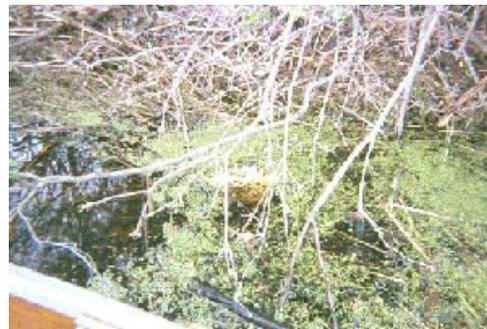
Plants: Duckweed, dead turtle, NBICE. Excess nutrients in the water can lead to excess plant growth. When the plants die, they sink to the bottom and decay--using up oxygen needed by fish and other aquatic life, and leading to unpleasant odors.

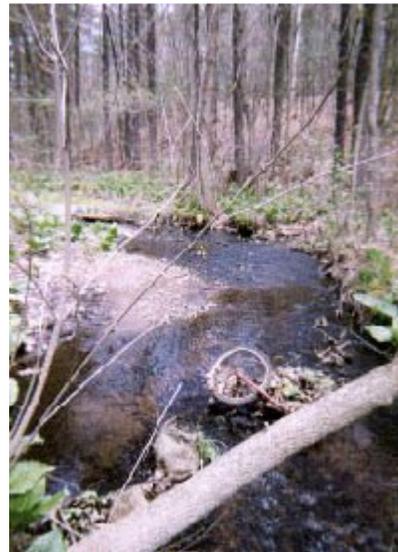
Trash: Bicycle in Wills Hole Brook, NBWL1

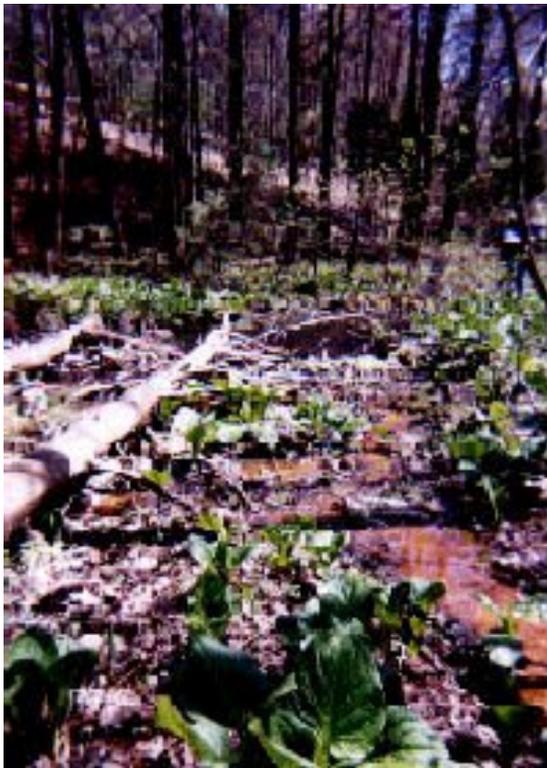
Sheens on the water: Stagnant rust colored water with oily sheen,

Wills Hole Brook, along Rte. 2A, NBWL1

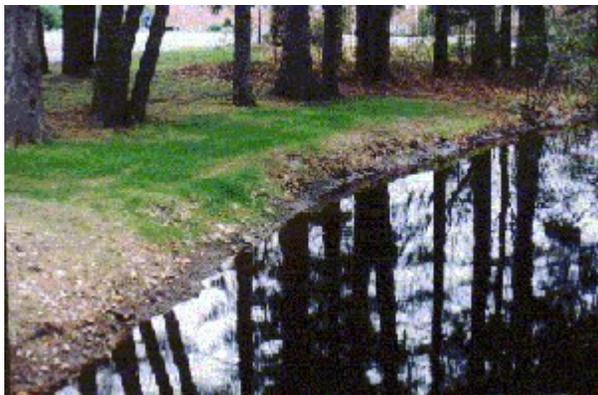
Buffer/Yard Waste/Runoff concerns: No buffer, grass up to edge of stream, erosion, NBWL2. When fertilizers, pesticides, and herbicides are applied to a lawn that runs to the streams' edge, these materials also end up in the stream.

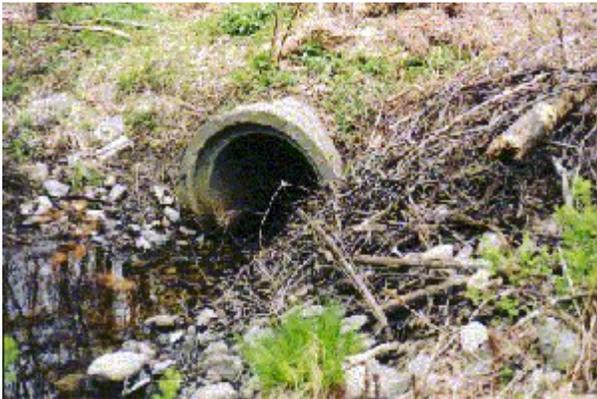
Dams, beavers: Beaver material in pile on right was previously removed from culvert pipe. It has been an ongoing challenge to keep the water flowing freely. NBWL2

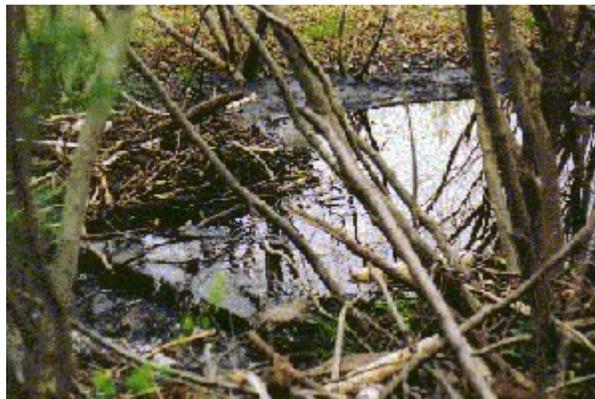
Dams, beavers: Beaver dam previously opened to prevent flooding, NBWL2

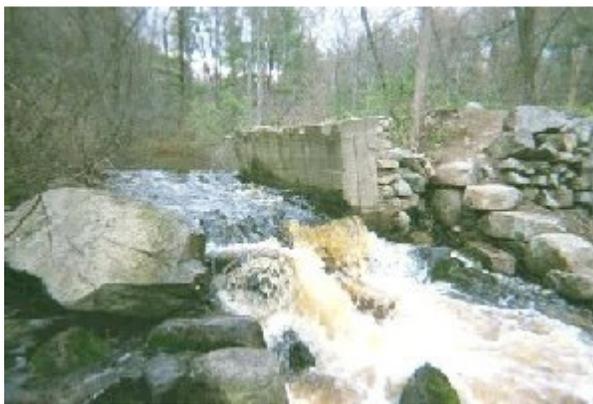
Historic Site: Crumbled spillway of 'pencil factory'

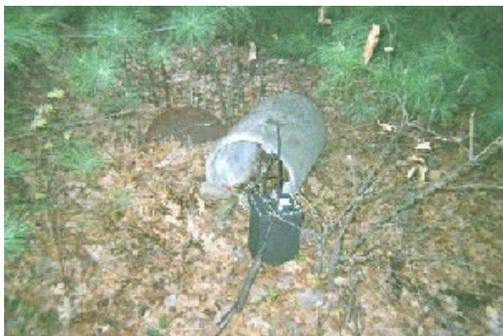
Trash: Railroad battery, stand knocked over, NB3

Scattered areas of trash were found here and there along the brook and a rusting bike was found at the northern end. Along the railroad tracks batteries, once stored in concrete containers, are exposed to the elements. Vandals have tried to disconnect them but have only damaged them. Battery acids are a very real hazard here. New construction planned for along Rt. 27 could be a future hazard and should be monitored.

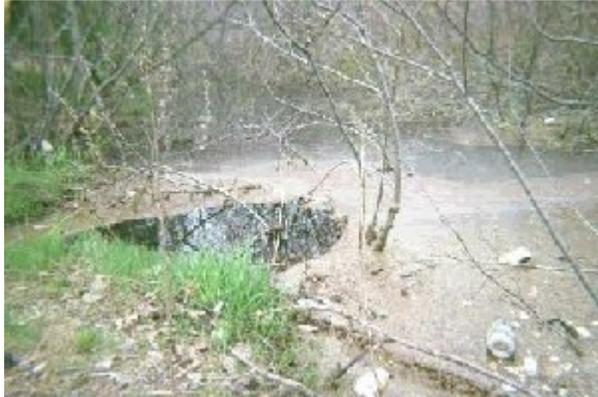
Trash: Butter Brook, near Rte. 27, NBBUT. One of the stream areas [cleaned up by the Acton Stream Teams on September 12, 1998.](#)
