March 24, 2010
File No. J0022-23-01

**Phase I Environmental Site Assessment
Caouette Property
2 Stow Street/90 Martin Street
Acton, Massachusetts**

O'Reilly, Talbot & Okun Associates, Inc.
19 West Main Street, Suite 205
Westborough, Massachusetts 01581

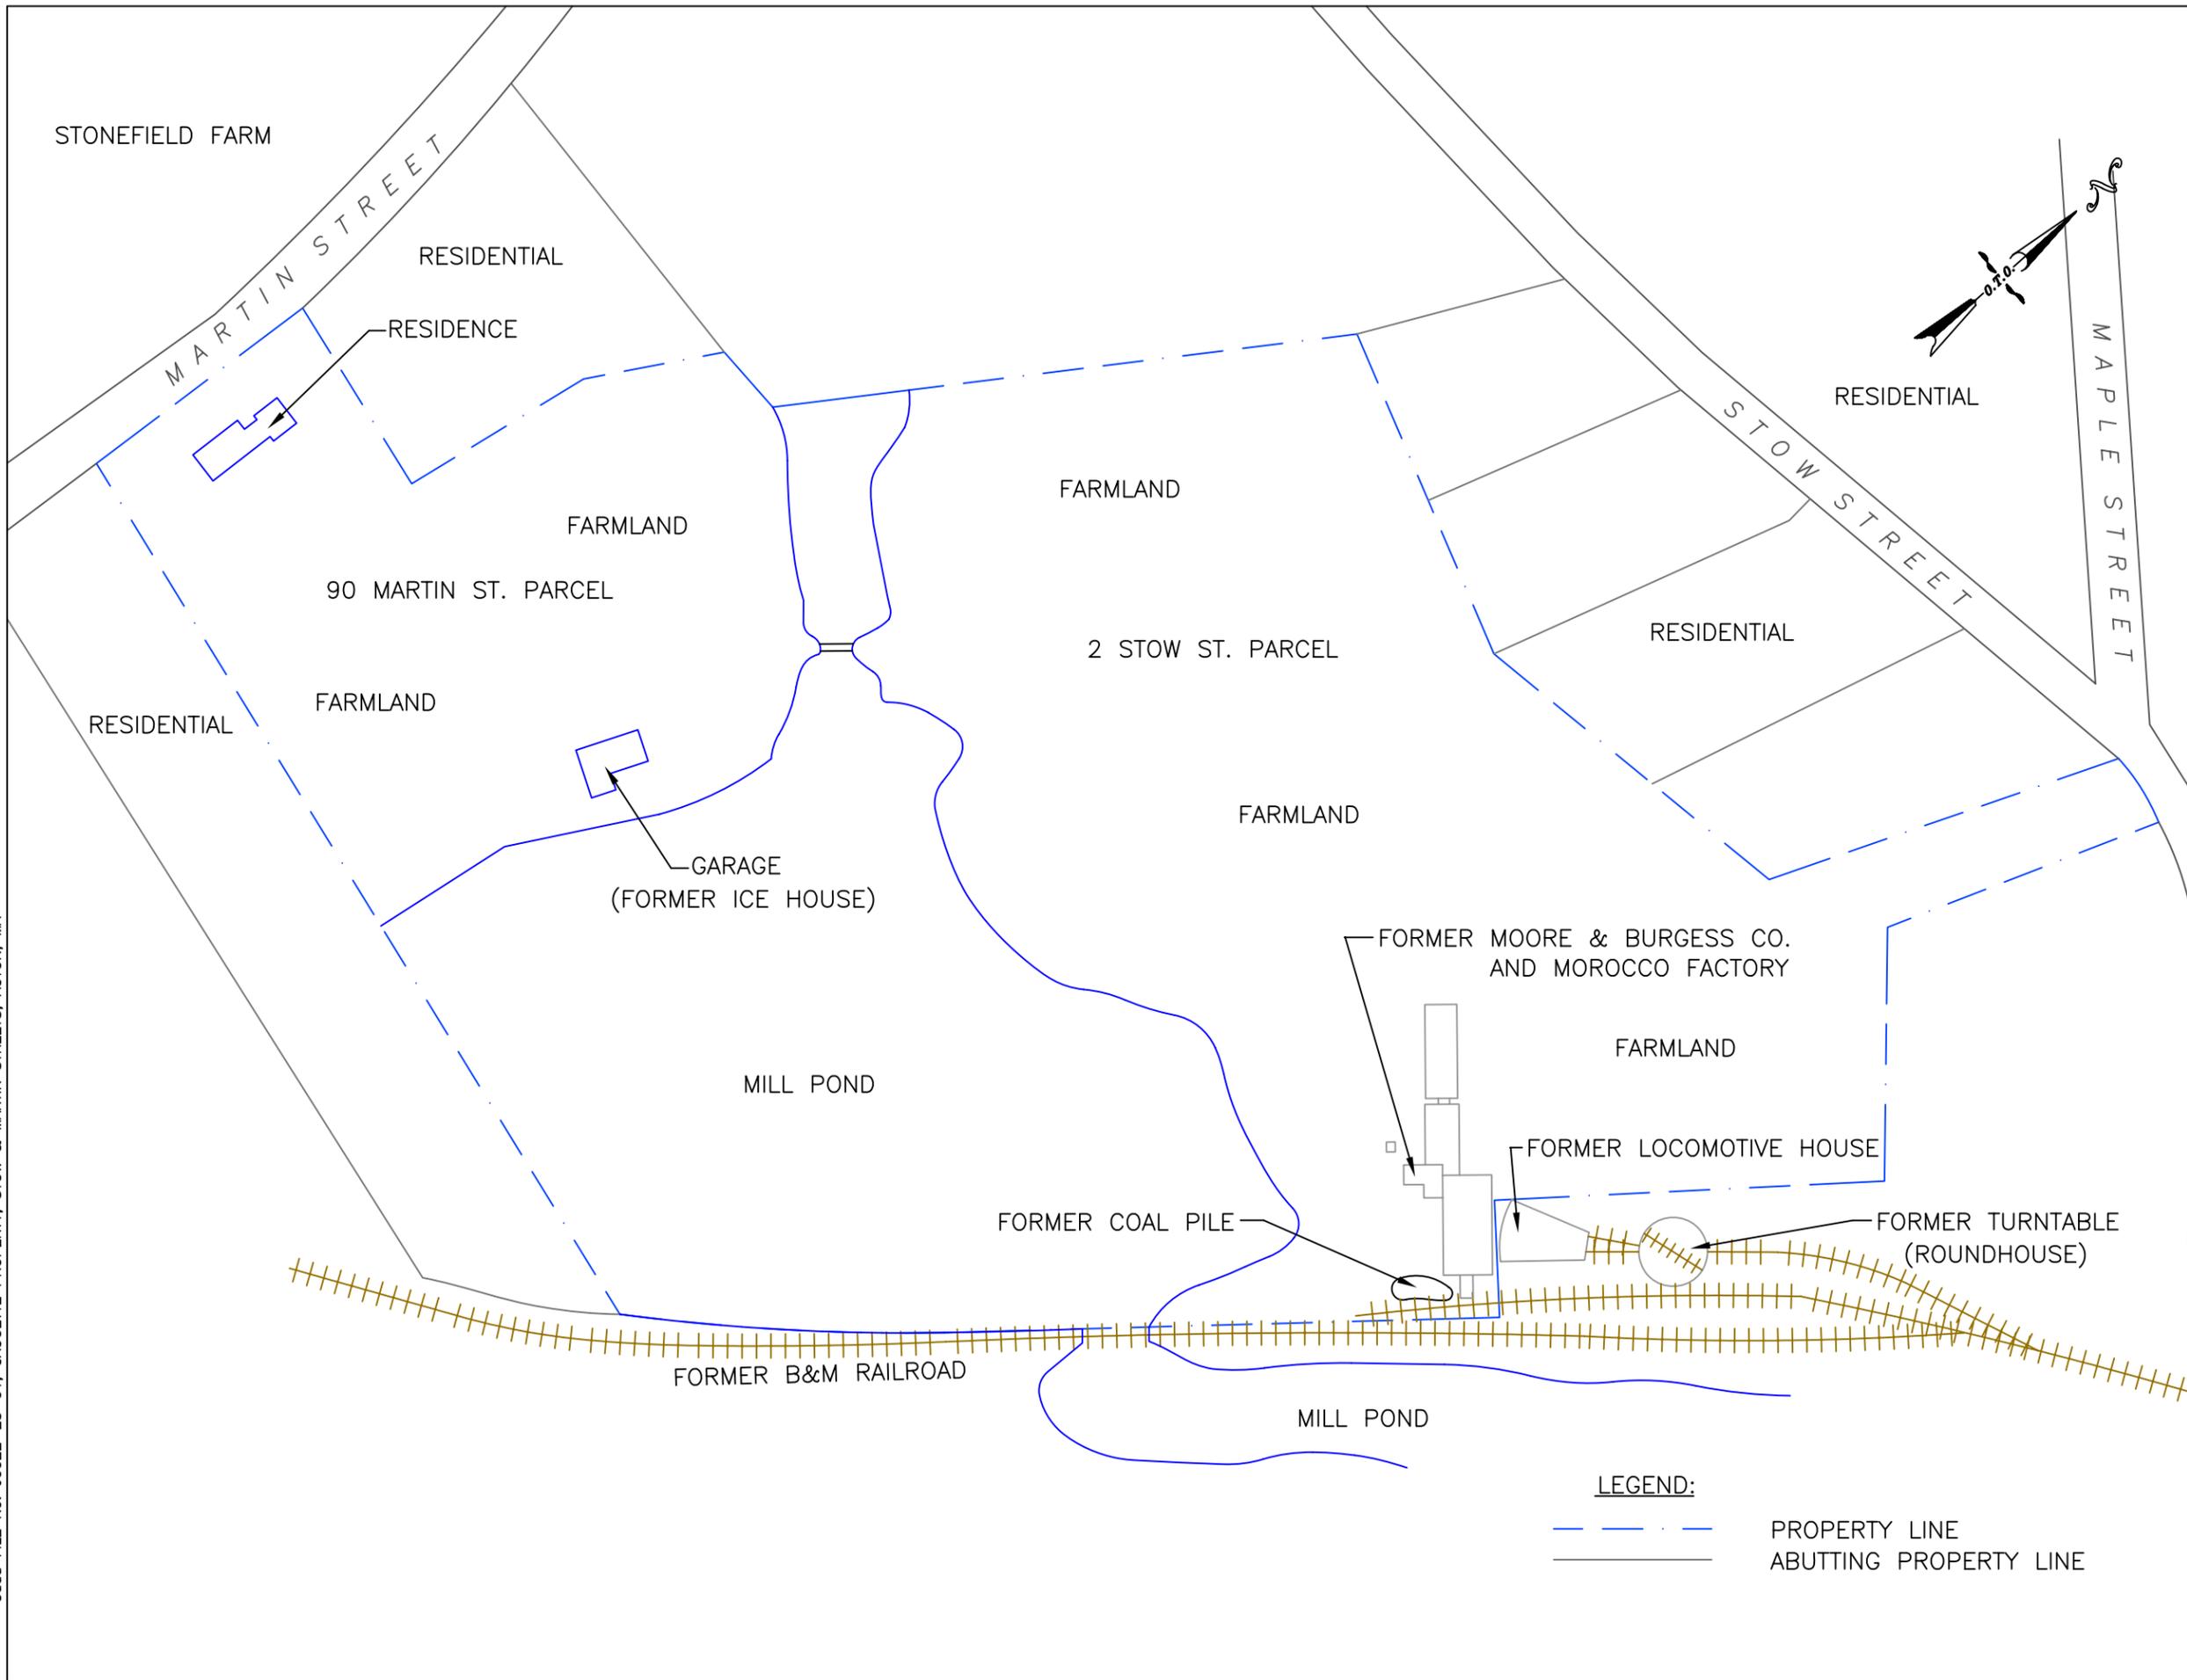
CAQUETTE PROPERTY
 90 MARTIN & 2 STOW STREETS
 ACTON, MASSACHUSETTS

A Site Locus based on the current United States Geological Survey (USGS) topographic map of the Maynard, Massachusetts Quadrangle (1:25,000 scale), dated 1987, is attached as Figure 1. A Site Plan is provided as Figure 2.

As shown on Figure 2, the Site can be accessed by Martin Street or Stow Street. Both roads are paved. The 90 Martin Street parcel has a paved driveway.

The information provided on the Sanborn Fire Insurance maps has been used to approximately locate the former Moore & Burgess Webbing and Morocco Factory buildings on Figure 2. Observations of foundation stones during our Site visit (Section 6.2) confirm the approximate locations as shown. On-line information indicates that “Morocco leather” was typically red, both strong and pliable and could have been used in book binding and purses. In addition to vegetable tanning, the possible use of chromium in the tanning method is mentioned.

Remnants of the old Morocco Factory (described in Section 3.7) were observed in a wooded area on the eastern portion of the 2 Stow Street parcel (Figure 2). The western portion of the former building footprint is now used for farming and no longer visible. Old stone and brick foundations were present up to the abandoned railroad tracks (eastern limit of Site).

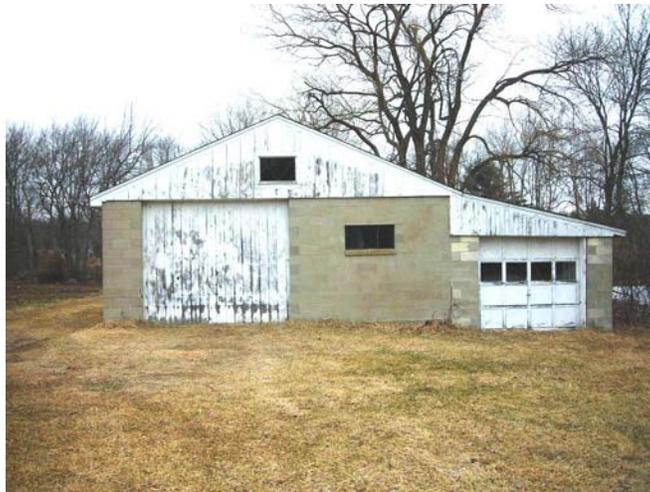
A storage garage is located approximately 300 feet to the northeast of the residence. Two large fields used to grow various vegetables are located between the house and the garage. The garage has one story and is of slab-on-grade construction. The garage is heated by a wood burning stove, and does not have water or electricity connections. The garage is currently used to store several old automobiles. The garage is not currently used by Stonefield Farm, which farms the aforementioned fields, but the garage was formerly used for farm equipment storage by Ms. Cauoette's father. The garage contained small amounts of gasoline and lubricating oils (less than 5 gallons) presumably used for the automobiles.

View of Storage Garage (next to Mill Pond) towards North

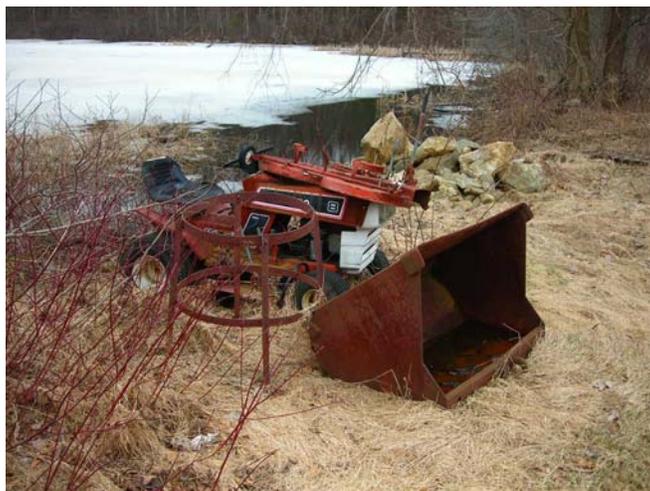
A partially exposed metal pipe was observed running between the garage and the vegetable fields. Mr. Simeone indicated that this was an old irrigation line that is no longer used. Several pieces of old farm equipment were observed next to the garage, proximate to the pond. A rusty overturned 55-gallon metal drum was also observed between the garage and the pond. Mr. Simeone indicated that this was formerly used to capture rainwater and was not used to store anything else.

Old Farming Equipment next to Mill Pond

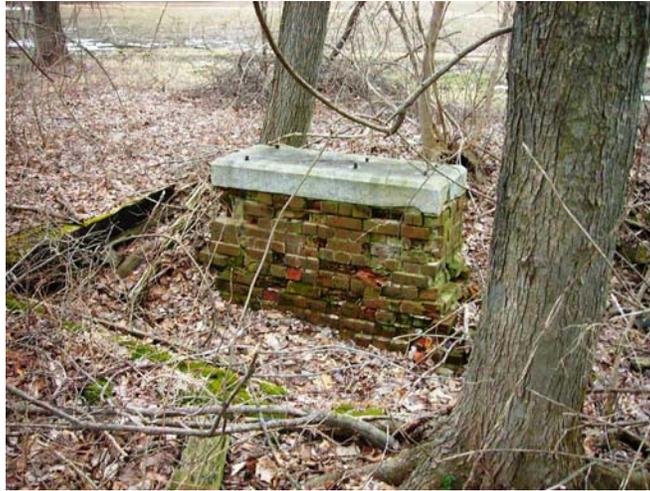
Remnants of Former Morocco Factory/Moore & Burgess Webbing Co.

Based on historical industrial uses of the northeastern portion of the Site from 1892 through 1917, soils and groundwater in that vicinity may have been adversely impacted. We would consider the past presence of industrial facilities at the Site to be a REC under the ASTM Standard. In order to evaluate possible impacts to Site soil and/or groundwater caused by former operations, a subsurface exploration program would need to be performed in the vicinity of the former on-site factory buildings.

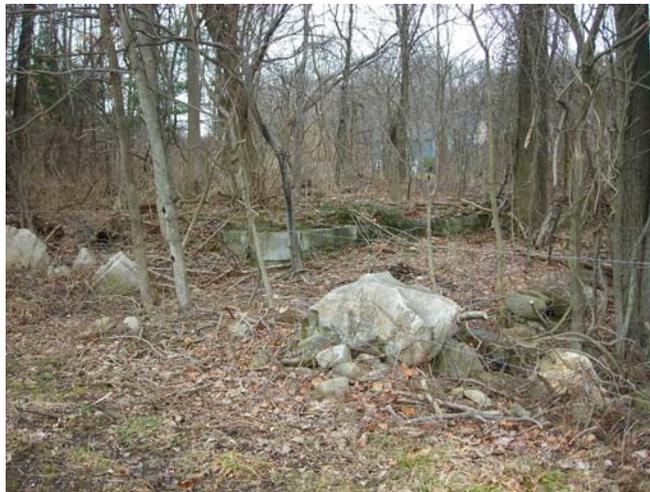
Remnants (walls/foundations) of Former Morocco Factory/Moore & Burgess Webbing Co.

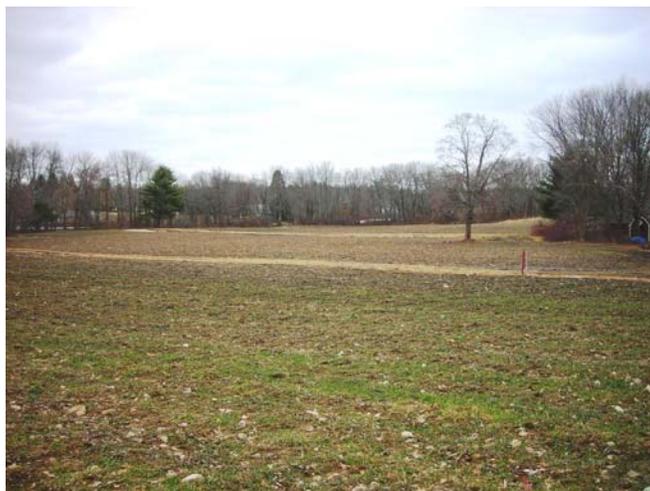
Fertilizers and pesticides are used at portions of the Site used for farming. The operator of the farm indicated that these are applied in accordance with the manufacturer's instructions and regulated by the Massachusetts Department of Agricultural Resources. He indicated that only approved pesticides are used at the Site. The Massachusetts Contingency Plan (310 CMR 40.0317(8)(c)) indicates that releases of hazardous materials indicated by residues in the environment resulting from the application of pesticides in a manner consistent with their labeling is exempt from reporting. We have found no information to indicate application of pesticides at the Site other than in a manner consistent with this exemption and have therefore not identified the use of herbicides and pesticides at the Site as a REC. However, we cannot rule out the possibility that detectable concentrations of pesticides may be present in Site soil and groundwater.

View of 2 Stow Street Farm Fields (towards the West)
