2 Stow Street & 90 Martin Street, Acton, MA

Environmental Condition Summary

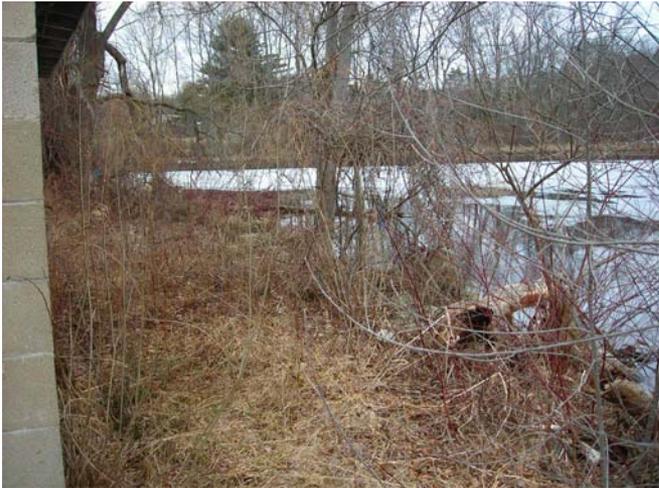
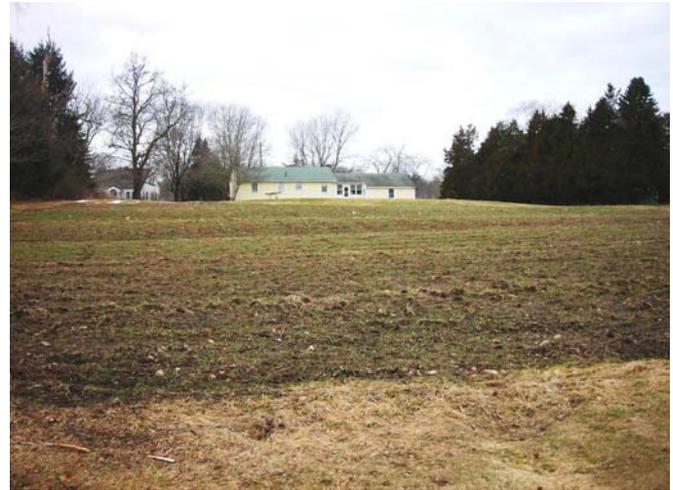
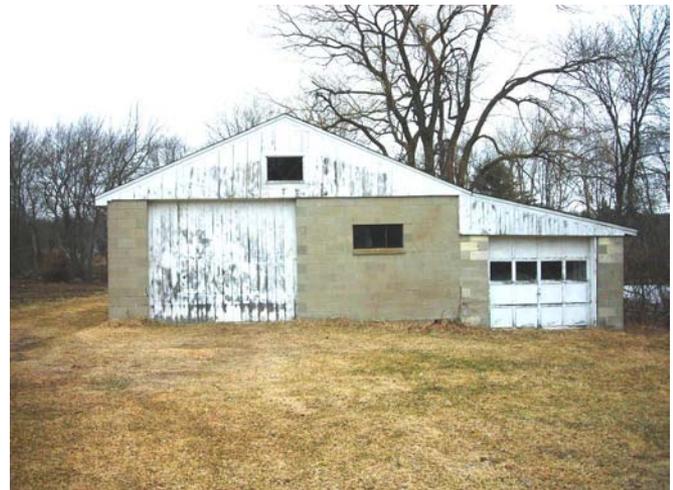
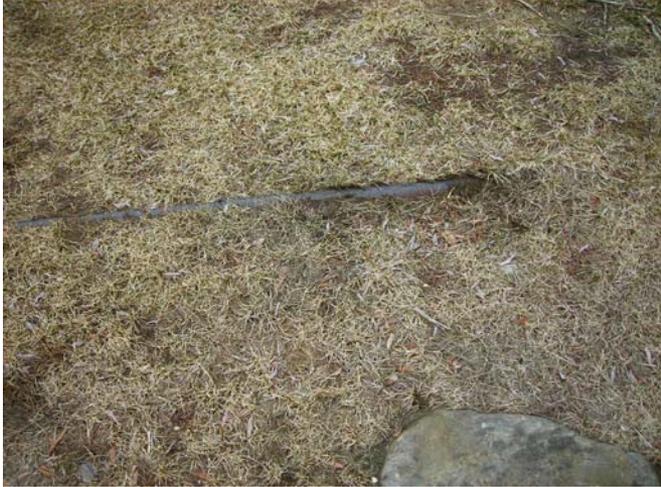
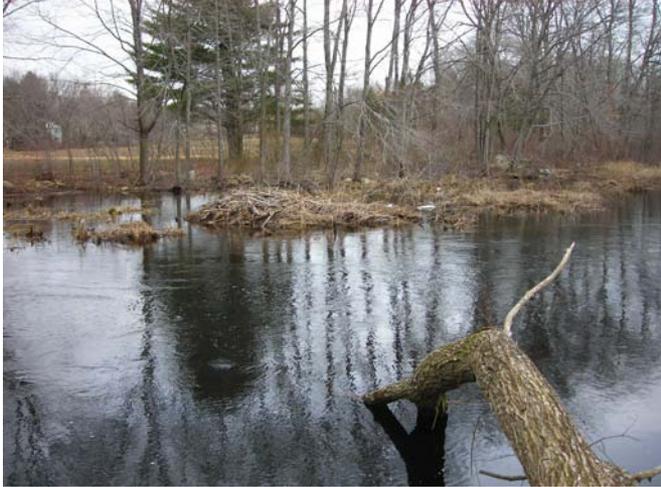
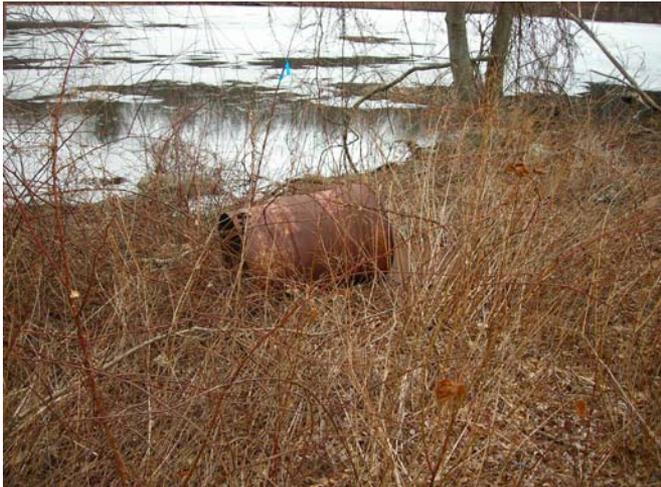
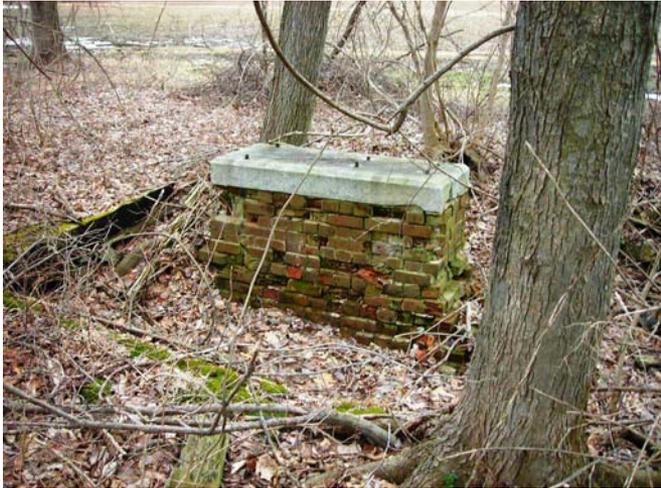
- We put our feet on the ground and look.

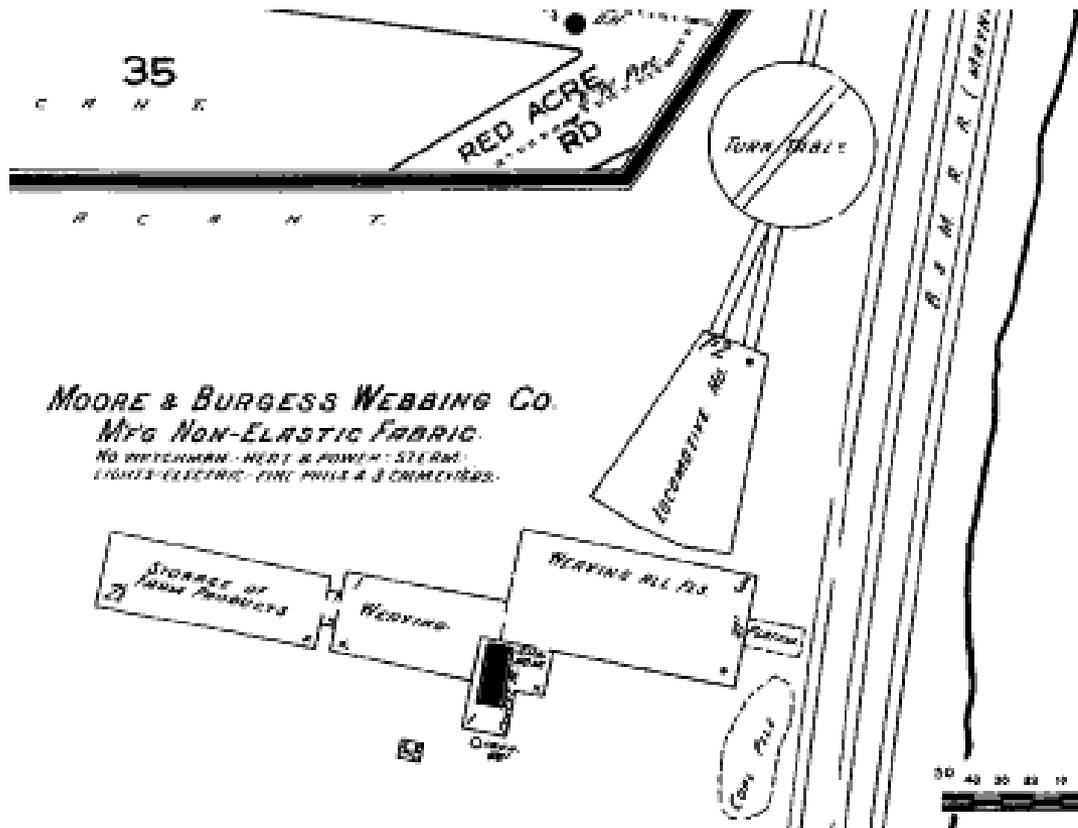
- Total property is 15.7 acres:
 - 2 Stow St. 7.5 acres undeveloped farm land;
 - 90 Martin St. 3 acres residence, garage and farm land; and
 - 5.2 acres Mill Pond and Fort Pond Brook.
- Area is not a current or potential water supply area.
- Pesticides at farm used in accordance with IPM.
- The eastern portion of the property has an industrial history.

MOORE & BURGESS WEBBING CO.
MG Non-ELASTIC FABRIC.
 NO WEIGHMAN - HEAT & POWER - STEAM
 LIGHTS - ELECTRIC - FIRE PAILS & CHIMNEYS.

- Based on the finding of past industrial use, we recommended that a Phase 2 environmental investigation be undertaken to assess whether the past use of the property caused a release of oil or hazardous material.
- Phase 2 was to include testing of soil, groundwater and sediments from around the Mill Pond.

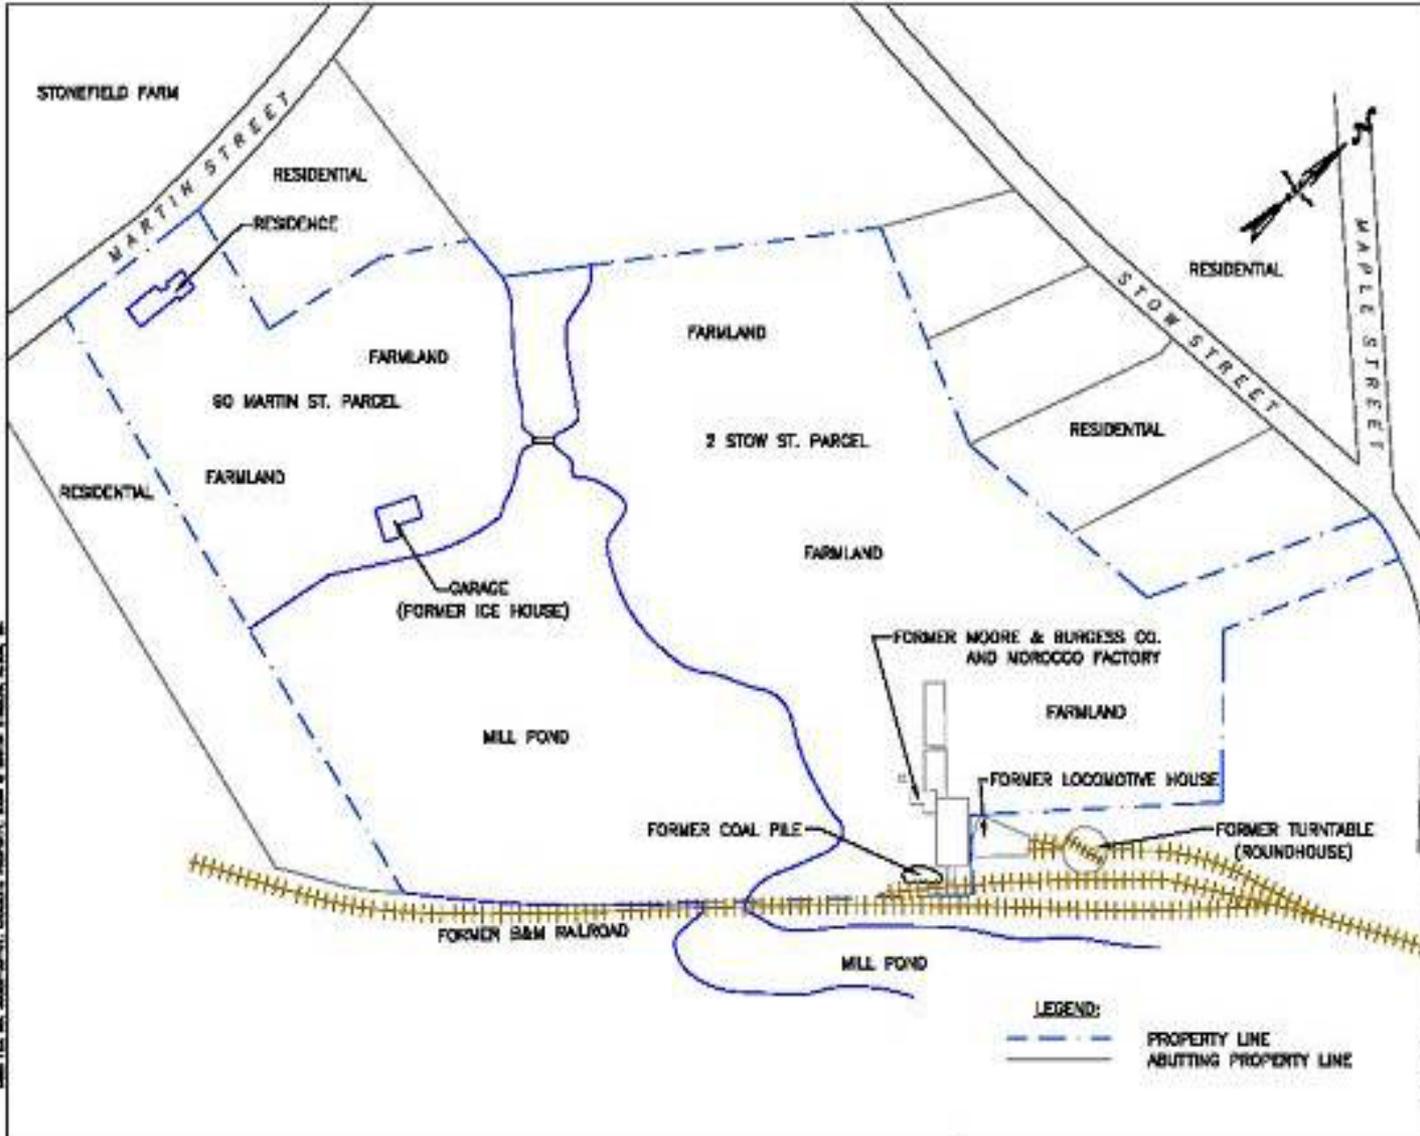
FIGURE No.
 2

SITE PLAN

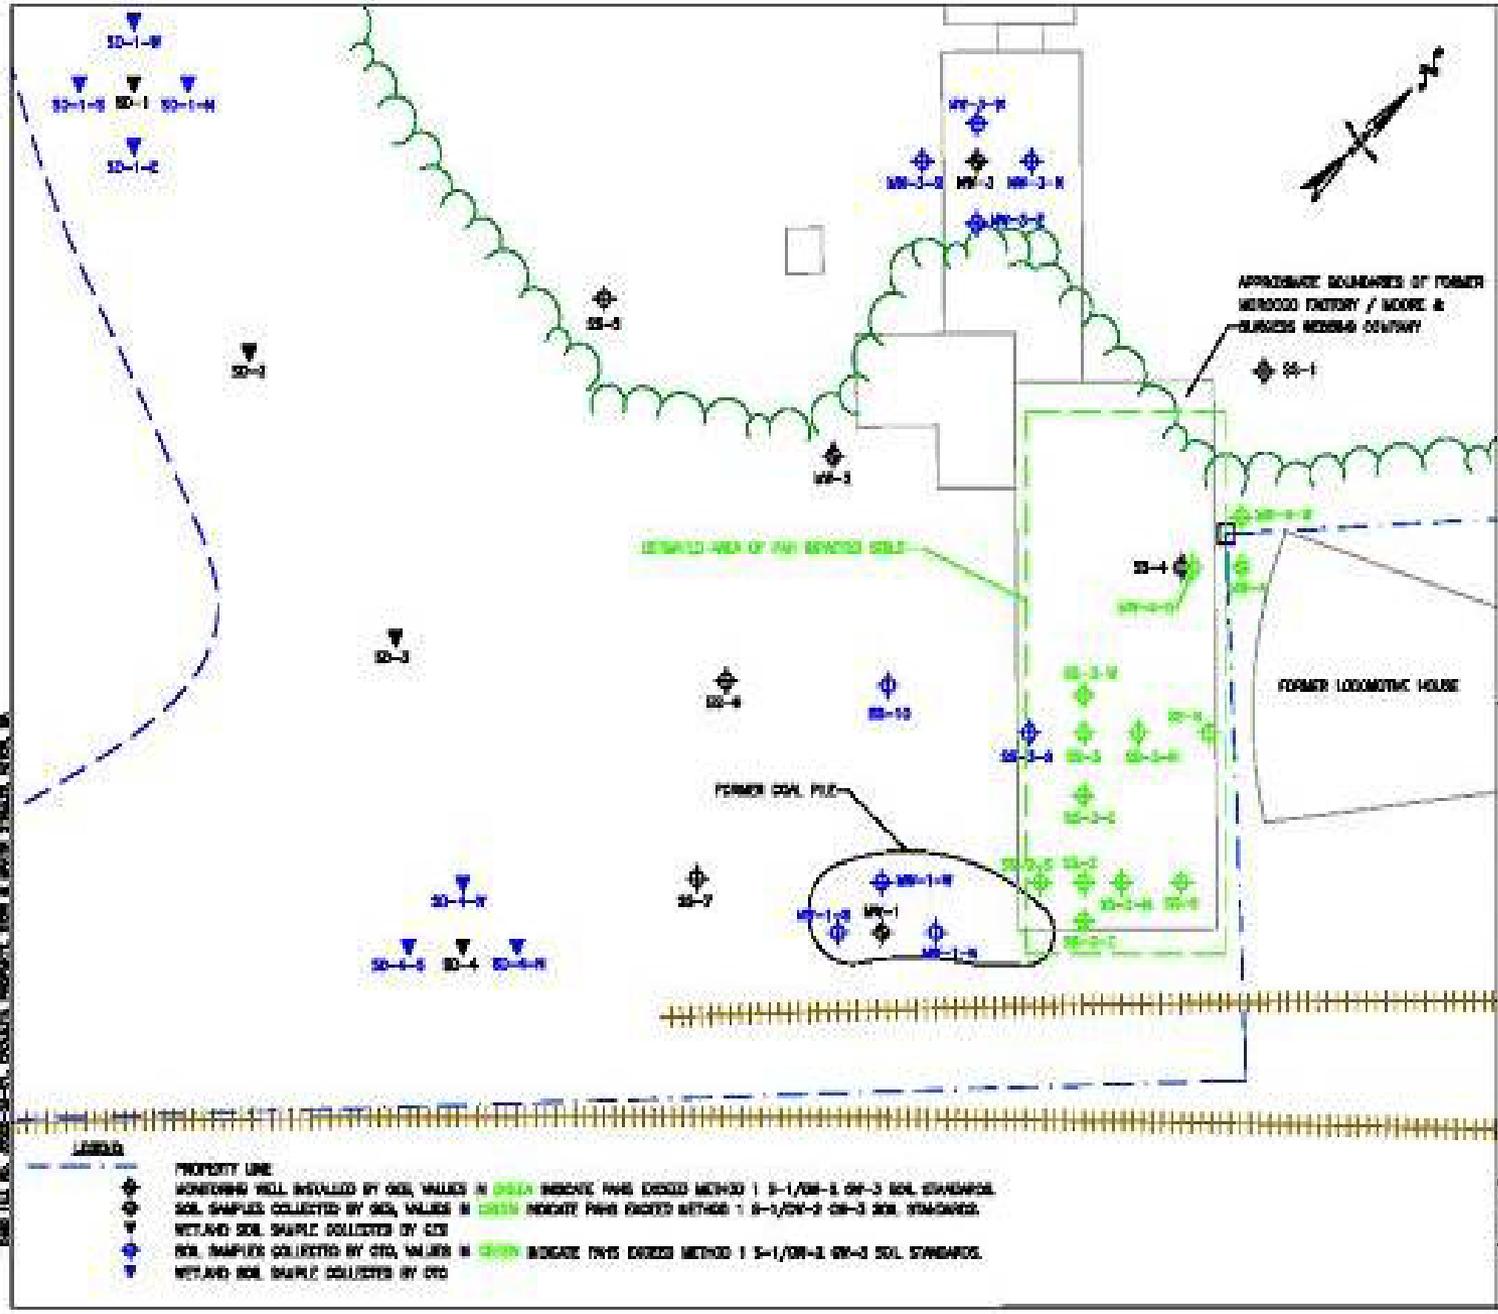
**PROJECT NO:
0022-25-01
PAGE NO:
3**

- In shallow soil (0-2 foot depth) concentrations of arsenic, lead, PAHs and chromium were found above MassDEP Reportable concentrations.
- It was recommended that an additional phase of testing be undertaken to better define the extent of the concentrations discovered.

- In some areas, the PAHs are due to coal, coal ash and wood ash.
- In other locations coal tar is also present in surficial soils and likely contributes to the PAH concentrations.
- The detected chromium was found to be in the low toxicity +3 valence state, and is therefore not of further concern.
- Lead and arsenic concentrations are variable with a number of detections greater than MassDEP reportable concentrations.
- Arsenic is present in three locations at concentrations equal to or greater than DEP's Imminent Hazard default level of 40 mg/kg.

**CAQUETTE PROPERTY
90 MARTIN & 2 STOW STREETS
ACTION, MASSACHUSETTS
EXCEEDANCES OF METHOD 1
SOIL STANDARDS (PAGES)**

- Two alternatives for reducing Site risk:
 - Securing the contaminated soil in-place; and
 - Removing the contaminated soil from the property and disposing of it in a permitted off-site facility.
- To make the decision of which is best requires looking at the cost to implement, the damage that may be done during implementation and other factors.

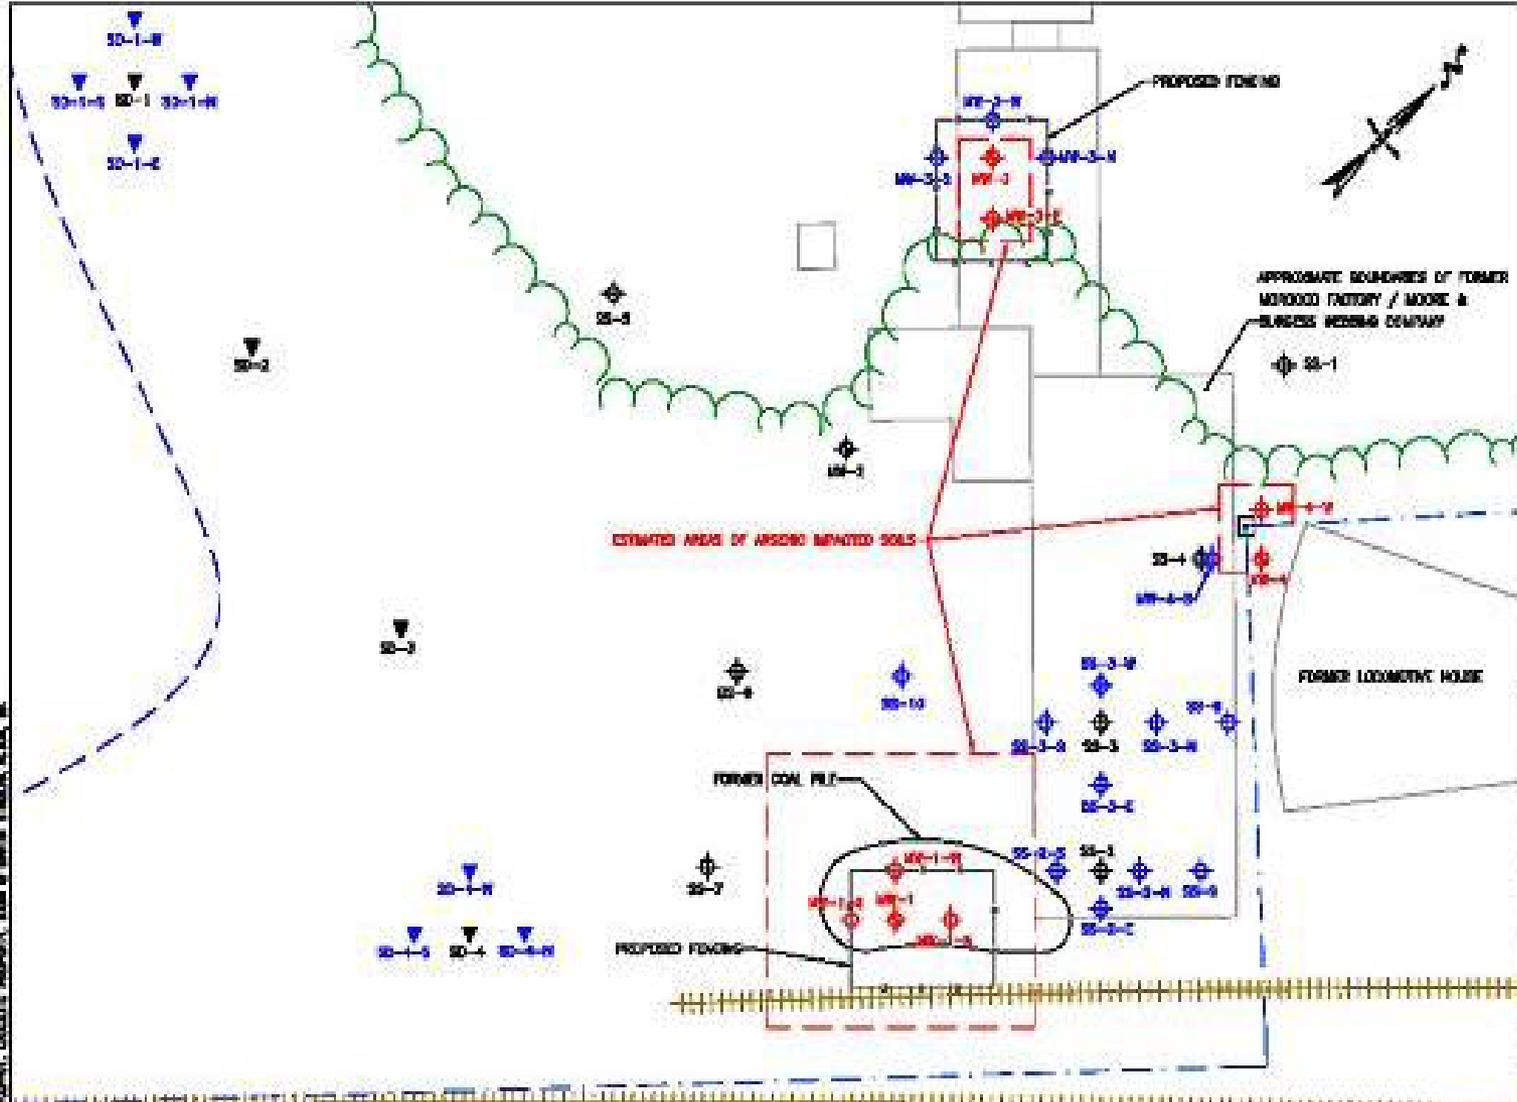
PAGE 5
 4

EXCEEDANCES OF METHOD 1
 SOIL STANDARDS (ARSENIC)

- You may have heard some discussion about the coal, coal ash and wood ash exemption and that really ended up not coming into play.
- Sediment concentrations were quite low and in our opinion do not pose ecological risk.
- Temporary fencing is already in place around the areas known to have elevated arsenic concentrations, these can be extended if necessary.
