## Caron Environmental Consulting

Re: Lot 3 Robbins Street

## DEP Bordering Vegetated Wetland (310 CMR 10.55) Delineation Field Data Form

**DELINEATION DATA PLOT PHOTOGRAPHS  
LOT 3 ROBBINS STREET  
ACTON, MA  
DECEMBER 4, 2010**

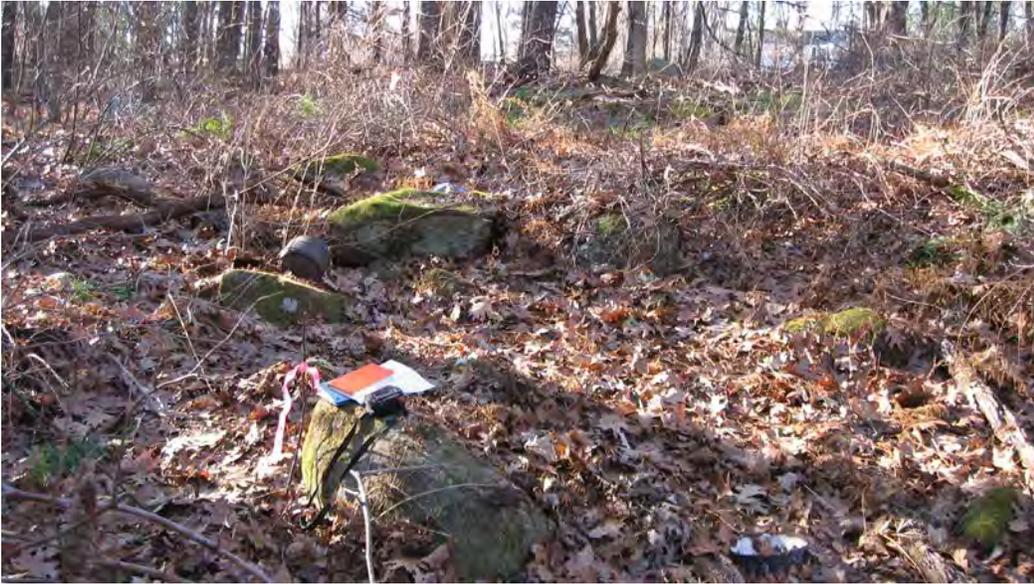
Photo 1: Uplands at Plot B10/11

We observed that some wetland species are present on the upland side of the line, but the vegetation analysis for the data plots indicates that there are 6 upland versus 2 wetland indicator species that are dominant in the area. We also observed that many upland plants are straggling into the wetlands in this location. In fact, the evidence from the data plots could argue for moving the line down slope. On the wetland side of the line we found there are 4 upland versus 3 wetland dominant indicator species.

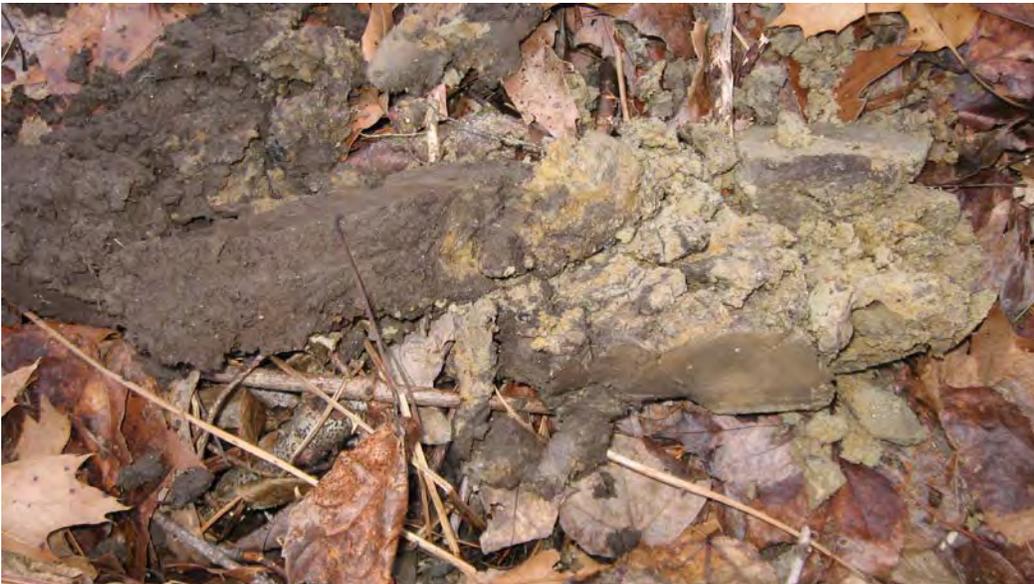
Photo 2: Soil Profile at Plot B10/11

The soils, however, reveal a distinct and sharp change from upland to hydric conditions between the two plots. Evidence of wet hydrologic conditions was not found on the upland side of the line within the upper two feet of the soil profile. There is a sharp change to reduced soil conditions just below two feet. On the wetland side of the line the soils are significantly (more than 5%) mottled to the surface and the B-horizon has a 2-chroma and is heavily mottled.

Horizon	Depth (inches)	Matrix Color	Mottles Color
A	0"-10"	10 YR 3/3	
Bw1	10"-18"	10 YR 5/6	less than 5% 10 YR 6/3 7.5 YR 5/6
Bw2	18"-22"	10 YR 5/4	5% -same
C1	22"-26"	2.5 Y 5/3	5% -same
C2	26"+	2.5 Y 6/2	10% 7.5 YR 5/6

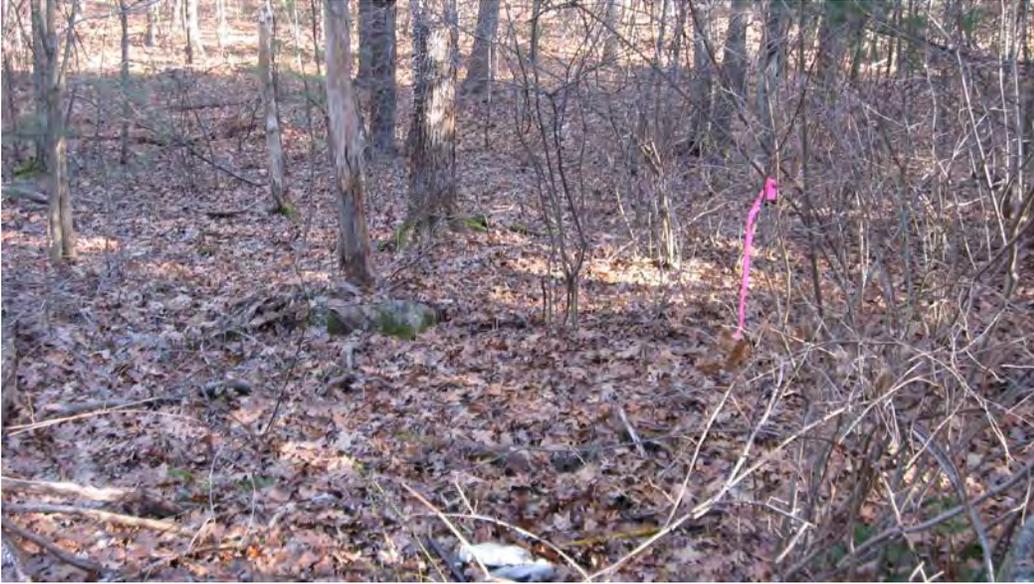
Photo 3: Wetlands at Plot B10/11

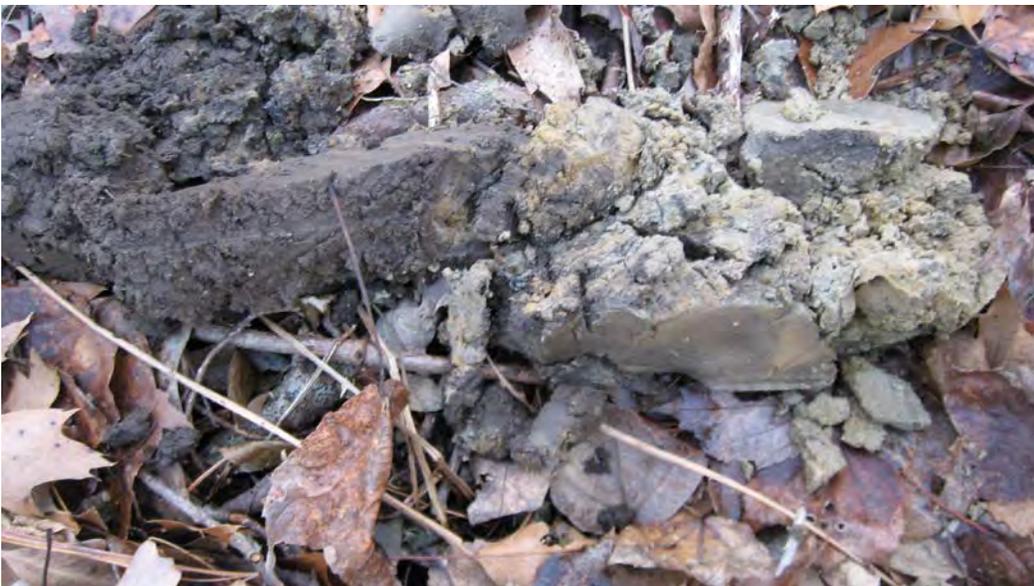
Photo 4: Soil Profile at Plot B10/11

Horizon	Depth (inches)	Matrix Color	Mottles Color
A	0"-8"	2.5 Y 3/2	5% 5 YR 4/6 10 YR 5/2
B	8"-16"+	2.5 Y 6/2	15% 7.5 YR 5/6 10 YR 5/1
