West Acton Baptist Church

Master Plan

The West Acton Baptist Church

Meeting #2 July 22 2013

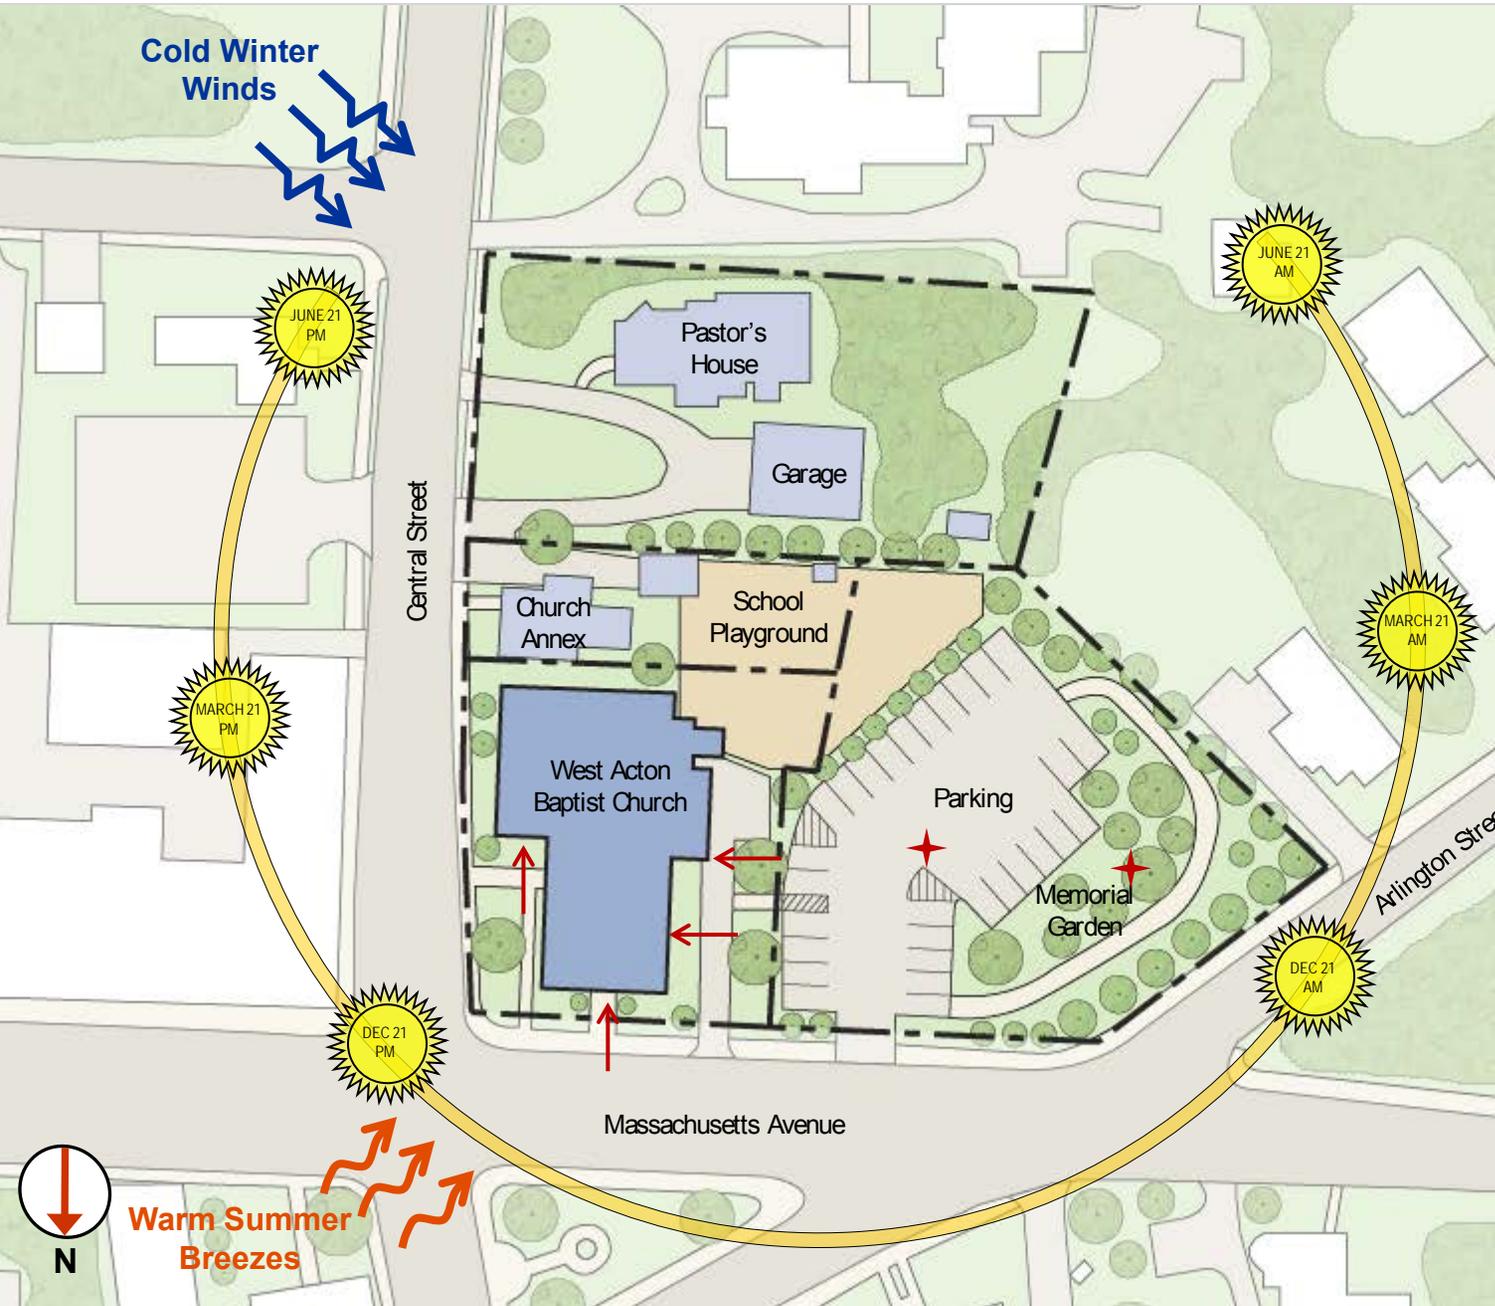
Site Analysis:

- Formal entry faces South offers opportunity to welcome
- Main entry difficult to locate
- School entry not well marked
- Parking is adequate
- Memorial plantings; beautiful and connect to church mission
- Office entry confusing

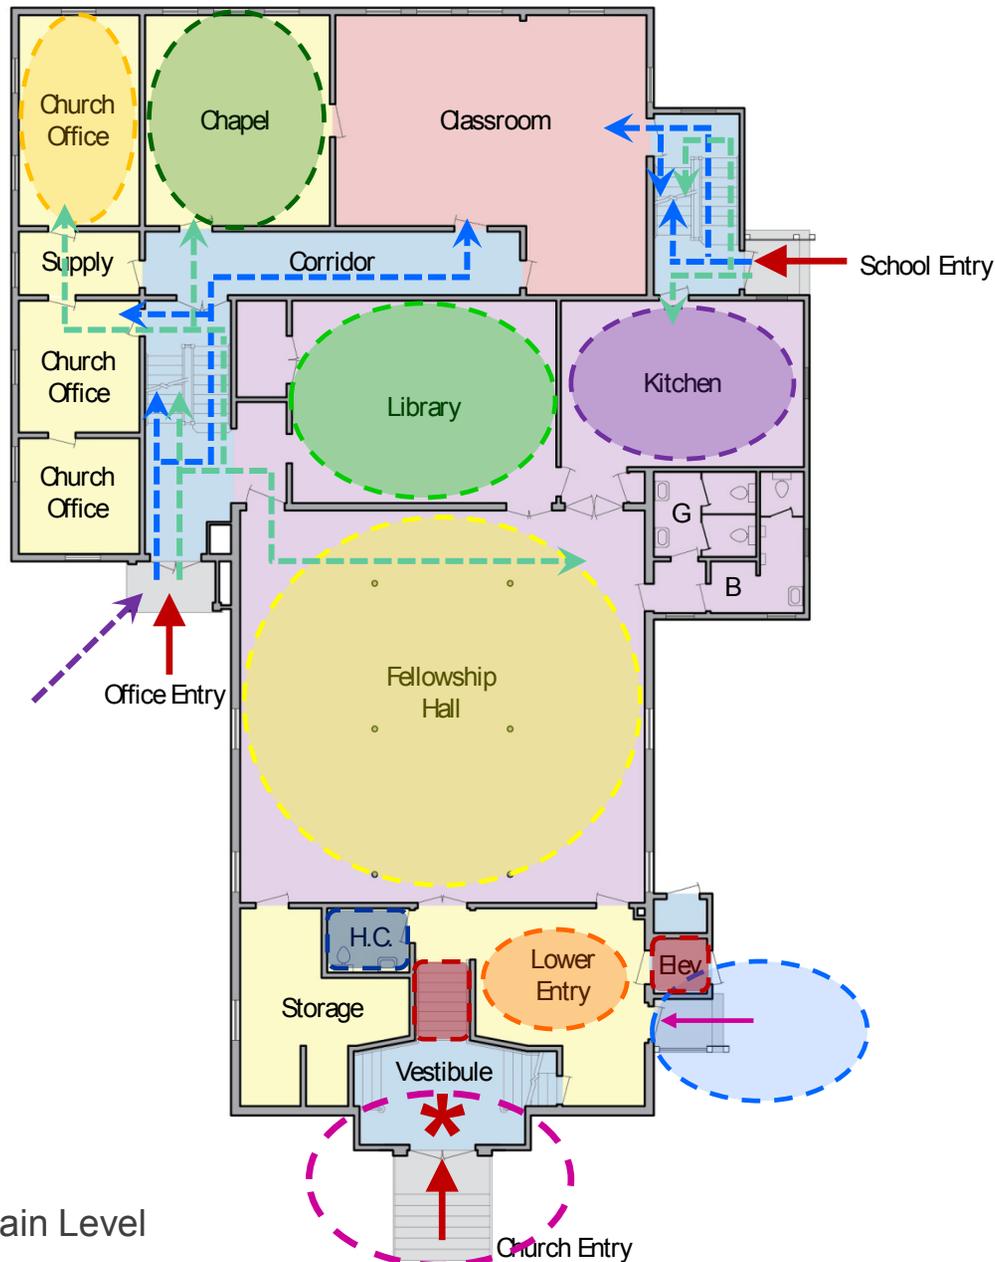
Building Observations: Main Level

- Entry Hard to Find - Not Welcoming
- Lobby is not inspiring/connected
- Stairs at Entry and elevator are small and unpredictable
- Formal entry rarely used (only for weddings and funerals)
- HC bathroom in good location
- Fellowship hall is spacious but run down / not inspirational
- Kitchen tired but functional
- Library serves many purposes– but does not have defined function for WABC
- Chapel serves as meeting room and CE room
- Circulation is shared with Coop
- Church office functions but needs updates
- Side entry difficult to navigate no doorbell, no handle (does not look active)

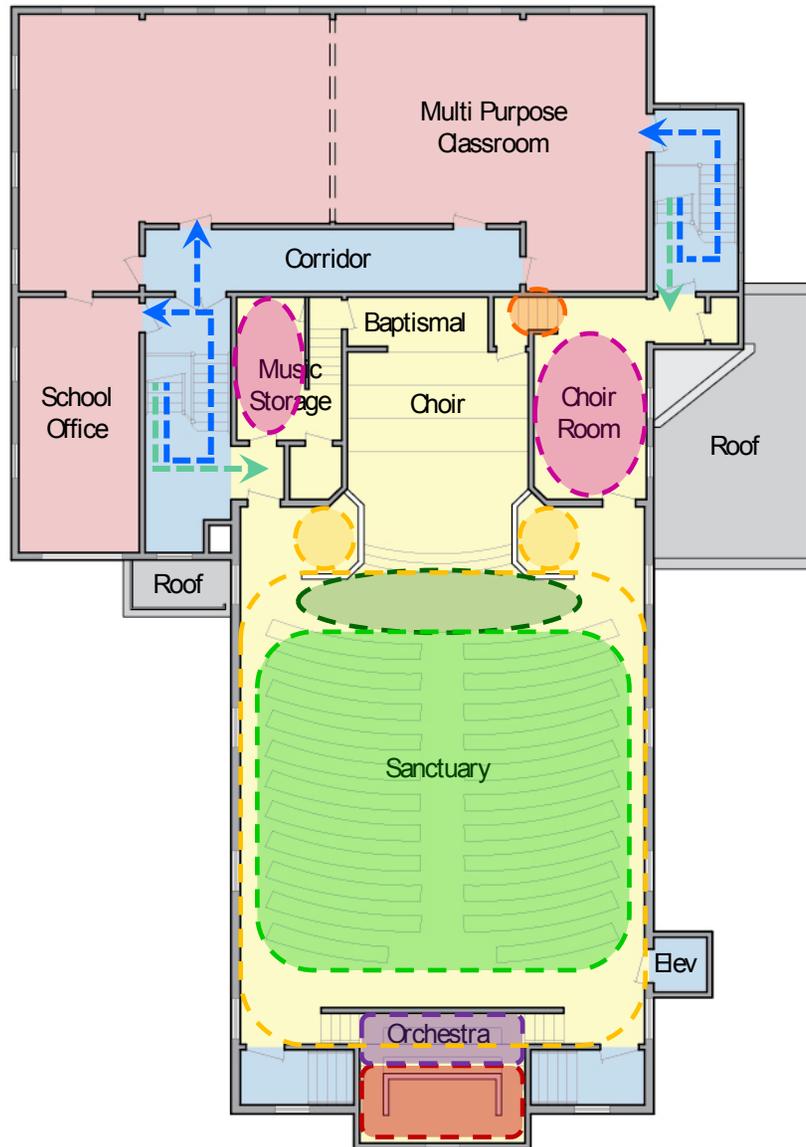
Building Observations: Upper Level

- Sanctuary is beautiful and historic
- Pews work well for seating
- Lack of space at front limits flexibility
- Organ/Drum areas also take up floor space/ limit flexibility
- Stairs Not Code Compliant
- Choir storage lacks music storage
- AV system inadequate
- Ceiling and floor are not in good shape - need to be rehabilitated
- Lighting is inadequate esp. over congregation seating
- Back area rarely used
- Hallways shared with Coop
- High Ceilings, Large Windows & Good acoustics

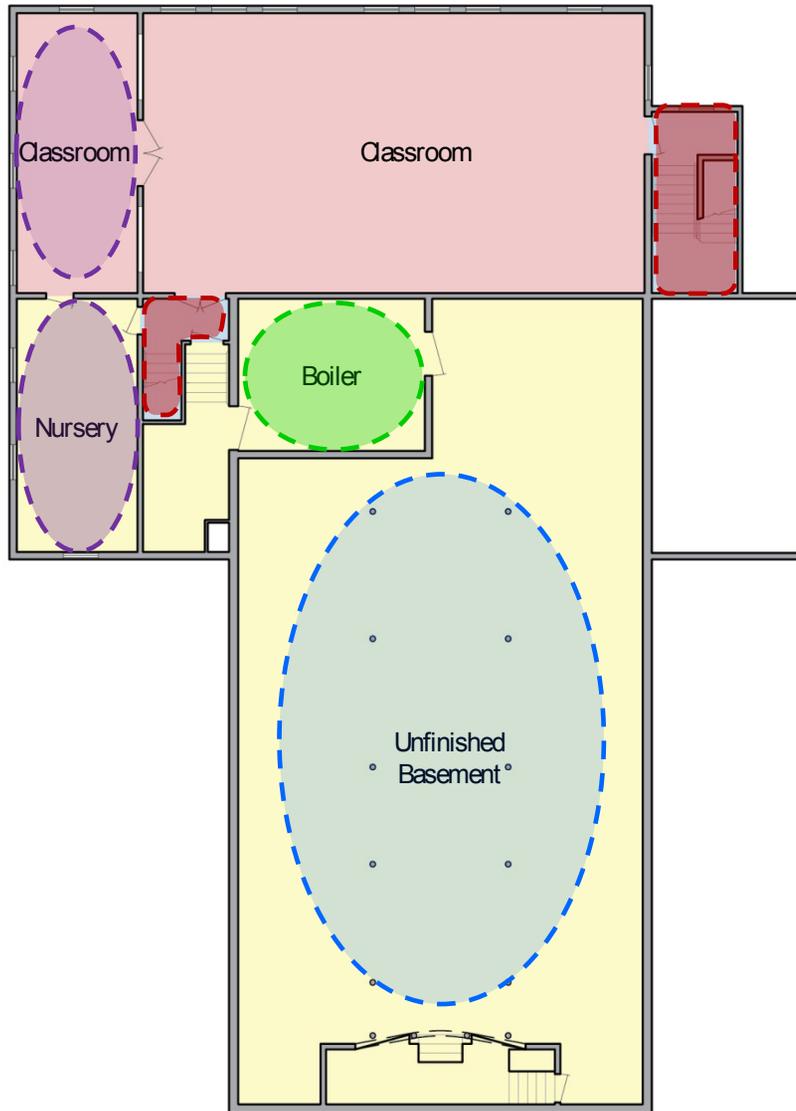
Building Observations: Lower Level

- Main basement space is very damp
- Systems are outdated
- Nursery is down stairs and feels isolated
- Shared CE Area with Coop Problematic
- Classrooms share access with WABC

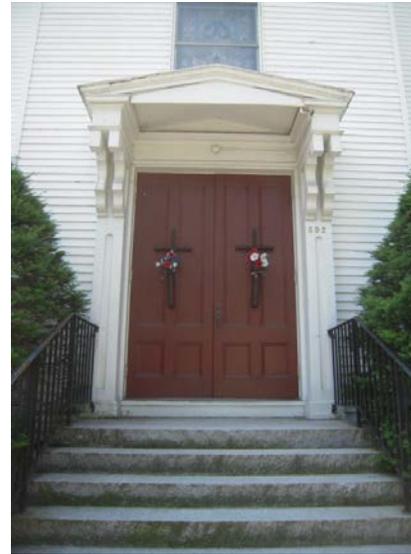
Main Entry on Mass Ave.

- Storm window enclosures over stain glass windows are in fair condition and have operable sashes for ventilation
- Main entry wood doors appear to be the original doors and will require refurbishment and new hardware
- Wood doors on east side entry are small and in need of new accessible hardware, suggest replacing the doors entirely
- Wood door on west side entry should have accessible hardware

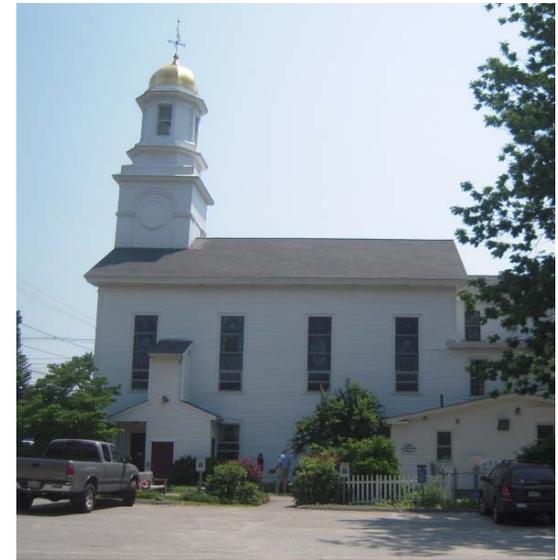
West Elevation

- Vinyl siding installed in the 70's is in fair condition- it could benefit from cleaning and minor repairs
- Wood canopies and trim located around exterior doors should be repaired and painted
- Existing Belfry will be repaired in the Fall 2013

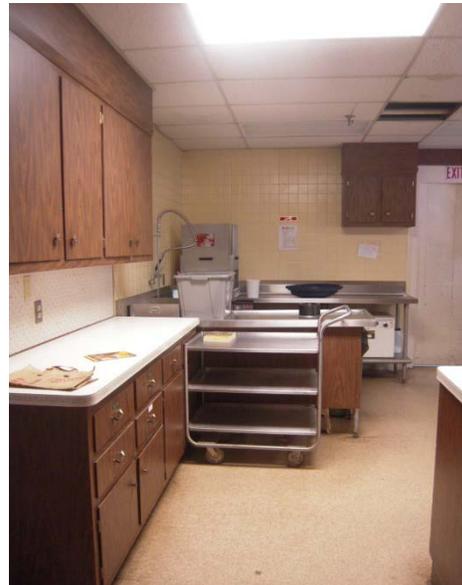
Kitchen/Dish Cleaning Area

- Kitchen: Sheet flooring may need to be updated to meet current BOH requirements
- Basement: Partial concrete and dirt floor allows water to flow through basement at times. Installation of better sump would improve condition (or installation of a perimeter foundation drain system).

- Kitchen: existing walls have ceramic tile and wall paper.. Wall paper would need to be replaced with tile or coated panels to meet current codes
- Basement: has rubble foundation walls in reasonable condition

- Kitchen: ACT ceiling is stained and not coated, BOH would require clean room tiles in this space if it is to be brought up to code.
- Basement: Exposed wood floor joists and no fixed lighting. Adding permanent lights would be helpful but are not required by the state building code.

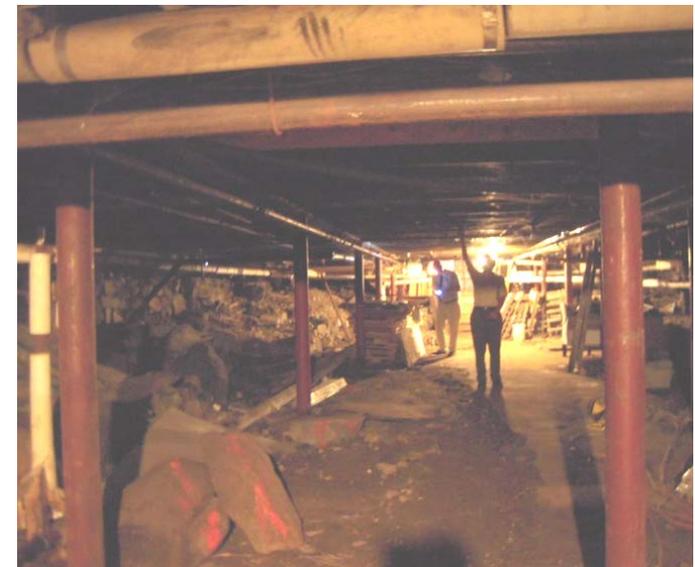
Rubble walls, Dirt Floor, Steel columns

- The bases/base plates of steel columns in the crawl space have corroded, recommend that these areas be mechanically cleaned and evaluated

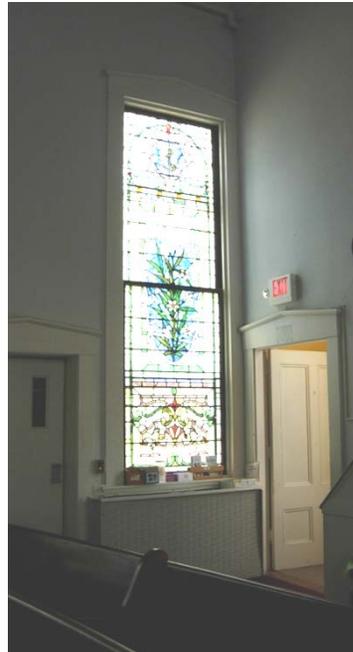
Stained Glass Windows

- Existing wooden pews are in good condition
- Minor repairs on stain glass window units maybe needed
- Retractable treads at choir appear to be in good condition

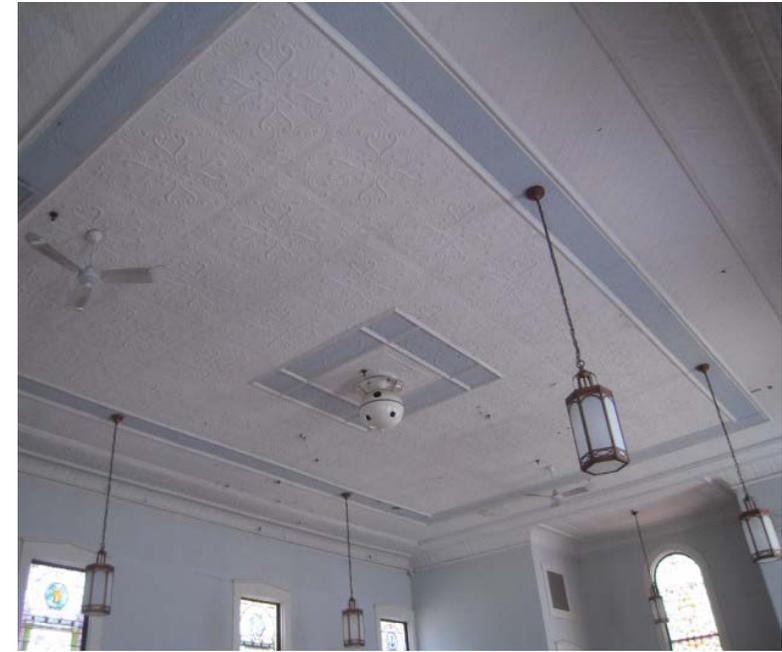
Tin Ceiling / Pendant Light Fixtures

- Steel ceiling appears to be part of the original architecture. Signs of water damage are apparent in the ceiling. Ceiling should be refurbished to maintain historic character

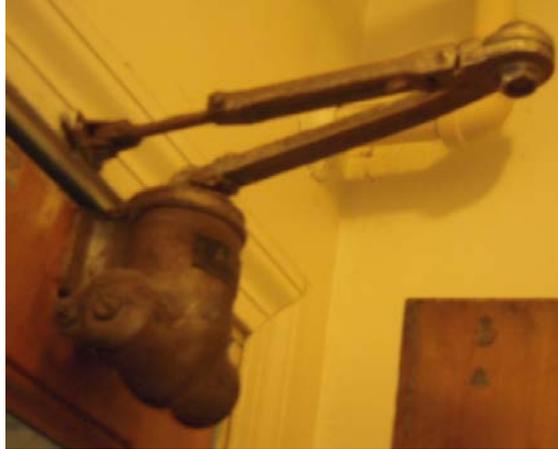
Outdated Door Closers

- Outdated door hardware should be replaced. Door closers exceed the required pressure to operate
- Some of the interior exit signs are not illuminated
- Some interior egress doors do not have the proper clearances
- Many of the doors have “door knobs” instead of accessible lever handles
- Access door to belfry does not open 90 degrees
- Stair access to belfry is not safe (repair and add railings for safety)
- Illumination in belfry access needs to be improved

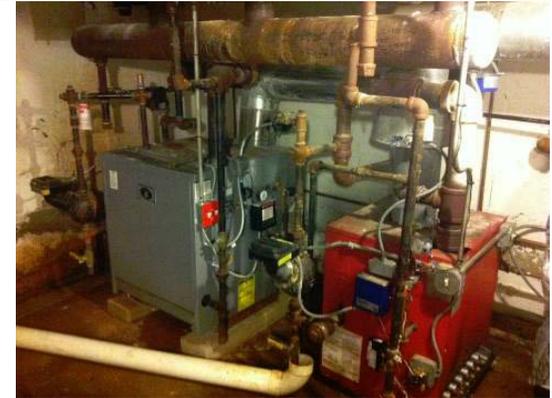
Steam Boiler

- Consideration should be given to converting the entire steam system to hot water.
 - The current boilers can be converted, however pumps and an expansion tank would be required for hot water circulation and hot water expansion. All steam traps would have to be removed from the piping system to allow flow throughout the piping system.

- **Conversion of the entire steam system to hot water.** The current boilers can be converted, however, new pumps, expansion tank, air separator and hydronic accessories would be required for hot water circulation and hot water expansion. All steam traps would have to be removed from the piping system to allow flow throughout the piping system. The existing condensate piping system would need to be replaced in sections for conversion to hot water return duty. The existing steam piping could be used for hot water supply service. \$120,000- \$150,000
- **Upgrade Piping Insulation, Control System, and terminal radiation equipment** as identified in Repair Option above. \$104,500- \$135,000

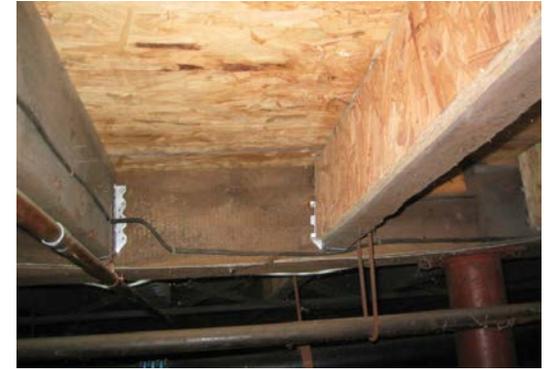
Wood Floor Joists

- The condition of the trussed roof construction over the Sanctuary appears to be satisfactory.
- The live load capacity of the wood framed floor construction at the Main Level of the original church appears to be as low as 40 to 50 psf. The present building code (8th Edition) would require a 100 psf live load for Fellowship Hall space and a 60 psf live load capacity for the Sanctuary. Further review is recommended. Additional supplemental beam supports in the crawl space would serve to increase the live load capacity.

- It is recommended that hangers be provided at all Main Level joist/beam connections. Further review is recommended at Upper Floors
- Wood subflooring of the Main Level was replaced by $\frac{3}{4}$ " plywood in some locations; this is structurally acceptable.
