RE: Notice of Intent Application
2798.820 kW Ground Mounted PV Facility
127 Stow Street
Acton, Massachusetts

**RE: Vernal Pool Assessment
127 Stow Street
Acton, MA
NEE #15-4777**

Vernal Pool Habitat

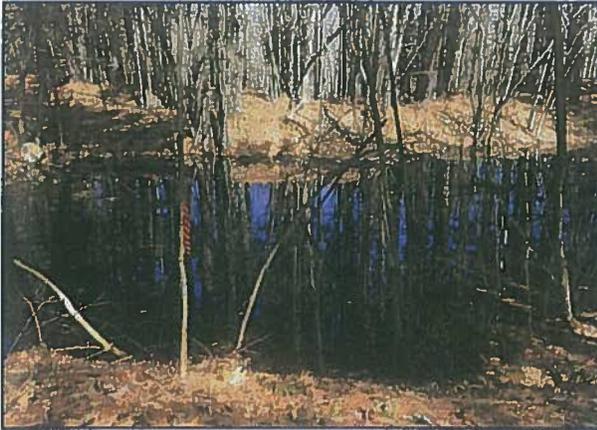
The A-Series Wetland. The isolated wetland delineated as the "A-Series" is a seasonally-flooded palustrine pool with no rooted/floating vascular submerged aquatic vegetation growing (indicator of a seasonally-flooded hydroperiod). The wetland is located within a topographically confined basin with no permanent inlet/outlet, which meets the physical criteria for a vernal pool [310 CMR 10.04, 10.57(1)(a)(3), 10.57(1)(b)(4), and 10.58(1)]. There is abundant submerged woody debris, suitable for amphibian eggmass attachment. The hydroperiod is sufficient to allow full development (metamorphosis) of obligate vernal pool breeding animals, and the wetland has no established fish population. The surrounding vegetation includes upland species consisting of eastern white pine (*Pinus strobus*) and mixed oaks (*Quercus spp.*), with an open understory.

Photo 1: View of the A-Series wetland, facing north (the flag in the foreground is A-15). 03.30.16

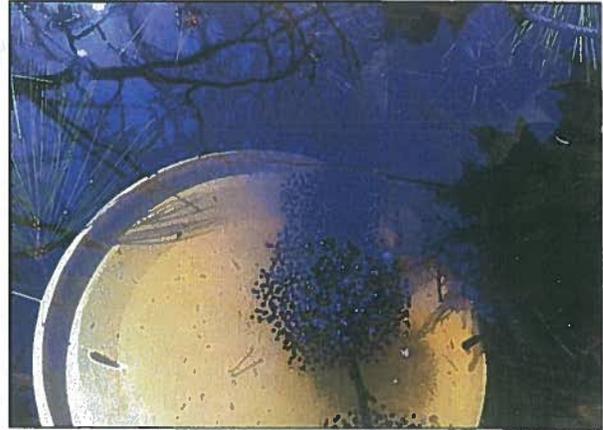
Biological vernal pool evidence observed includes 12 spotted salamander eggmasses and 63 wood frog eggmasses, including a communal wood frog oviposition site, where approximately 47 wood frog eggmasses were clustered. No caddisfly larvae or fairy shrimp were observed in the pool. This wetland does provide suitable vernal pool habitat and meets both the physical and the biological criteria for a vernal pool.

Photo 2: Several new (approx. 1 day old) wood frog eggmasses at the A-Series wetland. 03.30.16

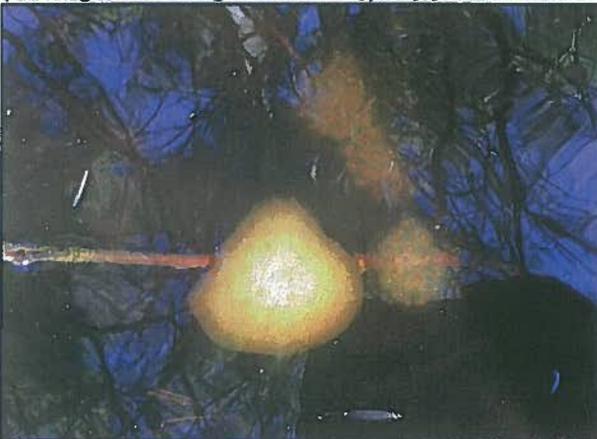
Photo 3: View of a cluster of spotted salamander eggmasses attached to submerged vegetation in the A-Series wetland. 03.30.16

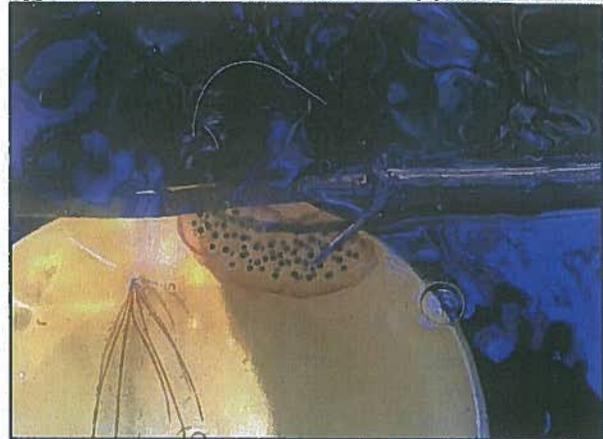
Photo 4: A new (approx. 1 day old) spotted salamander eggmass in the A-Series wetland. 03.30.16

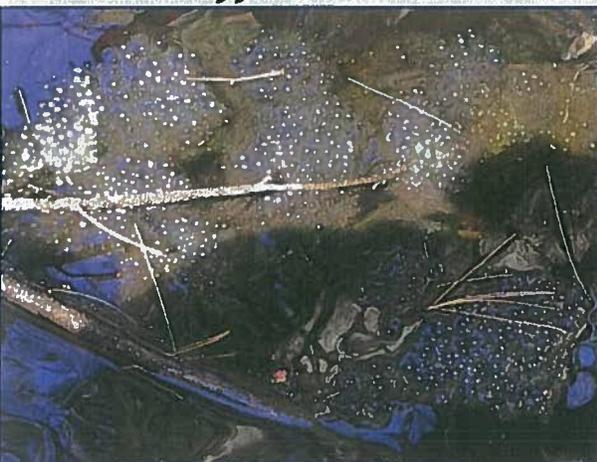
Photo 5: View of the communal wood frog oviposition site at the A-Series wetland (approx. 47 eggmasses are in this cluster). 03.30.16

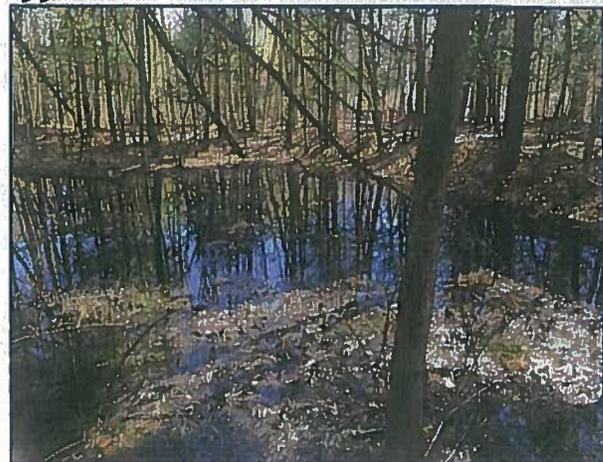
Photo 6: View of the A-Series wetland, facing south. 03.30.16

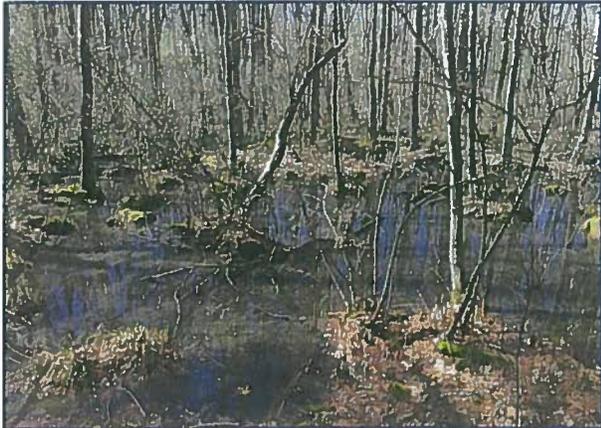
The B/C-Series Wetland. The B/C-Series wetland is a red maple (*Acer rubrum*) swamp with a pit-and-mound topography, several "islands" vegetated with sweet pepper bush (*Clethra alnifolia*), highbush blueberry (*Vaccinium corymbosum*), maleberry (*Lyonia ligustrina*), and winterberry (*Ilex verticillata*) in the shrub layer (see Photopages). The northern end of this wetland complex becomes vegetated with persistent emergent vegetation, such as common reed (*Phragmites australis*) and cattails (*Typha latifolia*), and the broad-leaved deciduous shrub density decreases.

Photo 7: View of the B/C-Series wetland, facing north from Stow Road. Note the pit-and-mound topography with "islands" and "pools". 03.30.16

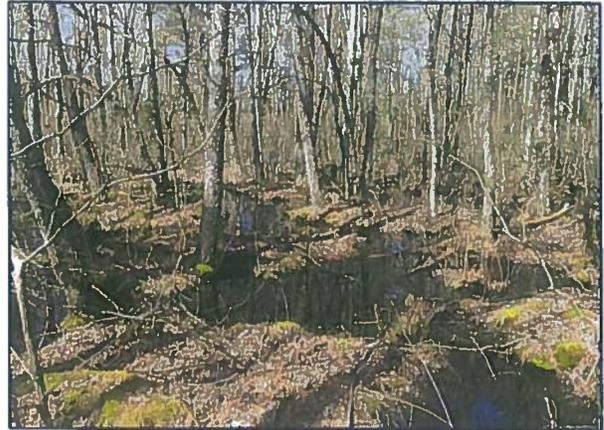
Photo 8: View of the B/C-Series wetland, facing west from B-31. Note the pit-and-mound topography with "islands" and "pools". 03.30.16

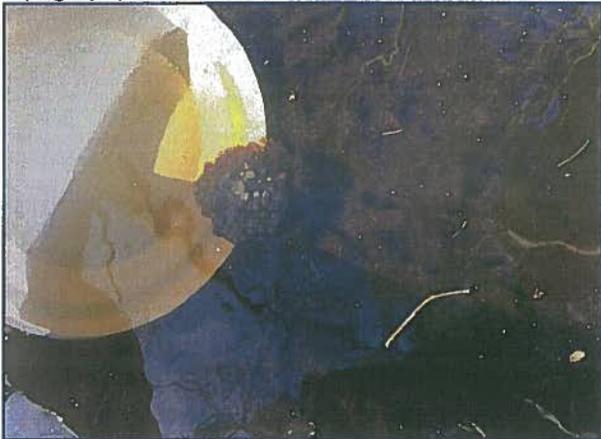
Photo 9: Wood frog eggmass, located near B-28. 03.30.16

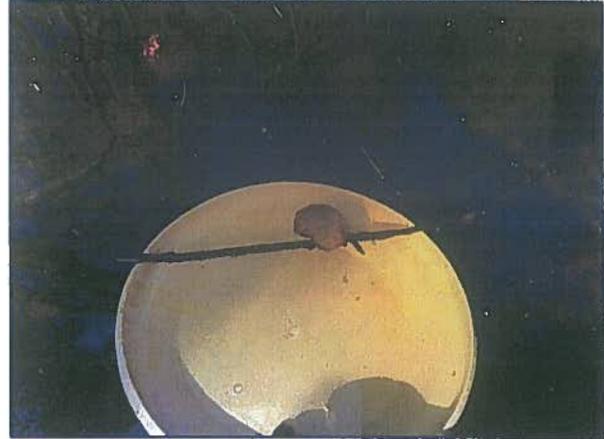
Photo 10: Spotted salamander eggmass located near B-26. 03.30.16

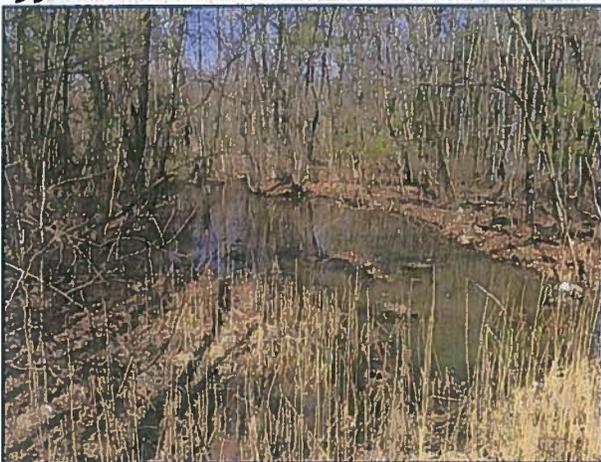
Trash, including many tires, a car, a stove, rusting metal of various type, cans, drums, and barrels, are located at a large and deep pool near C-10 (see Photopages). The water at this pool is murky and

Photo 11: Overview (facing north) of a pool within the B/C-Series wetland where wood frogs were actively chorusing (north of C-10). Note the trash dump. 03.30.16

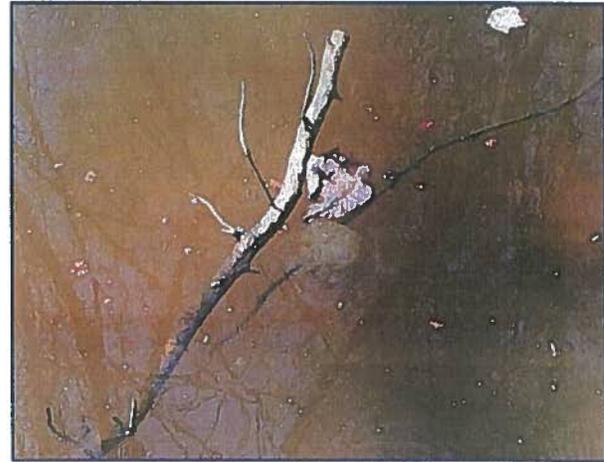
visibility is extremely poor, making this pool nearly impossible to survey for vernal pool eggmasses. However, one wood frog eggmass was observed at the eastern edge of this pool, and wood frogs were chorusing (video including with the electronic copy of this report). No fairy shrimp or caddisfly larvae were observed throughout the B/C wetland complex.

Photo 12: Wood frog eggmass from pool near C-10. Note the murky water, which made locating eggmasses nearly impossible. 03.30.16

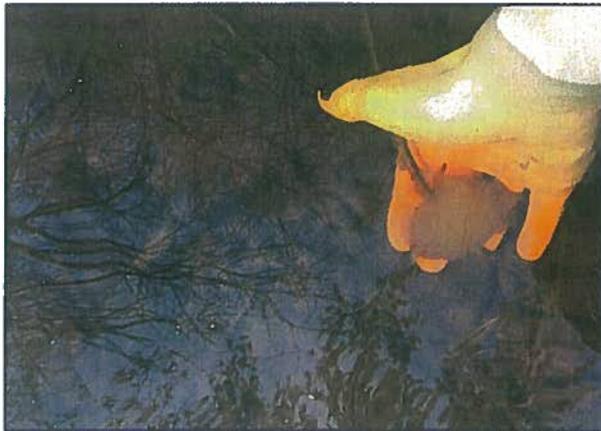
Photo 13: Five spotted salamander eggmasses were observed near D-9. 03.30.16

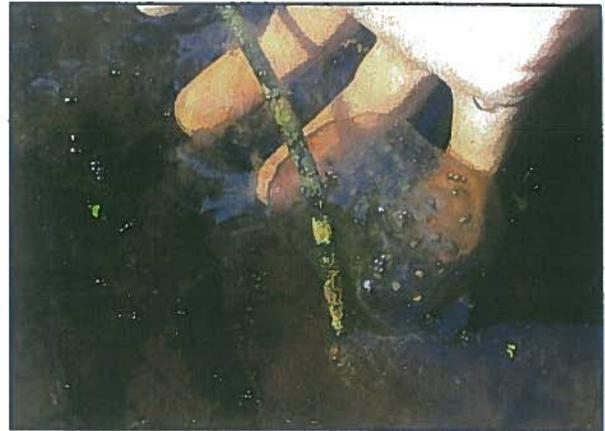
Photo 14: Five spotted salamander eggmasses were seen near flag D-9. 03.30.16.

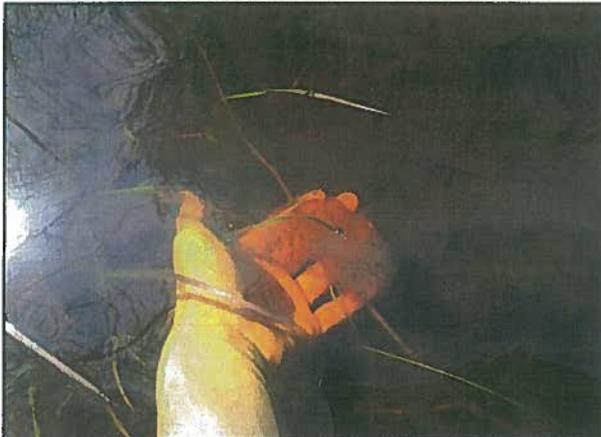
Photo 15: Spotted salamander eggmass seen near wetland flag D-14. 03.30.16

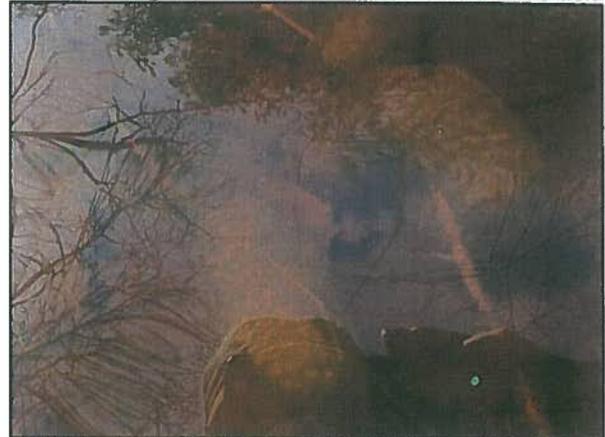
The D/E-Series Wetland. The D-Series wetland is a ditch, with water flowing in a south/southwest direction towards the E-Series wetland to the southwest. There is a very deep pool located near wetland flag D-12 (the depth was too deep to measure with chest waders), and a small pocket of duckweed (*Lemna spp.*) was floating near the southern corner of the pool (which indicates a more permanent hydroperiod). The channel is approximately 4-6' in width. Thirteen spotted salamander eggmasses were found within this channel.

Photo 16: Cluster of spotted salamander eggmasses (8) attached to submerged woody debris near flag D-14. 03.30.16

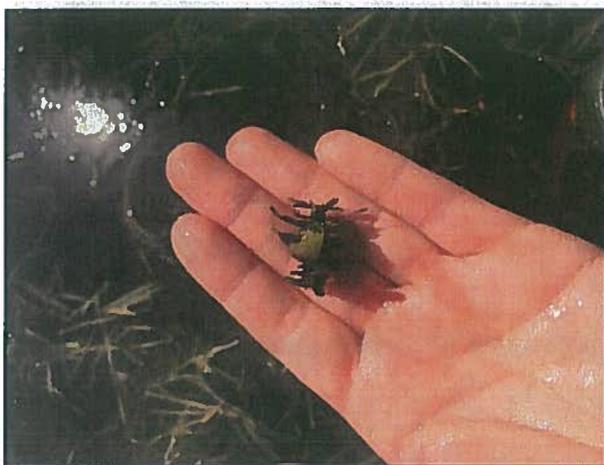
The D-Series wetland empties into a palustrine wetland dominated with persistent & non-persistent emergent vegetation such as tussock sedge (*Carex stricta*) and cattails, and flagged as the E-Series. Caddisfly larvae are common throughout the wetland (see Photopages). This pool was not entirely searched for amphibian eggmasses, and survey effort was ceased at flag E-9. Three spotted salamander eggmasses were observed up flag E-9, and wood frog chorusing was videoed. The 3 spotted salamander eggmasses in conjunction with wood frog chorusing is sufficient to document that the E-wetland does provide vernal pool habitat for obligate vernal pool breeding amphibians.

Photo 17: Caddisfly larvae were common throughout the E-Series wetland. 03.30.16

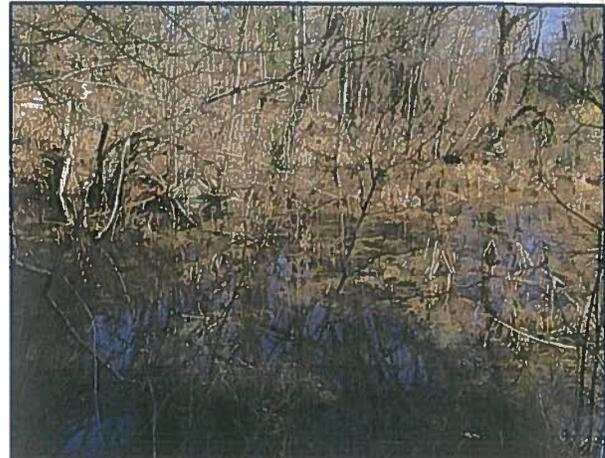
The E-Series wetland contained at least 3 spotted salamander eggmasses (the entire wetland was not surveyed since sufficient evidence of vernal pool habitat is obtained after 2 obligate eggmasses are documented). Further, wood frogs were chorusing, indicating breeding evidence of a second obligate vernal pool animal. This wetland therefore meets the biological criteria of a vernal pool. The E-Series wetland may also meet the physical criteria, if the existing wetland connection is not permanent. Documentation later in the year will be required to substantiate the physical criteria.

Photo 18: Overview of the E-Series wetland, where many spotted salamander and wood frog eggmasses were observed, and where wood frogs were actively calling. 03.30.16
