Towns of Acton, Carlisle and Westford

Bruce Freeman Rail Trail

Existing Structures Evaluation and Modification Report

ACTON BIKEPATH PRELIMINARY STRUCTURES REPORT

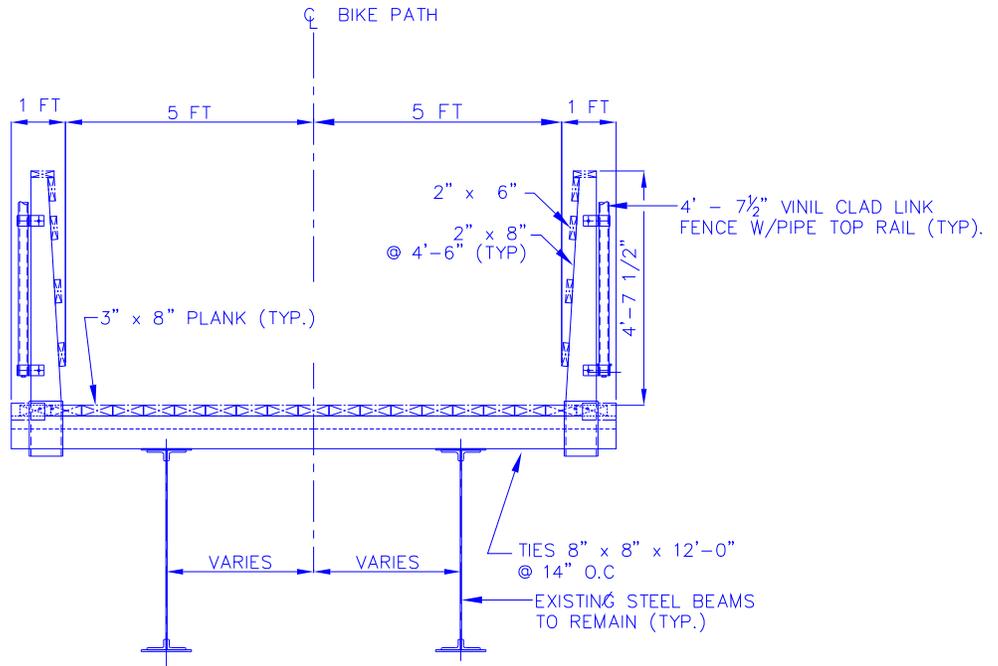
PROPOSED TYPICAL SECTION

Construct new bridge deck from 3" x 8" pressure treated timber & 8" x 8" cross timber beams.

Provide new 4'-9" timber safety railing with protective screen.

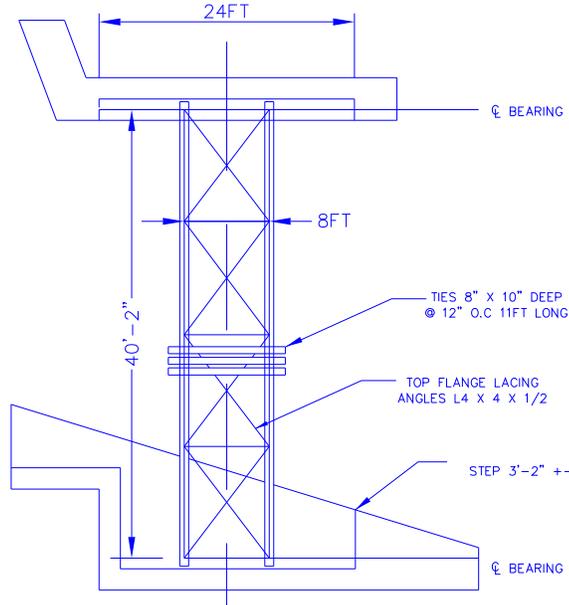
PLAN (N.T.S)

The bridge span is 40'-2" and is supported on abutments constructed from large granite blocks. The depth of the beam members is a constant 43 ¼".

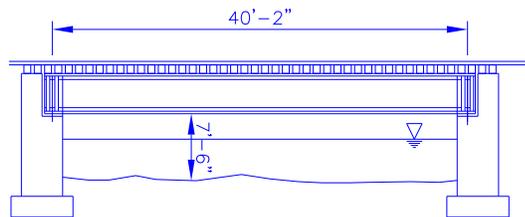
ELEVATION (N.T.S)

Lateral bracing is provided to the compression flange by means of inclined angles at quarter points along the span.

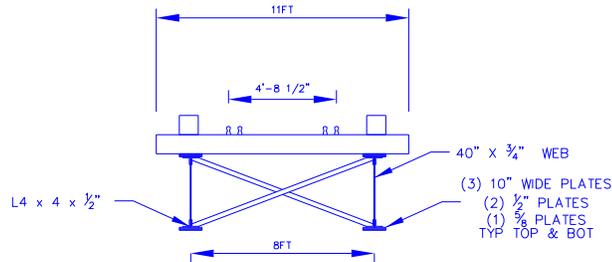
CROSS SECTION (N.T.S)

This structure currently carries a disused railroad over Nashoba Brook. The structure consists of plate girders constructed from steel plates, rolled angles and rivets. From plaques affixed to nearby bridge structures the estimated date of construction is 1919.

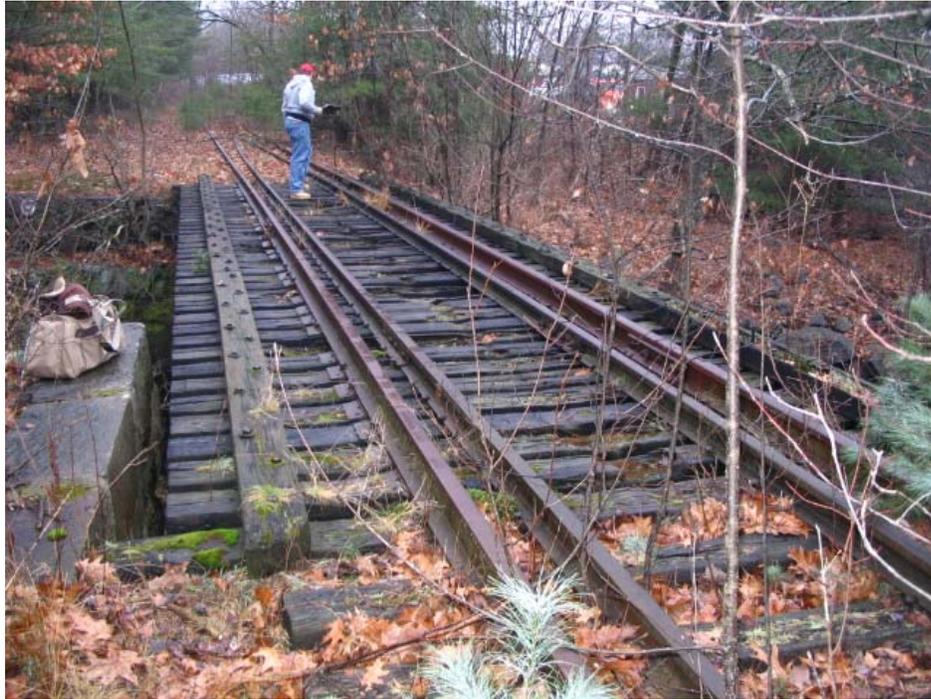
Plan View

The Steel superstructure is in good condition with no significant section loss. Almost all the original paint has been lost.

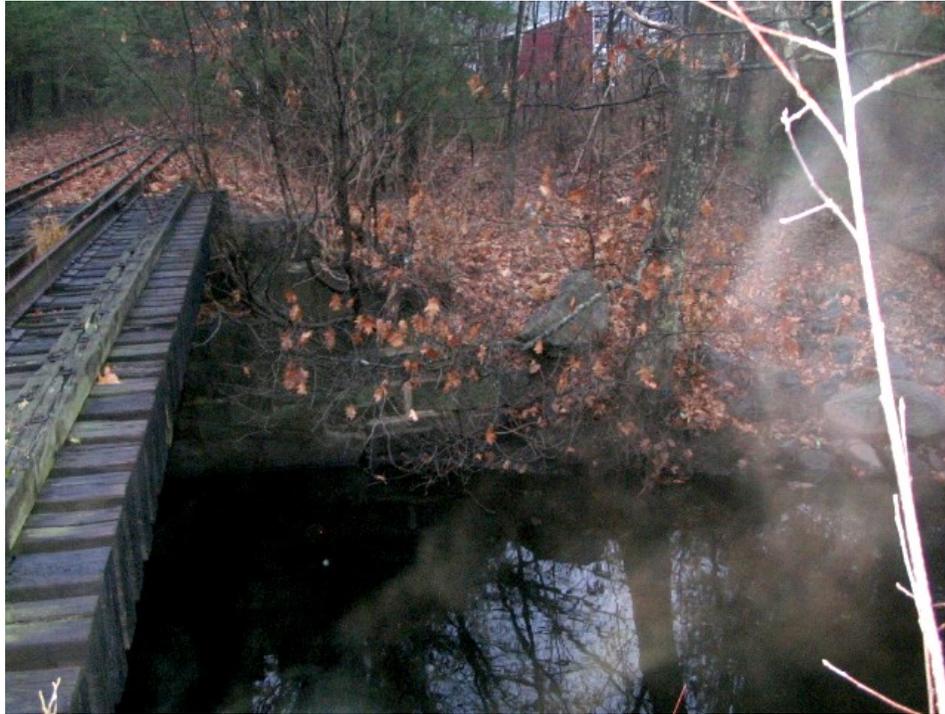
Typical Abutment

The Granite substructure is in good condition with some gaps in joints and missing/moved blocks in the adjacent retaining walls.

Abutments and retaining walls are not affected by scour.

Replace/reset missing granite blocks.

Grout joints between granite blocks.

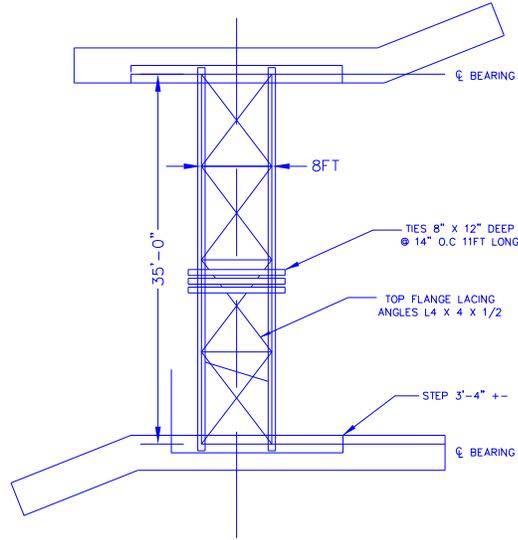
PLAN (N.T.S)

The bridge span is 35'-0" and is supported on abutments constructed from large granite blocks. The depth of the beam members vary as cover plates of varying lengths are used along the beams. The depth ranges from 40" adjacent to the bearings to 43" at the center of the span.

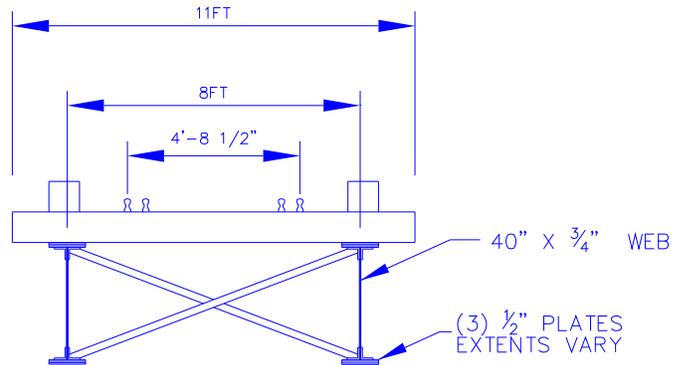
CROSS SECTION (N.T.S)

NOTE NO COVER PLATES TO ANGLES AT ENDS OF BEAMS

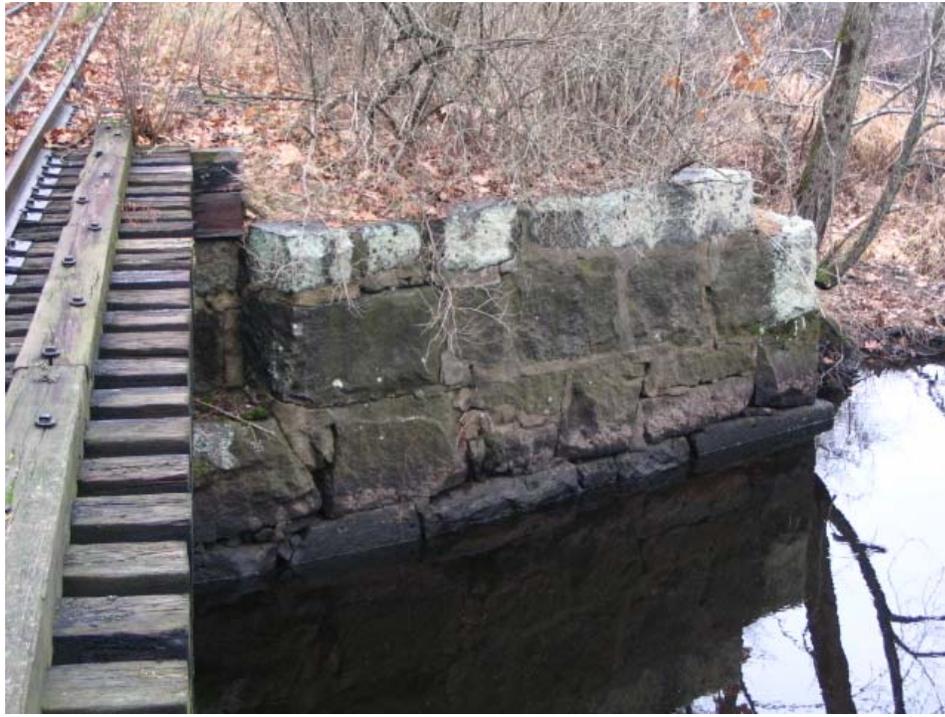
Typical Abutment

The Granite substructure is in good condition with some gaps in joints and missing/moved blocks in the adjacent retaining walls. Abutments and retaining walls are not affected by scour.

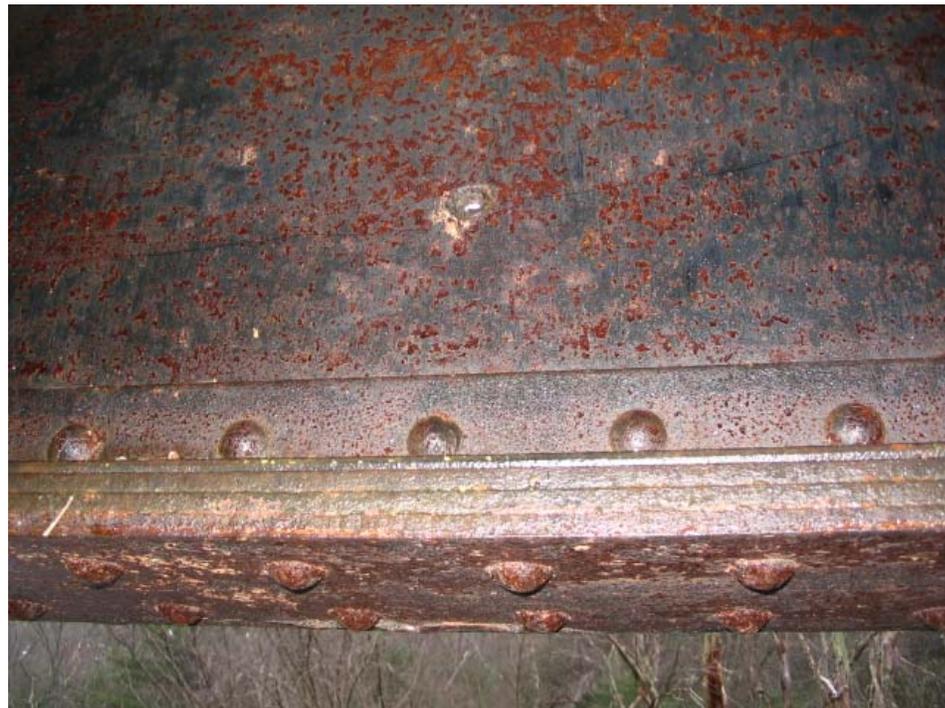
Damage on the Beam Web

The Steel Superstructure is in good condition with no significant section loss. Almost all the original paint has been lost. Timber rail ties on top of the bridge are in poor condition. A small hole exists in the web of one of the supporting beams. The hole is small and will have a negligible effect on the structural capacity.

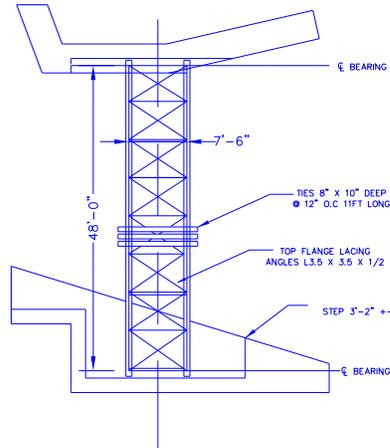
PLAN (N.T.S)

The bridge span is 48'-0" and is supported on abutments constructed from large granite blocks. The depth of the beam members vary as cover plates of varying lengths are used along the beams. The depth ranges from 48" adjacent to the bearings to 51" at the center of the span.

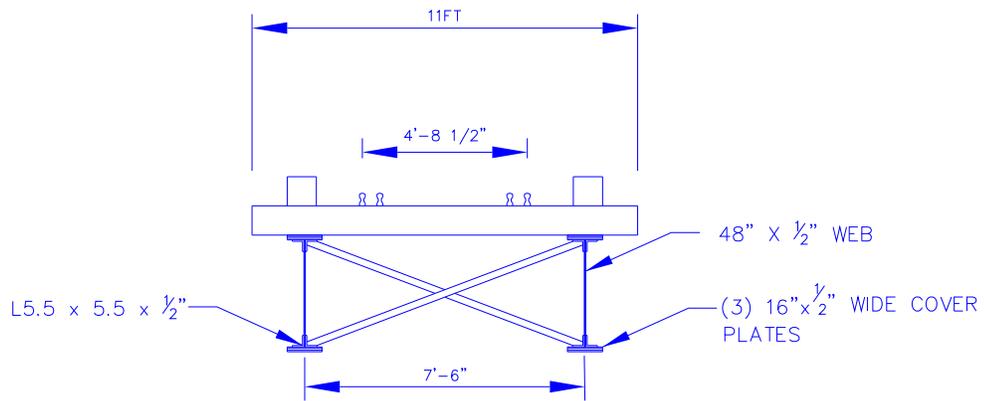
CROSS SECTION (N.T.S)

This structure currently carries a disused railroad over Nashoba Brook. The structure consists of plate girders built from steel plates, rolled angles and rivets. From a plaque affixed to the bridge structure the estimated date of construction is 1919.

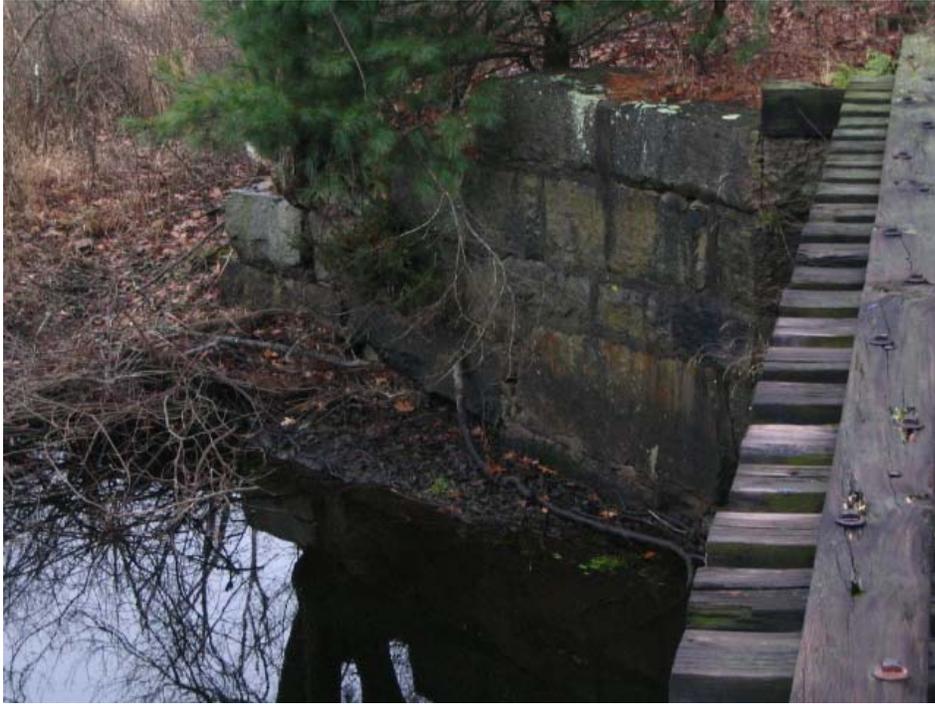
Typical Abutment

There is a significant build up of dirt and debris at beam seats/bearings which should be removed.

The Granite substructure is in good condition with some gaps in joints and missing/moved blocks in the adjacent retaining walls.

Abutments and retaining walls are not affected by scour.

Remove all debris and dirt from beam seats and replace bearings with deeper elastomeric bearings so as to ensure that beam ends are above debris and dirt that may accumulate again in the future.

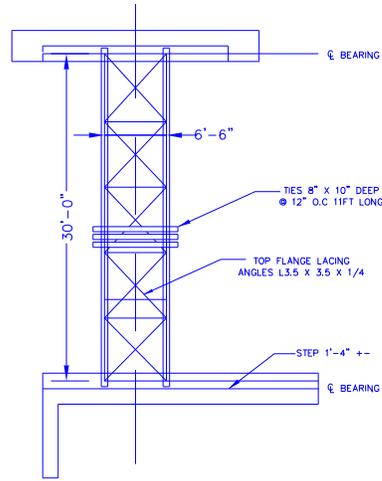
PLAN (N.T.S)

The bridge span is 30'-0" and is supported on abutments constructed from large granite blocks. The depth of the beam members is a constant 43 ¼".

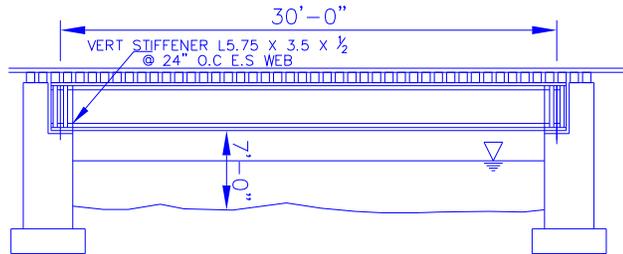
ELEVATION (N.T.S)

Lateral bracing is provided to the compression flange by means of inclined angles at fifth points along the span.

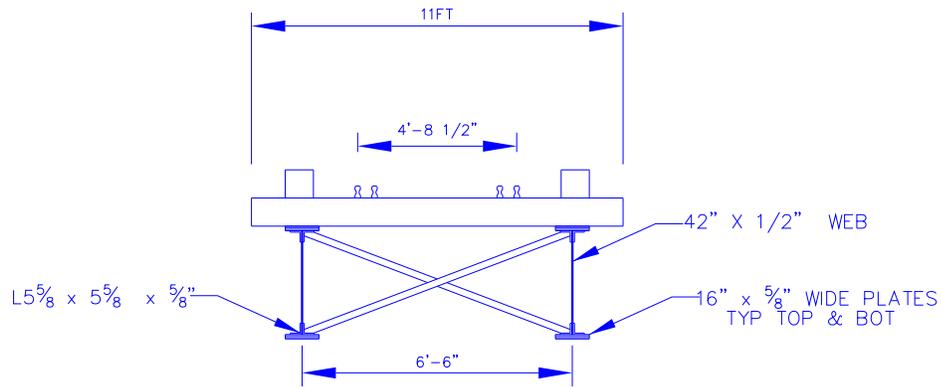
CROSS SECTION (N.T.S)

This structure currently carries a disused railroad over Nashoba Brook. The structure consists of plate girders built from steel plates, rolled angles and rivets. From plaques affixed to nearby bridge structures the estimated date of construction is 1919.

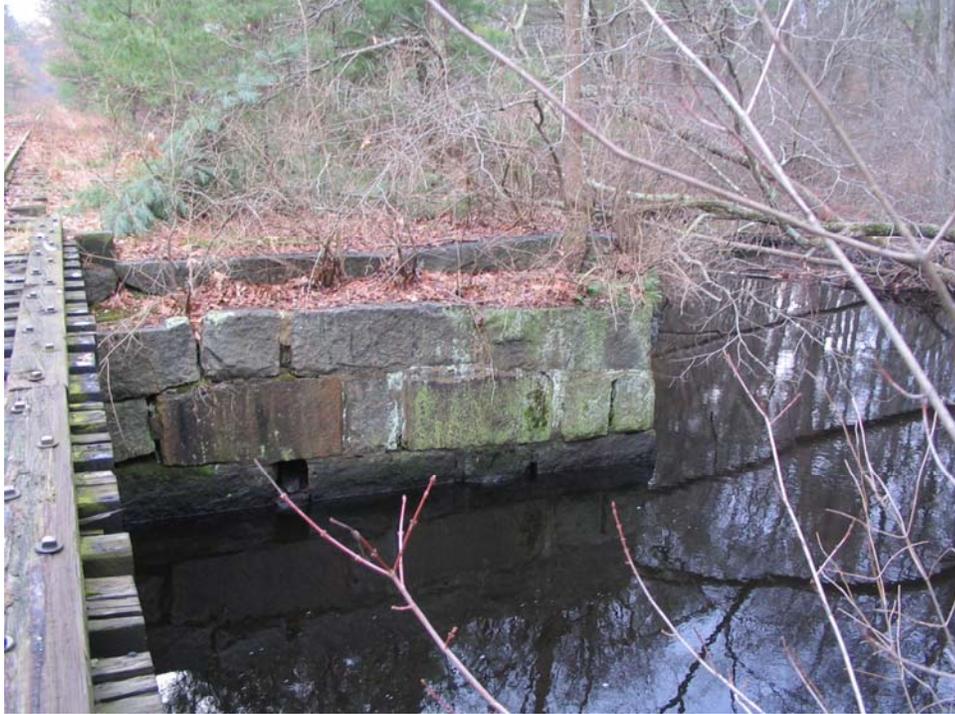
Typical Abutment

The Granite substructure is in good condition with some gaps in joints and missing/moved blocks in the adjacent retaining walls.

Abutments and retaining walls are not affected by scour.

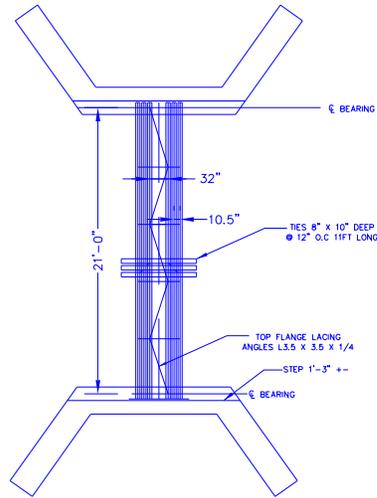
PLAN (N.T.S)

The bridge span is 21'-0" and is supported on abutments constructed from large granite blocks. The depth of the beam members is a constant 25".

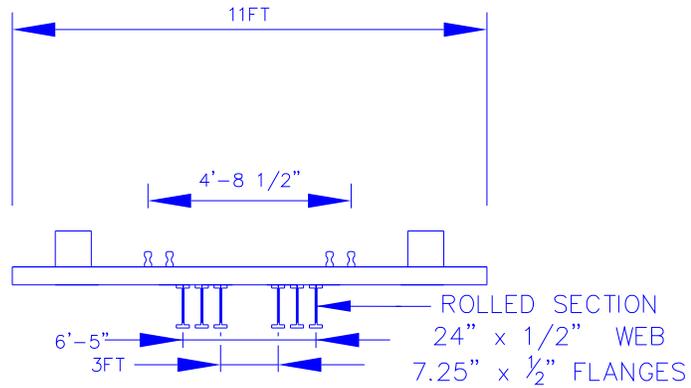
CROSS SECTION (N.T.S)

This structure currently carries a disused railroad over Butter Brook. The structure consists of six rolled beams. From plaques affixed to the bridge structure the estimated date of construction is 1907.

Lateral bracing is provided to the compression flange of the interior beams by means of inclined angles at fifth points along the span. Steel plates run perpendicular between the three beams to provide lateral bracing to the exterior beams.

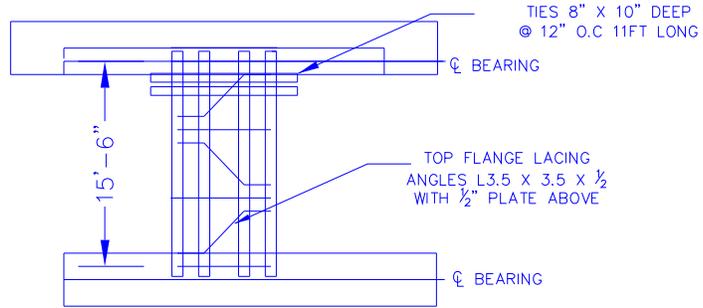
PLAN (N.T.S)

The bridge span is 15'-6" and is supported on abutments constructed from large granite blocks. The depth of the beam members is a constant 21".

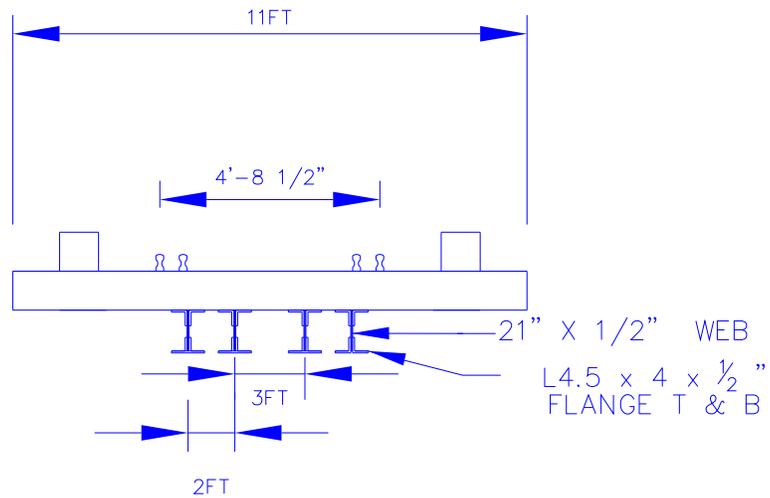
CROSS SECTION (N.T.S)

This structure currently carries a disused railroad over Butter Brook. The structure consists of four plate girders built from steel plates, rolled angles and rivets. From plaques affixed to nearby bridge structures the estimated date of construction is 1907.
