RE: Roosevelt Drive, Acton
Drainage Issue at 2 Jackson Drive, Acton, MA 01720

Memorandum

Subject: Update to Roosevelt Drive and temporary BMPs needed during construction

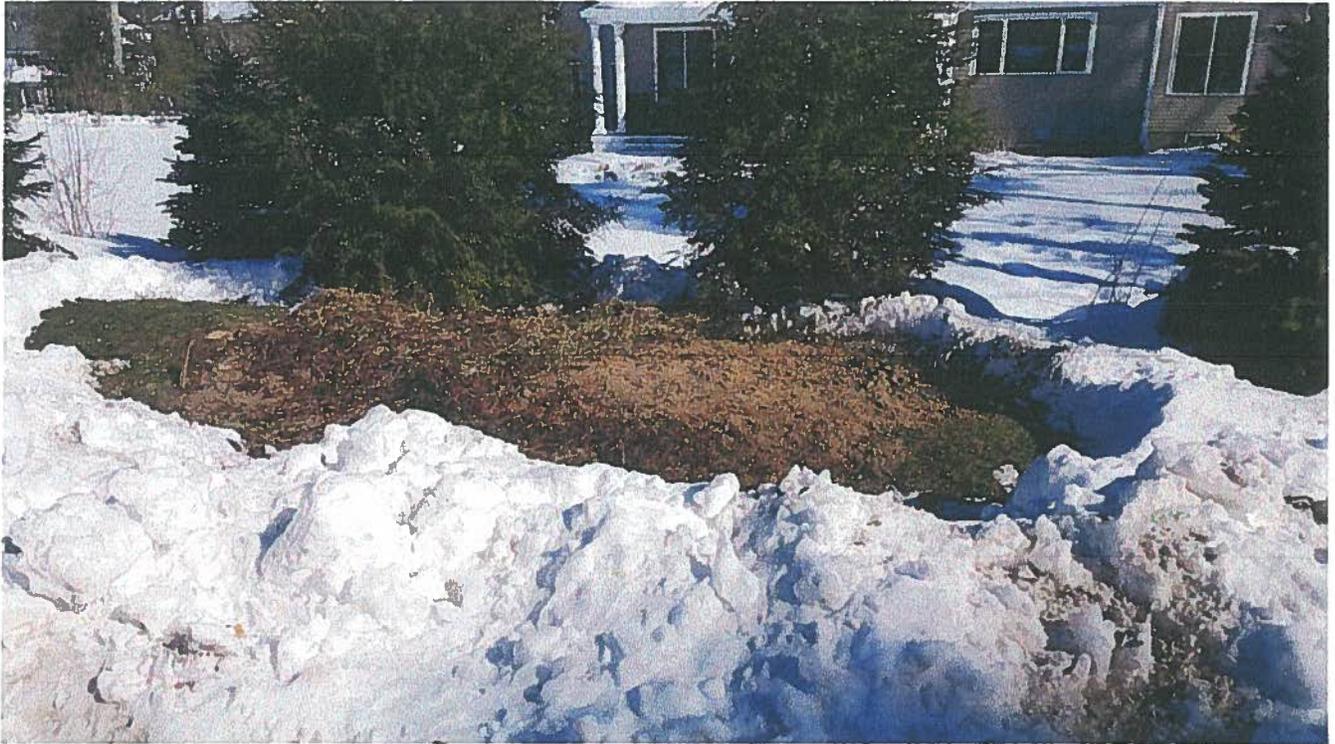
Earthen berm at previous overflow.

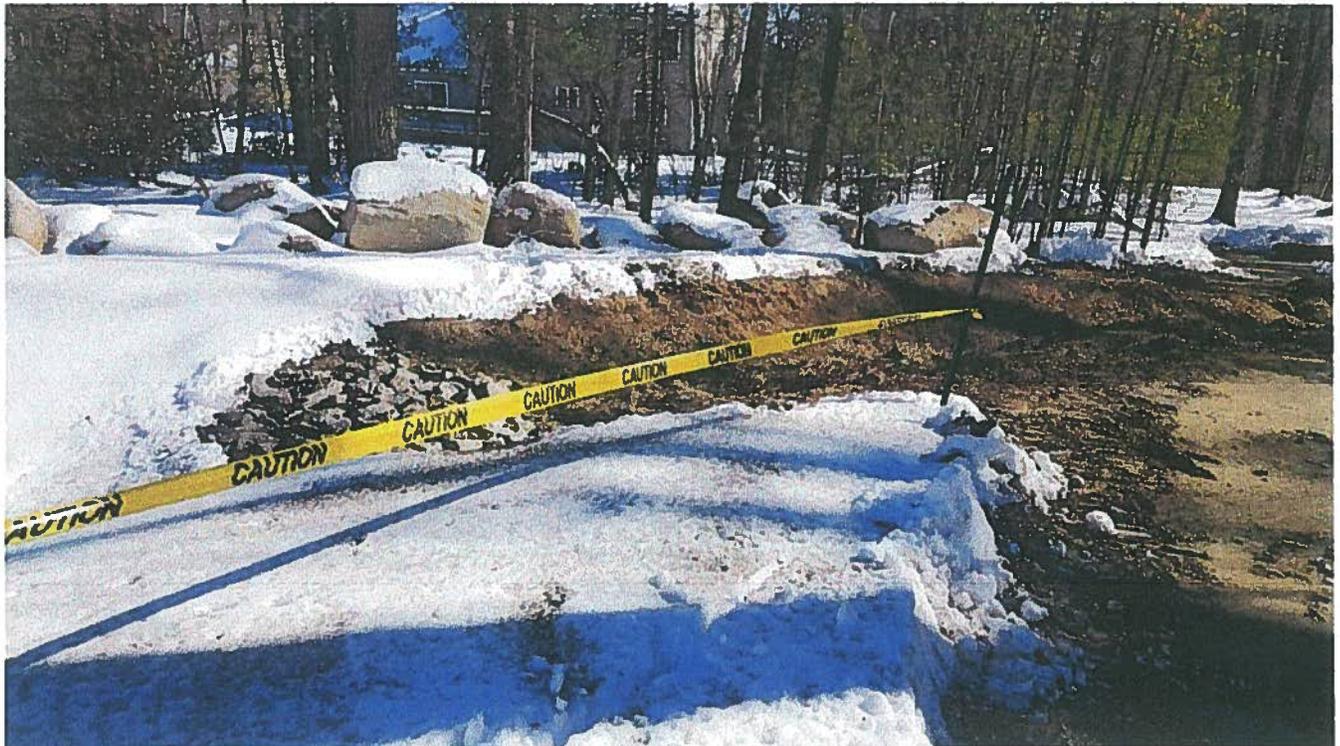
Temporary overflow and swale

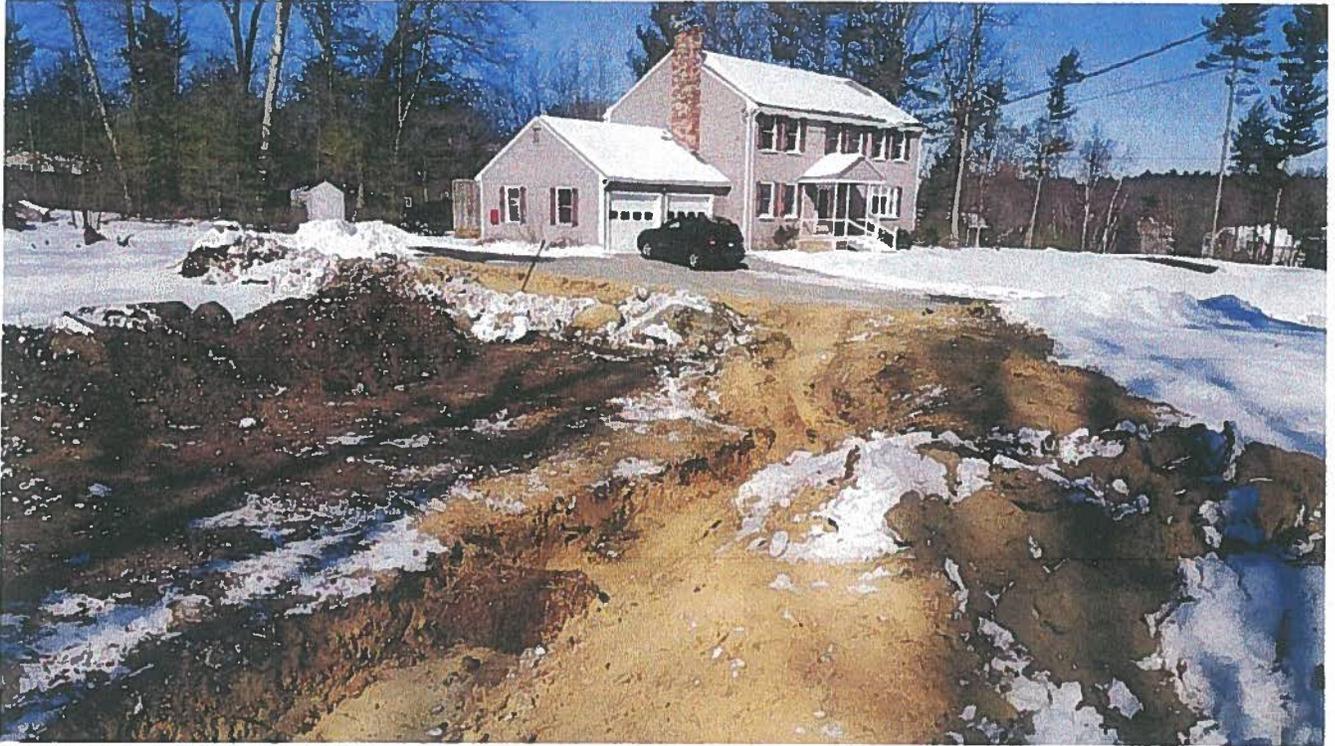
Trench and berm 1

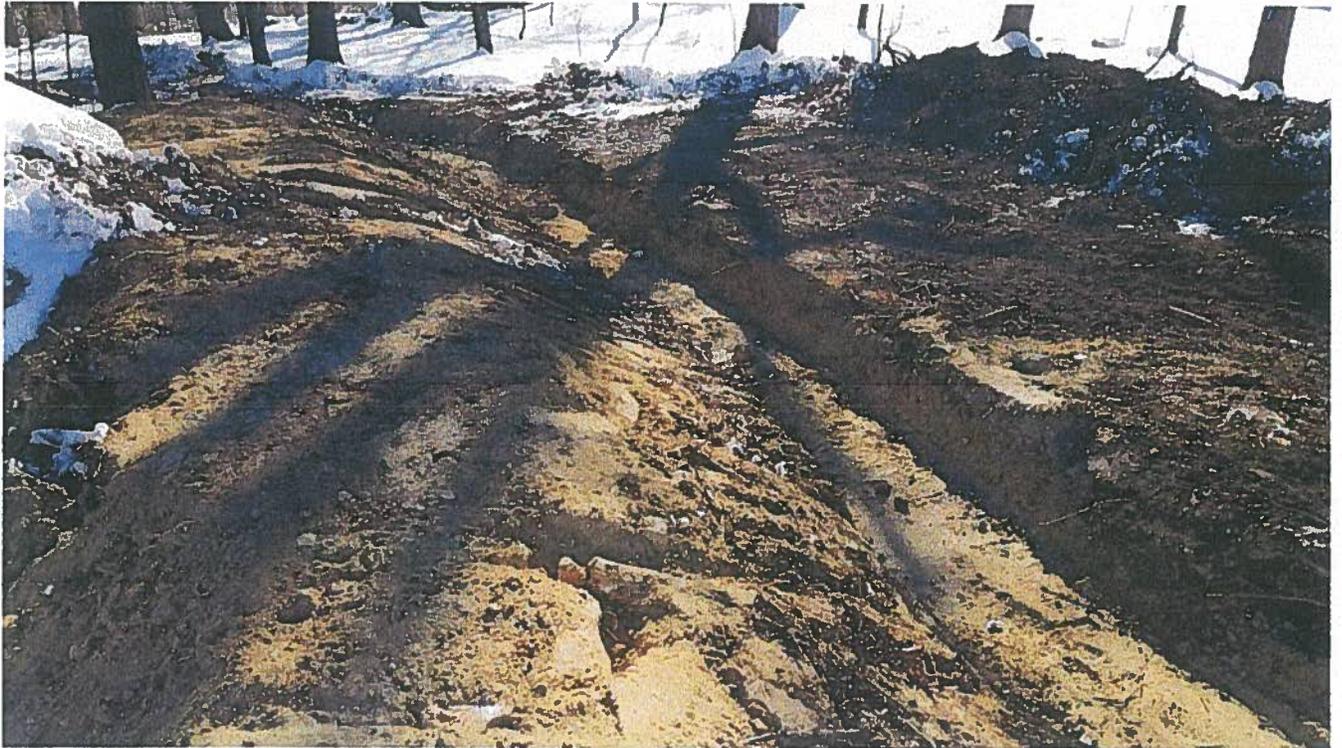
Trench and berm 2

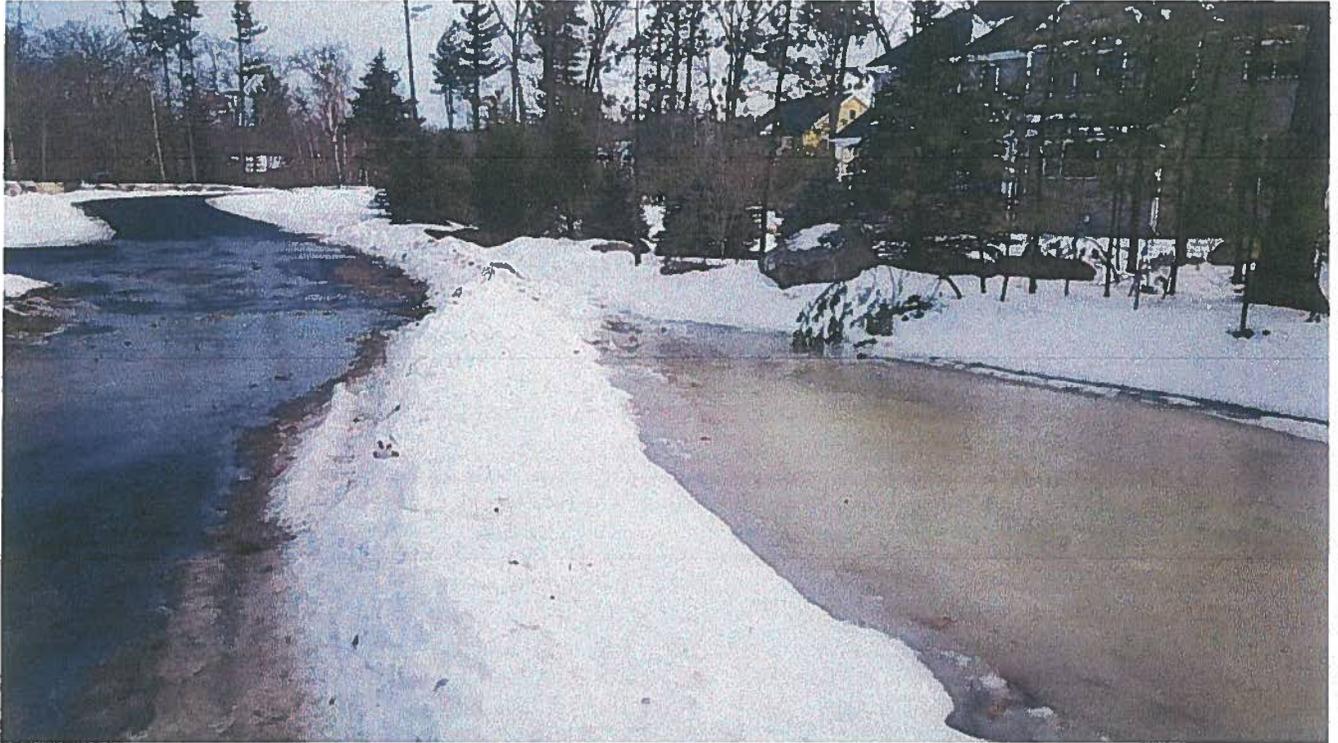
Modified basin after 2/16/16 rain and melt

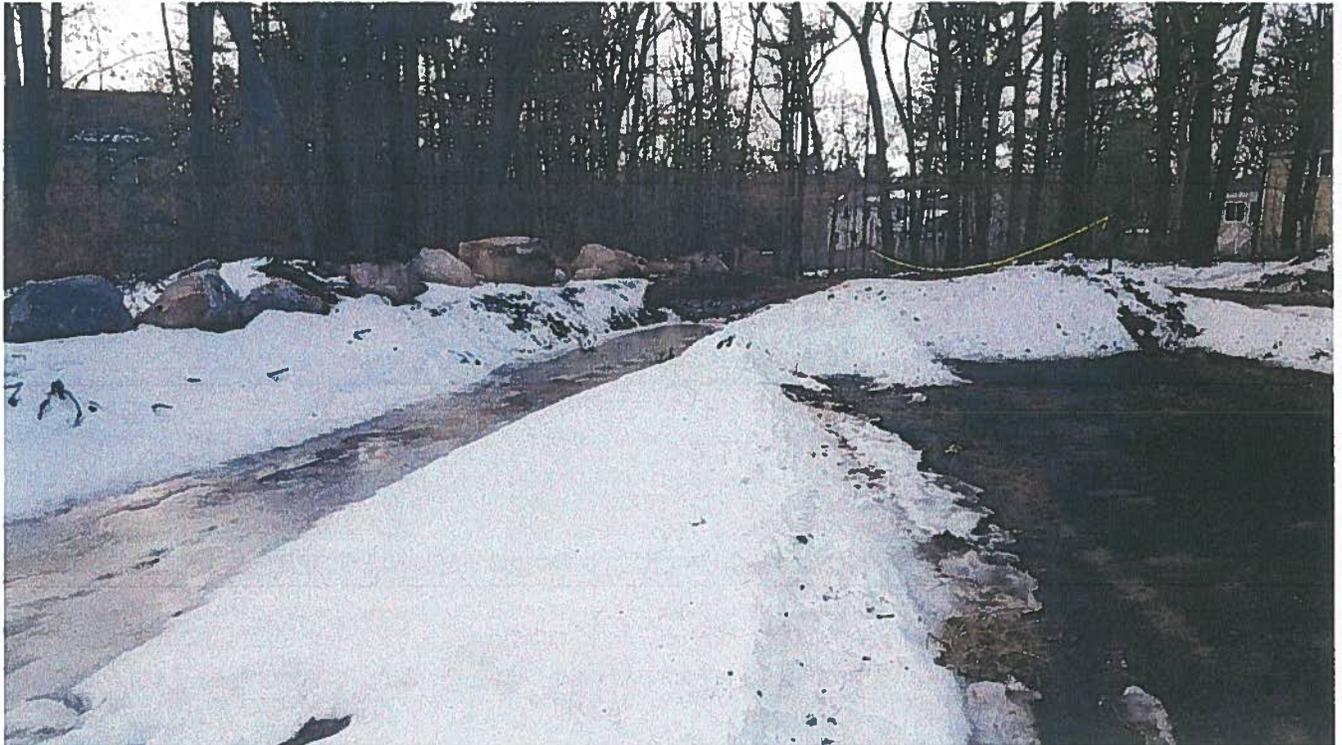
Modified basin after 2/16/16 rain and melt.
