# Conditions Assessment & Schematic Design Report

## The Asa Parlin House Acton, Massachusetts

October, 2012

menders, torrey & spencer, inc.

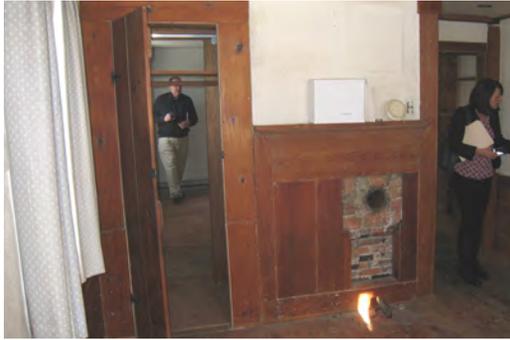
First floor. Center divider containing closet and built-over fireplace.

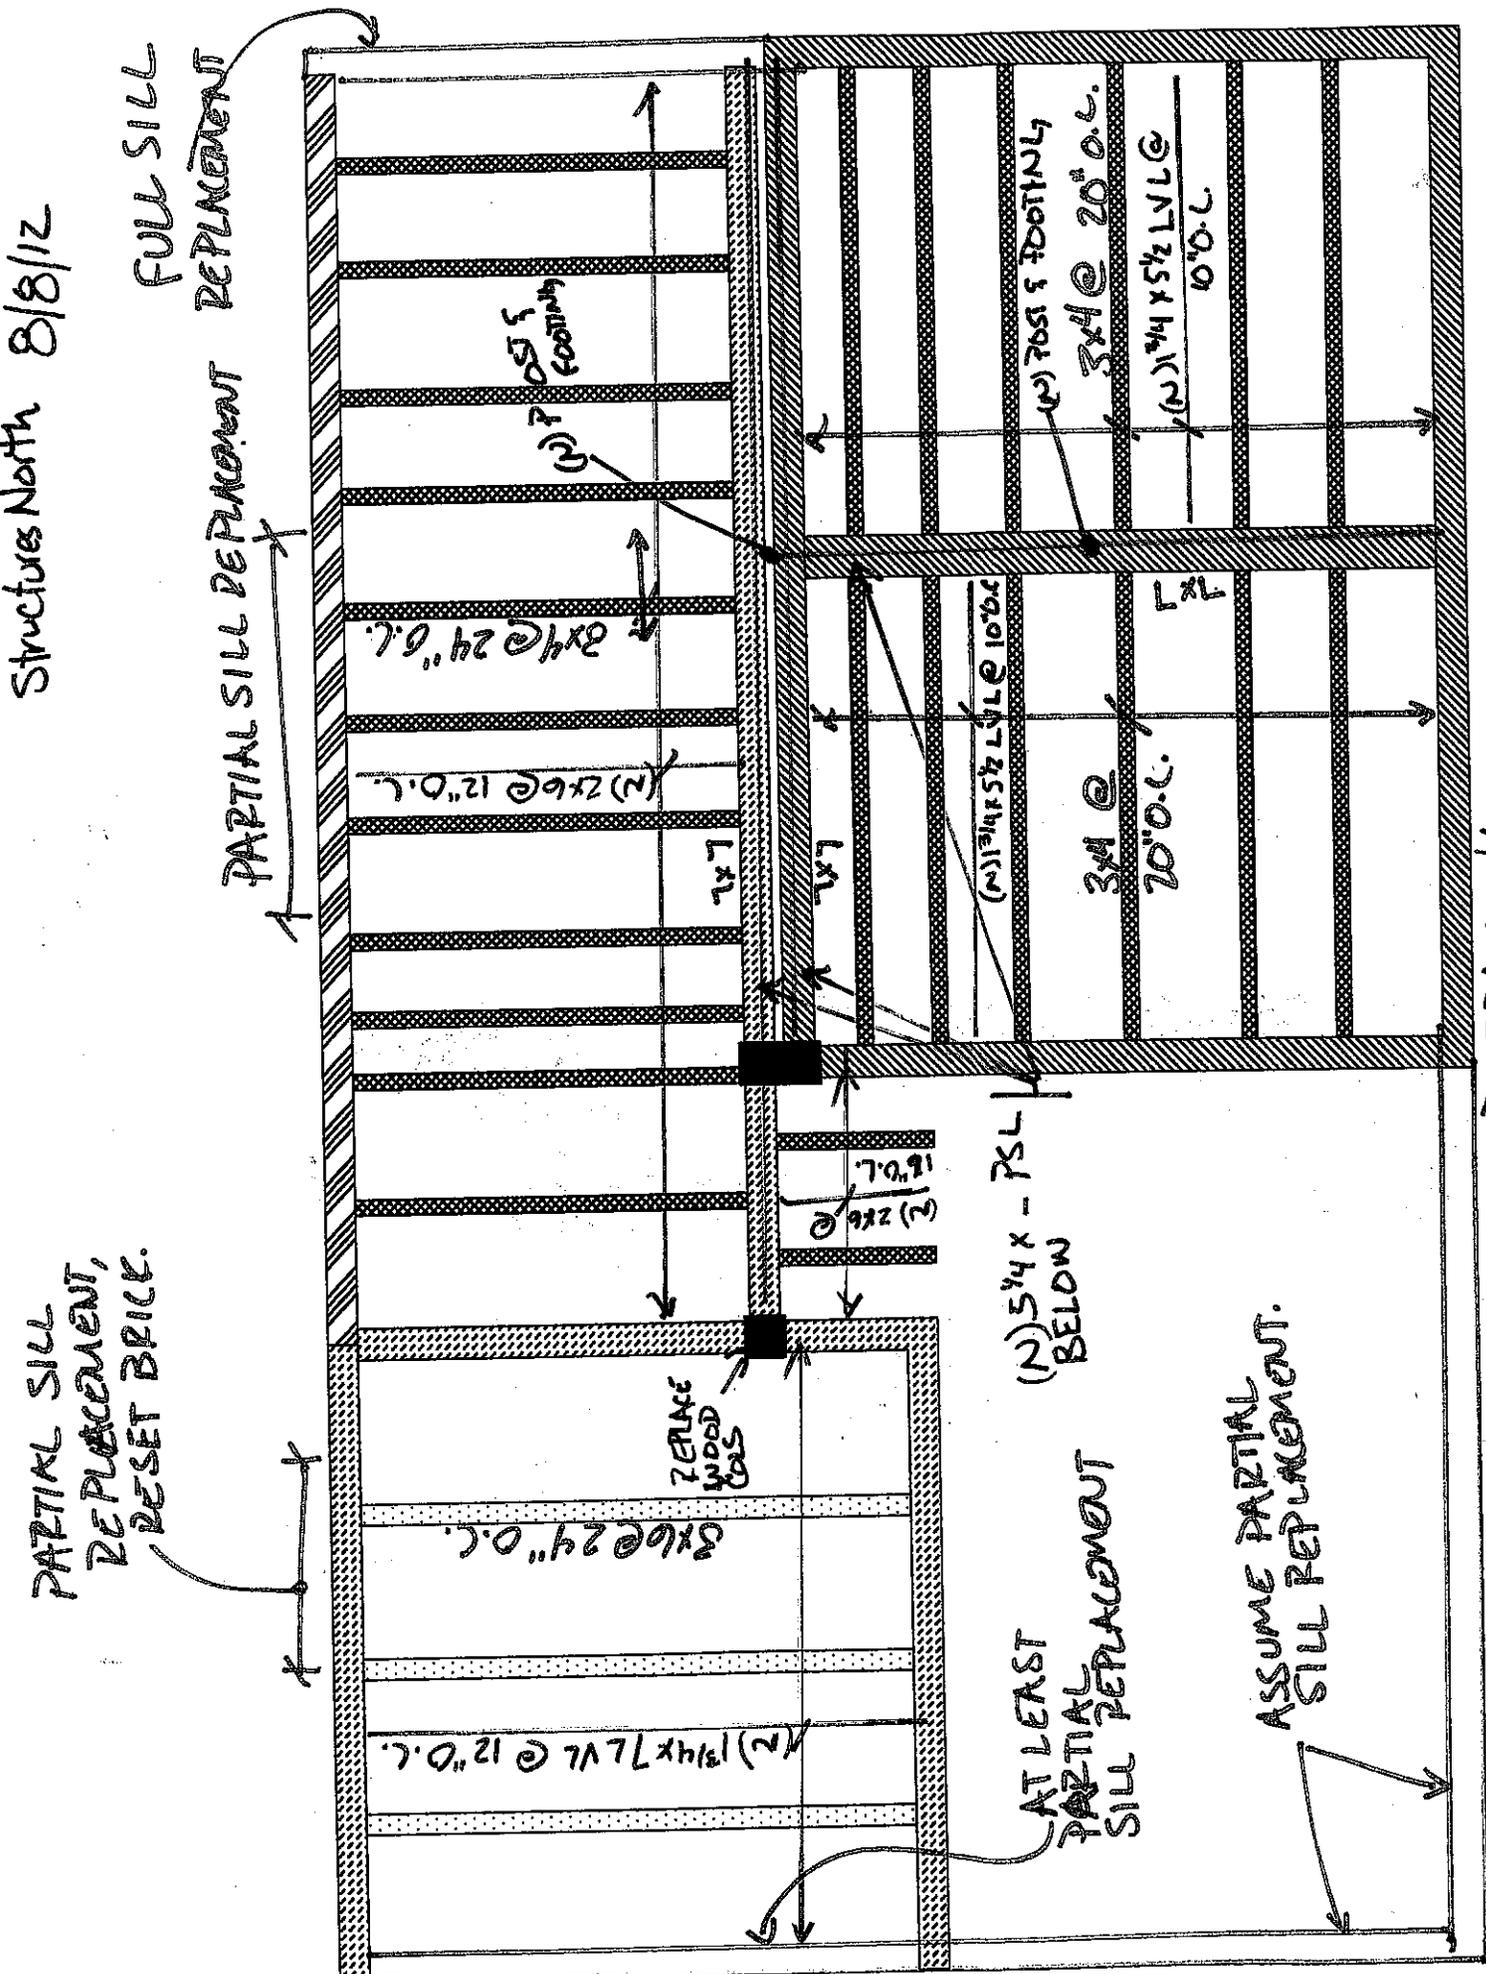
FIRST FLOOR FRAMING.

FULL SILL REPLACEMENT

PARTIAL SILL REPLACEMENT

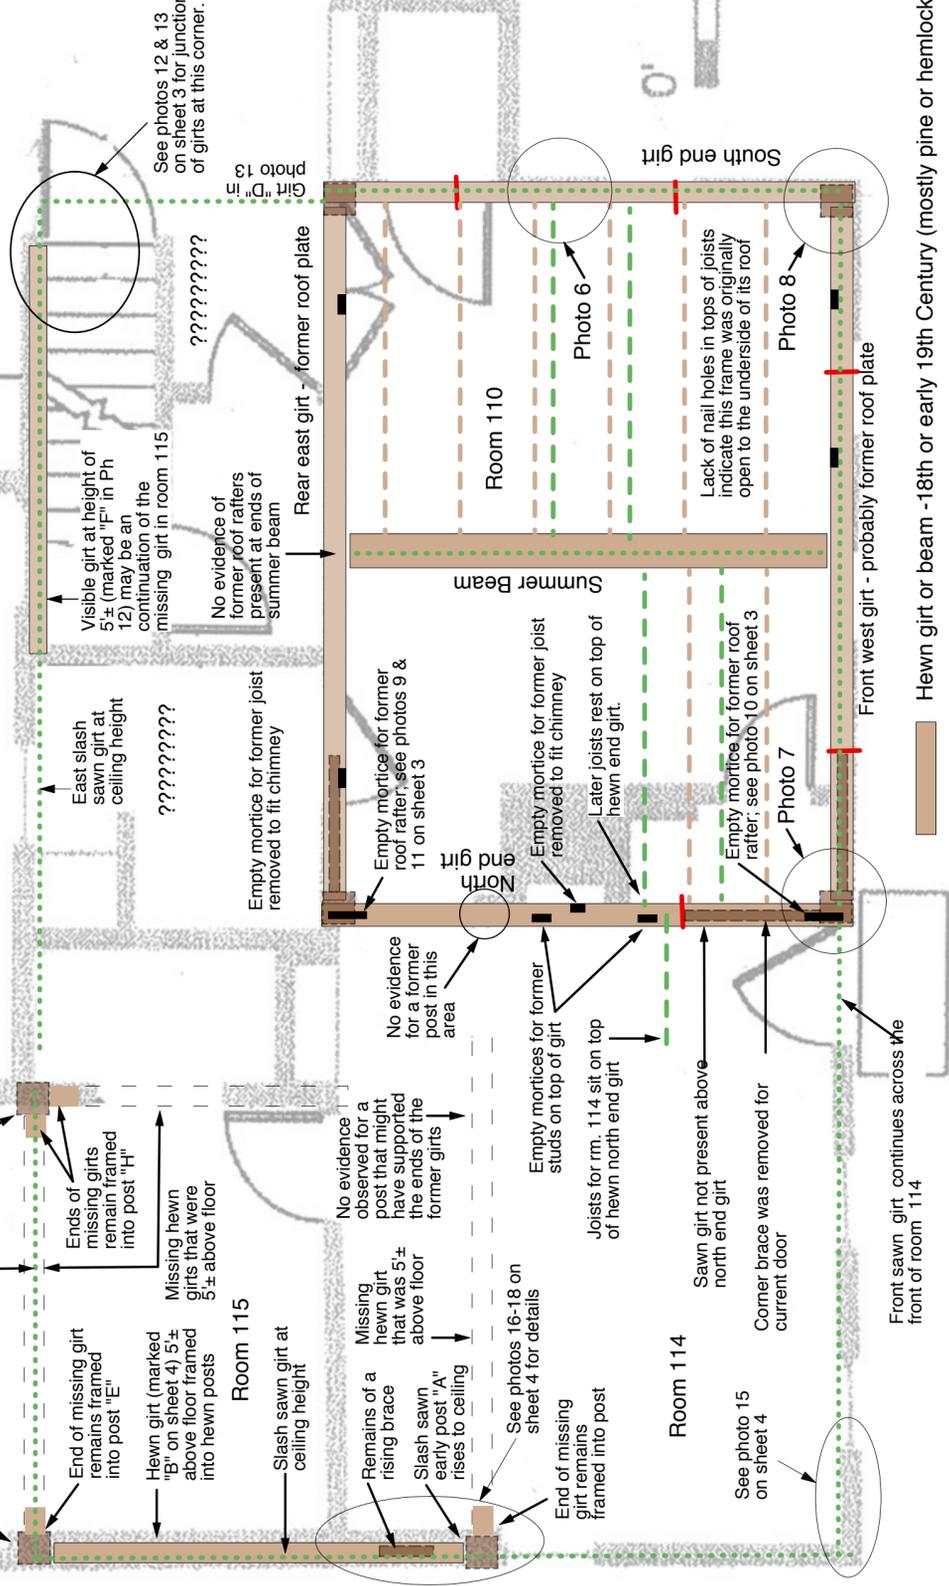
### ASA PARLIN HOUSE VISIBLE EARLY FIRST FLOOR FRAMING SHEET 2

NOTE: Circular sawn 5x5 girts and beams are set directly on top of the hewn frame front and south girts and summer beam and have their own joists to carry the second floor boards and rafters for the south pitch of the roof. These girts were probably installed when room 114 was added to the previous "L" shaped plan to create the current rectangular front block of the house in the second half of the 19th century.

NOTE: Positions of floor joists are approximate. Modern supplemental framing and framing that could not be seen is not shown.

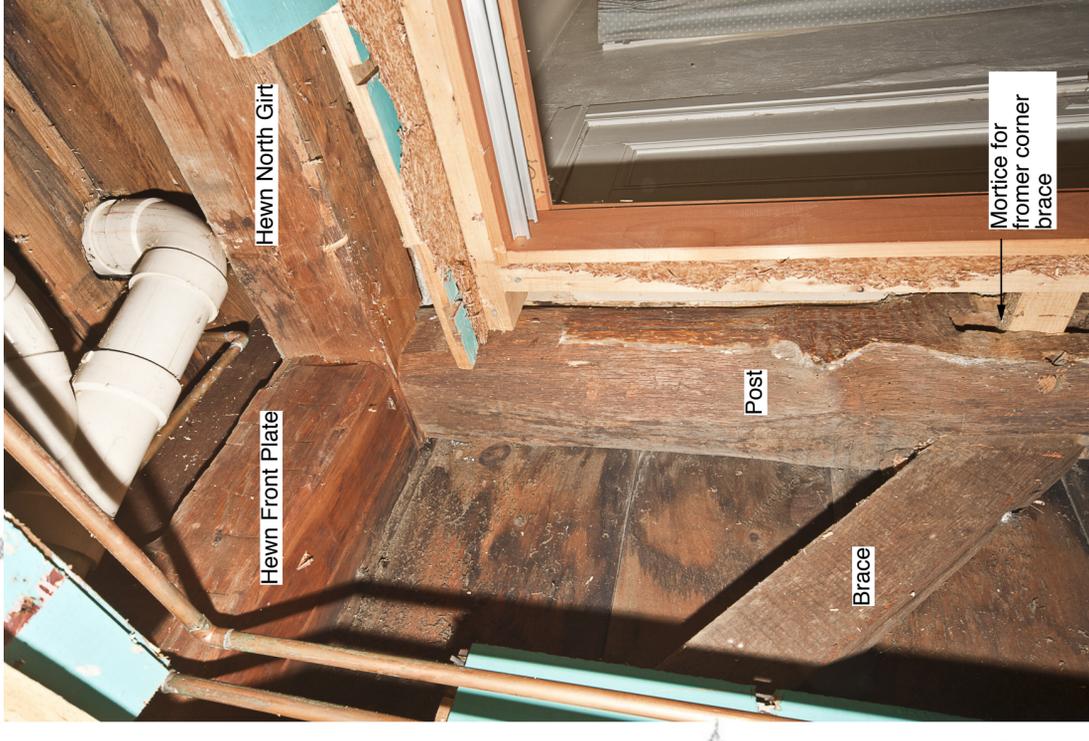
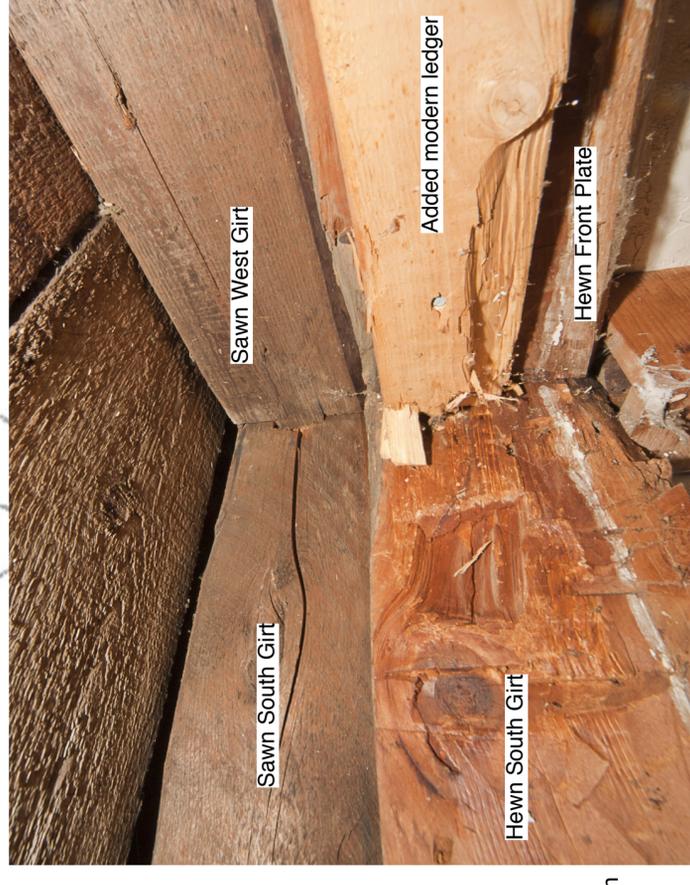
Photo 7: NW corner of hewn frame showing hewn oak post and slash sawn corner brace. Top of post is tenoned into the bottom of the south girt but does not have the shouldered haunch that would be normal for this joint in the 18th century (i.e., an English tie joint), suggesting it may date to the early 19th century. The front plate is tenoned into the north end girt, and the north girt has an empty mortise at its end to receive the tenon of a principal roof rafter. This indicates the hewn frame was once a one room, single story free standing structure. The existing lath and plaster on the walls is sawn lath of roughly uniform dimension and dates to the mid 19th century at the earliest. As there is no evidence of previous lath and plaster on the wall studs, the space defined by the hewn frame was likely originally unfinished and probably served some utilitarian function rather than being part of a dwelling.

Photo 8: Circular sawn girts set on top of hewn girts at SW corner of room 110. Hewn front plate is framed into the south girt.

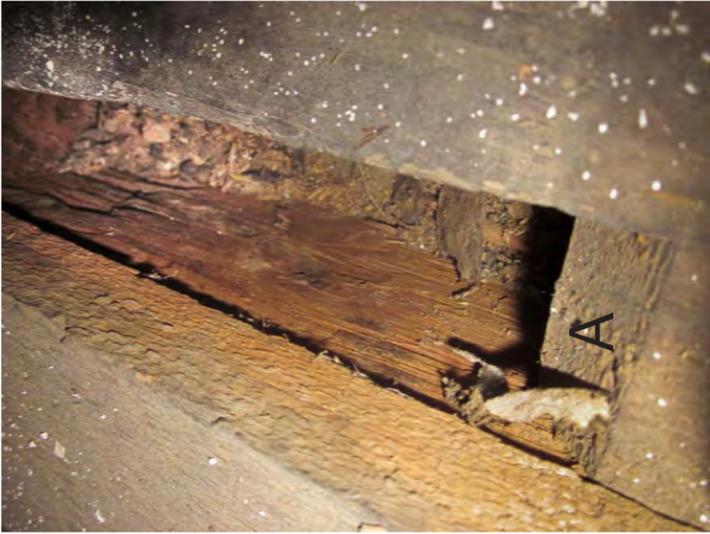
**Photo 9:** Mortise for former roof rafter in east end of north end girt. Slanted surface at "A" indicates the pitch of the roof rafter.

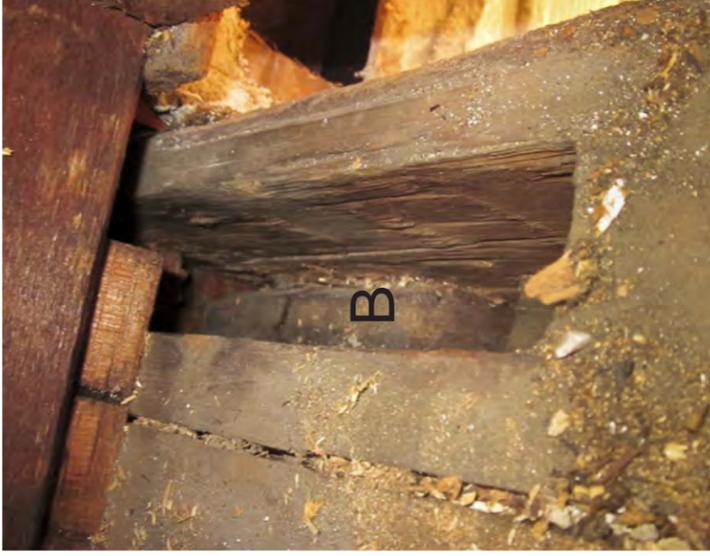
**Photo 10:** Mortise for former roof rafter in west end of north end girt. "B" indicates the top of the tenon of the corner post that is also housed in this mortise this mortise.

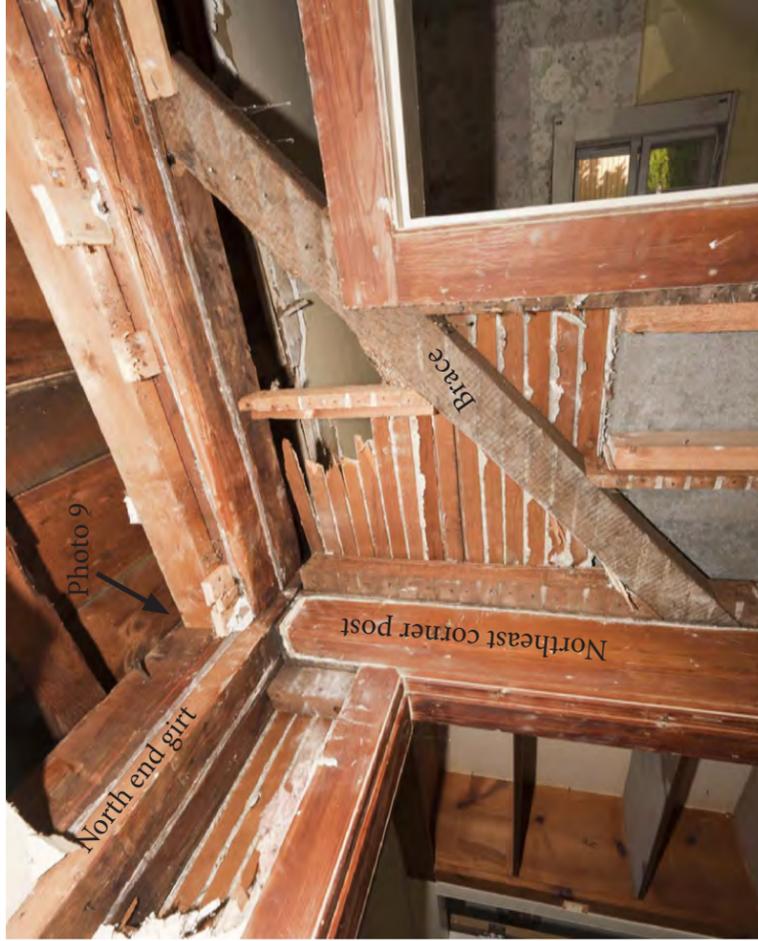
**Photo 11:** Northeast corner of room 110 with plaster removed to show the framing.

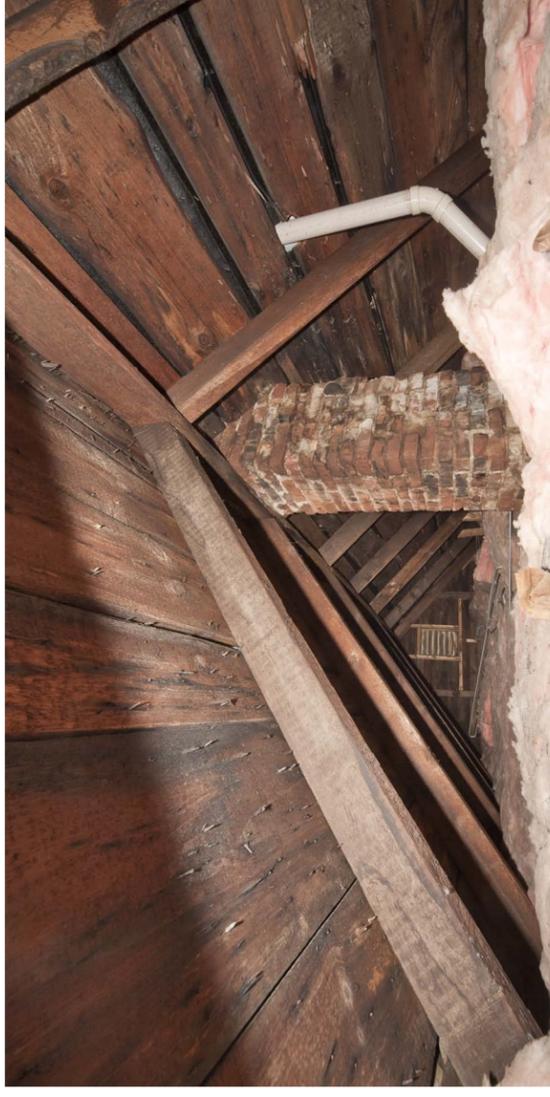
**Photo 14:** Overview roof framing. The rafters are clearly mid-19th century or later. The south (right) pitch uses mostly spaced boards with waney edges, while the north pitch (left) has tight boarding.

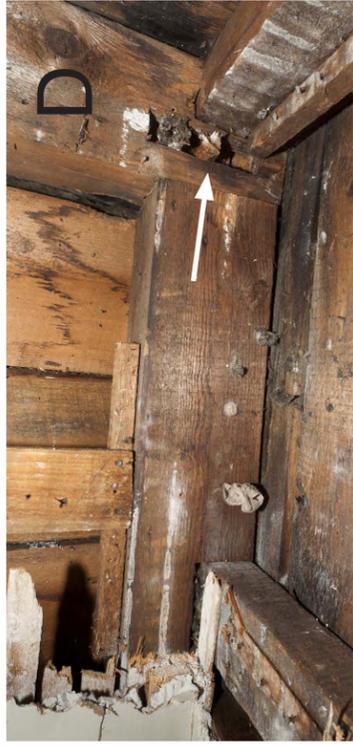
**Photo 15:** White arrow points to empty mortise in north girtd "D" from former corner post at the NE corner of rm 114. Whether this indicates an early alteration or that the girtd is reused is not clear.

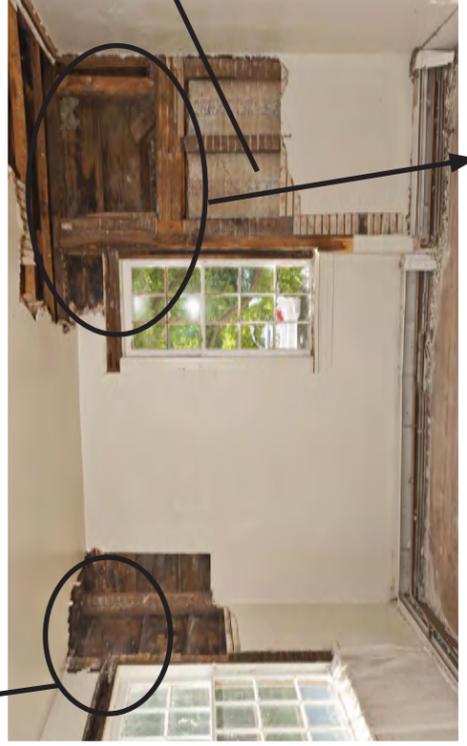
**Photo 19:** Looking west in room 115 towards room 114. Dashed line marks position of existing sawn girtd that is part of the mid-19th century frame (likely a continuation of "C" in photo 12).

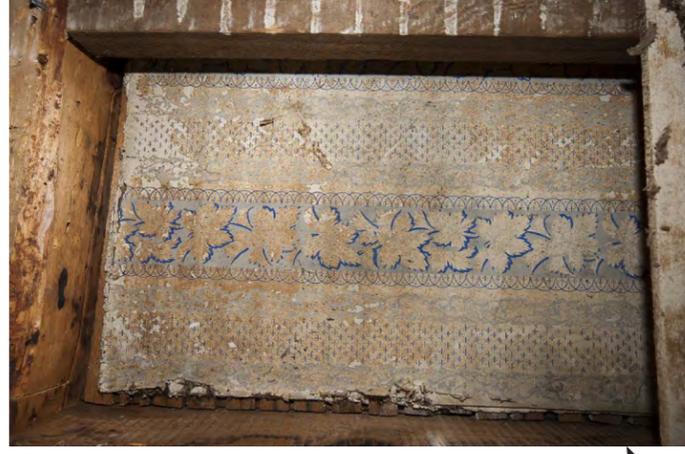
**Photo 16:** Detail of mid 19th century wallpaper. There is no evidence of this finish above horizontal girtd.

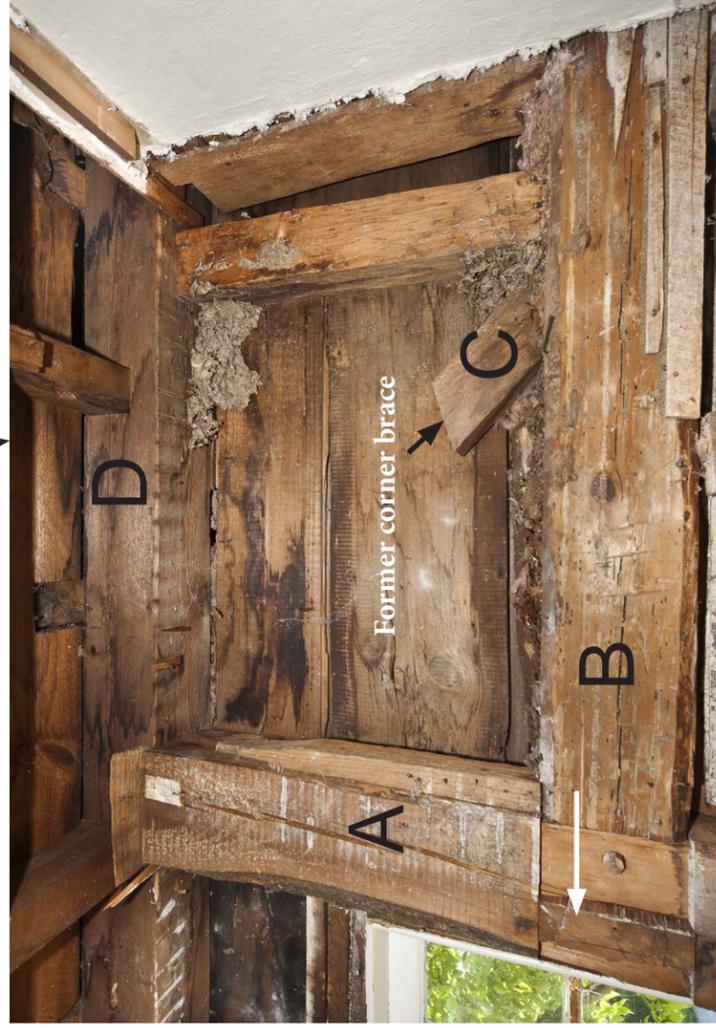
**Photo 18:** Detail of north wall in rm 114. "A" marks the upper section of the slash sawn post that rises to the full height of the room. "B" marks the hewn horizontal girtd framed into "A" at about the 5' level that extends into rm 115 where its end is framed into the top of post "E". "D" is the slash sawn north girtd that is part of the frame added to receive the current roof members A, B, and C are earlier than D and may have framed an earlier leanto structure, as posts E and H in photos 20 and 21 originally rose only to the height of girtd B. White arrow points to the tenon of a former north/south girtd.

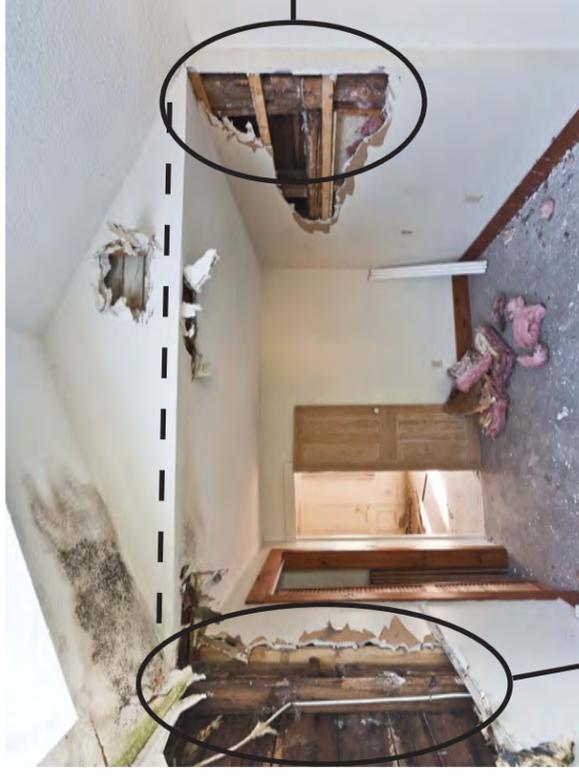
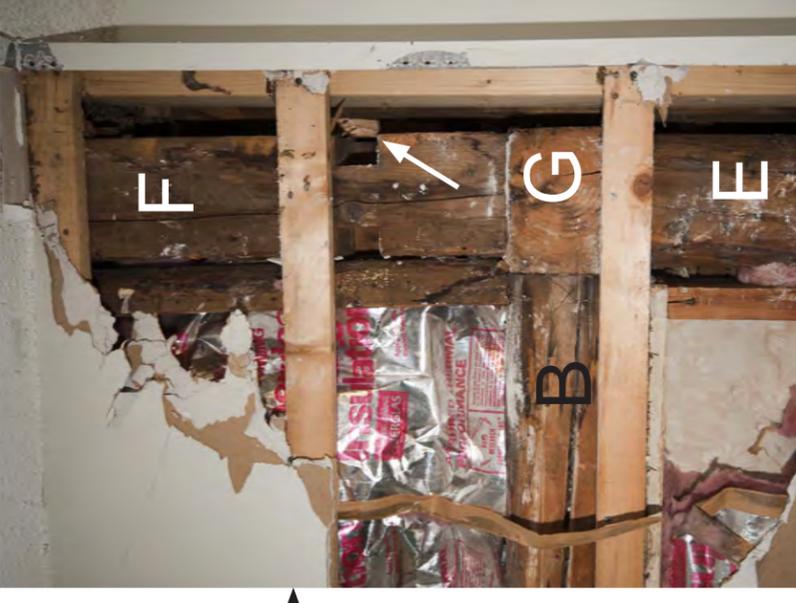
**Photo 21:** "E" is an early hewn post that ends at its joint with girts "B" and "G". "B" is the east end of the girtd marked "B" in photo 18. "G" is the end of a former girtd that spanned across to post "H". "I" is a reused timber that was added to extend post "E" up to the current roof frame. The white arrow points to mortise from its previous use.

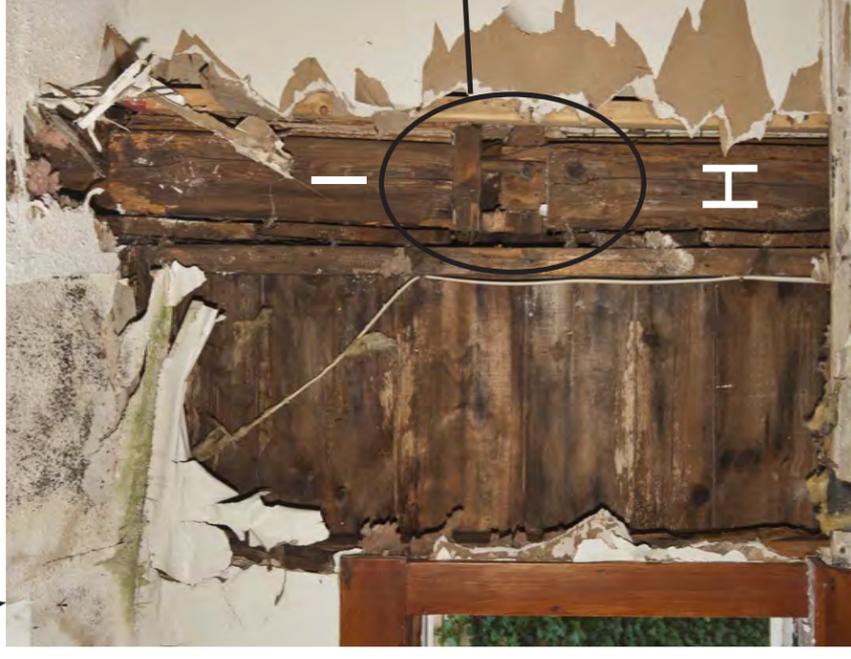
**Photo 20:** Early hewn post "H" terminates at its junction with the former girts about 5' above the floor. The section "I" above the joint with the girts is a reused piece to bring the post up to support the later sawn girts at the base of the current roof.

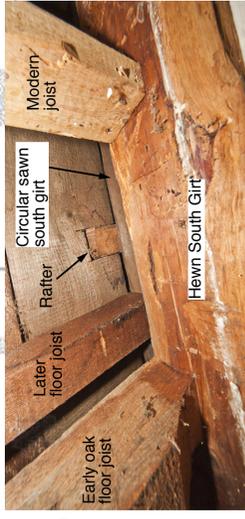
Photo 3: Detail of south end girt showing two layers of floor joists with the later joist framed into the circular sawn girt to carry the current second floor boards.

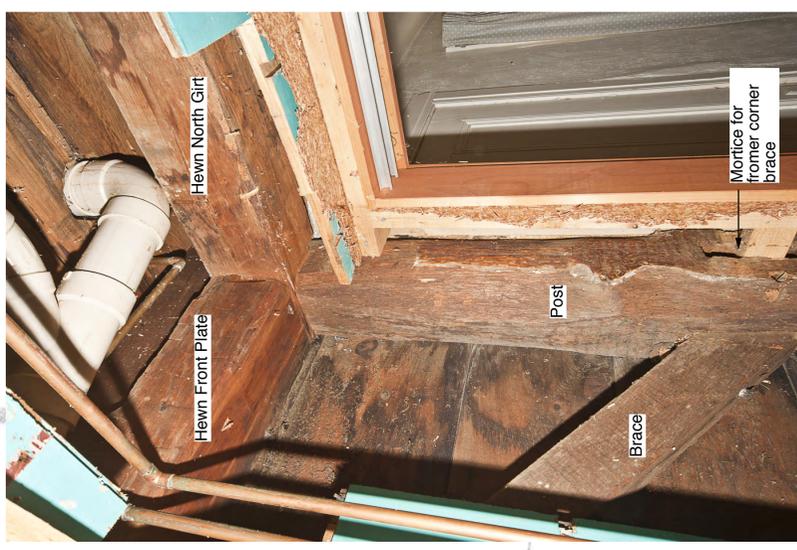
Photo 1: NW corner of hewn frame showing hewn oak post and slash sawn corner brace. Top of post is tenoned into the bottom of the south girt but does not have the shouldered haunch that would be normal for this joint in the 18th century (i.e., an English tie joint), suggesting it may date to the early 19th century. The front plate is tenoned into the north end girt, suggesting that the north girt might have once received a principal rafter. If the hewn frame was once a one room free standing structure.

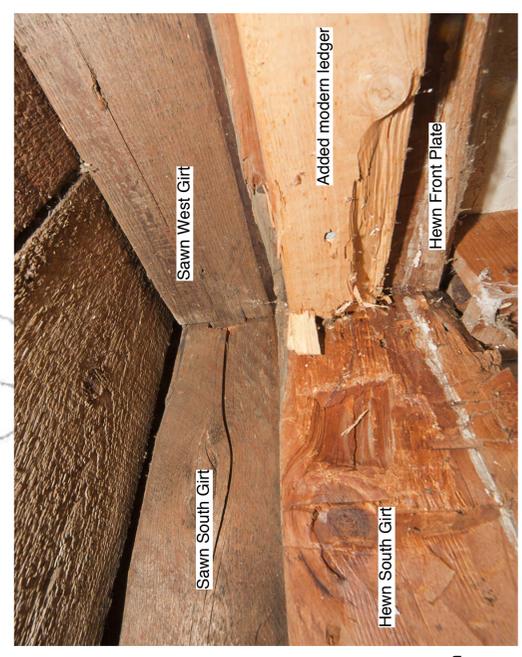
Photo 2: Circular sawn girts set on top of hewn girts at SW corner of room 110. Hewn front plate is framed into the south girt.

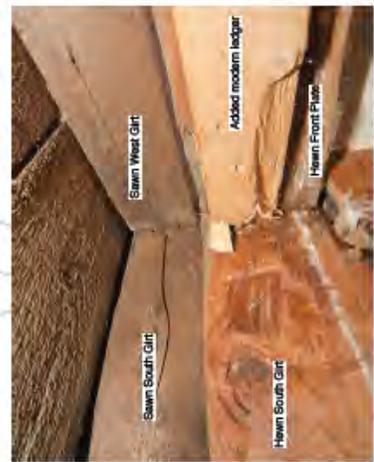
Photo 8: Circular sawn girt set on top of hemlock girt at SW corner of room 110. Hemlock girt is laminated into the south girt.

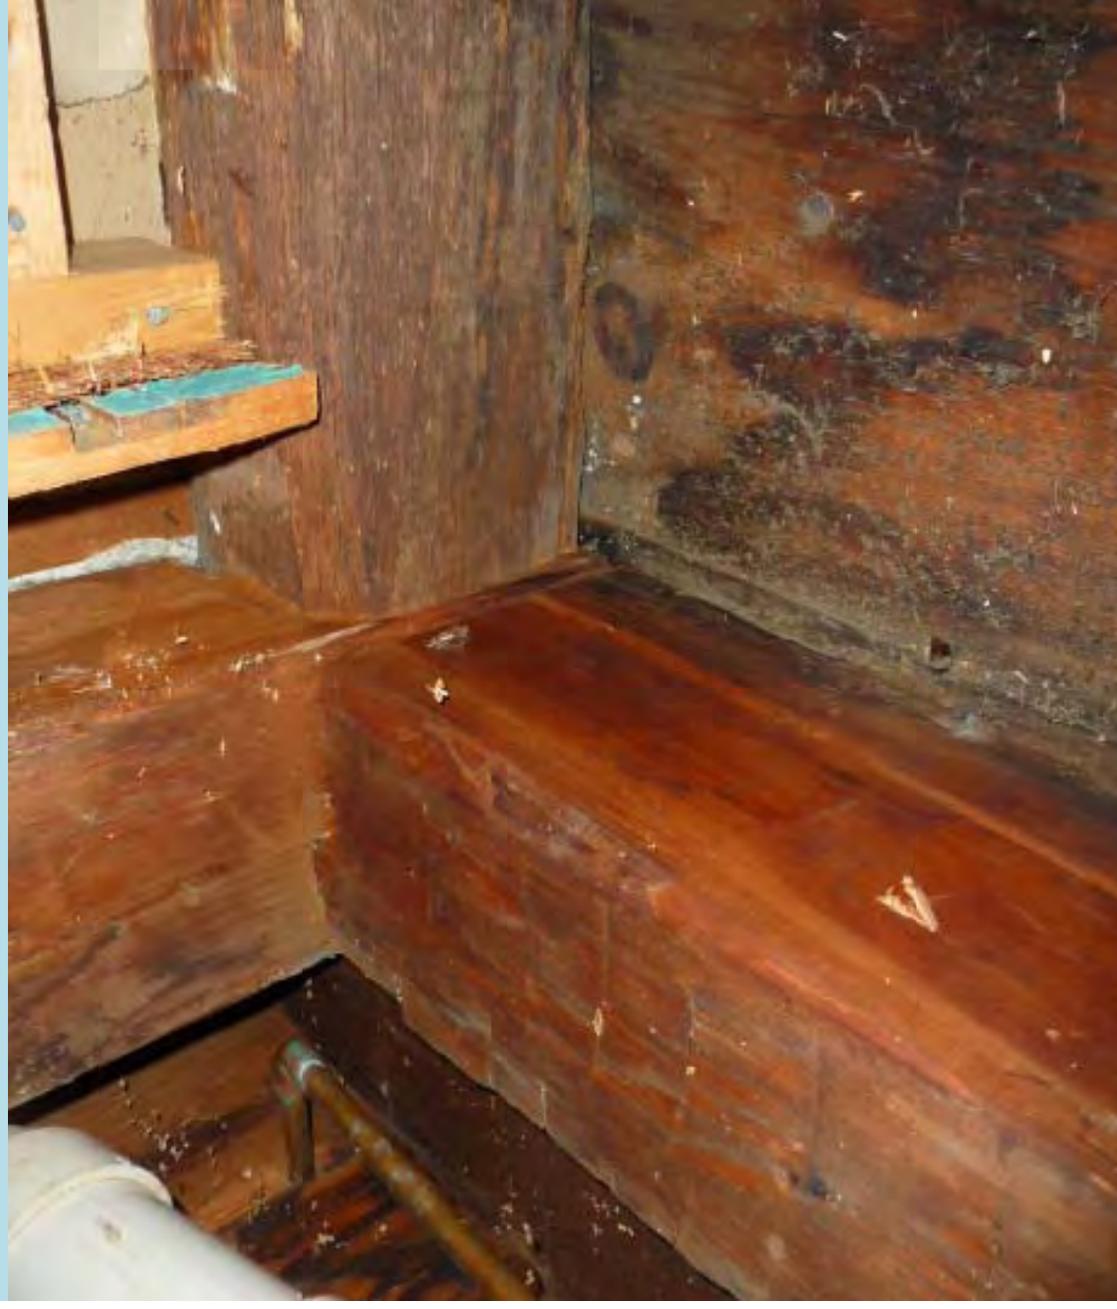
# Structural Conditions

- Core building is sound
- Limited structural reinforcement required (sills, etc.)
