# West Acton Baptist Church

## A. Architectural Report

June 21, 2013

## West Acton Baptist Church Building Condition Analysis

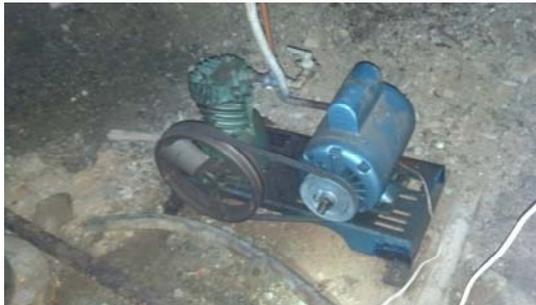
*Air compressor*

- Sprinkler piping is black steel with threaded joints. Piping is generally exposed throughout the building.
- Sprinklers are solder type, upright or vertical sidewall, heads and several show sign of corrosion.

- Due to the age of the system we would recommend full replacement. This would include new double check valve assembly on incoming service, new dry type alarm valve and air compressor.
- Due to the potential of corrosion inherent in dry sprinkler systems, we would recommend use of galvanized pipe and fitting for new systems.
- All new sprinkler heads should be quick response type in accordance with NFPA 13 standard.

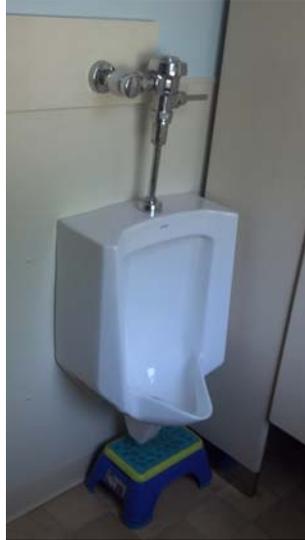
- The water closets are floor mounted vitreous china with flush tanks.
- Urinals are wall hung vitreous china with manually operated flush valves.
- Lavatories are wall hung vitreous china. Some lavatories have been retrofitted with metering sensor faucets. Other lavatories are fitted with hot and cold water handle faucets.
- Service sink and classroom sinks are wall mounted laundry basins. Sinks are fitted with hot and cold water deck mounted handle faucets
- Kitchen area fixtures are in fair condition. There is a pre-rinse sink and dishwasher, with both discharged to a grease interceptor. The dishwasher includes an electric booster heater (RUUD 9kW, 240 volt, 10 gallon booster heater).

*Wall hung urinal*

- Provide new high efficiency low flow plumbing fixtures throughout building.
- Due to age of existing piping, it is recommended to install new domestic water piping throughout the building.
- Provide new gas-fired high efficiency condensing water heater with thermostatic mixing valve and expansion tank.
- Provide proper backflow prevention at Janitor's cleaning solution systems.

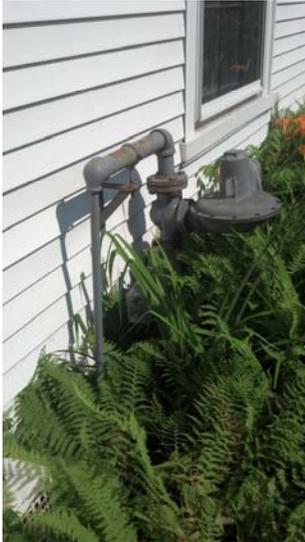
- The building is serviced by natural gas. The gas meter is located on the exterior, on the east side of the building. The gas service appears to be supplied from Central Street.
- Gas piping is black steel with threaded joints.
- Gas supplies the water heater and kitchen oven.

*Gas meter*

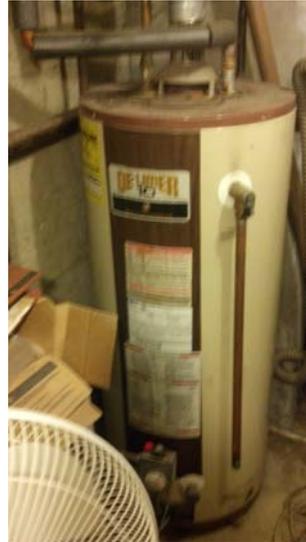
*Water heater*

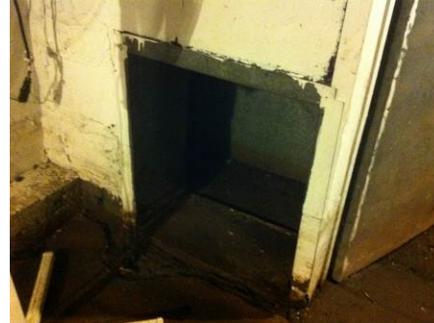
*Combustion Air Vent*

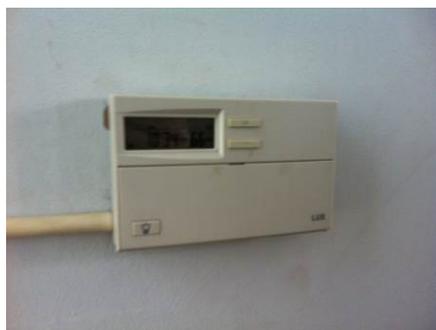
- The existing control system for each boiler is handled through the boiler manufacturer independent control panel. The boilers operate based on steam pressure and maintain 3 PSI within the system. Temperature control for individual rooms is handled through electronic wall-mounted thermostats which operate electronic control valves located on the supply side of each piece of fin tube radiation or cast iron radiator. These valves open/close based on space temperature and space set point. These settings are programmed into the thermostats and operate automatically. The majority of thermostats are of different manufacture and some appear antiquated as well as the control valves. Some of the control valves do not appear to be functioning properly due to their antiquated state.

*Typical Wall Mounted Thermostat*

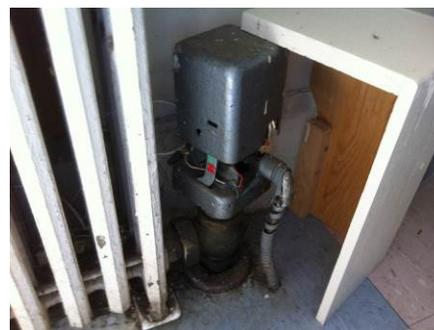
*Typical Control Valve*

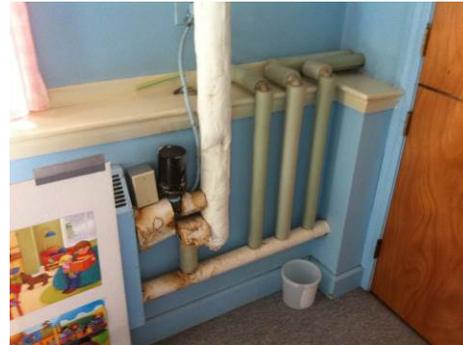
*Typical Exposed Soiled Insulation*

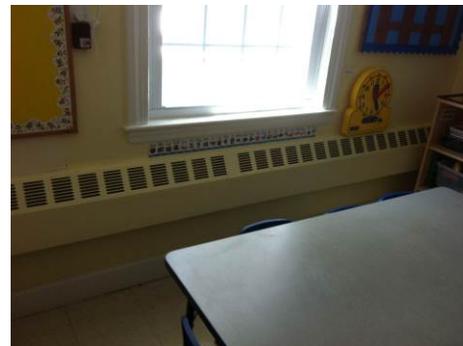
*Typical Fin Tube Radiation*

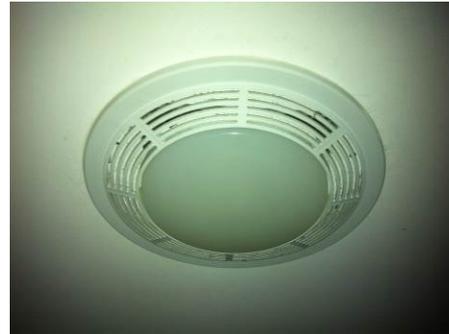
- Within the bathrooms, residential style ceiling exhaust fans are being utilized to provide ventilation. The fans are dirty which could affect its performance. The fans should be cleaned regularly to maintain proper air flow.

*Typical Bathroom Exhaust Fan*

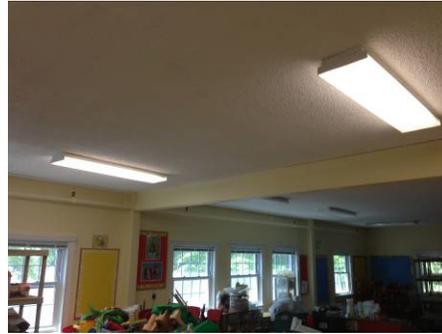
*Early Childhood Area Lighting*

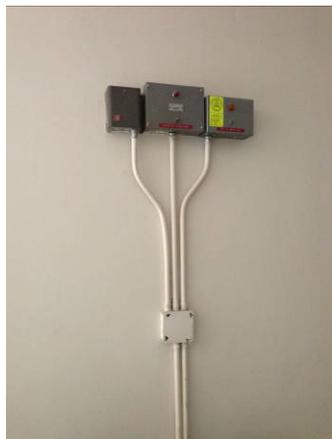
- There is a sprinkler supervisory system present. Notification is thorough an outside bell. Smoke detectors present are local type only.

*Sprinkler Supervisory System*
