Variance Number: 11 110

RE: **Exchange Hall
2 School Street
Acton**

**ACCESSIBILITY REVIEW
EXCHANGE HALL
2 SCHOOL STREET
ACTON, MA 01720**

**OWNER INTENT AND VARIANCE REQUEST
EXCHANGE HALL
2 SCHOOL STREET
ACTON, MA 01720**

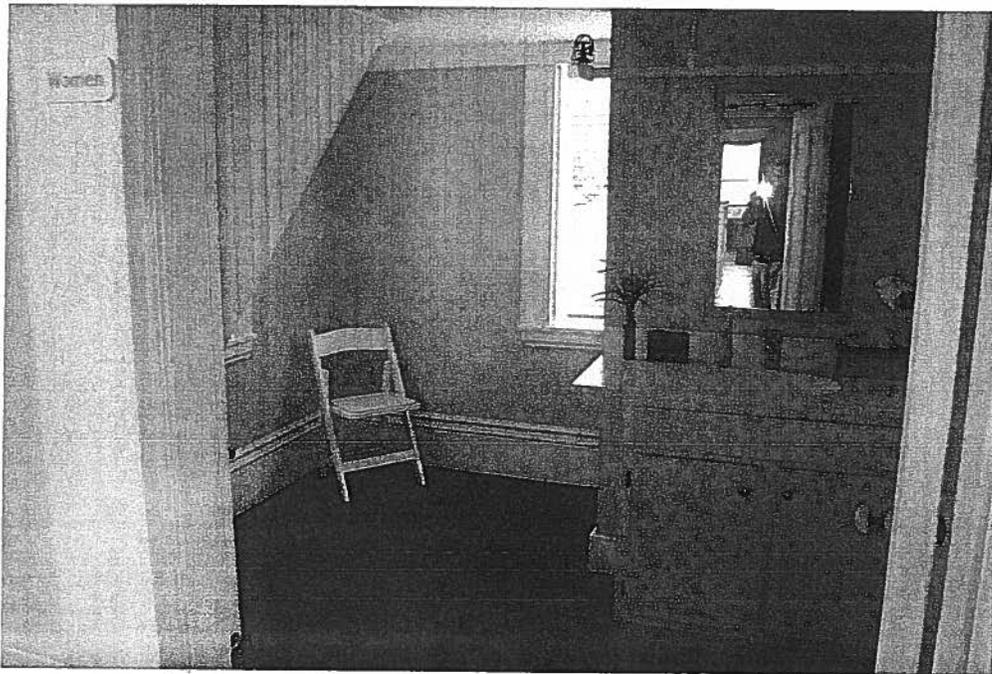
Photo No. 8

- B. The toilet room on the west side of the building does not comply with Section 30.00 PUBLIC TOILET ROOMS. Door number 305 leading into the room has a clear opening of 2'-6 1/4", which does not comply with Section 26.00 DOORS AND DOORWAYS. The water closet is in a stall which is less than 3'-0" wide, which does not comply with Section 30.6 TOILET STALLS (See Photo No. 7). The water closet does not comply with Section 30.7 WATER CLOSETS. The sink does not comply with Section 30.9 SINK (See Photo No. 8). There are no grab bars, which does not comply with Section 30.8 GRAB BARS. *The Owner requests a variance for full compliance with 521 CMR. The Owner asserts that the modifications necessary to achieve full compliance, including wheelchair accessibility, are impracticable as they would result in excessive and unreasonable costs without a substantial benefit to persons with disabilities. In an effort to achieve partial compliance, the Owner proposes to replace the non-compliant water closet, install one 36" grab bar on the wall adjacent to the water closet and install a lever-type faucet at the lavatory.*
