**NAGOG POND DAM
ACTON, MASSACHUSETTS**

**UNDERWATER INSPECTION
OF THE
RAW WATER INTAKE SUPPLY LINE**

APRIL 11, 2012

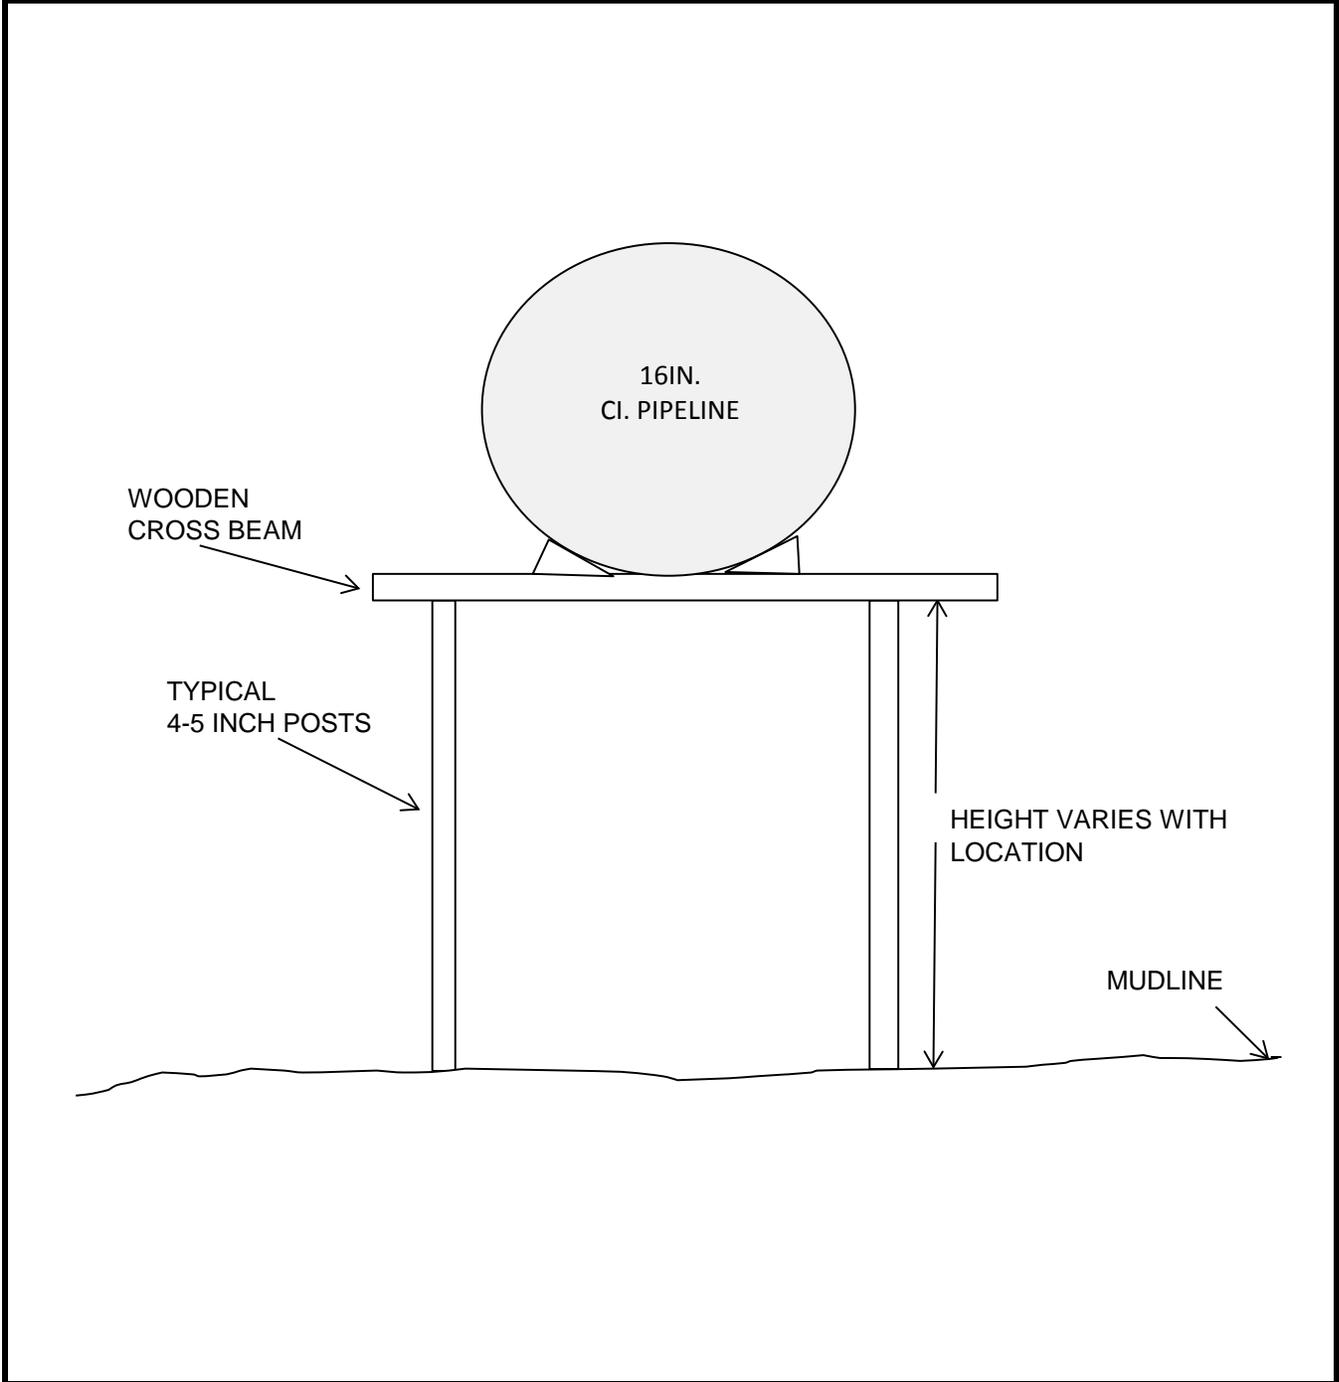
**NAGOG POND DAM
INTAKE PIPELINE CROSS-SECTION
FIGURE 2
PIPELINE SUPPORT DETAIL**

This section of pipeline was generally visible and covers an area from and adjacent to the island (situated at the center of the pond) to the end. The pipeline protrudes out of a bank of sand and rock which extends from the Island to the Easterly shore. The pipeline appears heavily rusted but intact and without observable cracks or broken sections. The pipeline is supported off the bottom of the pond by previously described wooden posts topped with cross timbers and bottom wedges holding the pipe on center. The posts and timbers appear heavily weathered and grainy with reduced X section from deterioration. The height of the wooden pipe supports varies with the elevation off the bottom. Discussion with the Town engineer detailed a previous inspection in which some settling of the pipe supports was noted. This could not be determined during this inspection effort because the as-built elevation of the pipeline was not known. The pipeline joints do not appear to have rotated or moved recently and the pipeline is currently bearing on all wooden pipe supports. Generally, the pipeline passes over a deeper area from the bank, into a shallower area for 50 to 100 lf, changes direction or elevation and back into a deeper area to the end. During this direction or elevation change, the greatest pipe joint angle was noted, the joint appeared intact and without leakage. (note photograph following)

The pipeline is typically covered with silt until the final 400 lf which is exposed. The pipeline is generally intact but heavily rusted with reduced inside diameter. The wooden pipe supports are intact but are very deteriorated. A deteriorated scour pad exists at the end of the pipe. The pad is covered with a light layer of silt.
