Town of Acton - Health Department

NARA Water Quality Testing - 2004

Acton's Streams

Acton Shoreline Survey Spring 1998

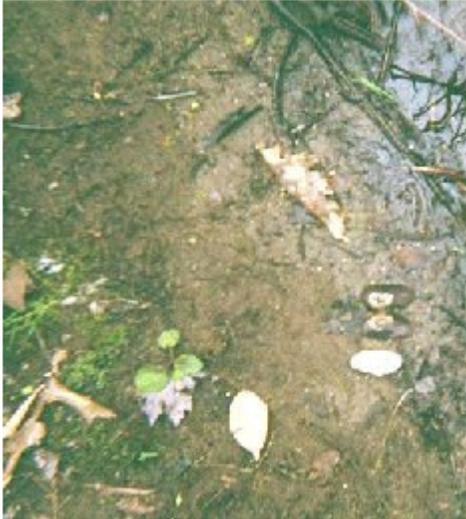
FP4, Fort Pond Brook

Segment FP4 starts at a dam as two outflow sections, one on the River St. side and one on the railroad side. The River St. side section flows through a parking lot of a paving company, where there appears to be runoff of fresh asphalt, oil, and a possible road salt pile. The two sections rejoin after about 300 feet. Trucks and equipment are stored on an island between the sections.

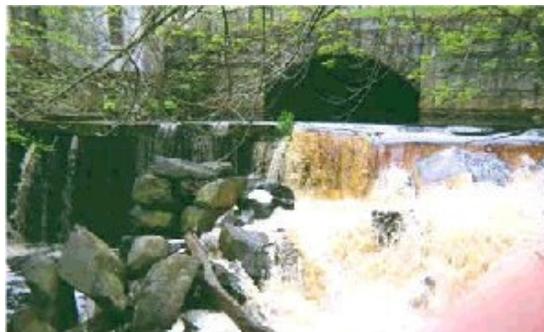
The upper segment (1) from Rte. 27 to the Railroad Bridge crossing is fast moving beginning with a dramatic falls over ledge and boulders with steep banks, which make it difficult to access to determine depth. The water color is tannic with a slight septic odor (sensed by one surveyor), with some foam due to turbulence. The historic mill buildings exist with evidence of past operations. Access here is from High Street at Rte. 27 with room for parking between the River and the Railroad.

Historic site: Mill dam on Fort Pond Brook, View from Rte. 27

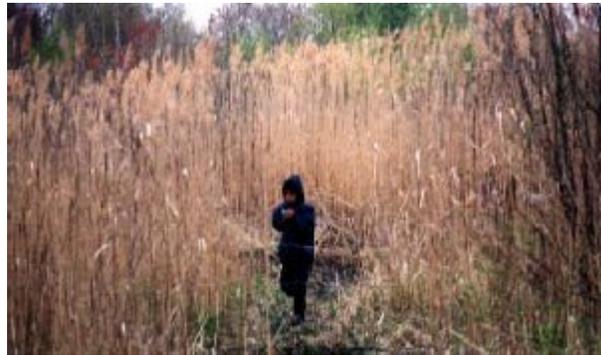
Plants: Phragmites, FPGUG

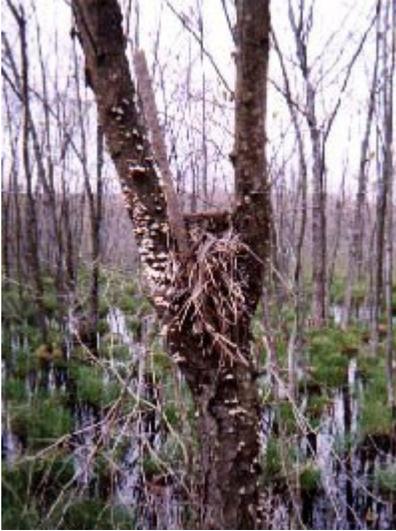
FPPR4, Pratt's Brook

Segment FPPR4 flows well near the start at High Street. The underbrush is thick, and access is difficult. Further on the brook splits, and the area becomes swampy. Vegetation is lush and includes skunk cabbage, yellow and white flowers, and many trees, especially oaks. The brook flows through a residential area and under Conant Street. Most of the land between Conant St. and Rte. 27 is dense woods and wetlands. The area where Pratt's Brook crosses Rte. 27 and flows past the former Beacon Building has cleanup issues that need to be addressed.

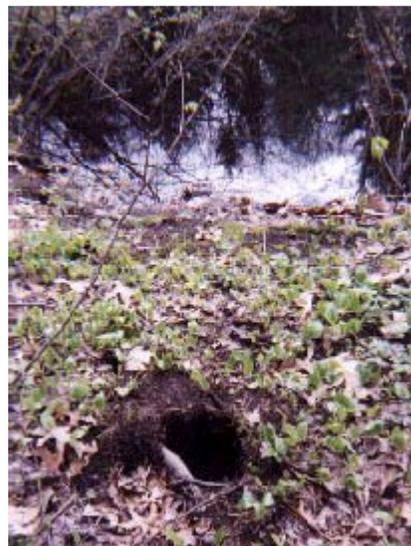
1) The construction dump along Wetherbee St. is the biggest problem. A landowner has used the wetlands along the streambed as a site to store his construction equipment, and it now includes a great deal of large, useless machinery, cinderblocks, and other construction debris.

2) The general level of trash along the streamside is high in this area, and needs a good clean-up effort.

Wildlife: Animal den?, NB1

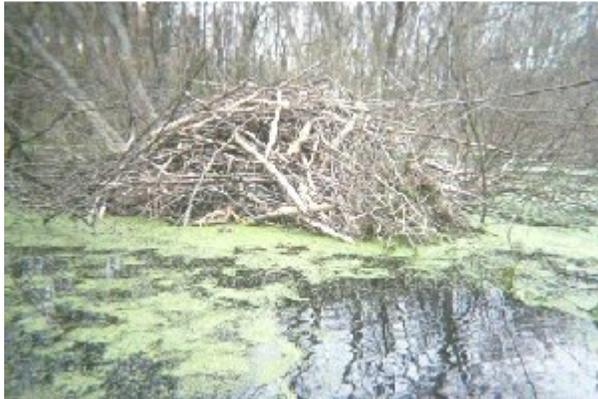
Dams, beavers: Beaver activity on Conant Brook, NBCON1

- Lots of litter near Newtown Road.
- Beaver ponds had rotting bottoms, lots of duckweed, dying and fallen trees, and a stagnant, sometimes scummy surface.

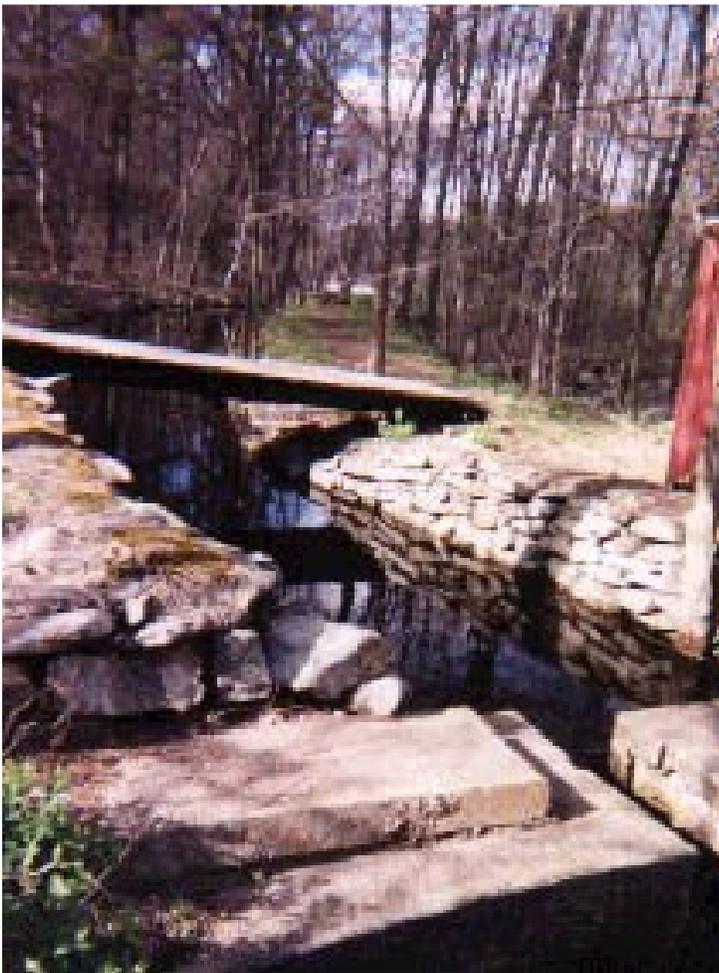
This stream is almost dry in the summer time and gets completely choked off with water chestnuts. It becomes foul smelling. Water will only flow under the dam, not through it and the sluiceway (man made stream) was totally dried up last September. The dam is also in need of repair and further study.

Historic Site: Sluiceway from Grist Mill, NB4
