*MINUTEMAN REGIONAL VOCATIONAL TECHNICAL HIGH SCHOOL - GRADES 9 THROUGH 12; APPROX. 820 STUDENTS*

EVALUATION OF EXISTING FACILITIES  
MINUTEMAN REGIONAL CAREER & TECHNICAL HIGH SCHOOL  
758 MARRETT ROAD • LEXINGTON, MA 02421

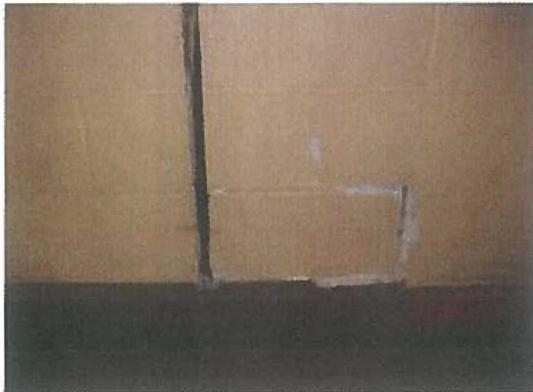
Known issues with the walls, are that they do not meet current energy code standards for required continuous R-values, and location of air/vapor barrier. Also found on the exterior walls are multiple settlement stress-cracks; they are found throughout the facility. These cracks allow air to infiltrate the building, particularly in the stair towers. Another issue observed was some expansion joints that are un-caulked, leaving yet another place for air to infiltrate.

Air infiltration equals heat loss or gain depending, on the season. Furthermore, field cut holes to install the supplemental heating/cooling units are not sealed correctly adding to the air infiltration issues.

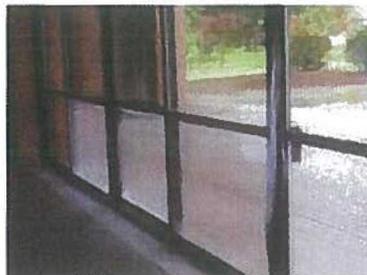
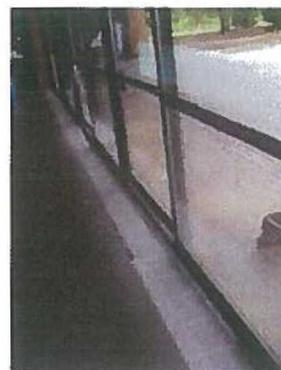
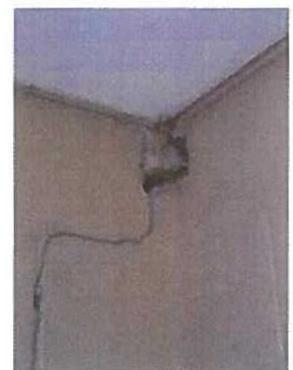
The glazing throughout Minuteman is 1" tinted single-pane insulated glazing set in a non-thermally broken aluminum frame (Curtain wall type system). These windows are original to the 1974 building and do not meet the current energy code requirements (specifically the window frames). This allows for rapid heat gain in the warmer months and rapid heat loss during the cooler months. Many of the windows have gaps allowing air to infiltrate due to failing neoprene gaskets. The most extreme example of this occurrence is in the pool area; the sealant is failing and noticeably pulling away from the frames, allowing air infiltration. The windows are required to have a U-value of .6, and skylights must have .8; not to exceed more than 3% of the roof assembly area.

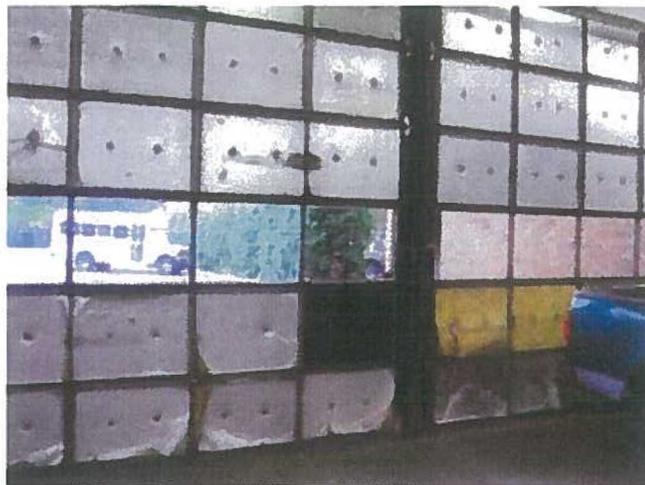
While some of the overhead doors in the shop areas remain original to the building some have been replaced. All of the overhead doors are in need of replacement due to the long term wear and abuse that they have suffered.

Our recommendation is that a replacement program be instituted. This would be in concert with fulfilling code requirements.

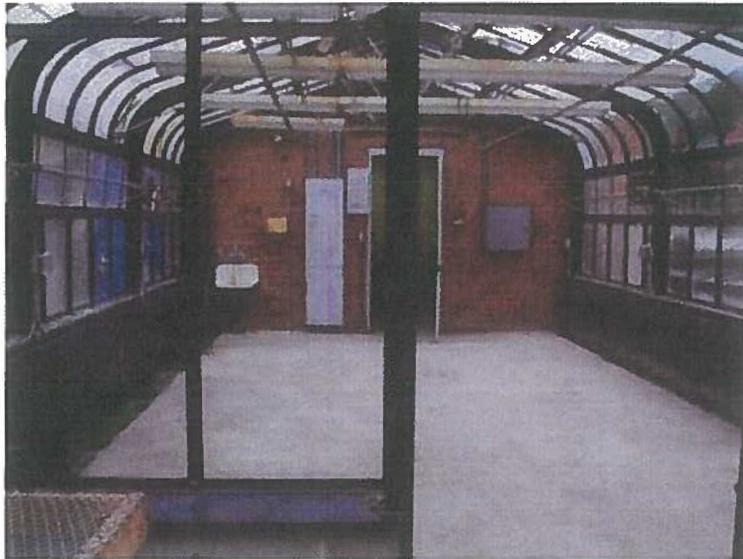
The trim throughout the exterior of Minuteman appears to be well maintained and in good condition considering the 30+ years out in the elements. An exterior element that is in need of some attention is the greenhouse adjacent to the Landscape Department. Glazing and the associated framing are stained and deteriorating due to the high humidity levels that occur in that space.

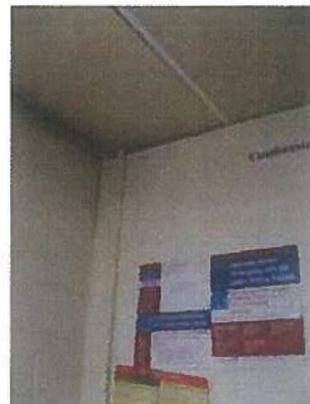
Both the corridor walls and the declining partitions are painted concrete block. Generally, all of the interior walls are non-load bearing since this building's primary structure is steel beams bearing on interior and exterior piers. However, there are some temporary walls that have been introduced, perhaps by the staff or students that vary in construction. The preservation of these walls is reasonable, not requiring ample care, and withstanding a great deal of abuse; they present themselves well. The foremost issue that the current wall system presents is improper sound separation between classrooms. It was observed that the walls in many areas terminate at the ceilings. In other areas of the building, the wall stops short, leaving gaps between the top of the wall and the ceiling. This produces a disruptive environment, distracting both teachers and students.

Our recommendations are to maintain the existing walls as has been done and make changes that are needed by Code or educational requirements. With the interior partitions measures should be made to improve the sound transmission coefficient rating between spaces. The interim walls that were installed should be replaced with more permanent non combustible construction.

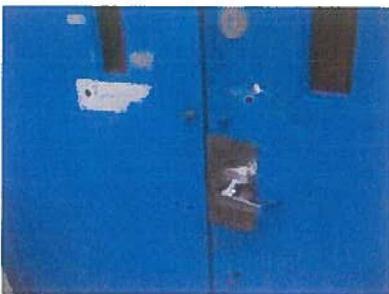
There are a series of overhead doors that are in service at the High School. Coil overhead doors are used in the cafeteria to close the individual serveries. These doors are in good condition and good working order. Sectional overhead doors used in the shop areas are damaged from long-term wear; many of the insulated panels have fallen off, or are significantly damaged.

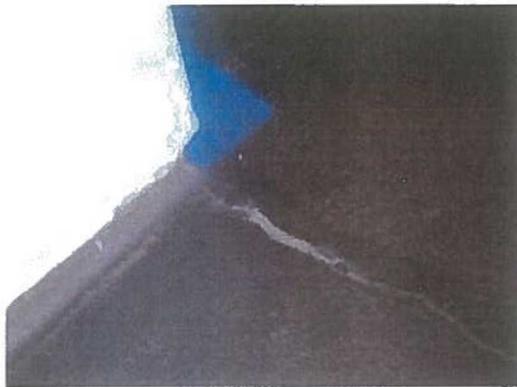
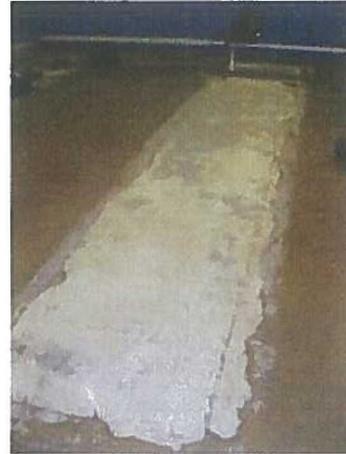
The interior finishes of this building vary from area to area. The floor finishes vary from area to area. Resilient flooring was used in and around the pool, locker rooms, along with their associated circulation elements, and toilet room areas. This floor finish is cracking and in some areas coming up. The locker room floors need to be redone due to the removal of locker bases which resilient remnants still remain.

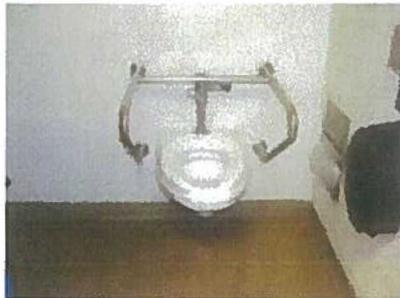
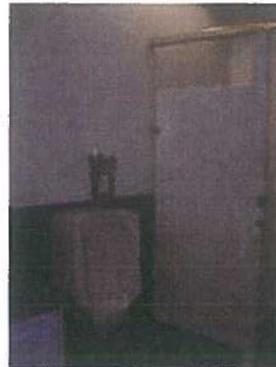
Toilet partitions in this building are in fairly good condition for a vocational high school however appear to be from the original construction due to the amount of paint on their surfaces. In many instances they improperly divide the compartments and make non handicap accessible toilet areas which are required to be. There is relatively little damage in the Toilet Rooms.

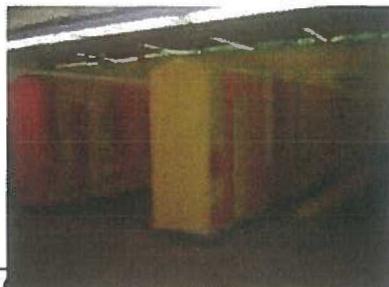
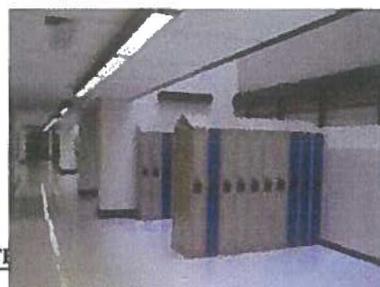
The lockers in the corridors are in good condition in spite of their age, they would however benefit from refreshing. Where lockers have been damaged, they have been replaced with other doors and components from other lockers which do not match the remaining lockers. Lockers in the Male and Female Locker rooms are in fairly good condition. The lockers in the male locker room appear to have been updated from the originals.

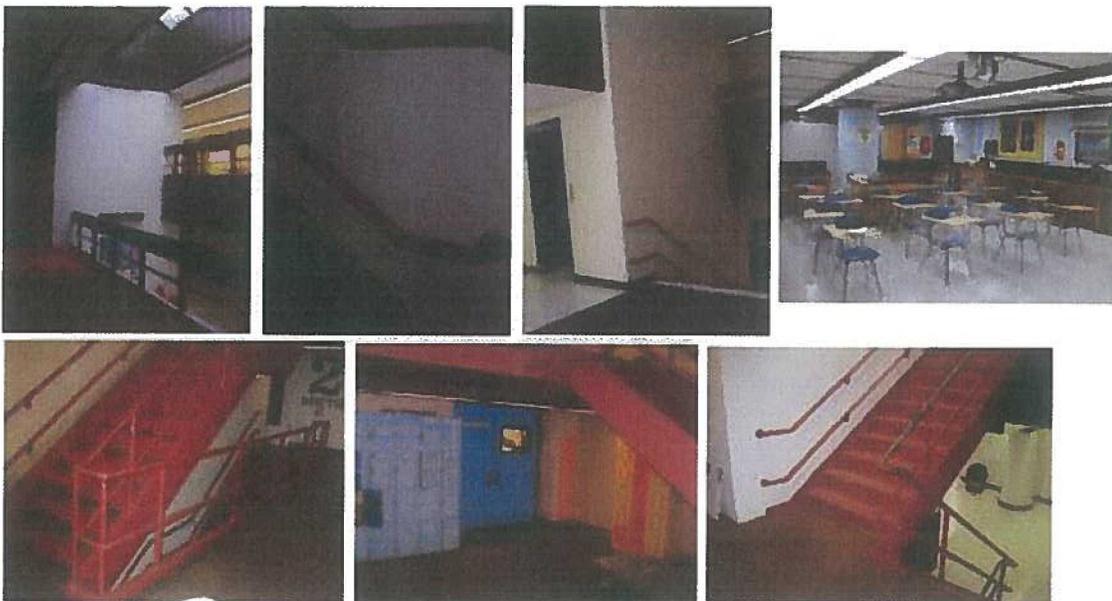
All stairs are a metal pan stair system with concrete treads in all egress stairs. Code violations in the stairs consist of the lack of guardrails as required for the continuous railing in the center of the stair. The wall mounted handrails do not have the required approaches of 1'-11" at the bottom of the run or 12" at the top. Furthermore, the continuous rail lacks the required vertical balusters that are required for fall protection. The bottom of the stairs near the shop areas are being used for storage which is also a code violation.

The guard rails throughout the facility where they are the proper height lack fall protection that is required per building code. There needs to be a system installed that will not allow for a 4 inch ball to pass through and fall to the lower levels.

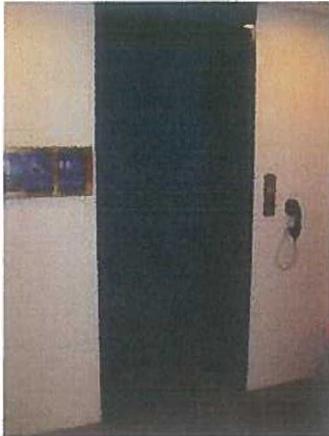
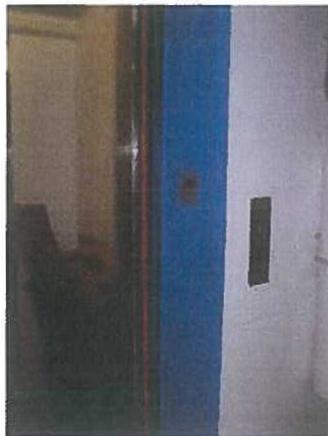
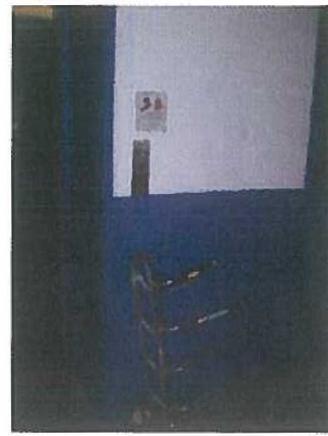
Deficiencies that were found amongst all the elevators were found to be with the signage and controls. Where the main entrance elevator had adequate signage, the other elevators only had signage on the door jambs and none on the exterior face of the corridor walls that served them. In all of the elevators, the control buttons on the corridor walls were to higher than the required 42" to the center of the panel.

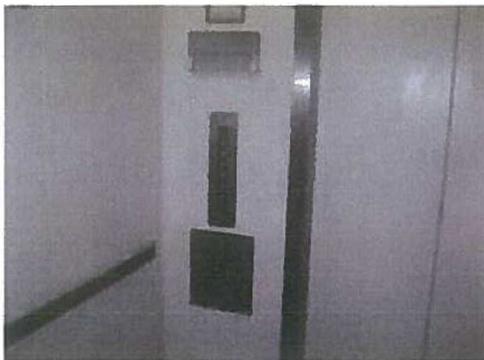
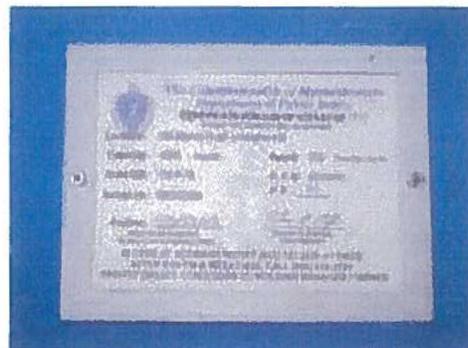
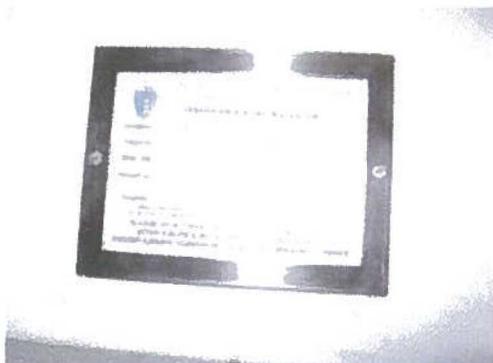
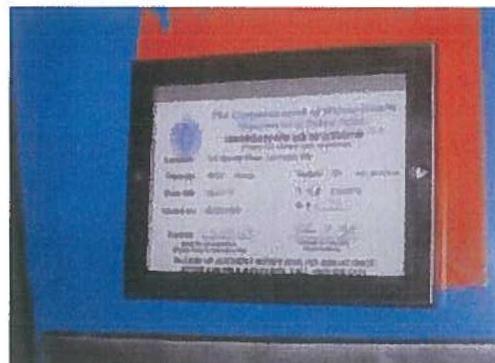
Exterior lanterns which indicate the elevator is in use are located on the control panels however lanterns are required to be a minimum of 2-1/2" in the smallest dimension and mounted with its centerline at 72" above the finish floor. Furthermore there was no recollection of an audible alarm which alerts once for up, and twice for down heard upon observation.

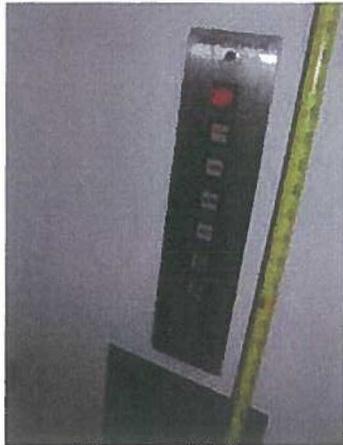
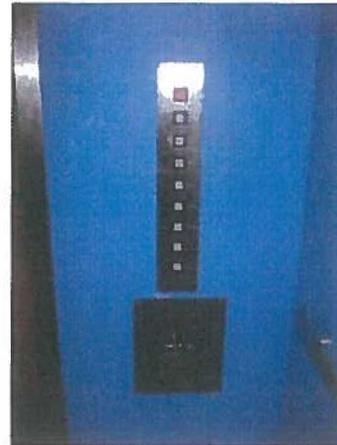
Inside the cab, the controls were found also to be in violation with the Massachusetts Architectural Access Board's (MAAB) requirements. Per MAAB, the control buttons are to be mounted between 34" and 48" for frontal approach and 34" and 54" for side approach. The emergency buttons were also found to be on the upper portion of the control panel and are actually required to be at the bottom. Furthermore, the controls are required to have Arabic characters and standard symbols which coincide with each button (i.e., raised star indicating the main level) in addition to Braille. KBA recommends possible finish upgrades and the installation of MAAB required indicators, signage, and controls.

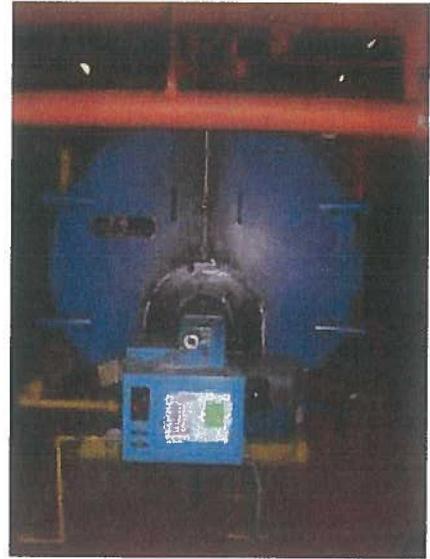
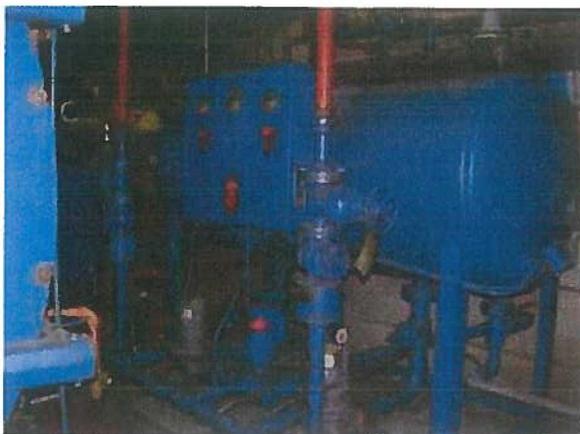
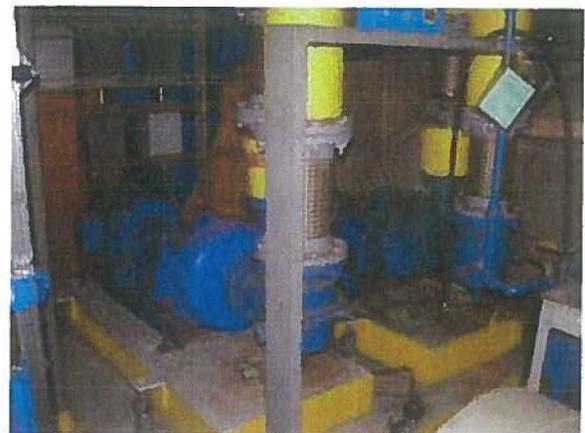
At the rear of the boilers is a blow-down separator which is mounted on the wall. This separator receives blow-down sediment from each boiler, and is mixed with City water for cooling prior to discharging to the City sewer. The blow-down separator is provided with discharge aquastats and operating controls; it does appear to be in operating condition. In conversation with Maintenance Personnel, it was said to have been abandoned in-place. This is a concern, should this be the case, system sediment could be collecting within the steam system and possibly reducing heat transfer and overall power plant efficiency.

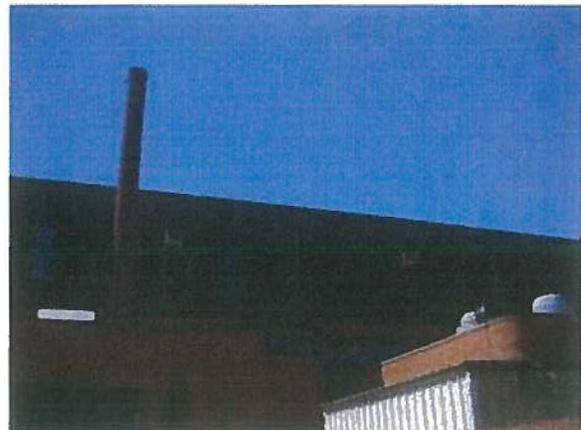
The breeching from the boilers appears to be of the single wall welded black steel design and is insulated with what appears to be calcium silicate insulation (or asbestos) with a canvas jacket. Samples of this material should be tested for the presence of asbestos and remediated if noted positive. The breeching was provided with a single cleanout at the end of the common breeching. The chimney is of the pre-manufactured steel and refractory type and appears to be of adequate height to maintain proper draft. The entire installation of breeching and chimney was noted to be in good condition and operating as intended.

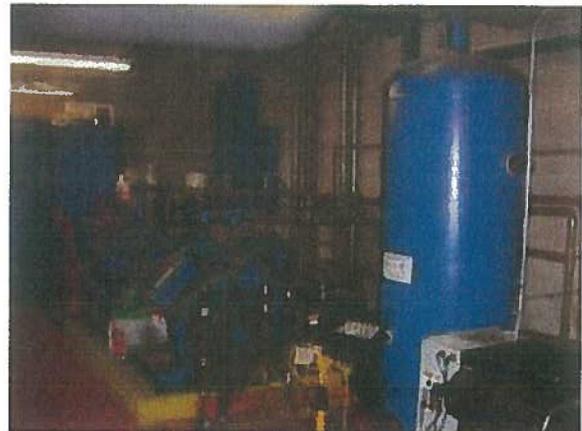
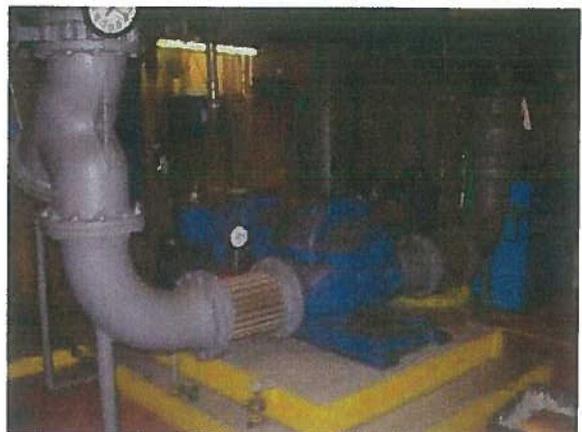
The automatic temperature controls for the entire building are through a central pneumatic automatic temperature control system. The system is provided with a single air storage tank with remote dual compressors and dual motors mounted on a concrete pad adjacent to the air storage tank itself. Located adjacent to the air storage tank is a wall mounted refrigerated air-dryer which is provided with an oil and water separator. It does appear that the system is generating day and night control pressures which allows for night set back control and at the time of our visit pneumatic air was being generated for distribution to all control devices. Comments from maintenance personnel does suggest that the automatic temperature control throughout the building are somewhat antiquated which could relate to failing control devices throughout. Both the refrigerated air-dryer and the compressed air storage tank are provided with manual blow down lines and appear to operate. The original compressors were recently abandoned in-place and were replaced with the two slab mounted

compressors adjacent to the storage tank.

Although the pneumatic system is considered to be in good condition, considering the relatively antiquated nature of all of the control devices, consideration should be given to a complete upgrade to include a new direct digital automatic temperature control system at this time.

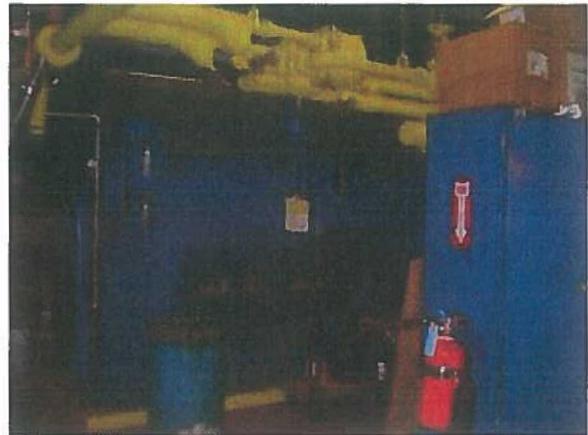
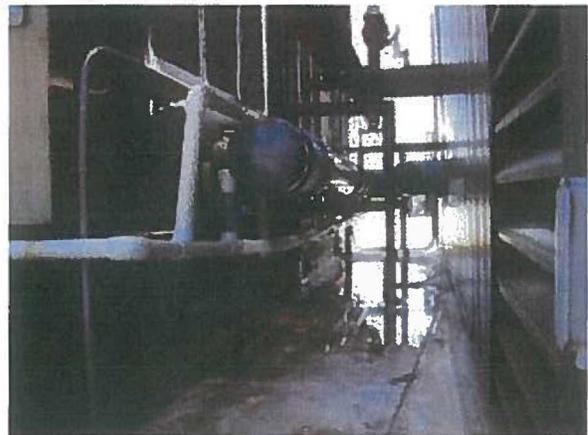
Also located within the boiler room is a low pressure steam absorption chiller. The chiller is the original installed in 1972 and provides a chilled water supply to the entire building. Located at the rear of the chiller are two base mounted condenser water pumps which communicate to a roof mounted PVC cooling tower. The single condenser water pump is of the horizontal split case design and communicates to the cooling tower through an un-insulated schedule 40 black steel piping system. The cooling tower appears to have been replaced within the last three years. Maintenance personnel have indicated that the new cooling towers continue to leak and the units are showing a general state of disrepair with numerous warped structural panels and leaking piping. Chilled water is distributed by a single horizontal split case distribution pumping system. Chilled water is provided to the entire building through a fiberglass insulated schedule 40 piping system. Both the condenser water piping system and chilled water piping system appear to be in very good condition and maintenance personnel has indicated that they have not been problematic in the past. It does appear that proper chemical treatment is being provided for the cooling tower. The absorption chiller is a very uneconomical operating chiller which requires the steam boilers to run throughout the summer months to create the cooling energy required within the chiller. Consideration should be given to a complete upgrade of the chiller, however, the condenser water and chilled water piping and pumps are capable of being reused. It does appear that the cooling tower is in need of replacement.

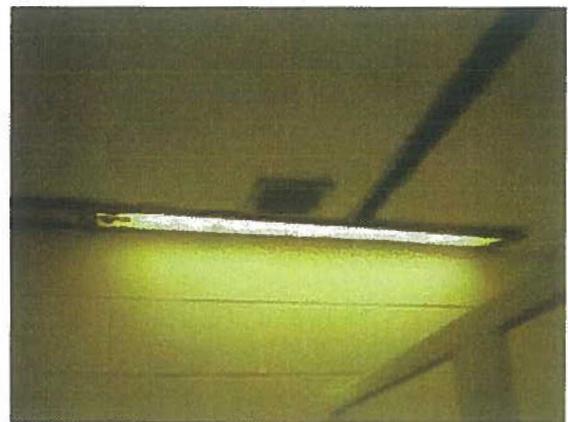
The individual public toilet areas are provided with a combination of ceiling and wall mounted exhaust registers generally located in the area of the plumbing fixtures. All exhaust registers were noted to be slightly soiled and in some damaged. The exhaust system is made up of galvanized sheet metal ductwork which terminates with roof mounted exhaust fans. Limited ventilation control is being maintained throughout all toilet spaces and it does appear that the exhaust fans are running; however, we cannot be certain if the air volumes are in compliance with building code conditions at this time. Considering the approximate 30 year age of all systems and general poor performance consideration should be given to an overall upgrade at this time.

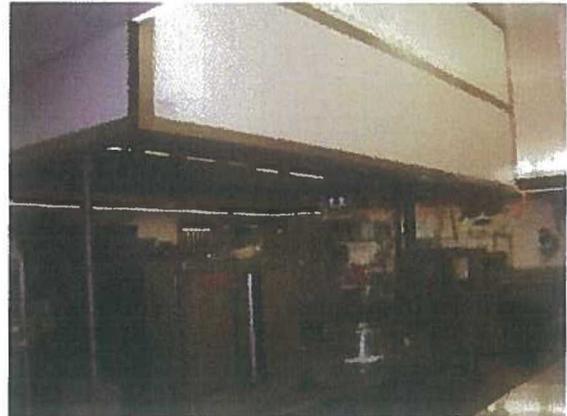
In addition to the above, the kitchen is provided with two additional air handling units which are located at the ceiling of the kitchen itself. Each air handling unit is provided with a supply fan, hot water heating coil with face and bypass control, and a direct source of outside air through wall mounted intake louver. Each unit is of the 100% outside air design and are intended as makeup air for a centrally located exhaust hood located within the kitchen. The overall condition of all ductwork, equipment, and supply diffusers is generally typical and reaching their maximum serviceable life.

The exhaust hood is of the canopy style stainless steel design which is ducted directly through a dedicated exhaust system to roof mounted exhaust fans. The overall condition of the hood was noted to be good and clean and was provided with cleanable cartridge filters, and vaportight incandescent lighting.

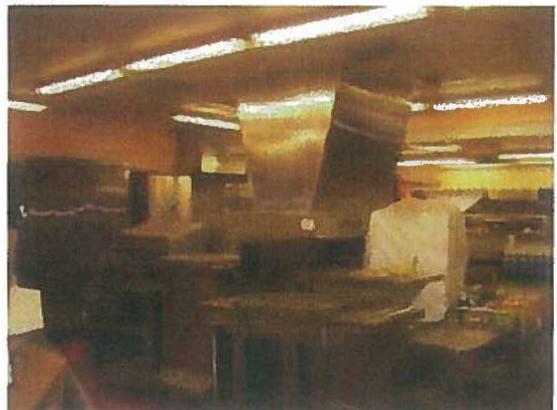
A secondary kitchen is located adjacent to the primary kitchen which was at one time used as a McDonald's restaurant. The secondary kitchen is provided with a first-class kitchen preparation area including stainless steel exhaust hood with roof mounted exhaust fan, and a gas-fired rooftop make up air unit. The exhaust hood is noted to be in excellent condition and is of the proper size and height for the area served. The rooftop unit is showing signs of surface contamination due to weather influences however as we understand it the unit does operate satisfactorily. The restaurant is no

longer in service and the entire system has been abandoned in place.

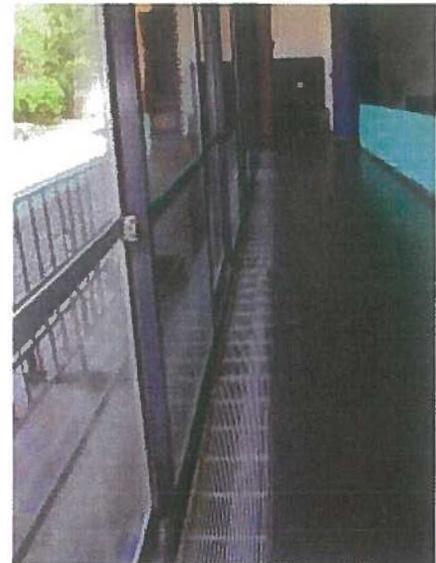
Located along the exterior wall of the pool is a continuous length of fin tube radiation located beneath the slab. Although the amount of heat provided is adequate to a set draft, convective air currents are reduced due to the location of the fin element obstructing make up air from entering the fin element. As a result overall output of the heating is dramatically reduced. It was also noted that there was extensive soiling and contamination on the discharge grille in fin tube elements.

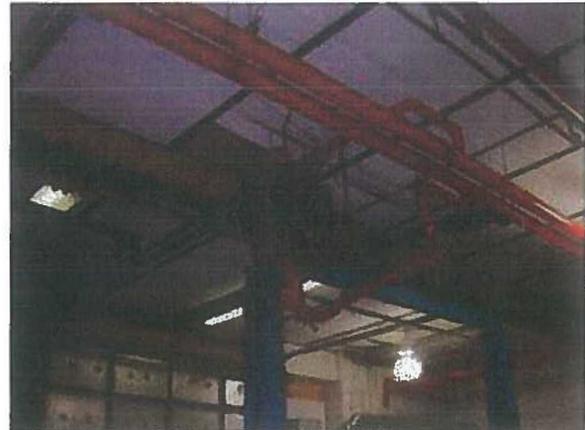
Also located within this space were various hot water horizontal unit heaters generally intended for space heating. As we understand it two of the three unit heaters do not operate at this time and generally one heater is maintaining all temperature control. All unit heaters were noted to be dirty and contaminated and generally in need of replacement.

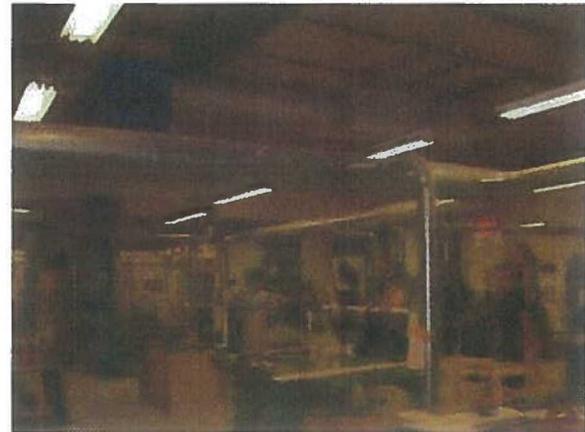
The woodworking area is provided with a dust collection system and through the communication of a spiral wound galvanized exhaust system, conveys all woodworking particulate between machinery and an outside mounted dust collection unit. This dust collection unit is of the 100% recirculation type and all exhaust from the space is distributed back to the space at the in-line filters. The outside dust collection unit is extremely rusty and antiquated and at the time of our visit the system was not operating. Consideration should be given to an overall upgrade at this time.

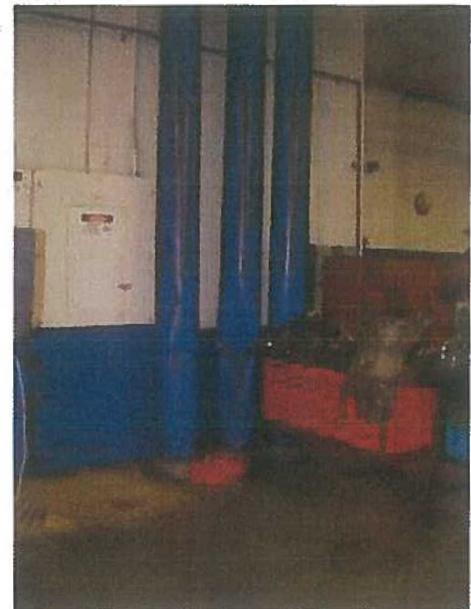
The welding area is provided with a series of welding benches located at one side of the space. Each welding bench is provided with a flexible exhaust captures system which collects in an overhead common exhaust duct which communicates to a space mounted centrifugal exhaust fan. The exhaust system does operate and appears to be sized with common industrial ventilation standards. Because of its use the system is extremely contaminated and upgraded the system is recommended.

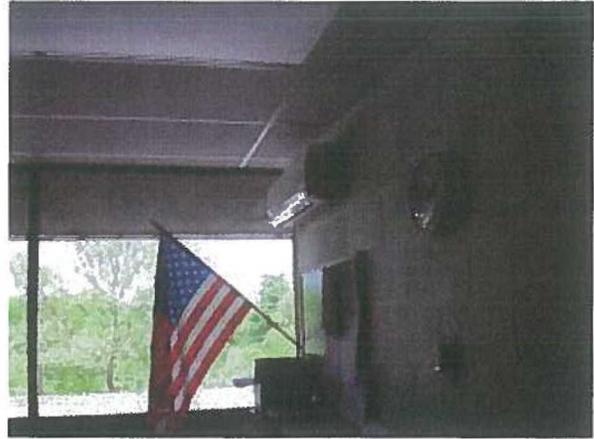
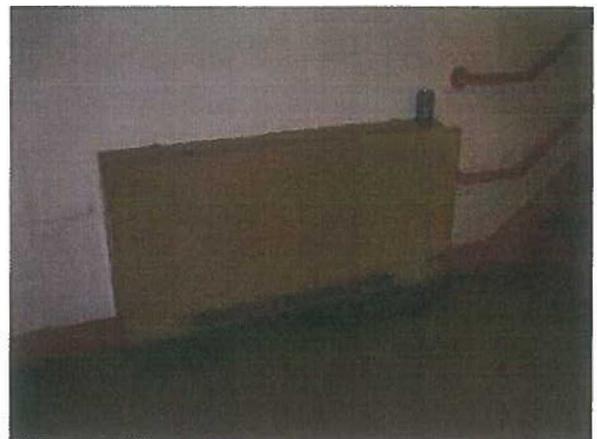
The main entrances and vestibules were all provided with hot water cabinet unit heaters adjacent to each doorway. It was noted that generally all heaters were slightly damaged, dirty, and contaminated, however, as we understand it do operate and maintain reasonable heating control at all entrances and doorways. All units are generally in need of cleaning and considering the 35 year age and general state of disrepair consideration should be given to an overall upgrade at this time.
