LERNER LADDS BARTELS

ACTON TOWN-WIDE FACILITY STUDY

Town of Acton, MA
472 Main St.
Acton, MA

23 June 2015

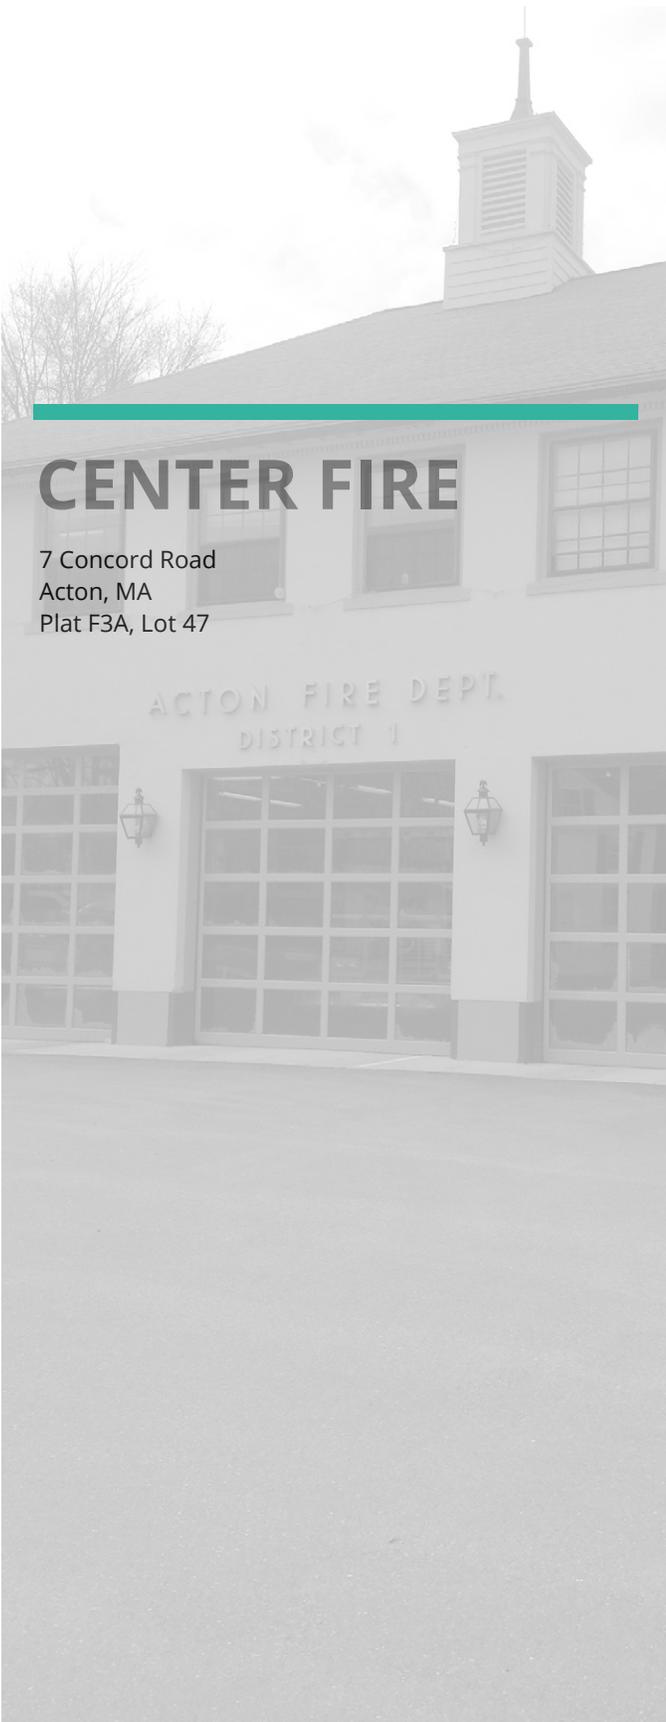
CENTER FIRE

ZONE R-2	CONSTRUCTION TYPE Masonry
CURRENT USAGE Fire/Emergency	GROSS AREA, SF 4,678
YEAR BUILT 1960	ARCHITECT
REPLACEMENT COST, SF \$1,637,300	ASSESSED VALUE \$768,500

Sloped roof is constructed of wood plywood deck, ice and water shield, asphalt shingle. Metal gutter and downspout system. Weathervane. Flat roof is an adhered EPDM system with rigid thermal insulation on gypsum board. A wood frame walkway is built directly on top of the flat roof, not on proper pads, and may impact the durability of the membrane. Both roof systems were replaced in 1997.

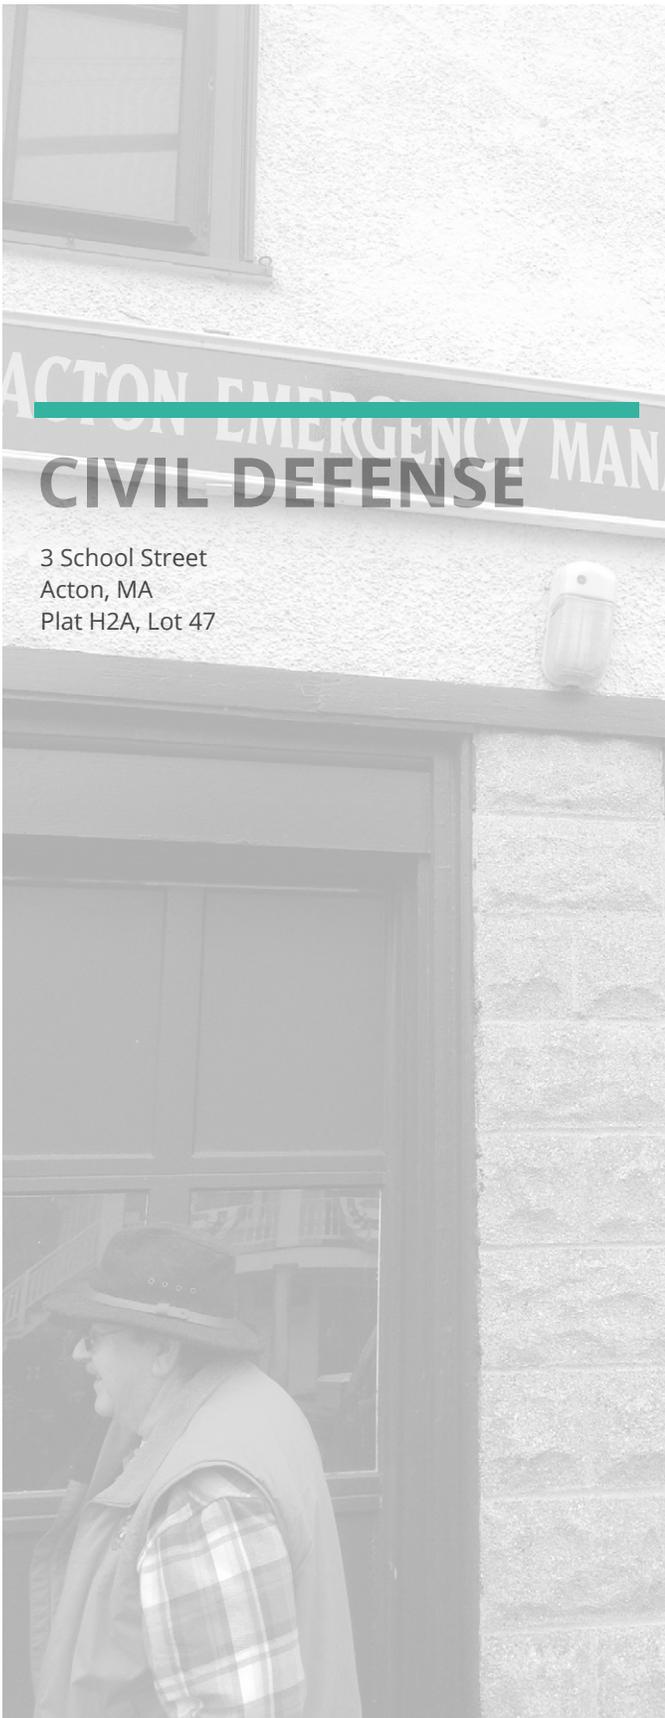
3 School Street
Acton, MA
Plat H2A, Lot 47

ZONE SAV	CONSTRUCTION TYPE Masonry
CURRENT USAGE Emergency Management	GROSS AREA, SF 2,628
YEAR BUILT 1940	ARCHITECT
REPLACEMENT COST, SF \$919,800	ASSESSED VALUE \$417,300

Timber frame an metal column, construction, concrete foundation and basement walls. Roof structure unidentified.

Settling is apparently on the rear of the building. Major cracks are visible, though they have been filled. Parged basement walls prevent from identifying whether the settling continues to the ground. A downspout is located directly where the settling appears to be.

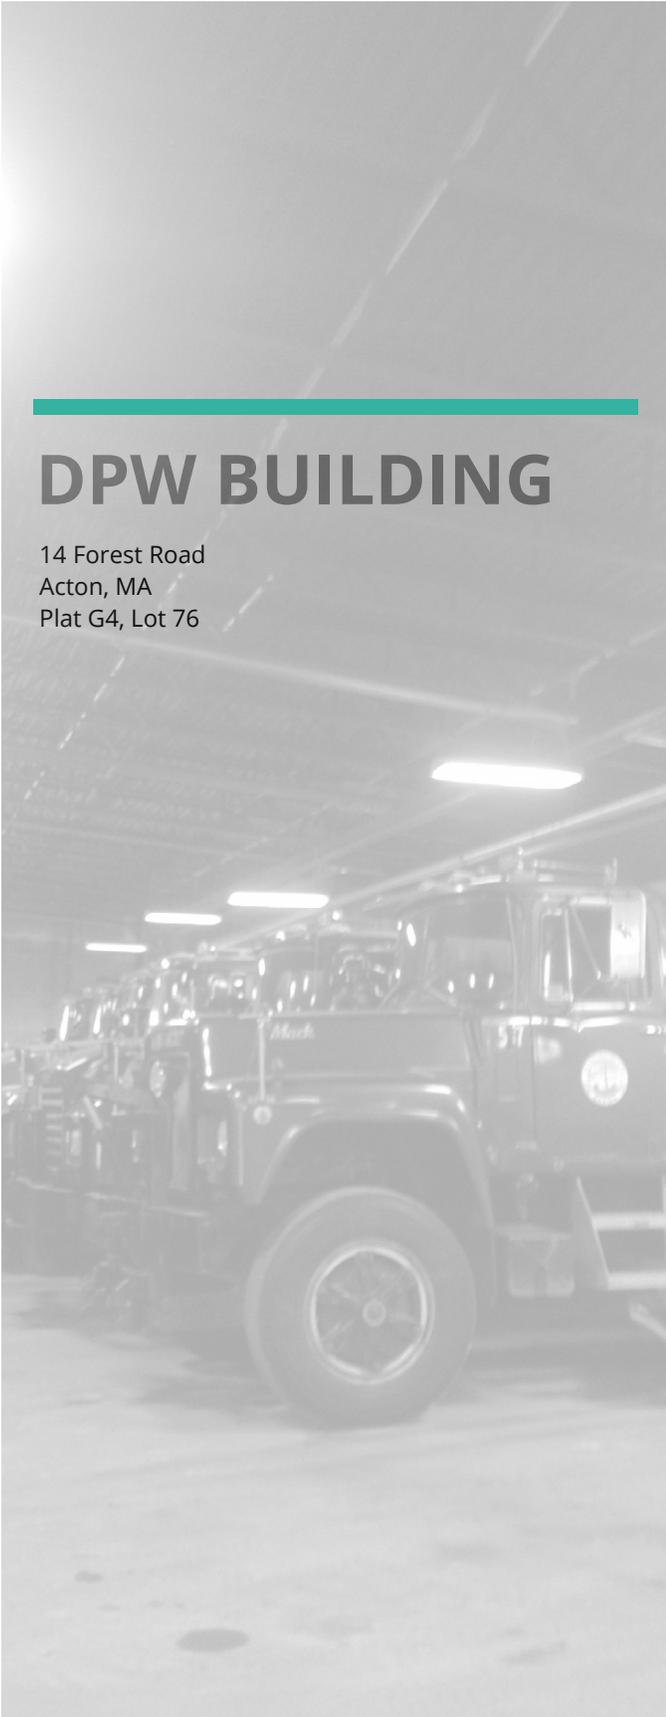
DPW BUILDING

ZONE R-2	CONSTRUCTION TYPE Masonry
CURRENT USAGE DPW Offices/Equipment	GROSS AREA, SF 19,200
YEAR BUILT 1971	ARCHITECT Fenton G. Keyes
REPLACEMENT COST, SF \$6,720,000	ASSESSED VALUE \$627,700

Slab-on-grade, single-story. load-bearing CMU walls and steel roof deck on steel joists. A wood-framed mezzanine exists in one area of the building. Areas of efflorescence indicate water infiltration or seeping groundwater. Lower sections of these exterior walls have been parged.

Corrugated steel roof, replaced 2002. Photovoltaics installed over EPDM and 4" insulation, approximately 2000. Metal gutter and downspouts.

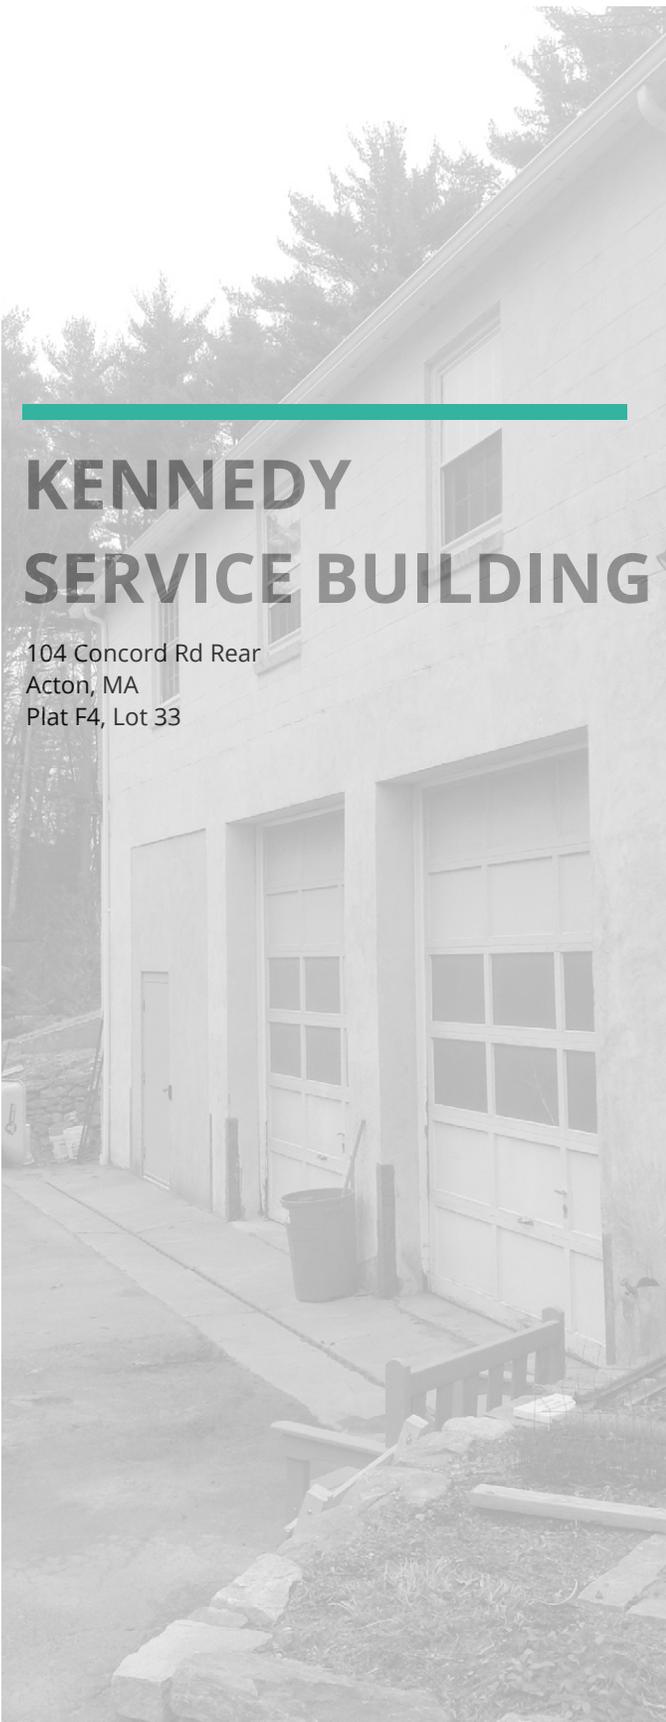
KENNEDY SERVICE BUILDING

ZONE R-2	CONSTRUCTION TYPE Masonry
CURRENT USAGE Office & Garage	GROSS AREA, SF 2,640
YEAR BUILT 1967	ARCHITECT
REPLACEMENT COST, SF \$924,000	ASSESSED VALUE \$75,400

Parged masonry foundation walls, concrete floor deck, roof deck unknown.

Brick veneer, stucco in rear of building, single paned wood with storm windows in front, hollow metal exterior doors, wood oversized utility doors. Some efflorescence found on rear of building at ground.

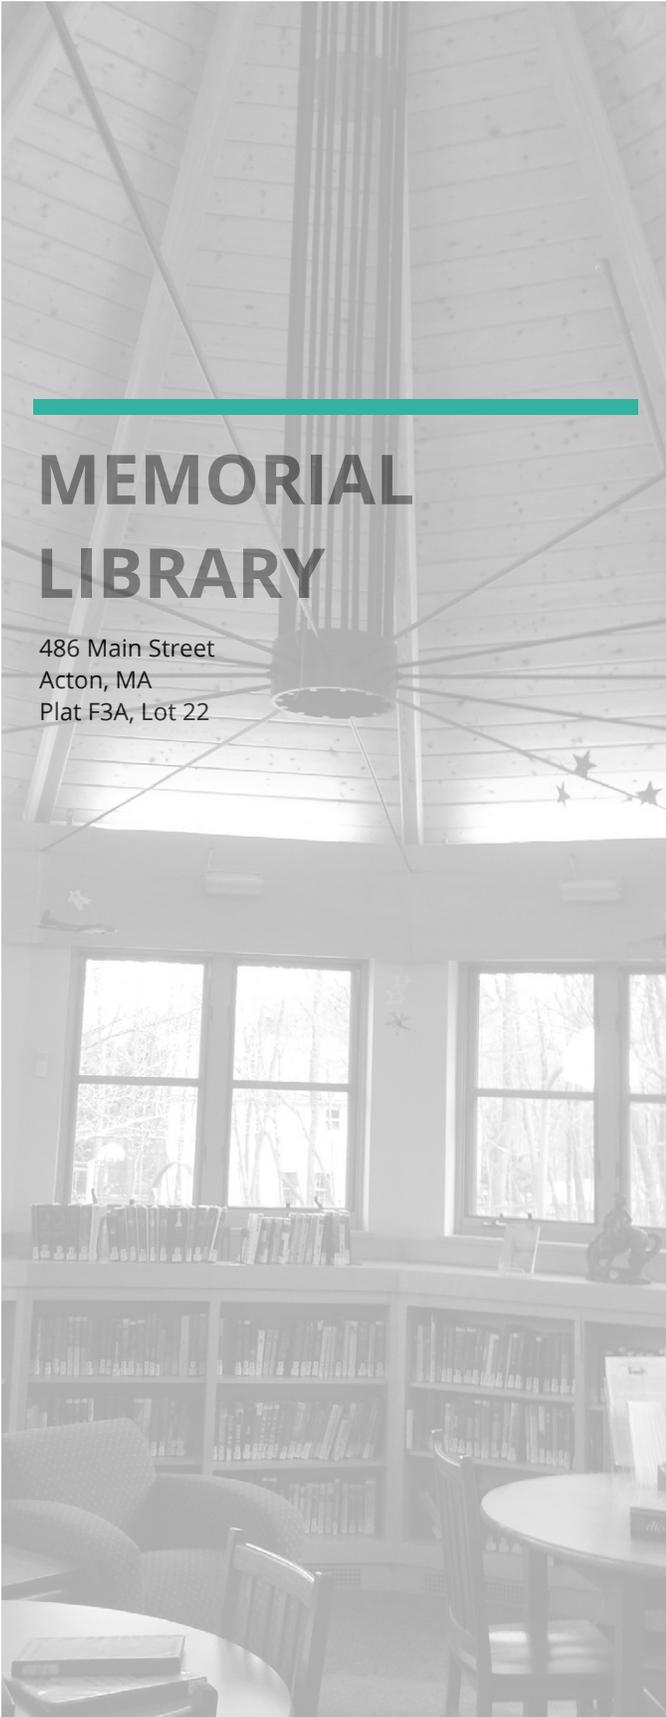
MEMORIAL LIBRARY

ZONE R-2	CONSTRUCTION TYPE Masonry
CURRENT USAGE Library	GROSS AREA, SF 48,259
YEAR BUILT 1899AYB/1997R	ARCHITECT Tappe'
REPLACEMENT COST, SF \$16,890,650	ASSESSED VALUE \$8,791,000

Original portion has a rubble stone foundation, brick columns, and timber framing. Newer addition's foundation is poured concrete, with steel beam and metal deck with poured concrete floor and roof decks.

Original portion slate shingle roof. Newer addition is made of built-up EPDM roof, tapered insulation, and slate shingle on exposed (visible) sides. Roof was replaced in 1996. Rainwater collects in downspouts at valleys, gutters at low eaves.
