Community Workshop - Asa Parlin House

FACT SHEET

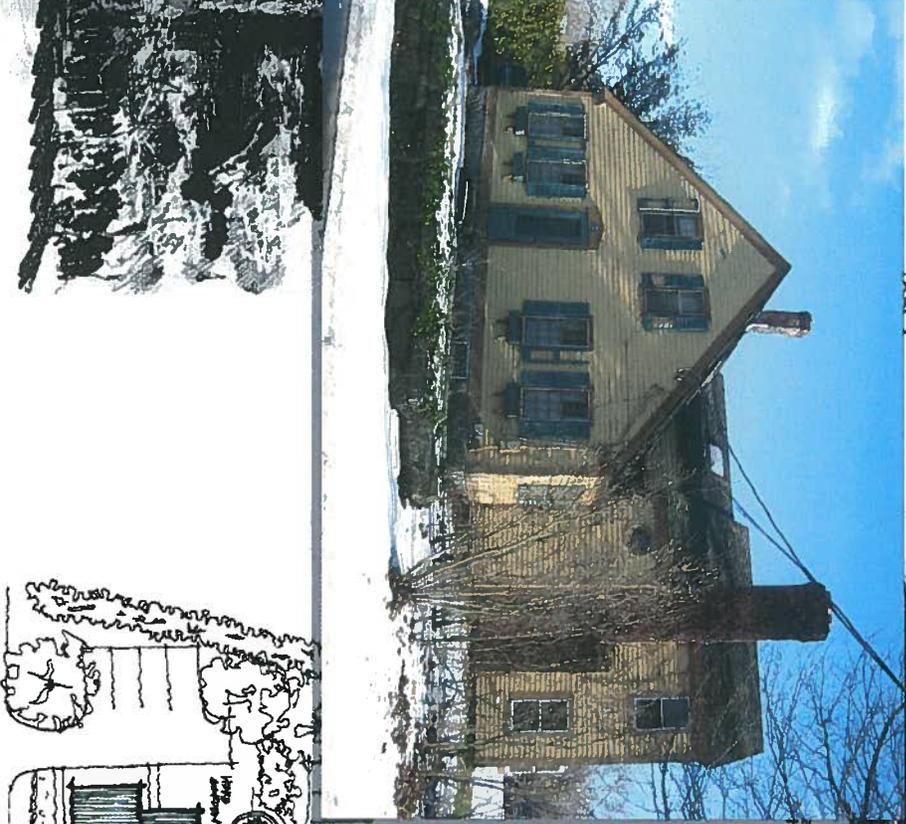
Rehabilitation Scenarios

Garden terrace
 New extension with
 breezeway glazed entry,
 kitchenette & WC
 Garden path from
 Town Hall & Memorial
 with hedge screening

Plans and renderings by:
 William Dickinson
 Nashawtic Architects

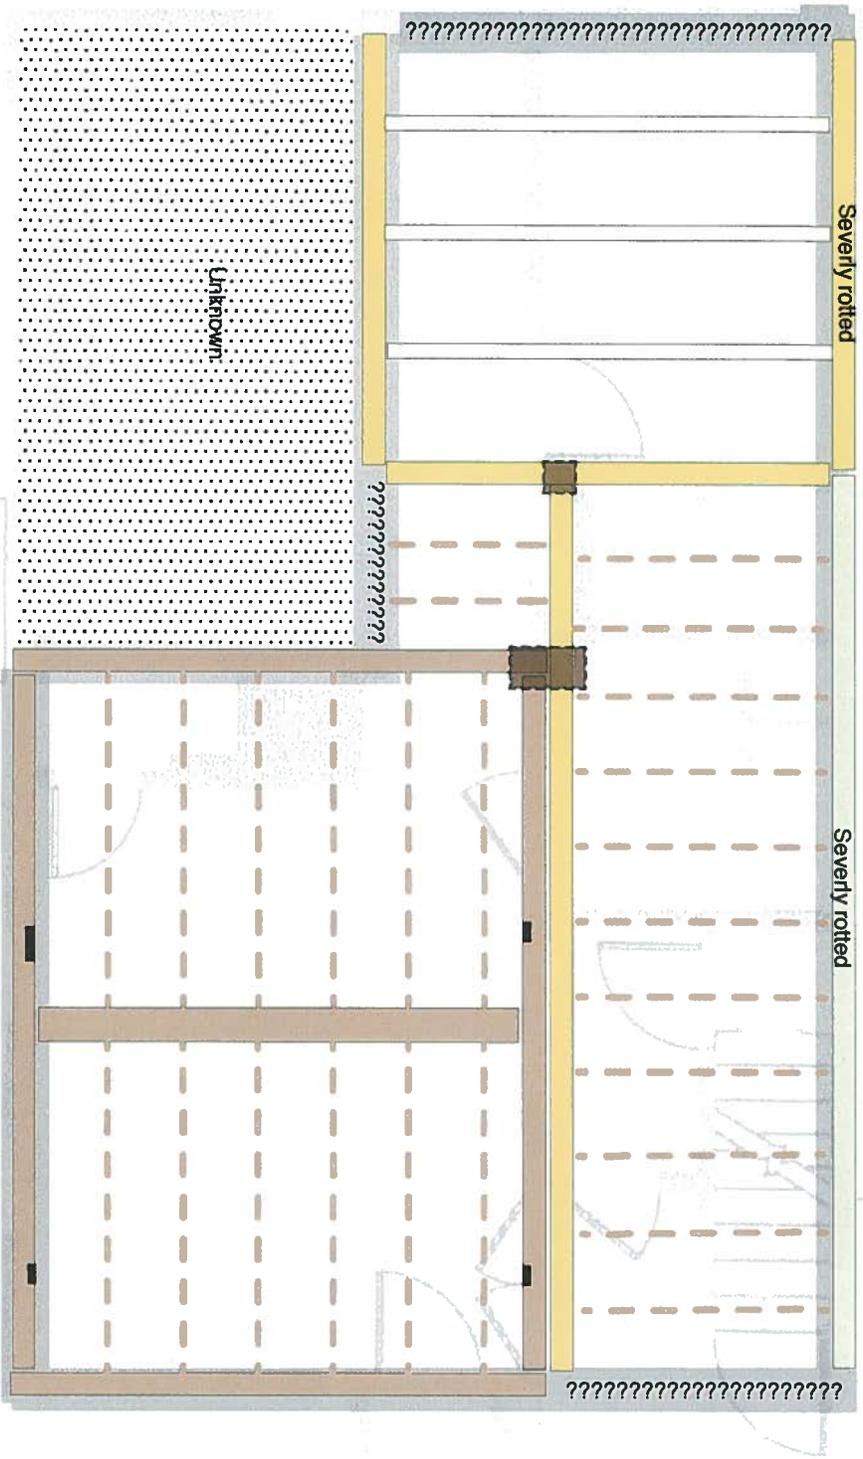
Asa Parlin House Cellar Frame

- Hewn sill or beam - 18th or early 19th Century (mostly pine or hemlock)
- Slash sawn oak 3x4 joist - 18th or early 19th Century
- Slash sawn sill or beam - early to mid 19th Century (pine ?)
- Half round joist - late 18th or early 19th Century (pine ?)
- Circular sawn sill or beam - Mid 19th to 20th century (pine ?)
- Fieldstone foundation
- Unused open mortise
- Wood post
- Not visible

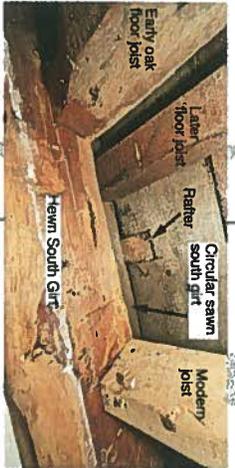
Photo 3: Detail of south end girt showing two layers of floor joists with the later joist framed into the circular sawn girt to carry the current second floor boards.

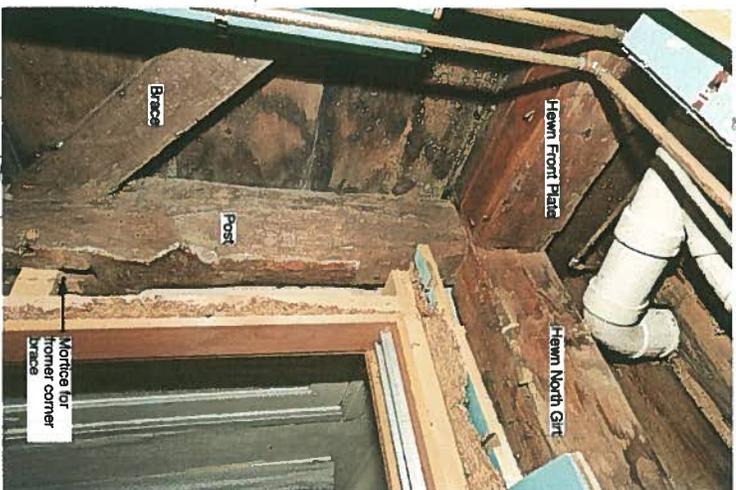
Photo 1: NW corner of hewn frame showing hewn oak post and slash sawn corner brace. Top of post is tenoned into the bottom of the south girt but does not have the shouldered haunch that would be normal for this joint in the 18th century (i.e., an English tie joint). The front plate is tenoned into the north end girt, suggesting that the north end girt might have once been a post. The hewn frame is placed once a one room free standing structure.

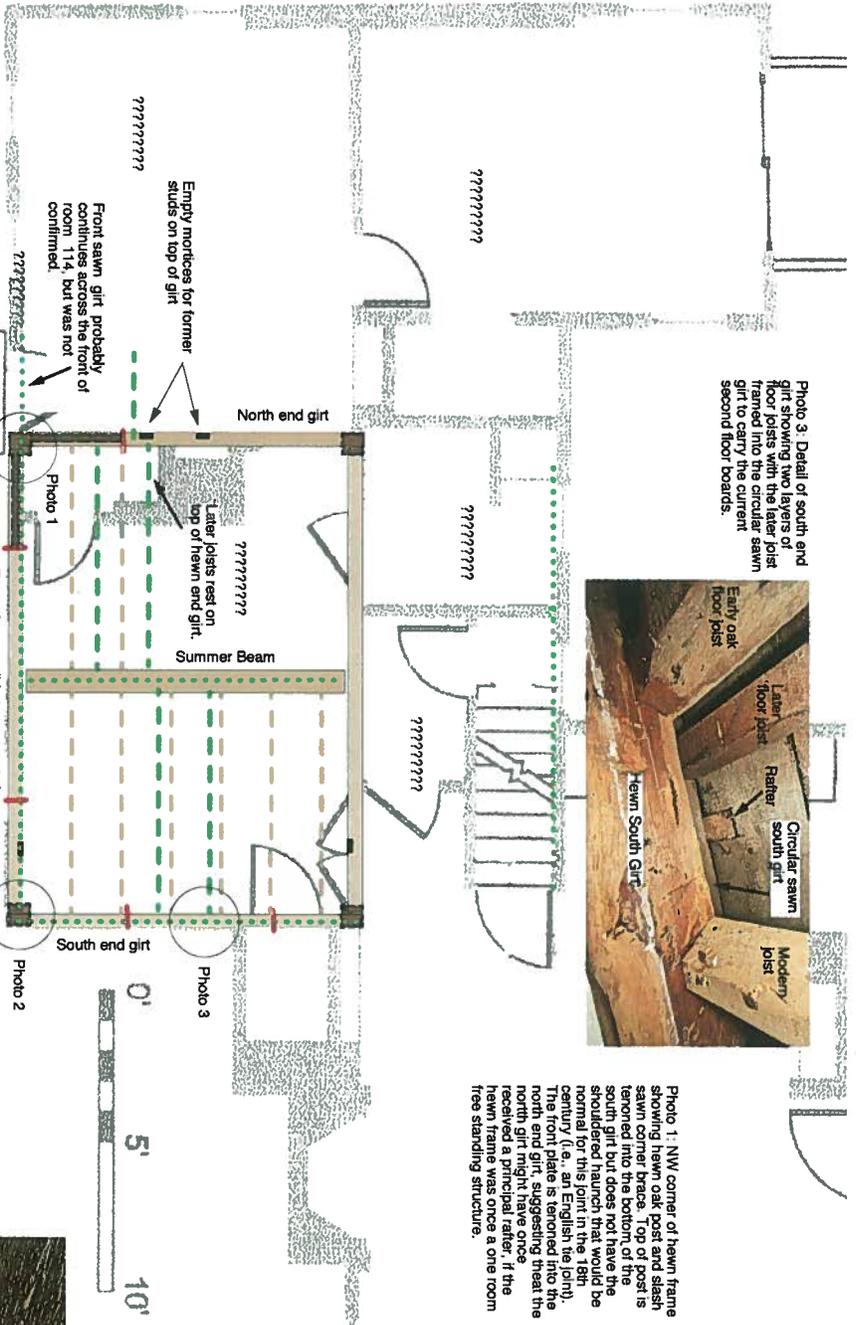
VISIBLE EARLY FIRST FLOOR FRAMING

Scale: 1/4" = 1'

NOTE: Circular sawn 5x5 girts and beams are set directly on top of the hewn frame front and south girts and summer beam and have their own joists to carry the second floor boards.

- Hewn girt or beam - 18th or early 19th Century (mostly pine or hemlock)
- Slash sawn oak 3x4 joist set in hewn girts - 18th or early 19th Century
- Slash sawn oak 3x4 corner brace - 18th or early 19th Century
- Pin for corner brace (brace not visible) - 18th or early 19th Century
- Circular sawn girts or beams - Mid 19th to 20th century - probably added with current roof frame (pine?)
- Sawn joists set in circular sawn girts - Mid 19th to 20th century (pine?)
- Unused open mortises
- Hewn post below girt - 18th or early 19th Century (oak)
- Not visible

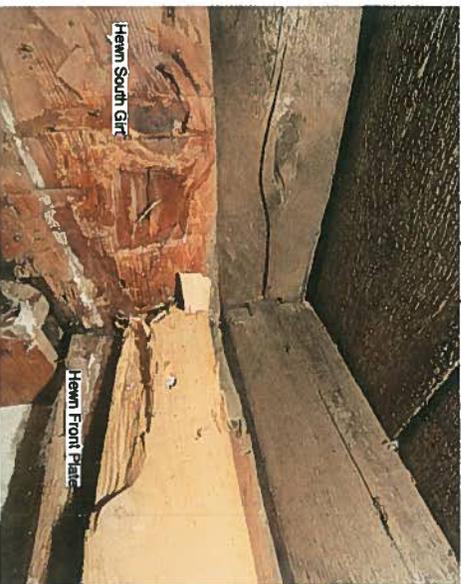
Photo 2: Circular sawn girts set on top of hewn girts at SW corner of room. Top hewn front plate is framed into the south girt.
