# PHASE I- PRELIMINARY REPORT

## Town of Acton

### Summary of Conditions and Recommendations for the Repair/Rehabilitation of Town Owned Bridges

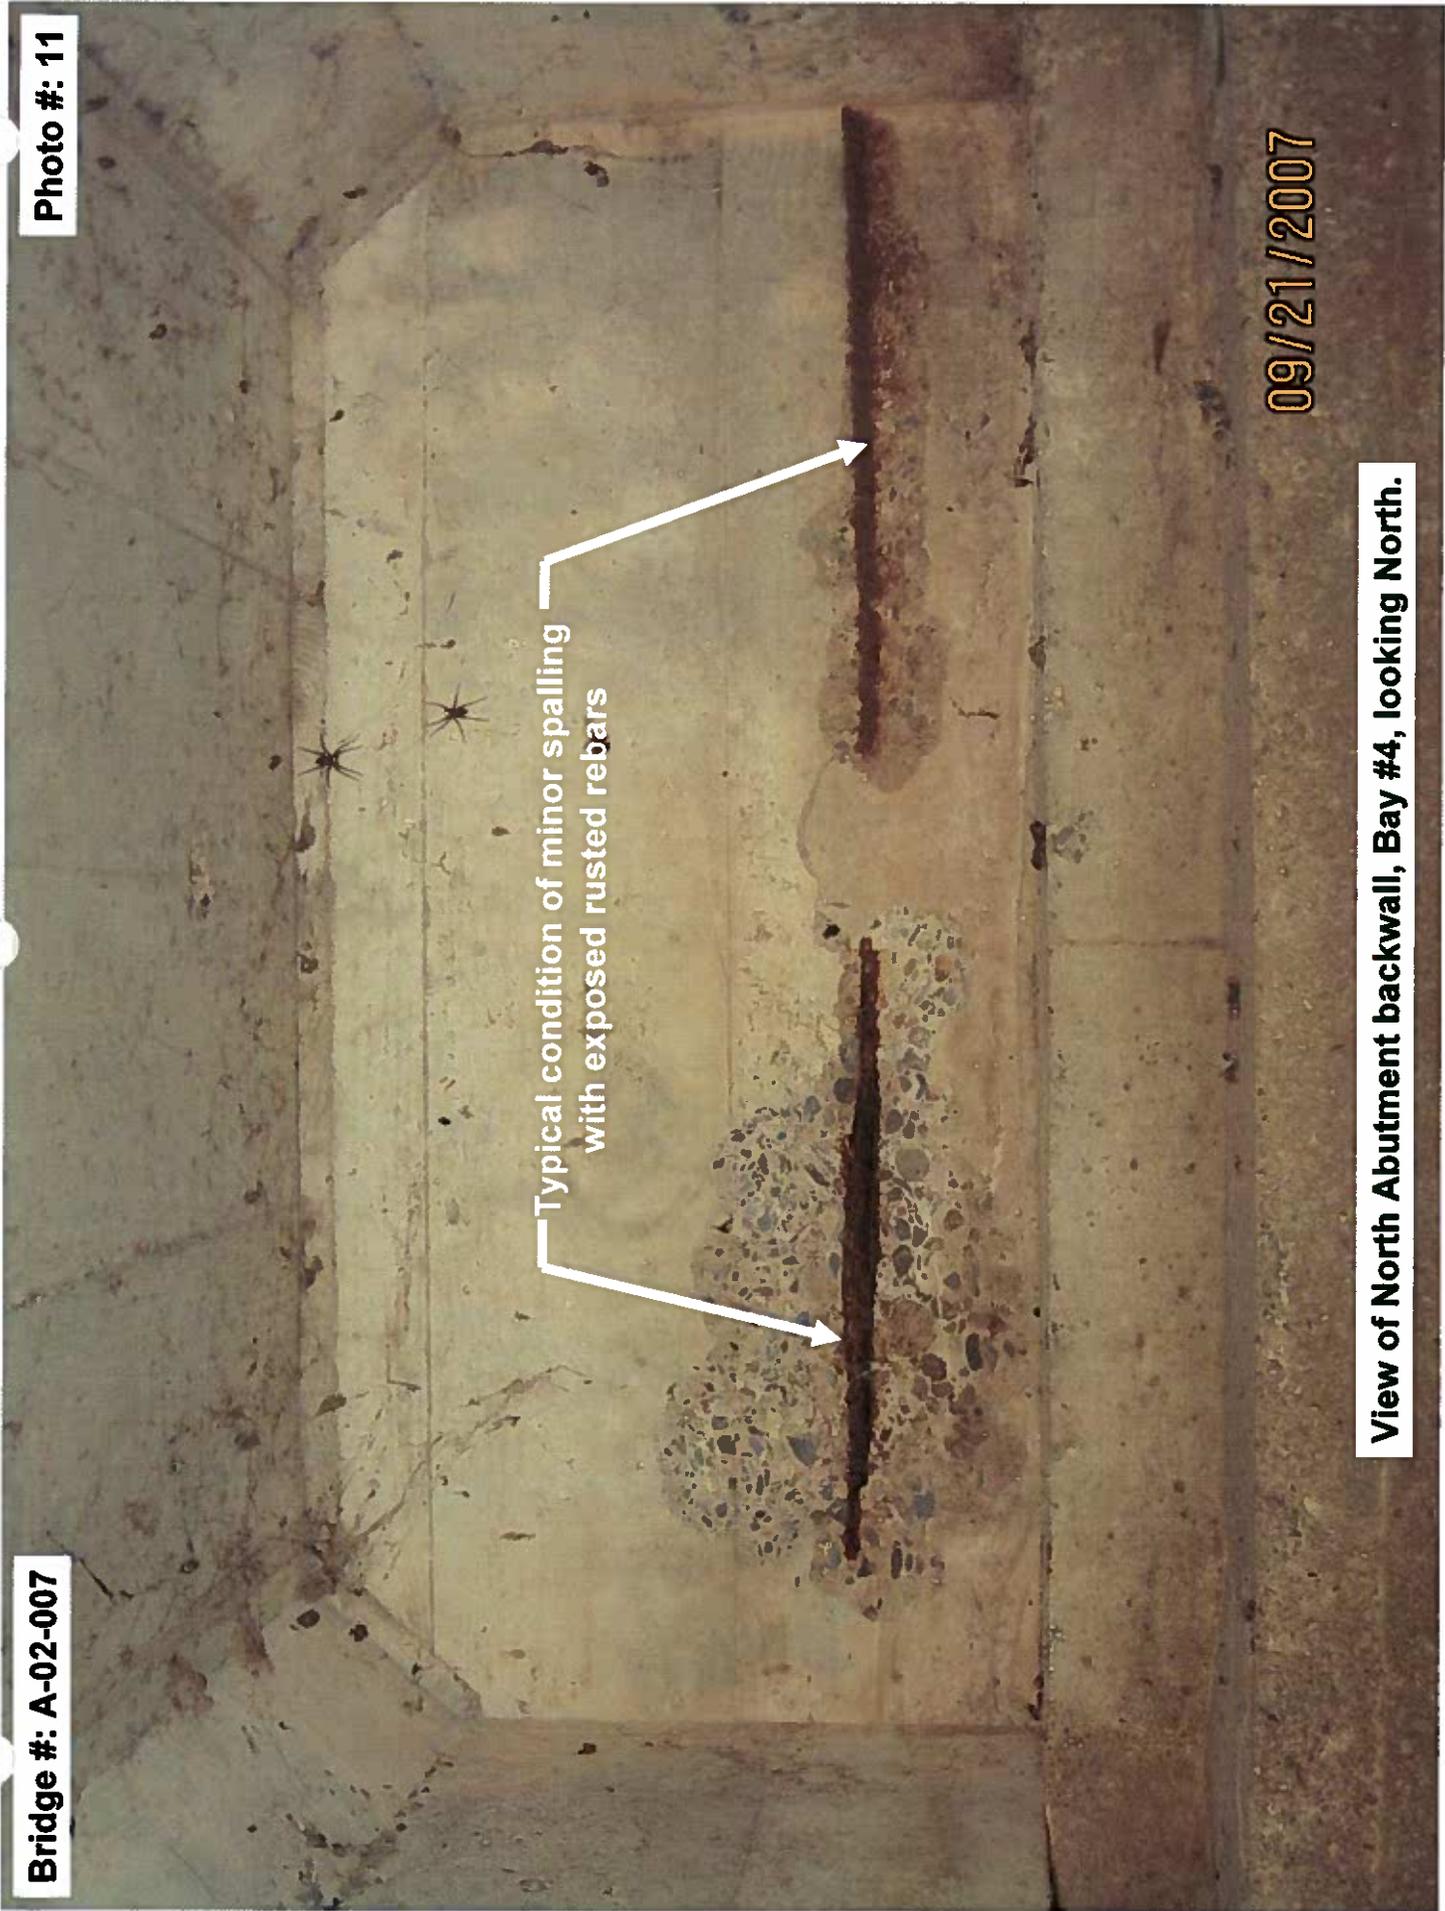
Typical condition of minor spalling  
with exposed rusted rebars

View of North Abutment backwall, Bay #4, looking North.

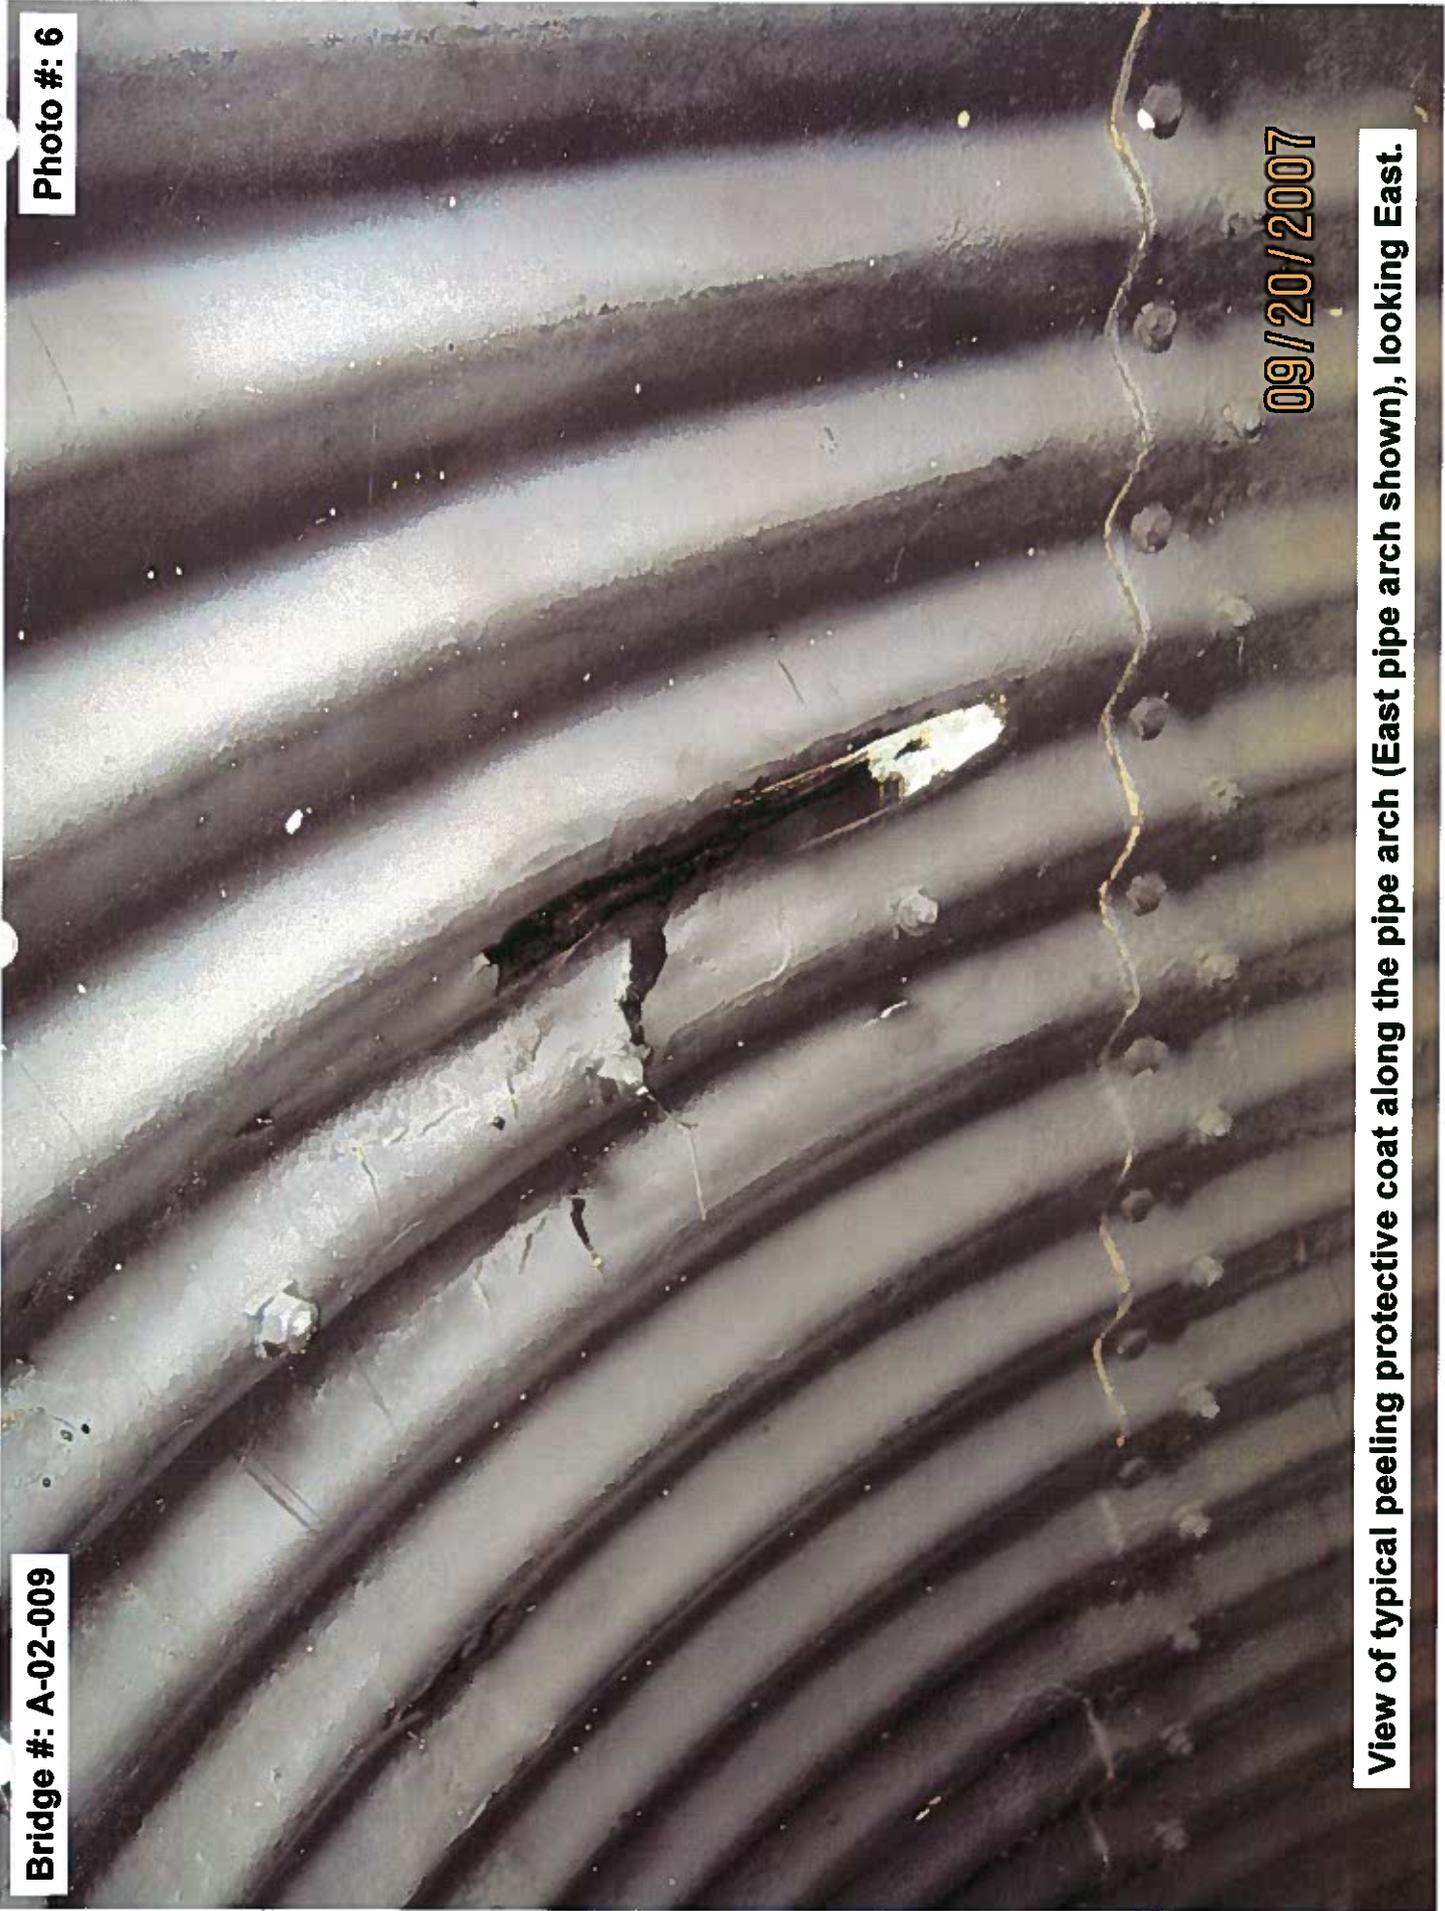
Photo #: 6

View of typical peeling protective coat along the pipe arch (East pipe arch shown), looking East.

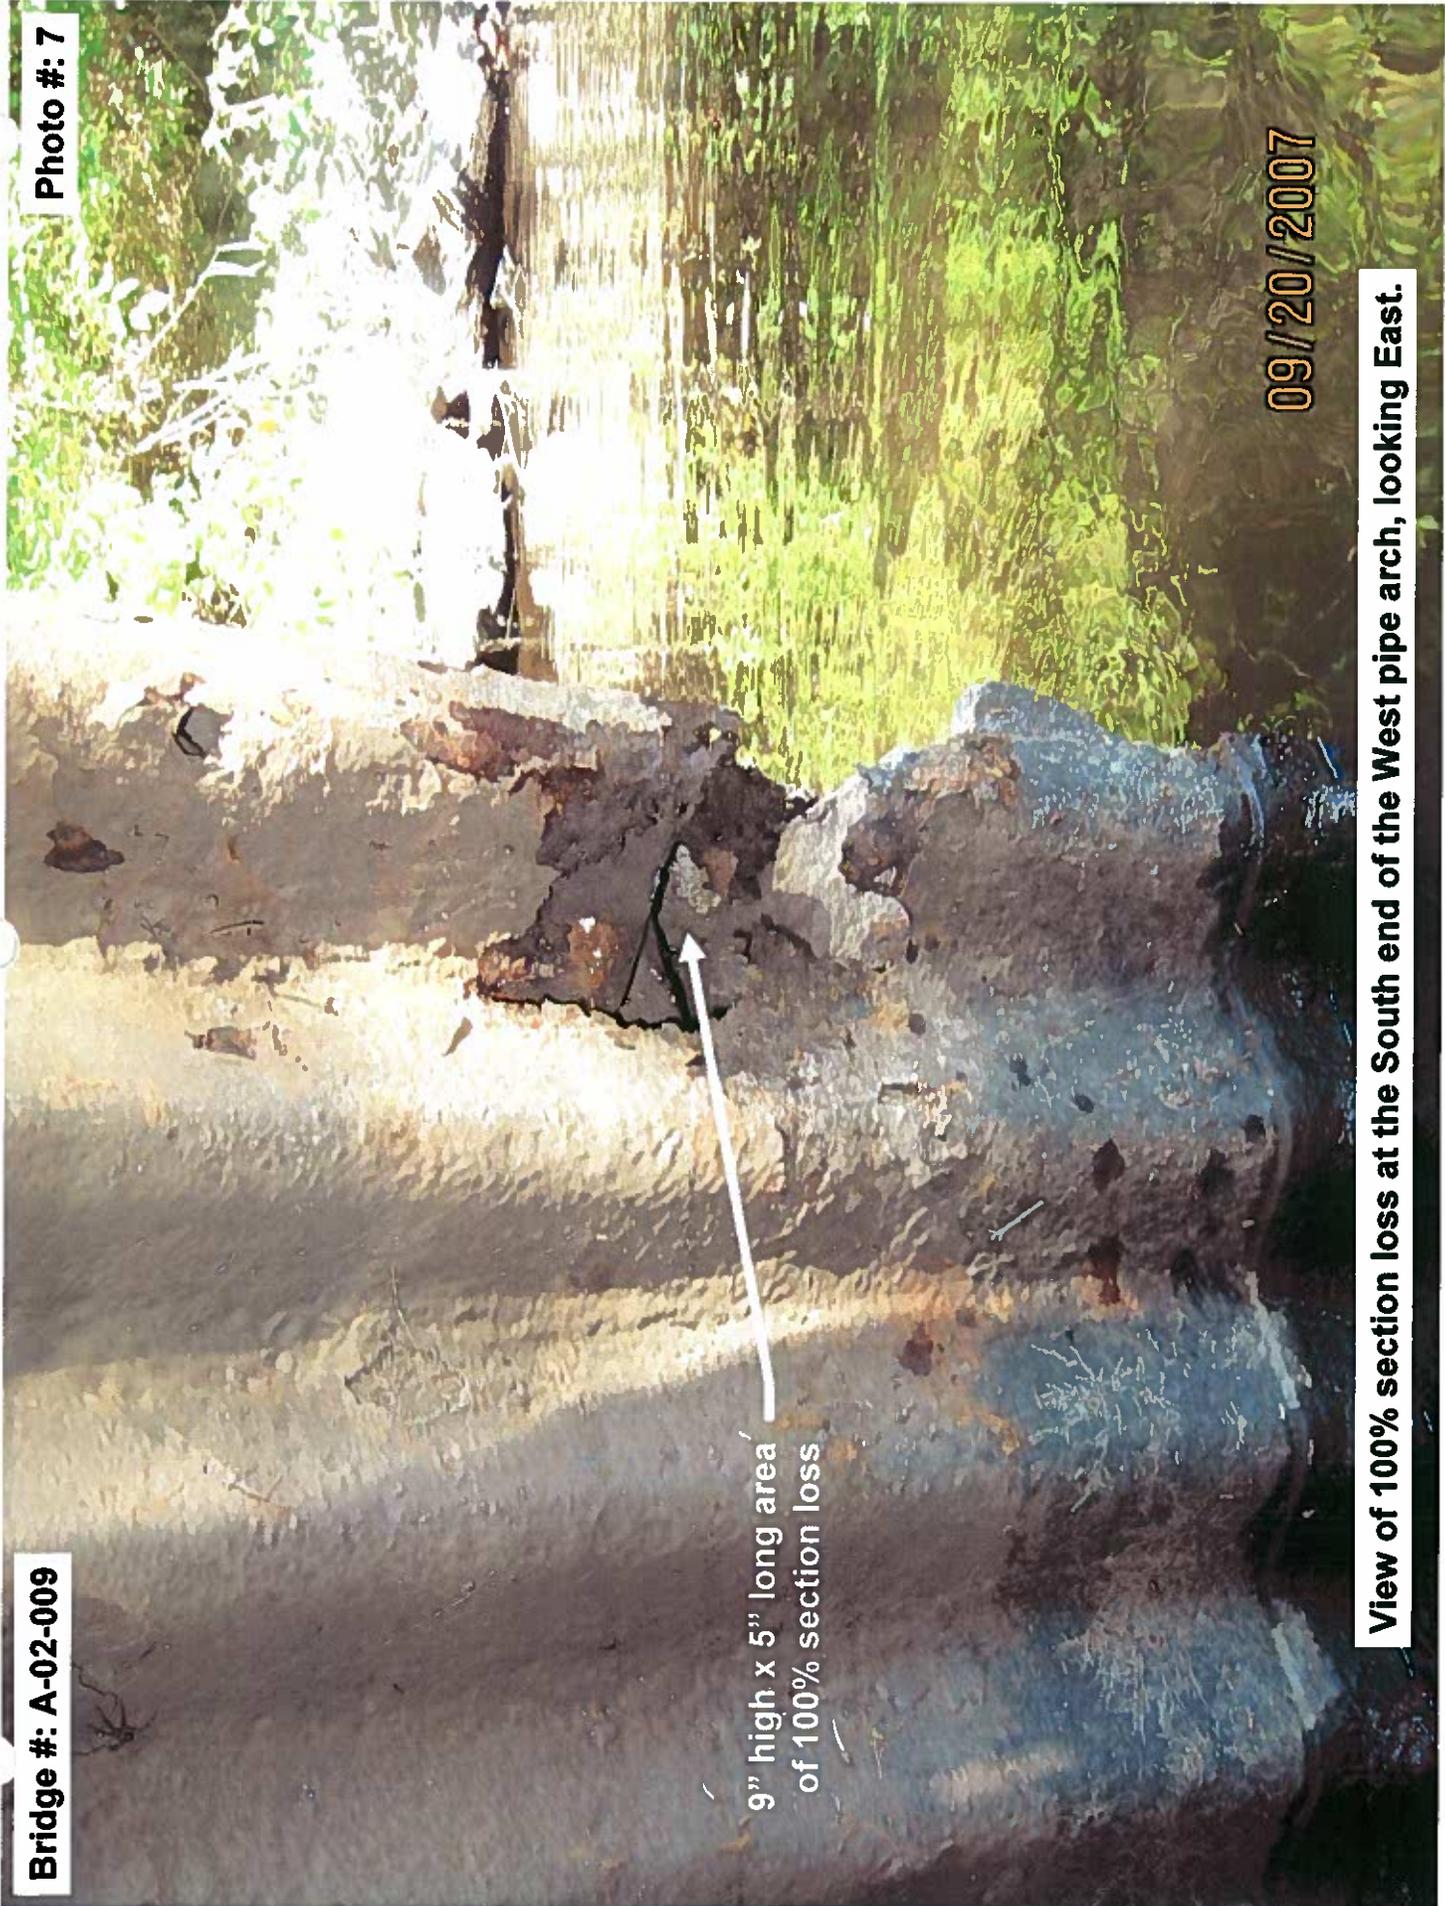
Photo #: 7

View of 100% section loss at the South end of the West pipe arch, looking East.

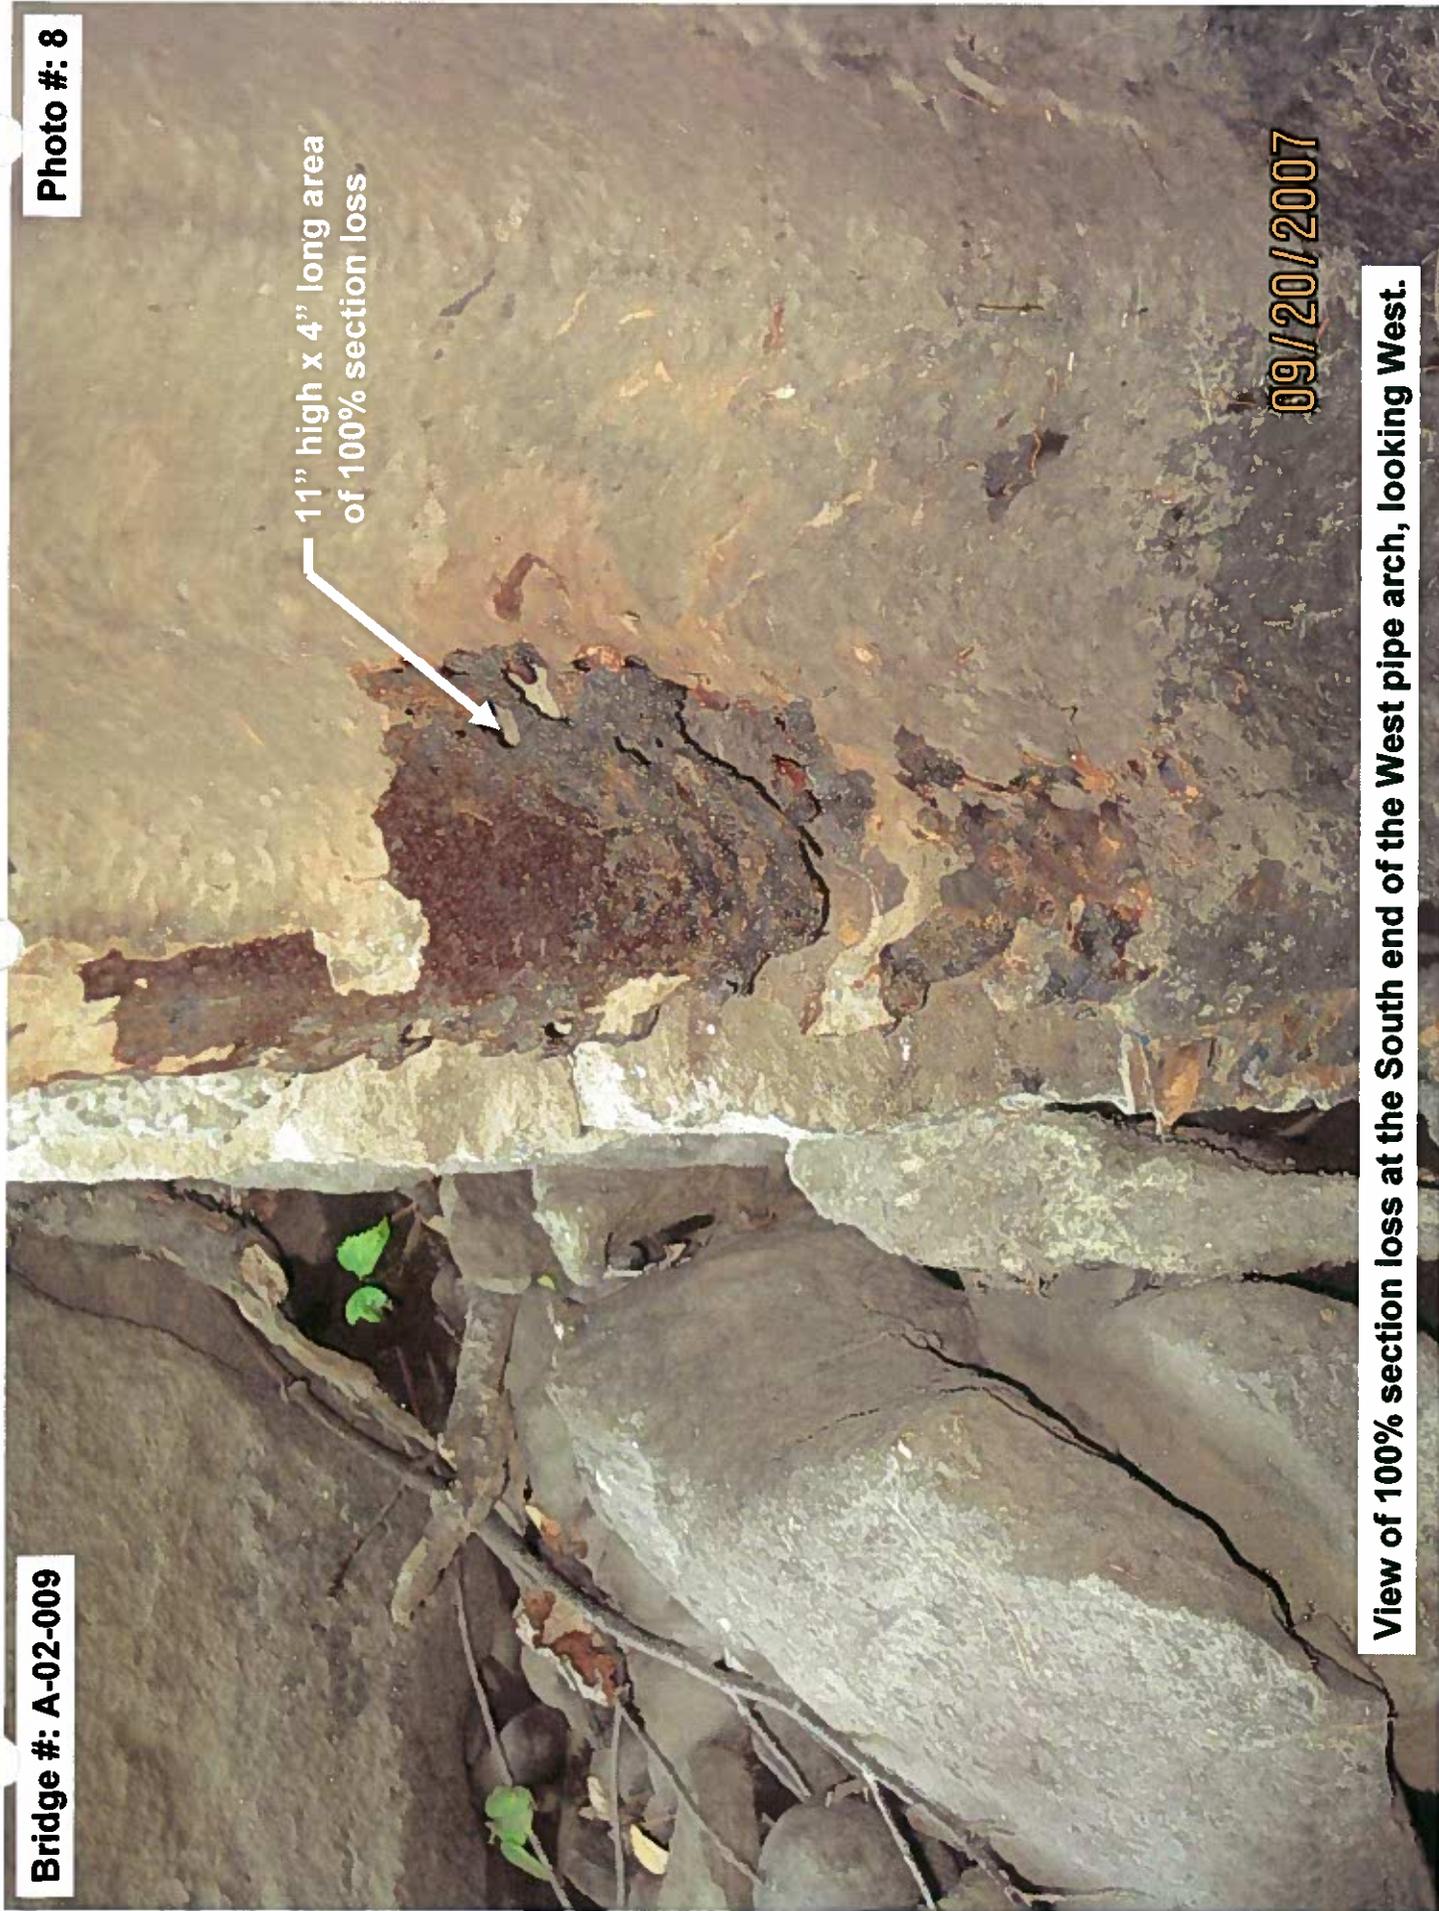
Photo #: 8

View of 100% section loss at the South end of the West pipe arch, looking West.

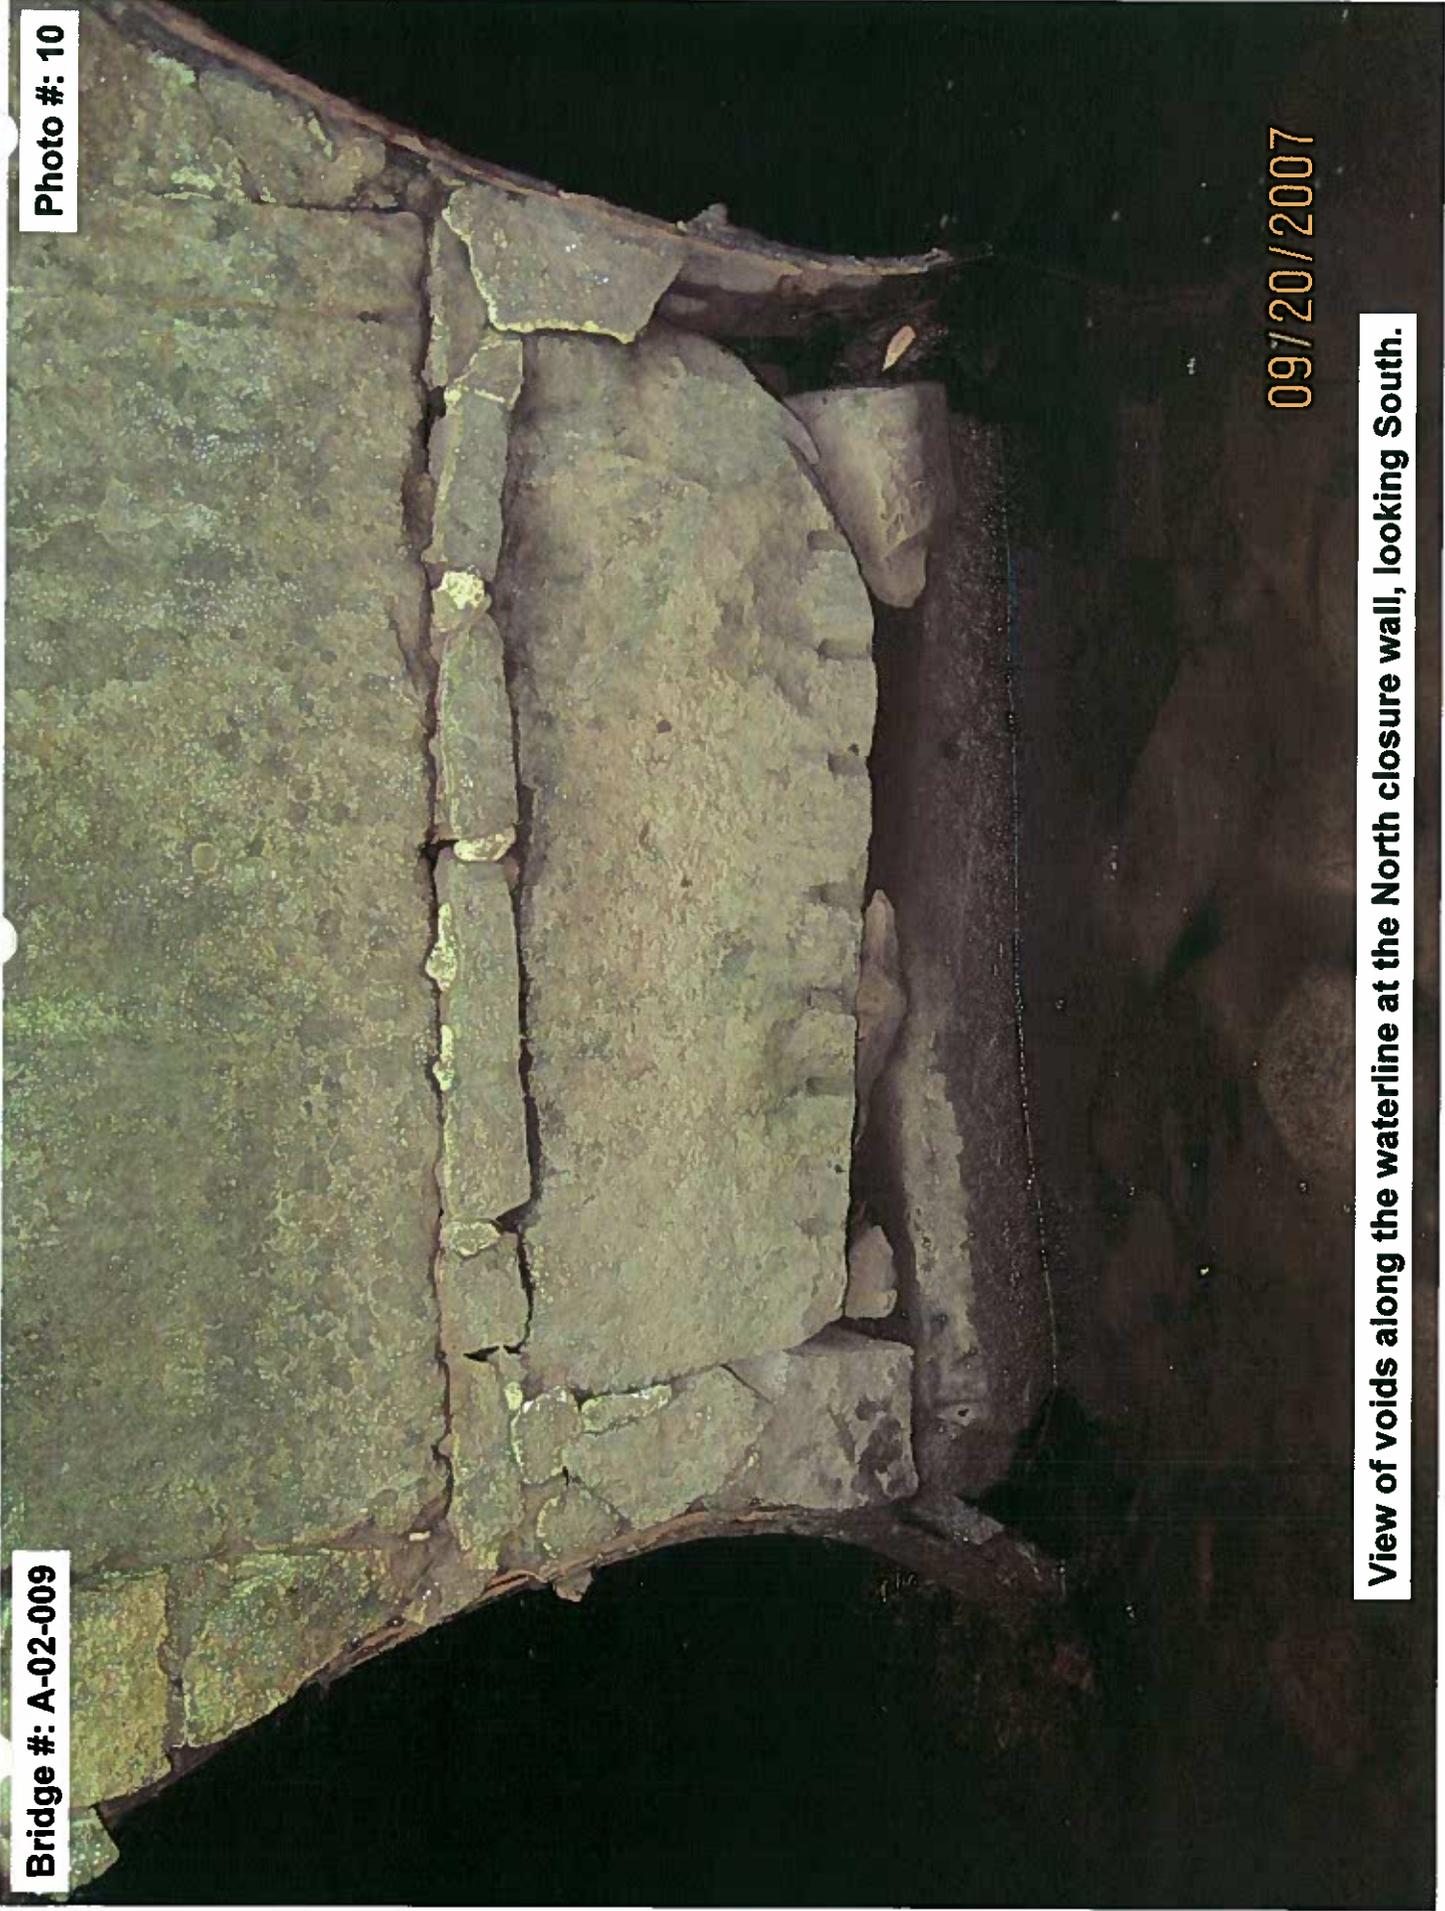
Photo #: 10

View of voids along the waterline at the North closure wall, looking South.

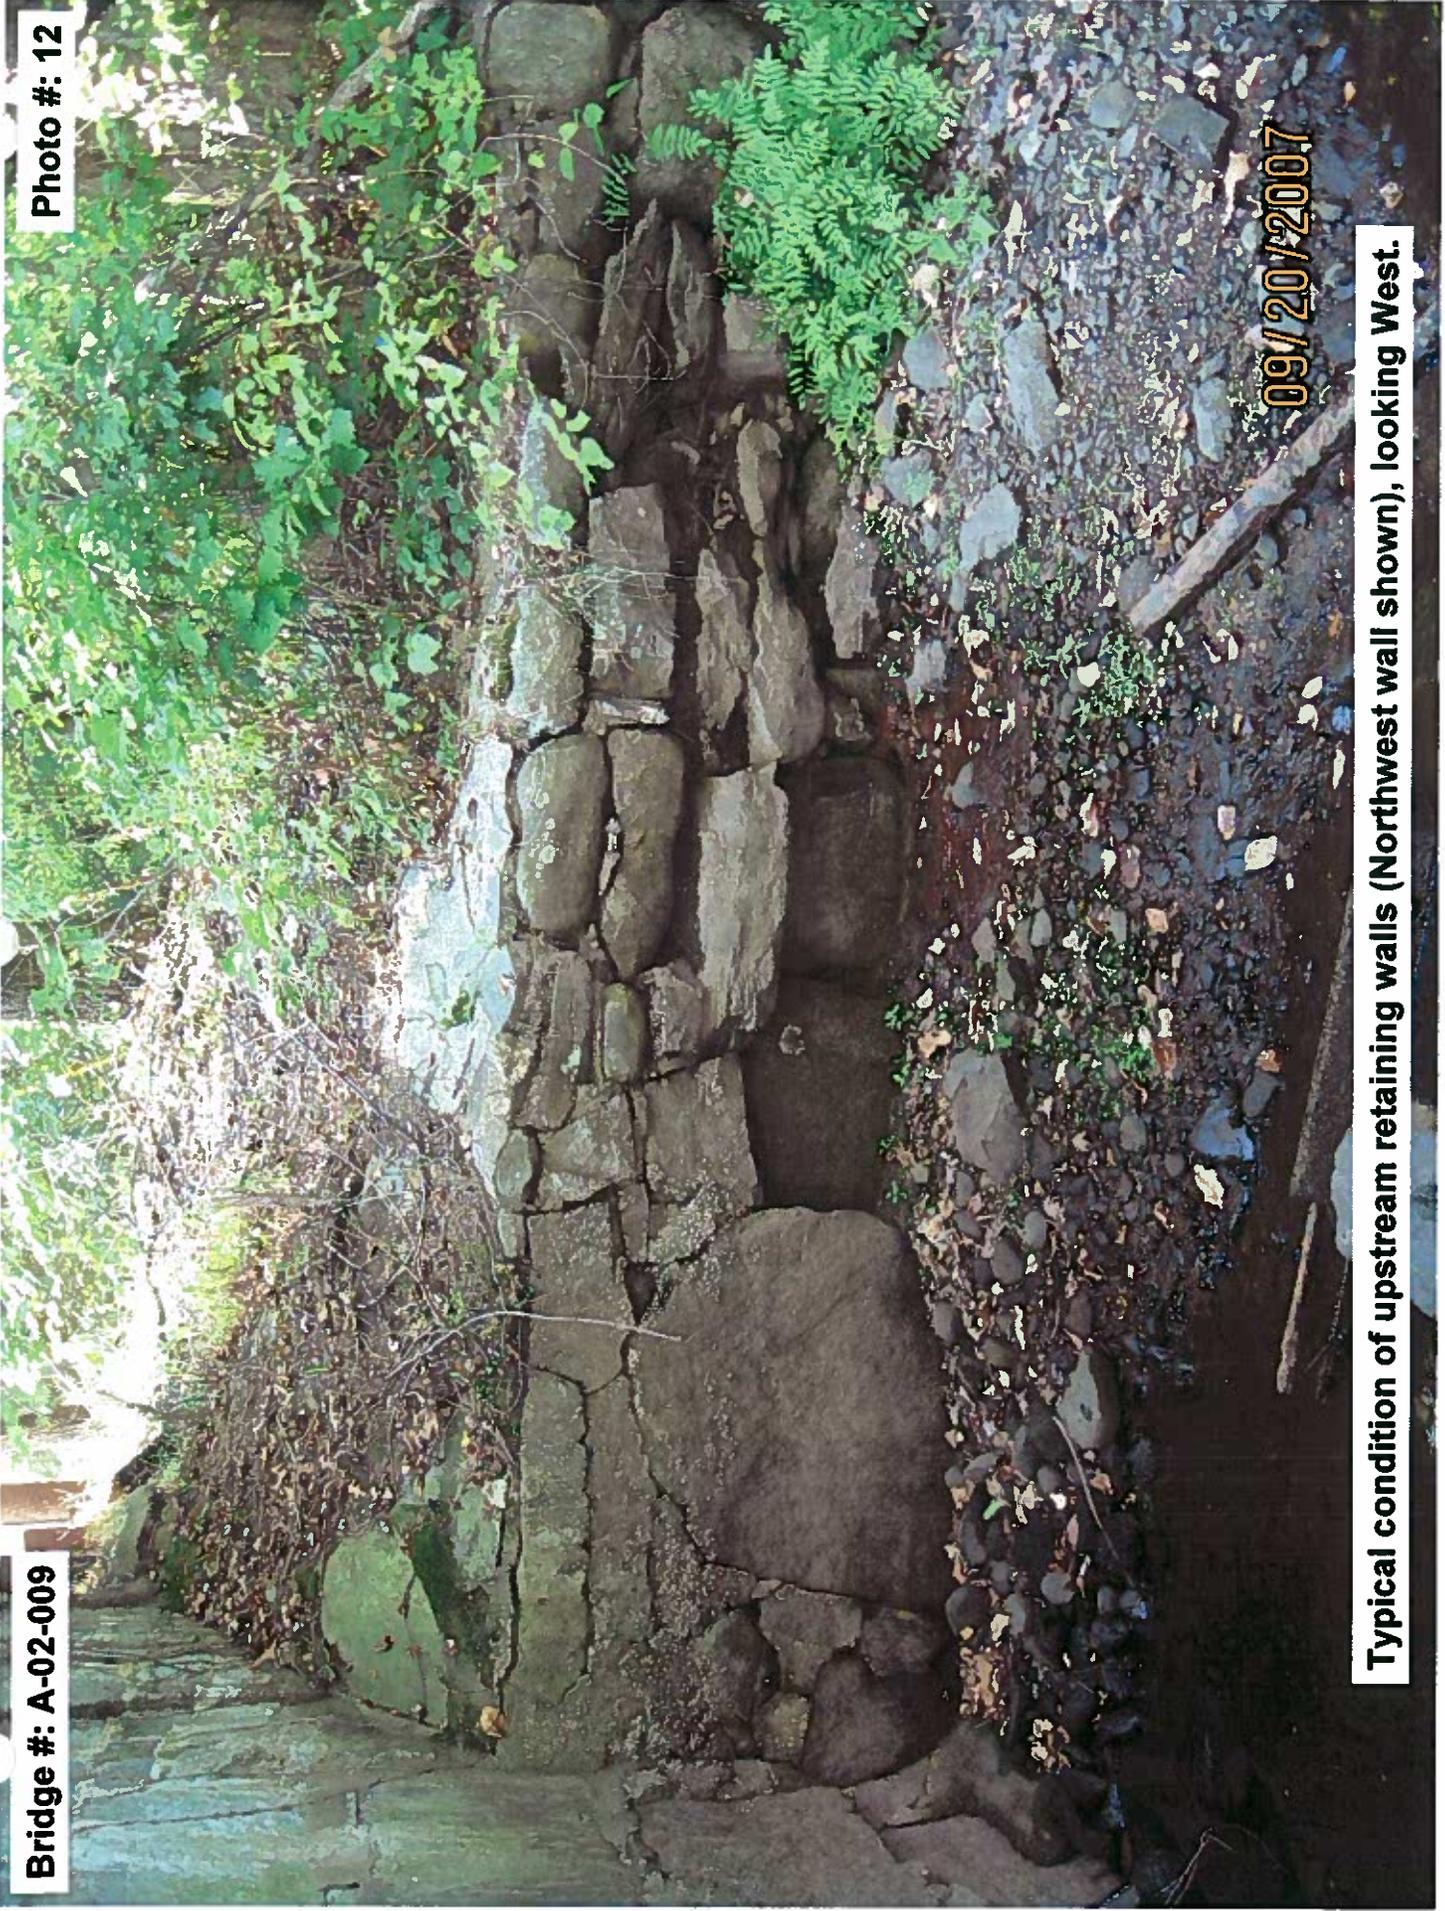
Photo #: 12

Typical condition of upstream retaining walls (Northwest wall shown), looking West.

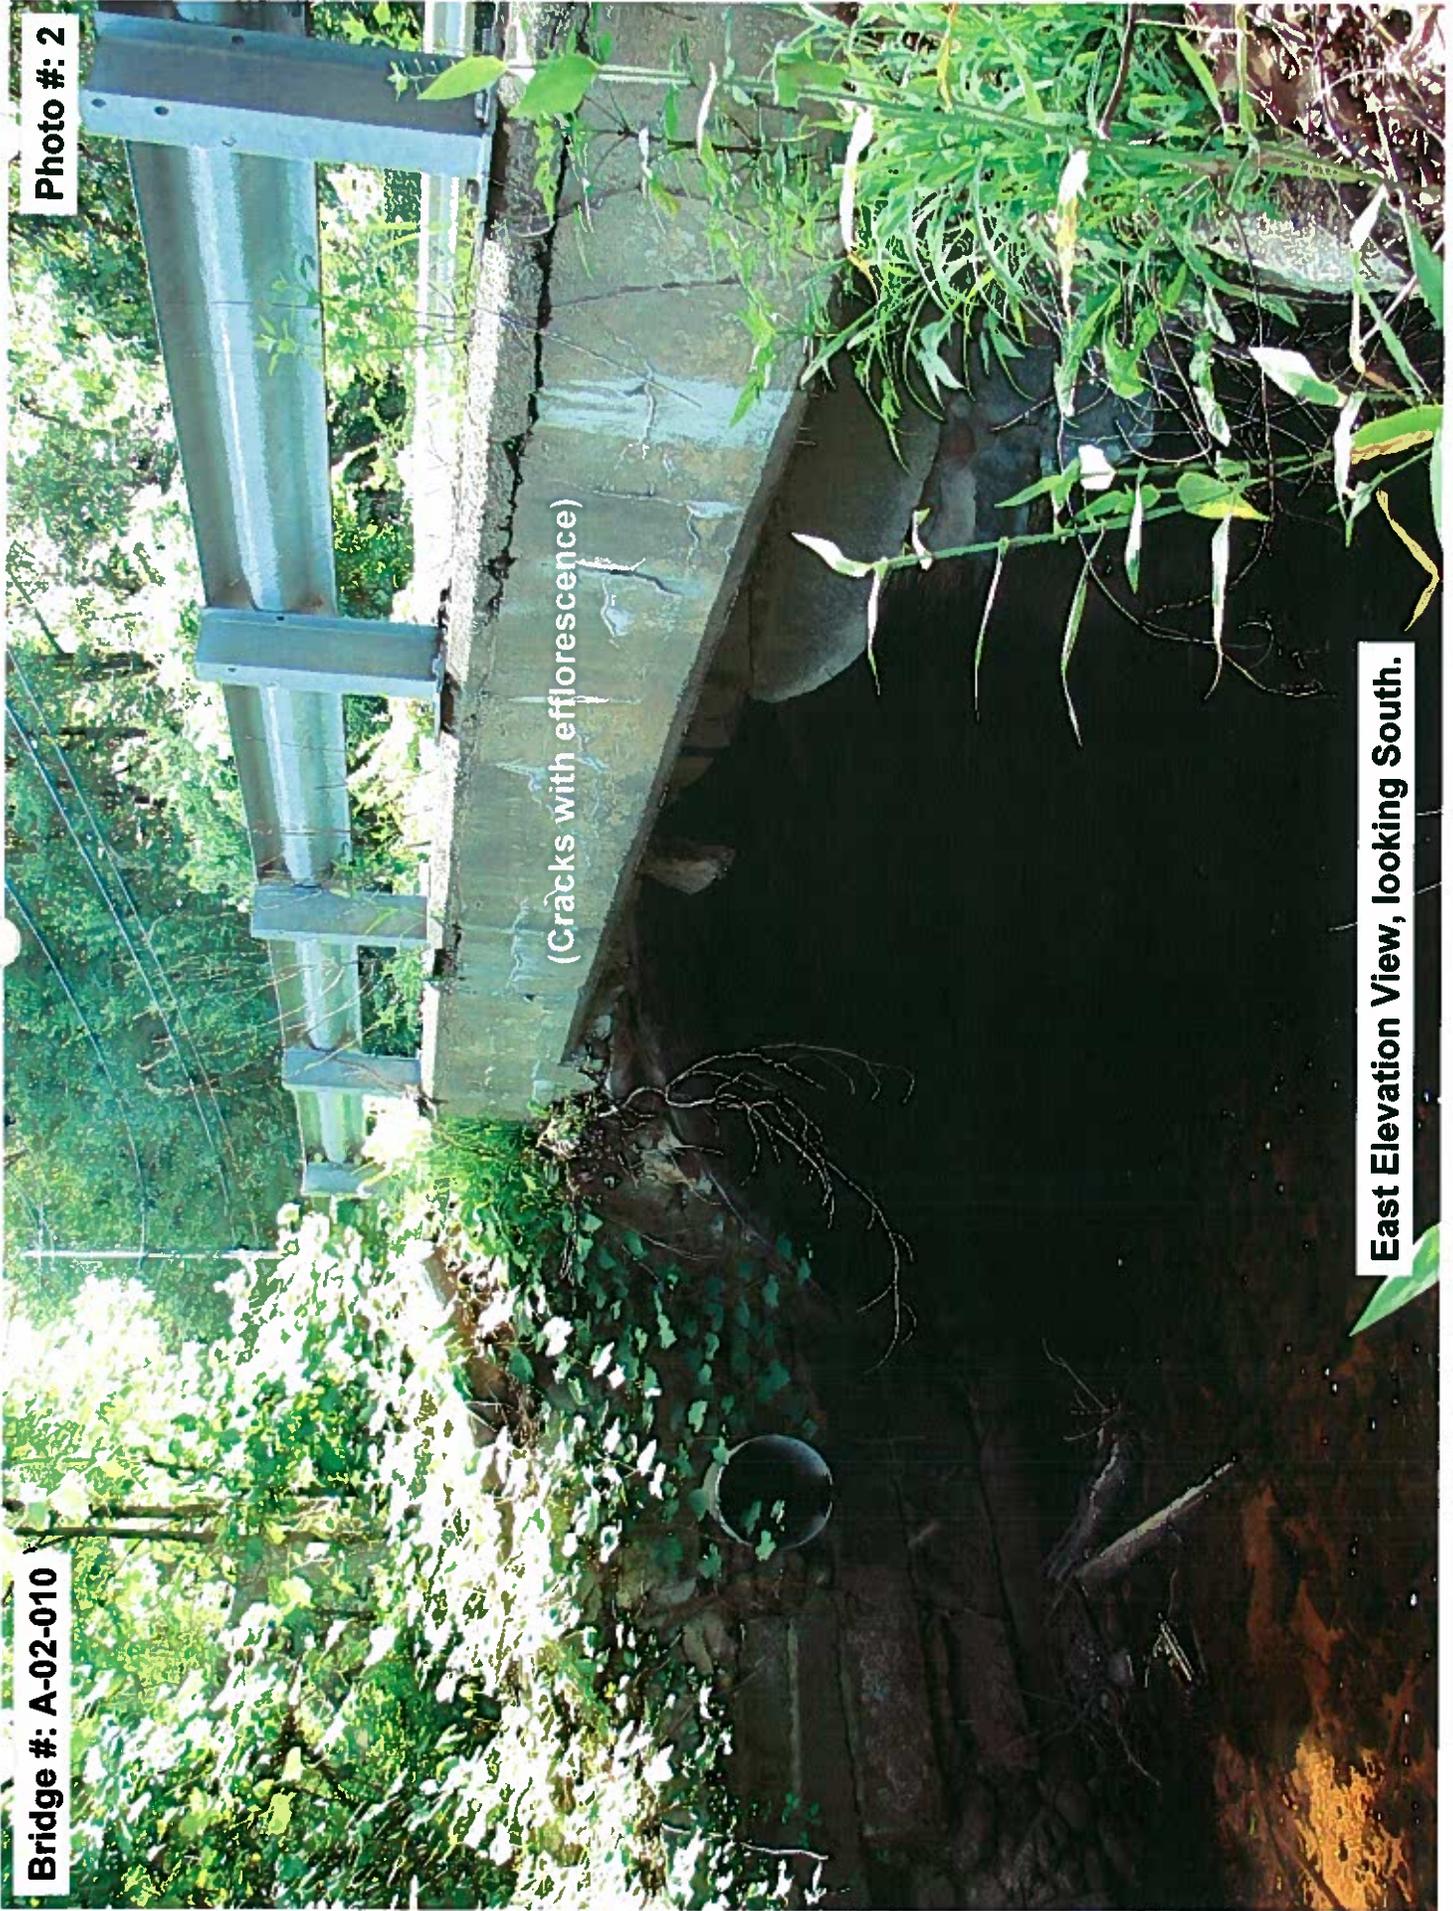
(Cracks with efflorescence)

East Elevation View, looking South.

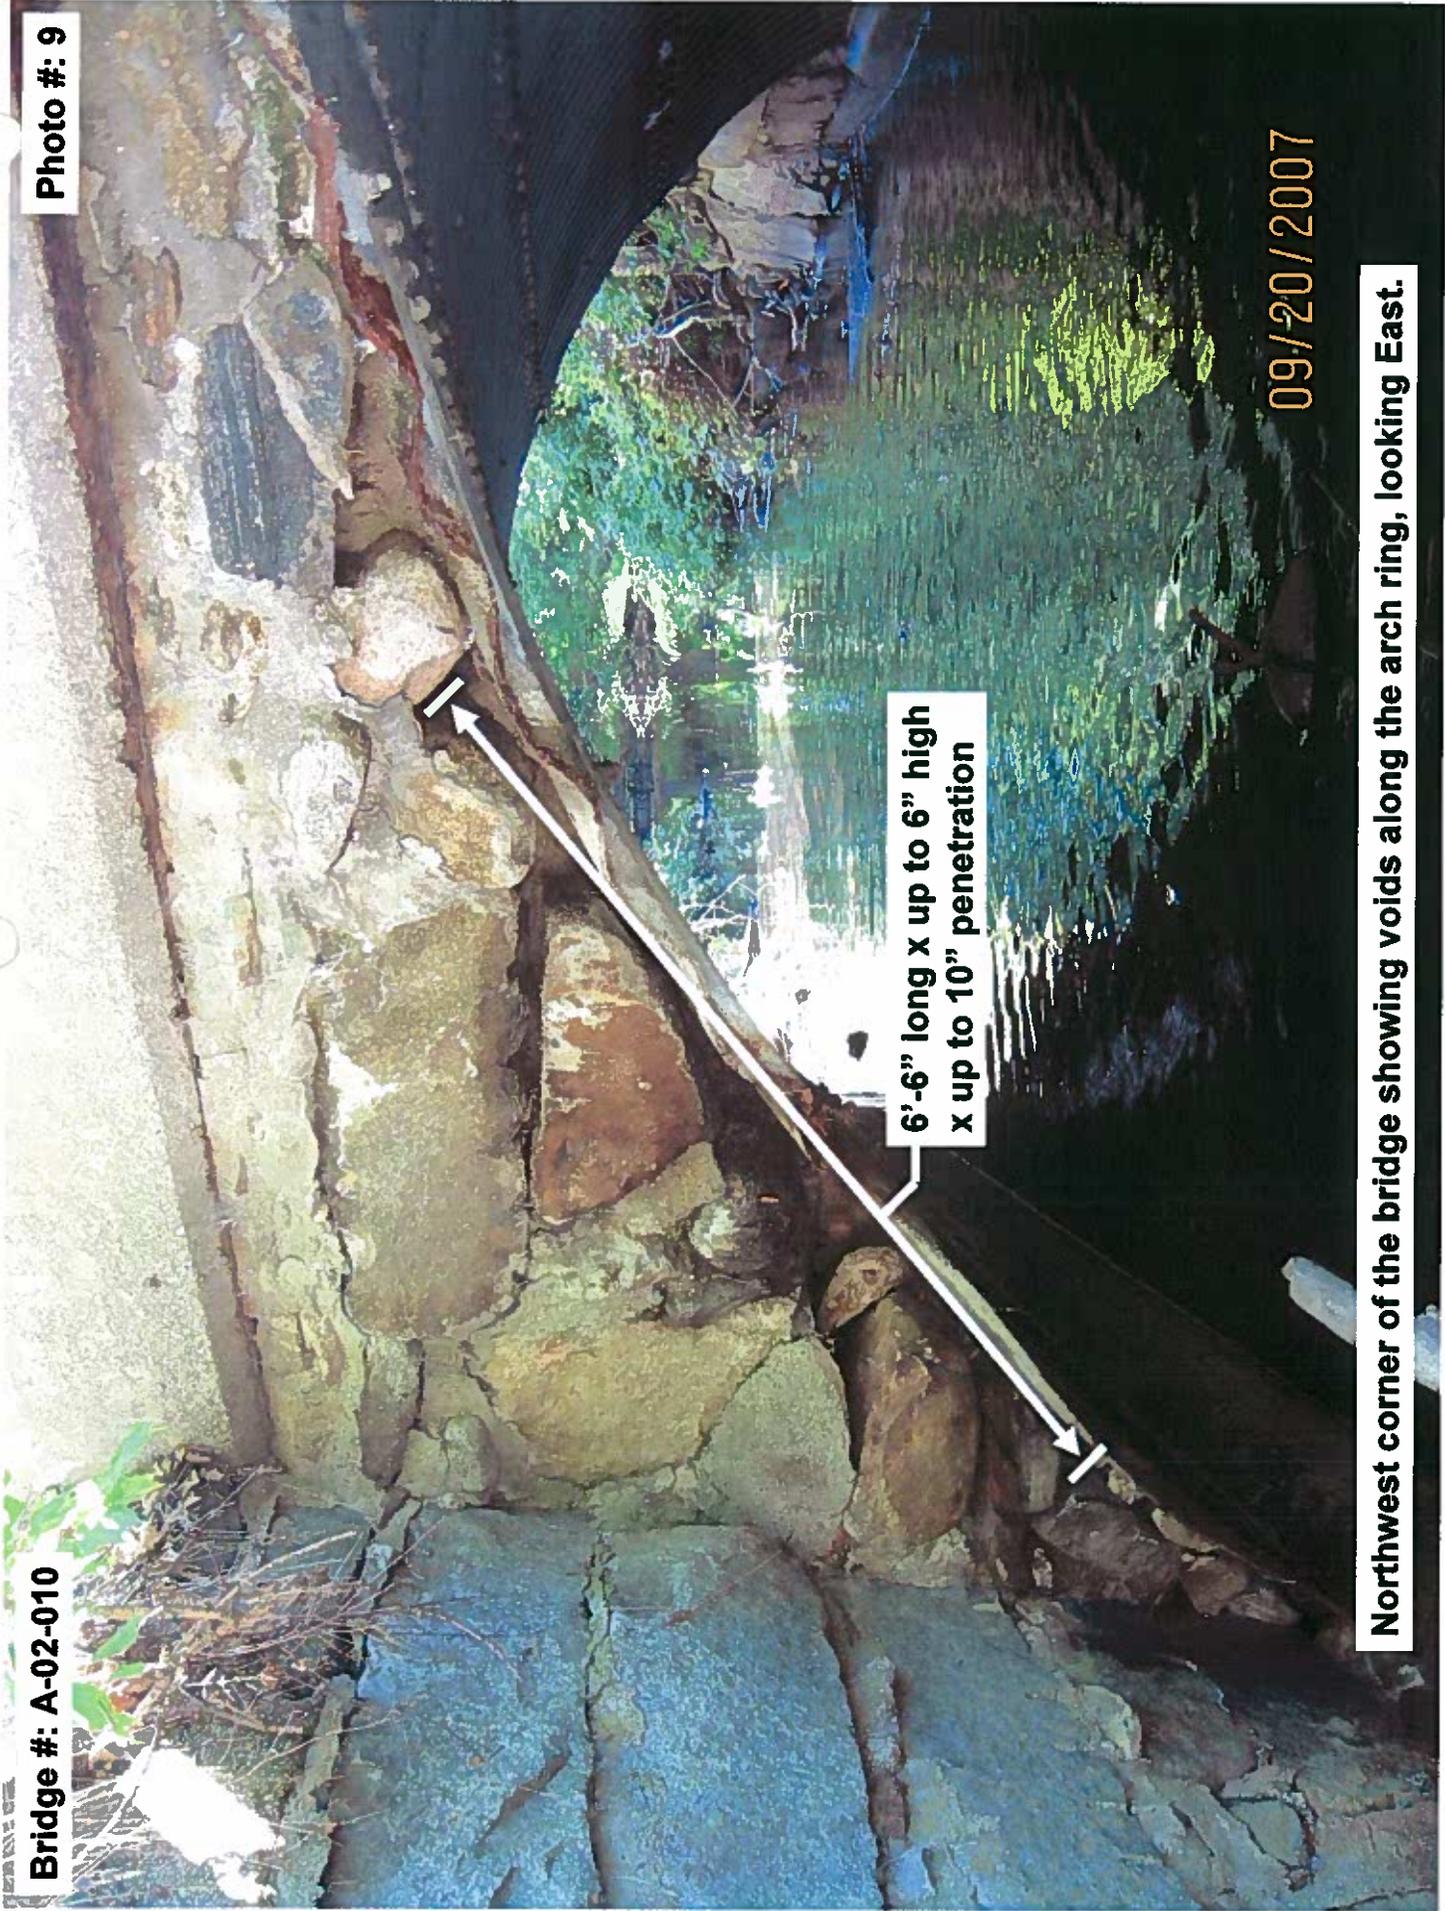
Photo #: 9

Typical condition of voids along the deck arch ring (East side shown), looking Northwest.
