# PHASE I- PRELIMINARY REPORT

## Town of Acton

### Summary of Conditions and Recommendations for the Repair/Rehabilitation of Town Owned Bridges

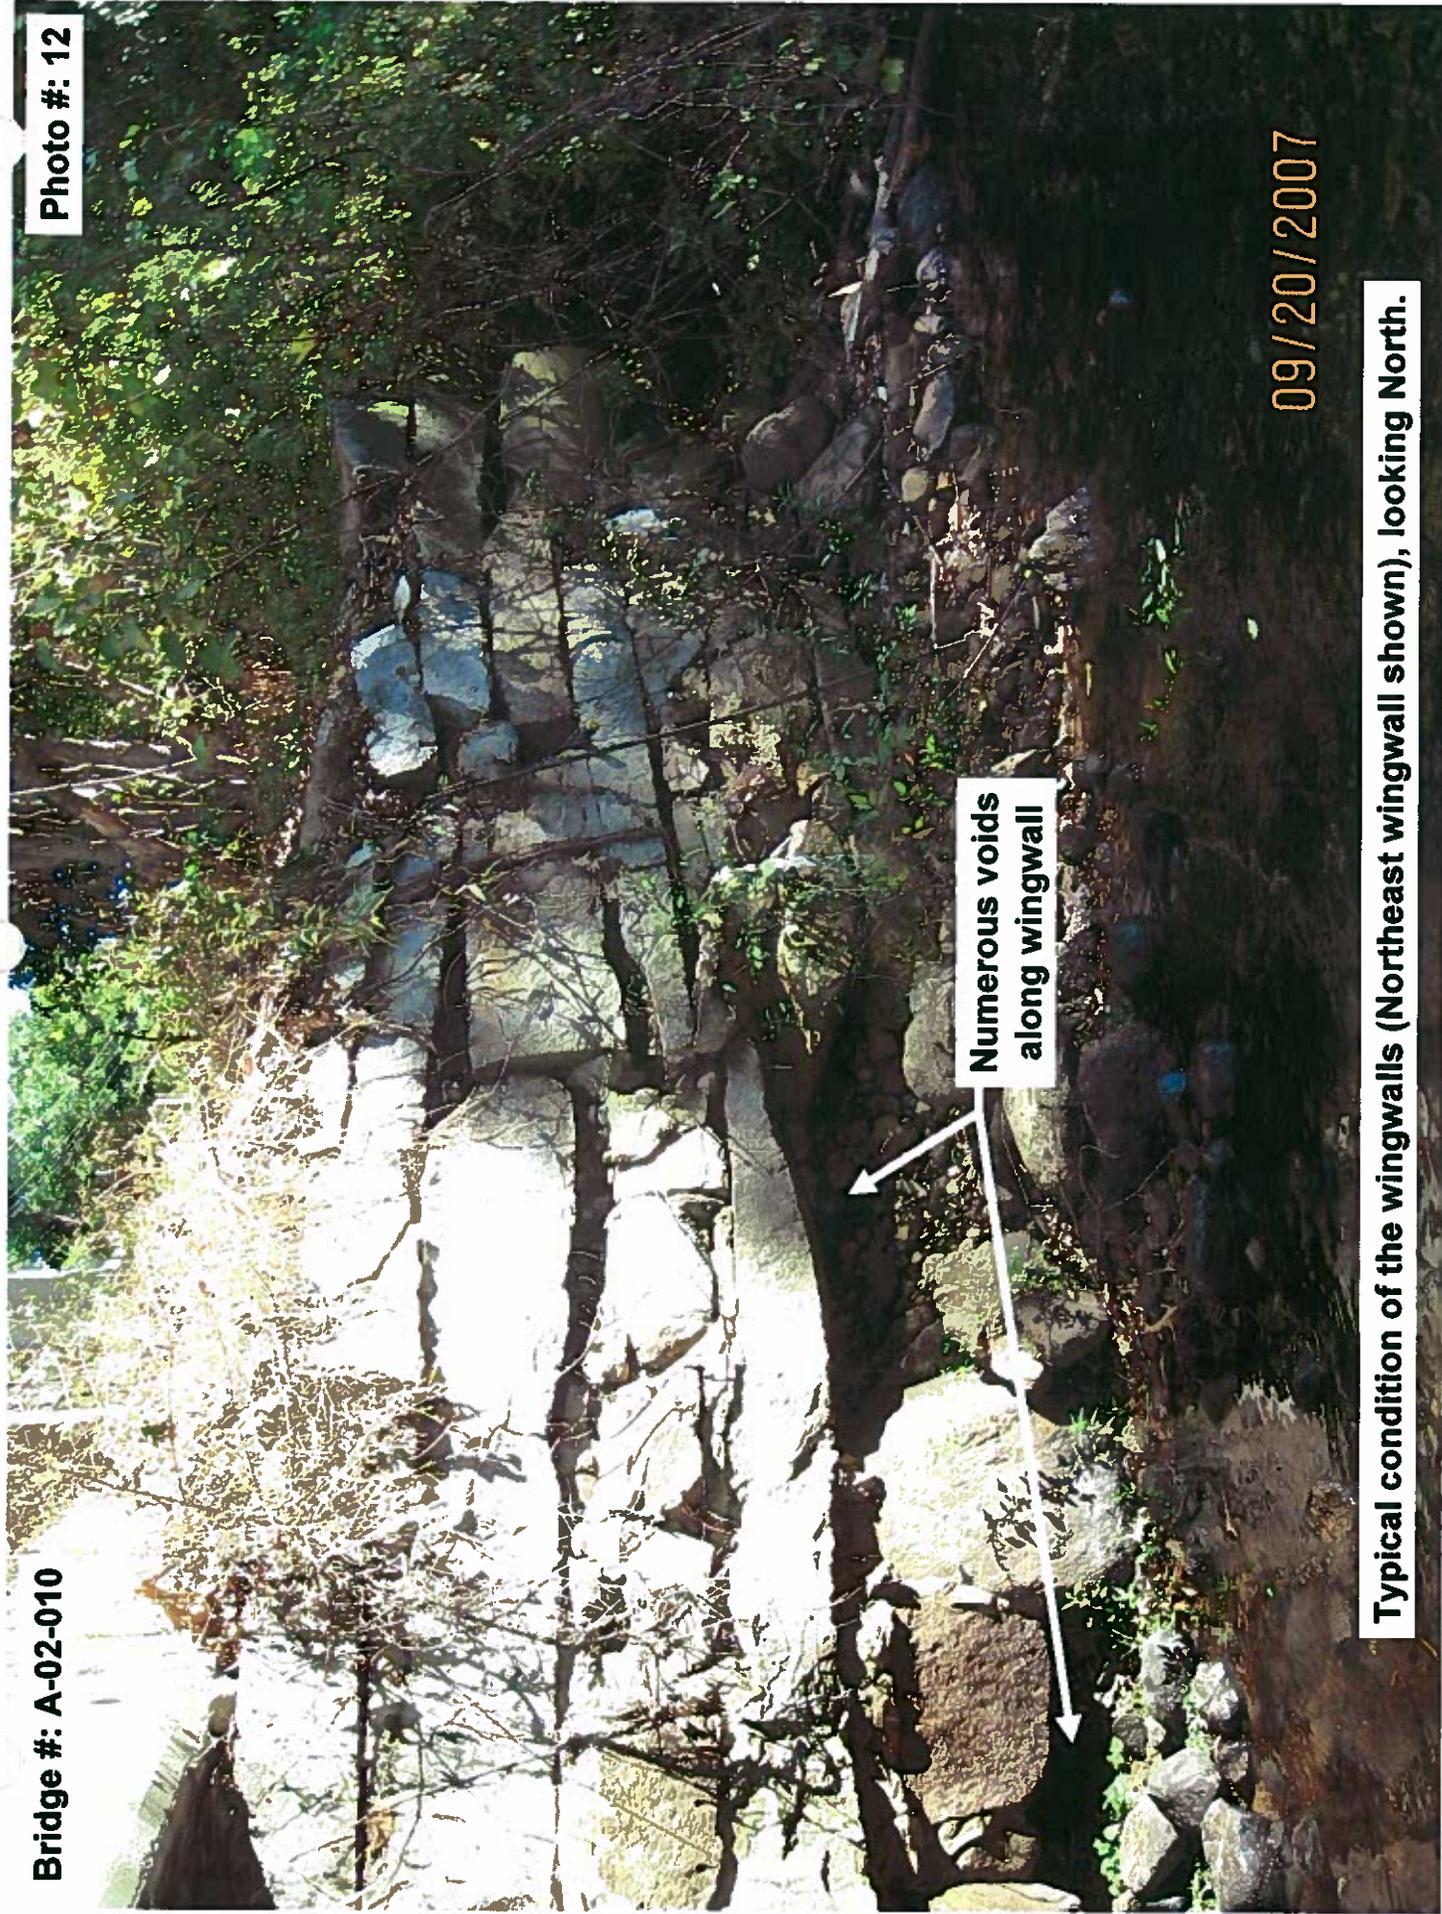
Photo #: 12

Numerous voids  
along wingwall

Typical condition of the wingwalls (Northeast wingwall shown), looking North.

#9	West end of South Abutment	Exposed footing	Consider placing riprap along abutments	Low
#10	West end of South Abutment	Severe scaling and minor spalling	Patch with cementitious mortar	Low
#11	Southeast wingwall	Numerous dead trees along top of wall	Remove trees	Low
#12	Wingwalls	Voids and deteriorated mortar	Fill voids and repoint stone masonry as needed	Moderate

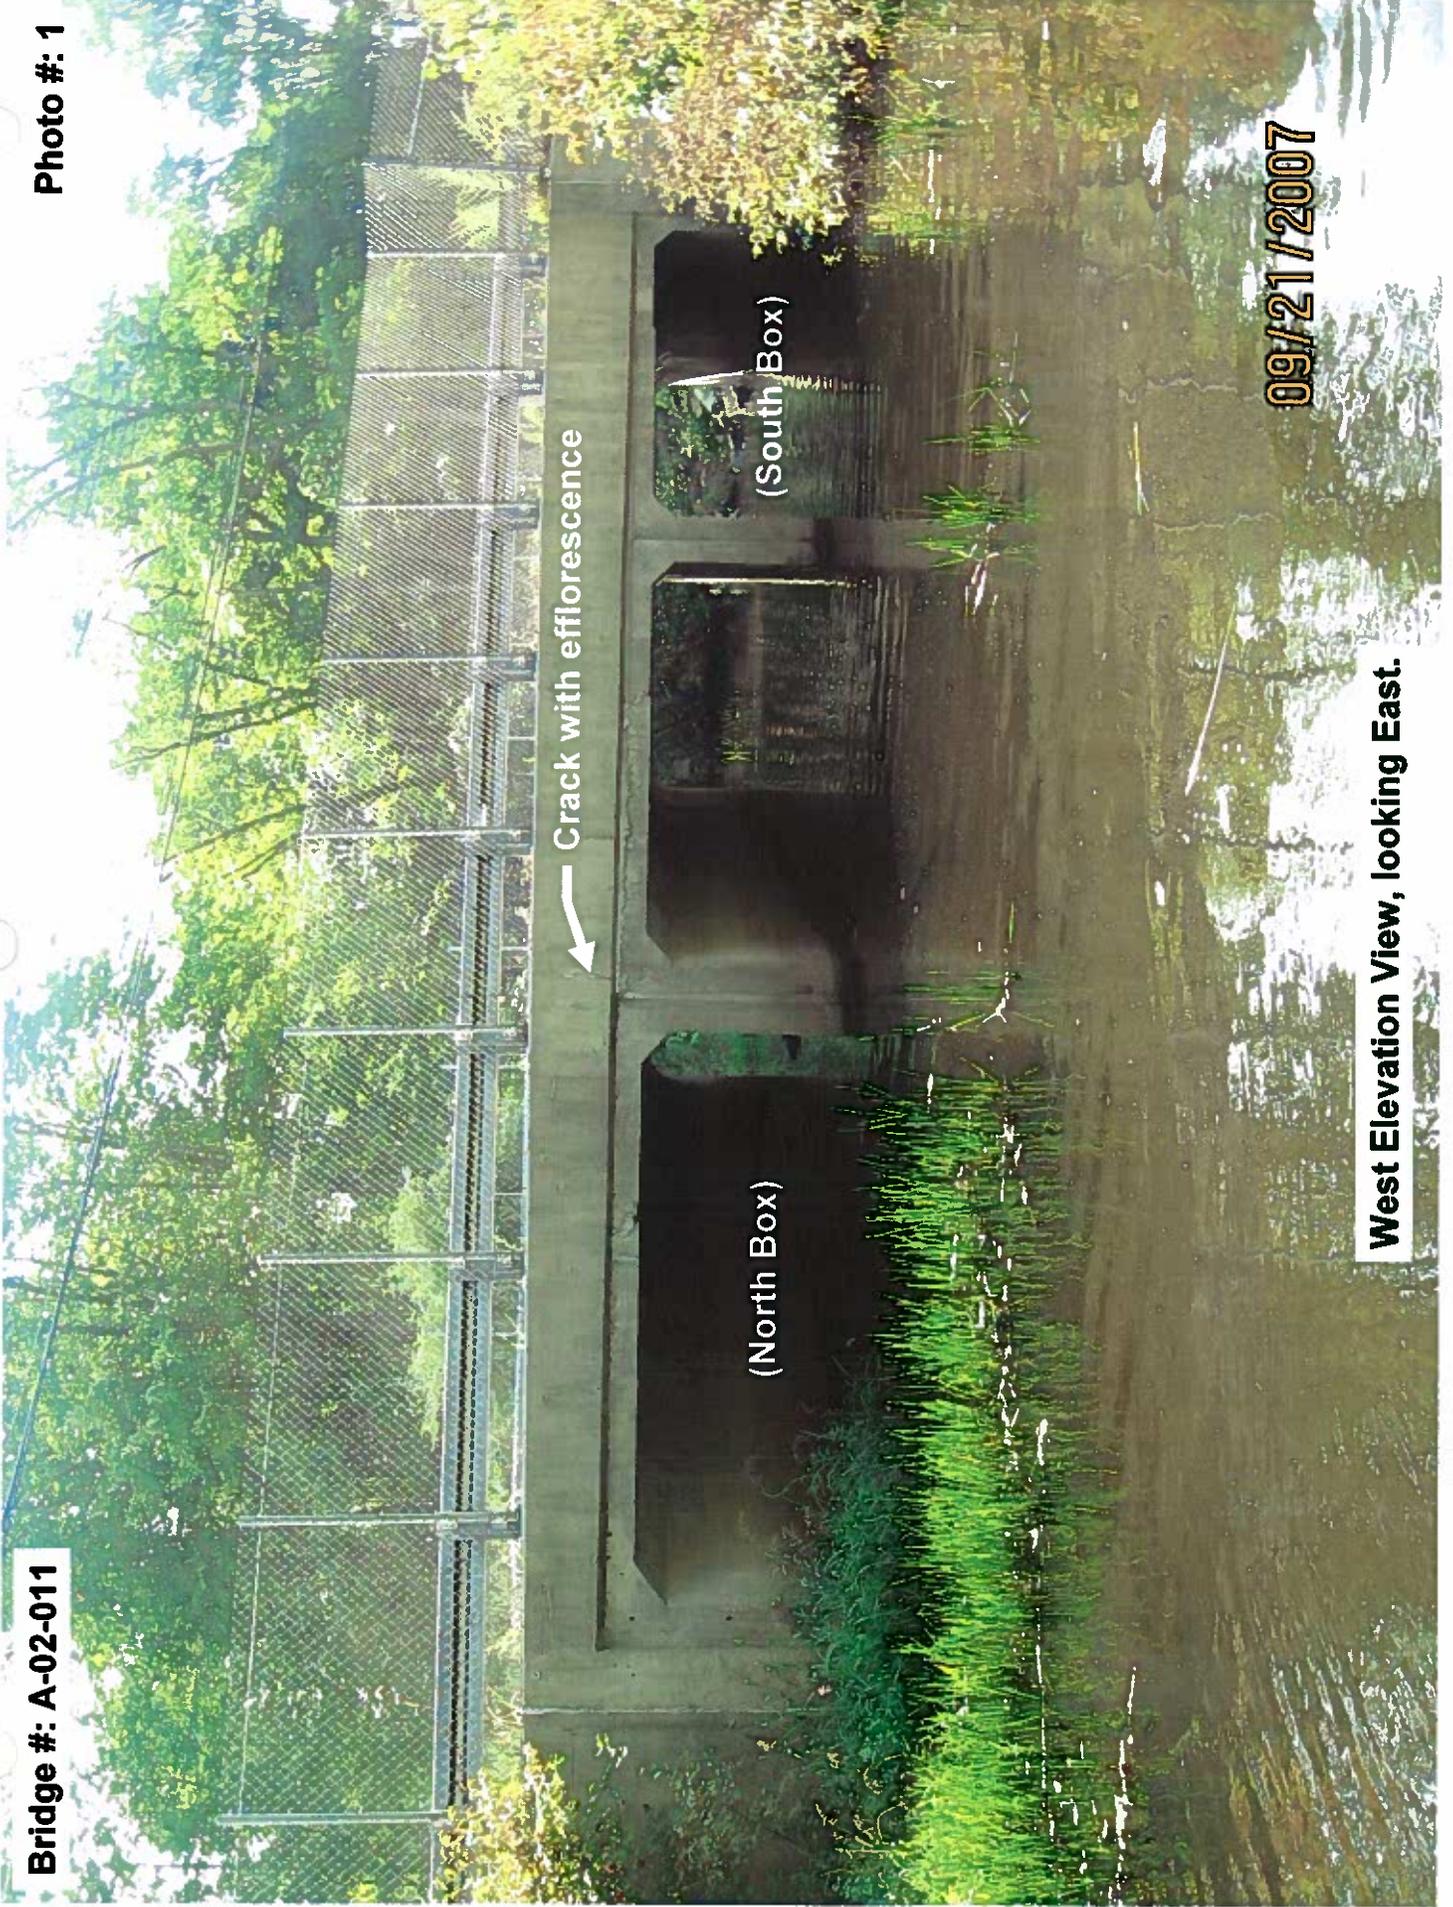
Crack with efflorescence

West Elevation View, looking East.

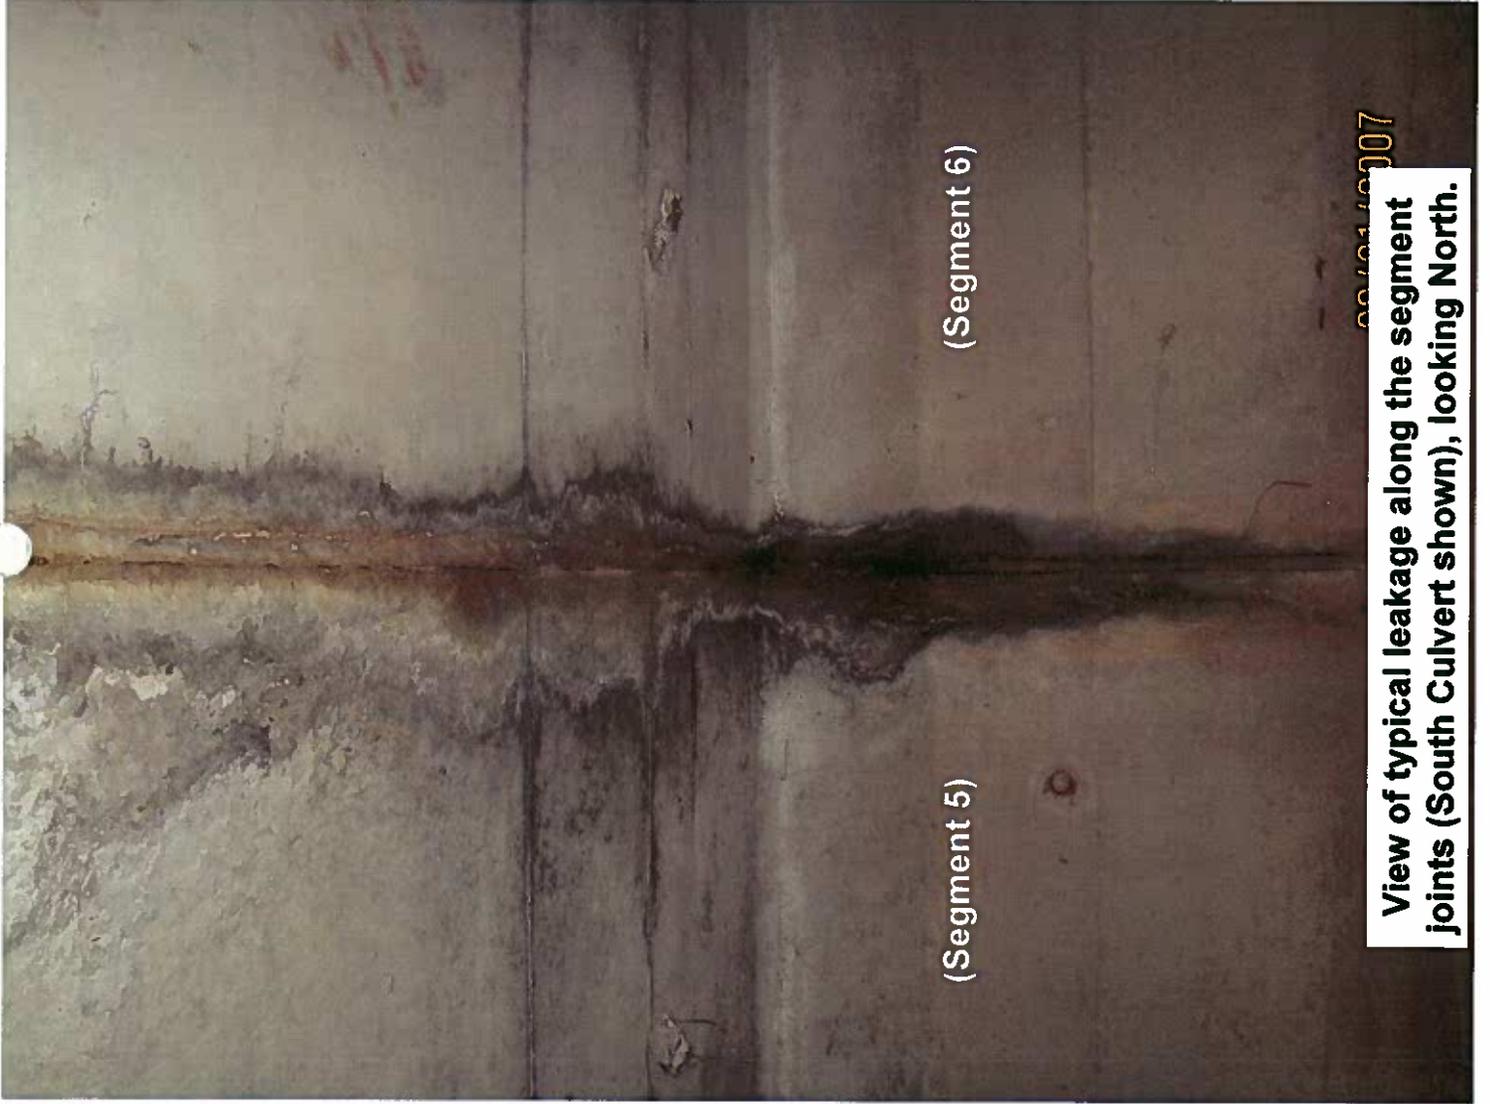
Photo #: 4

(Segment 5)

(Segment 6)

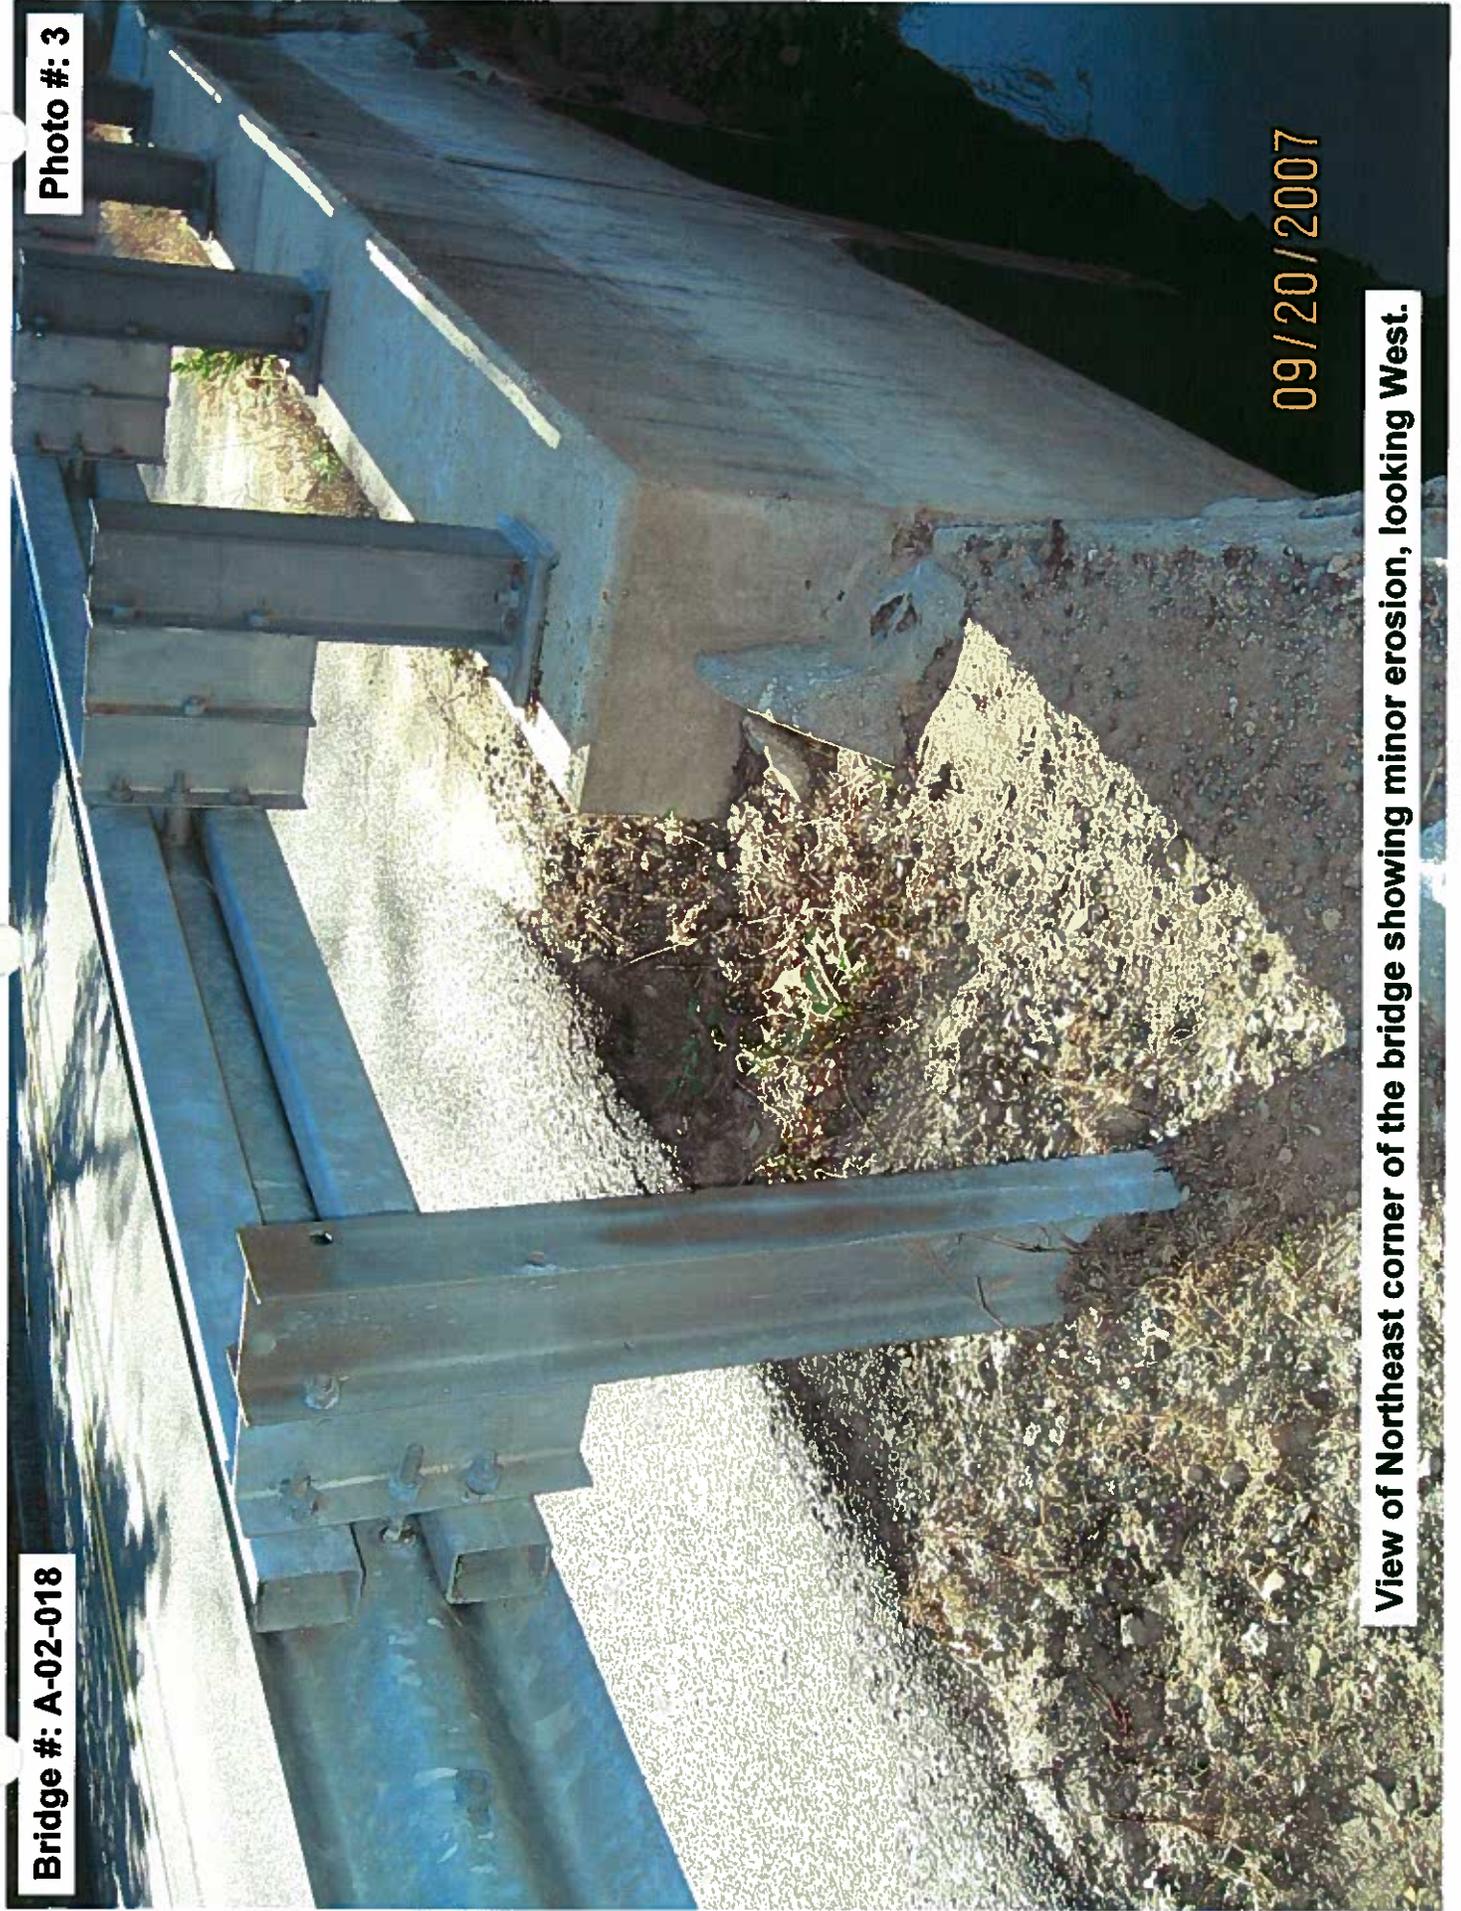
View of Northeast corner of the bridge showing minor erosion, looking West.

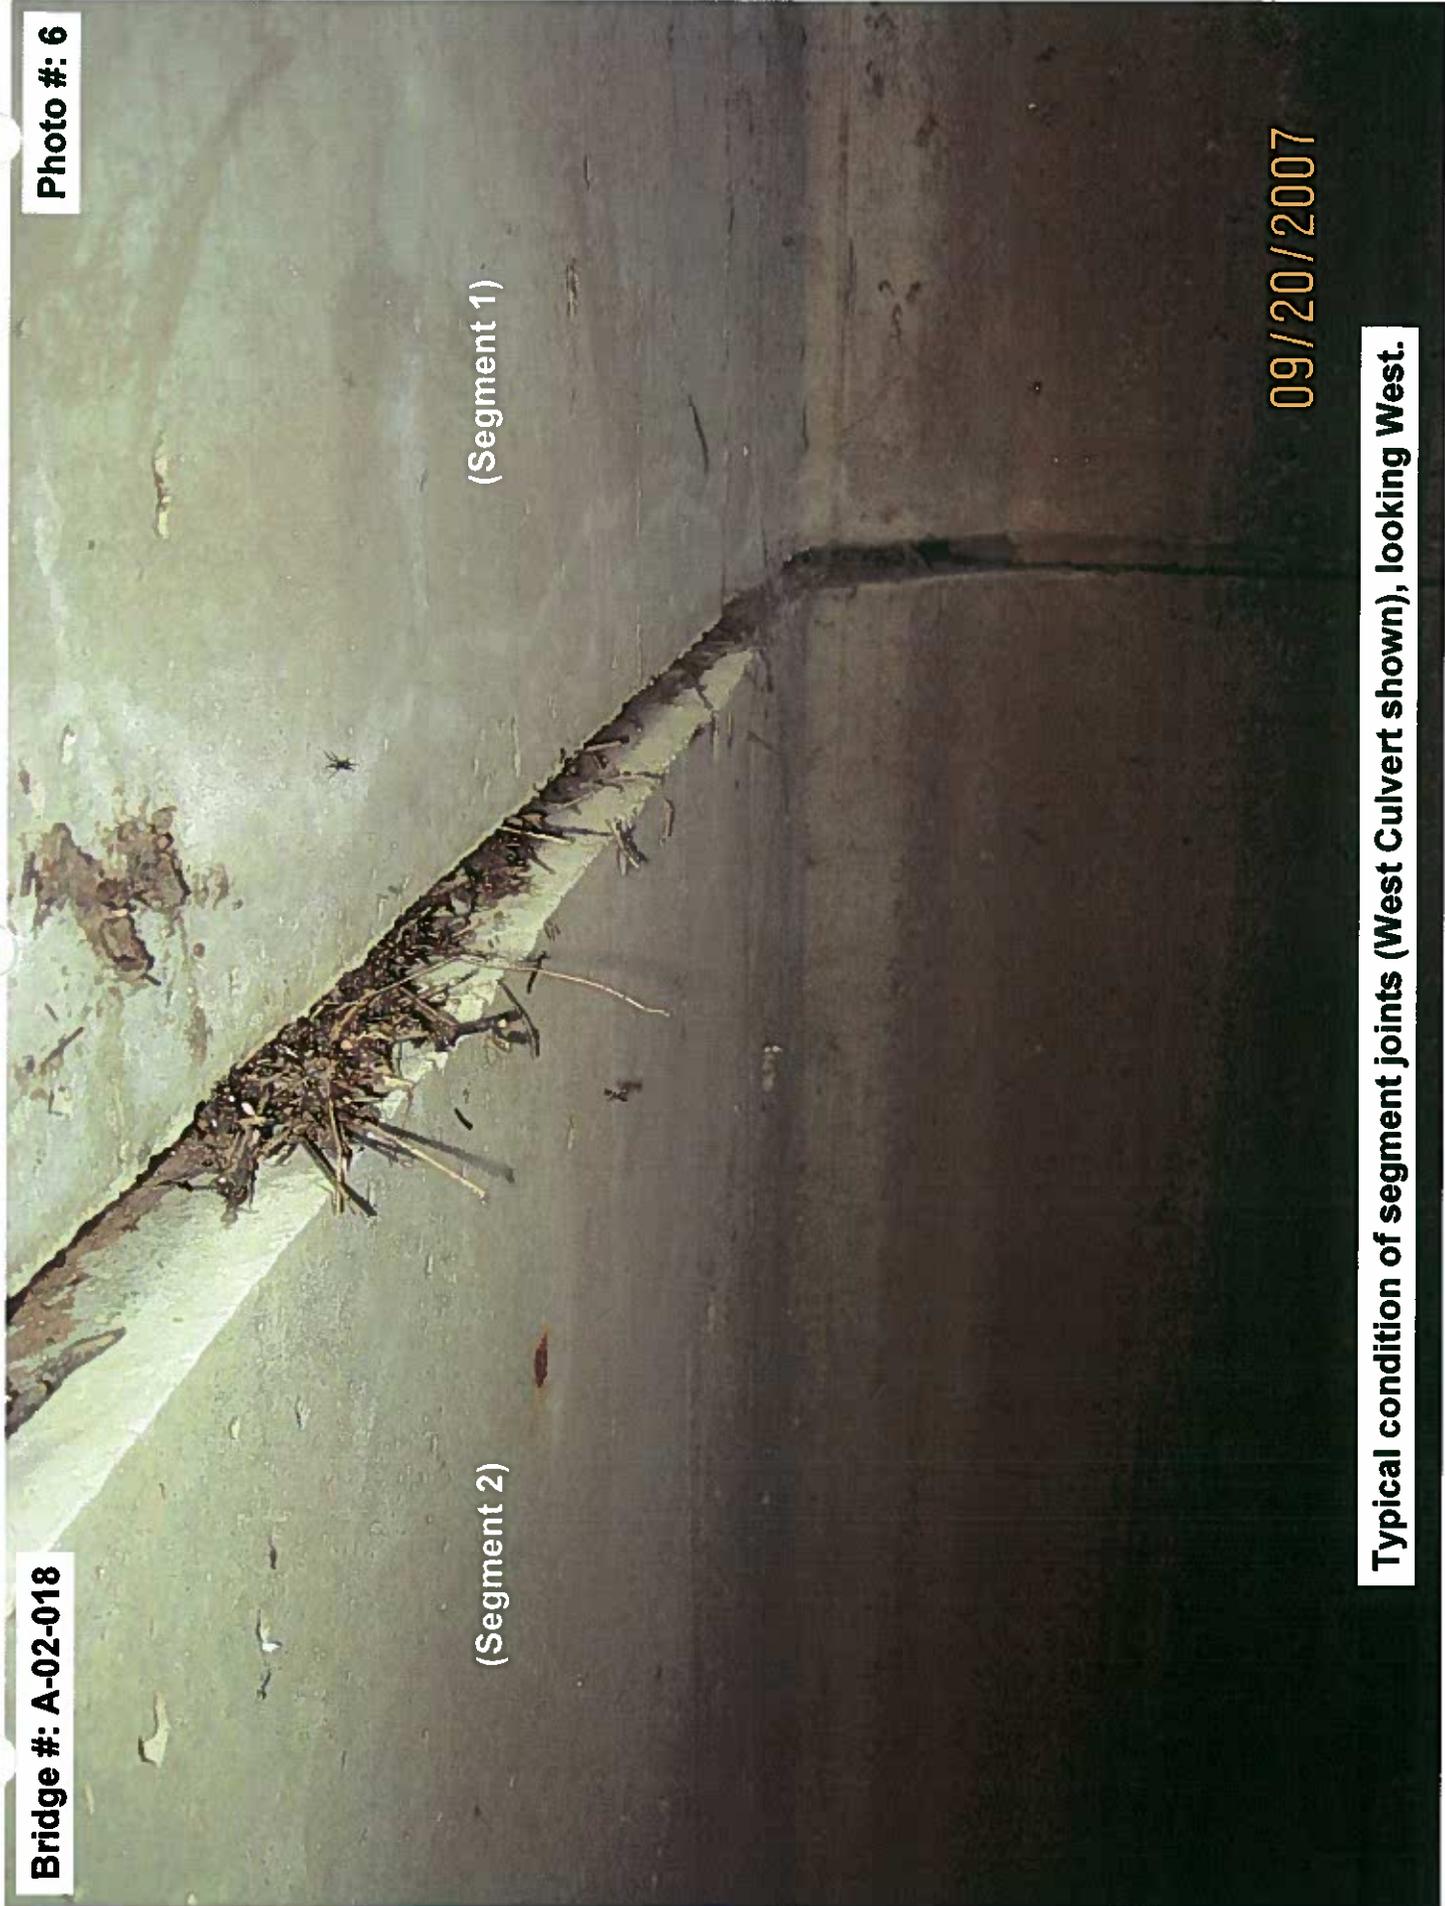
Typical condition of segment joints (West Culvert shown), looking West.

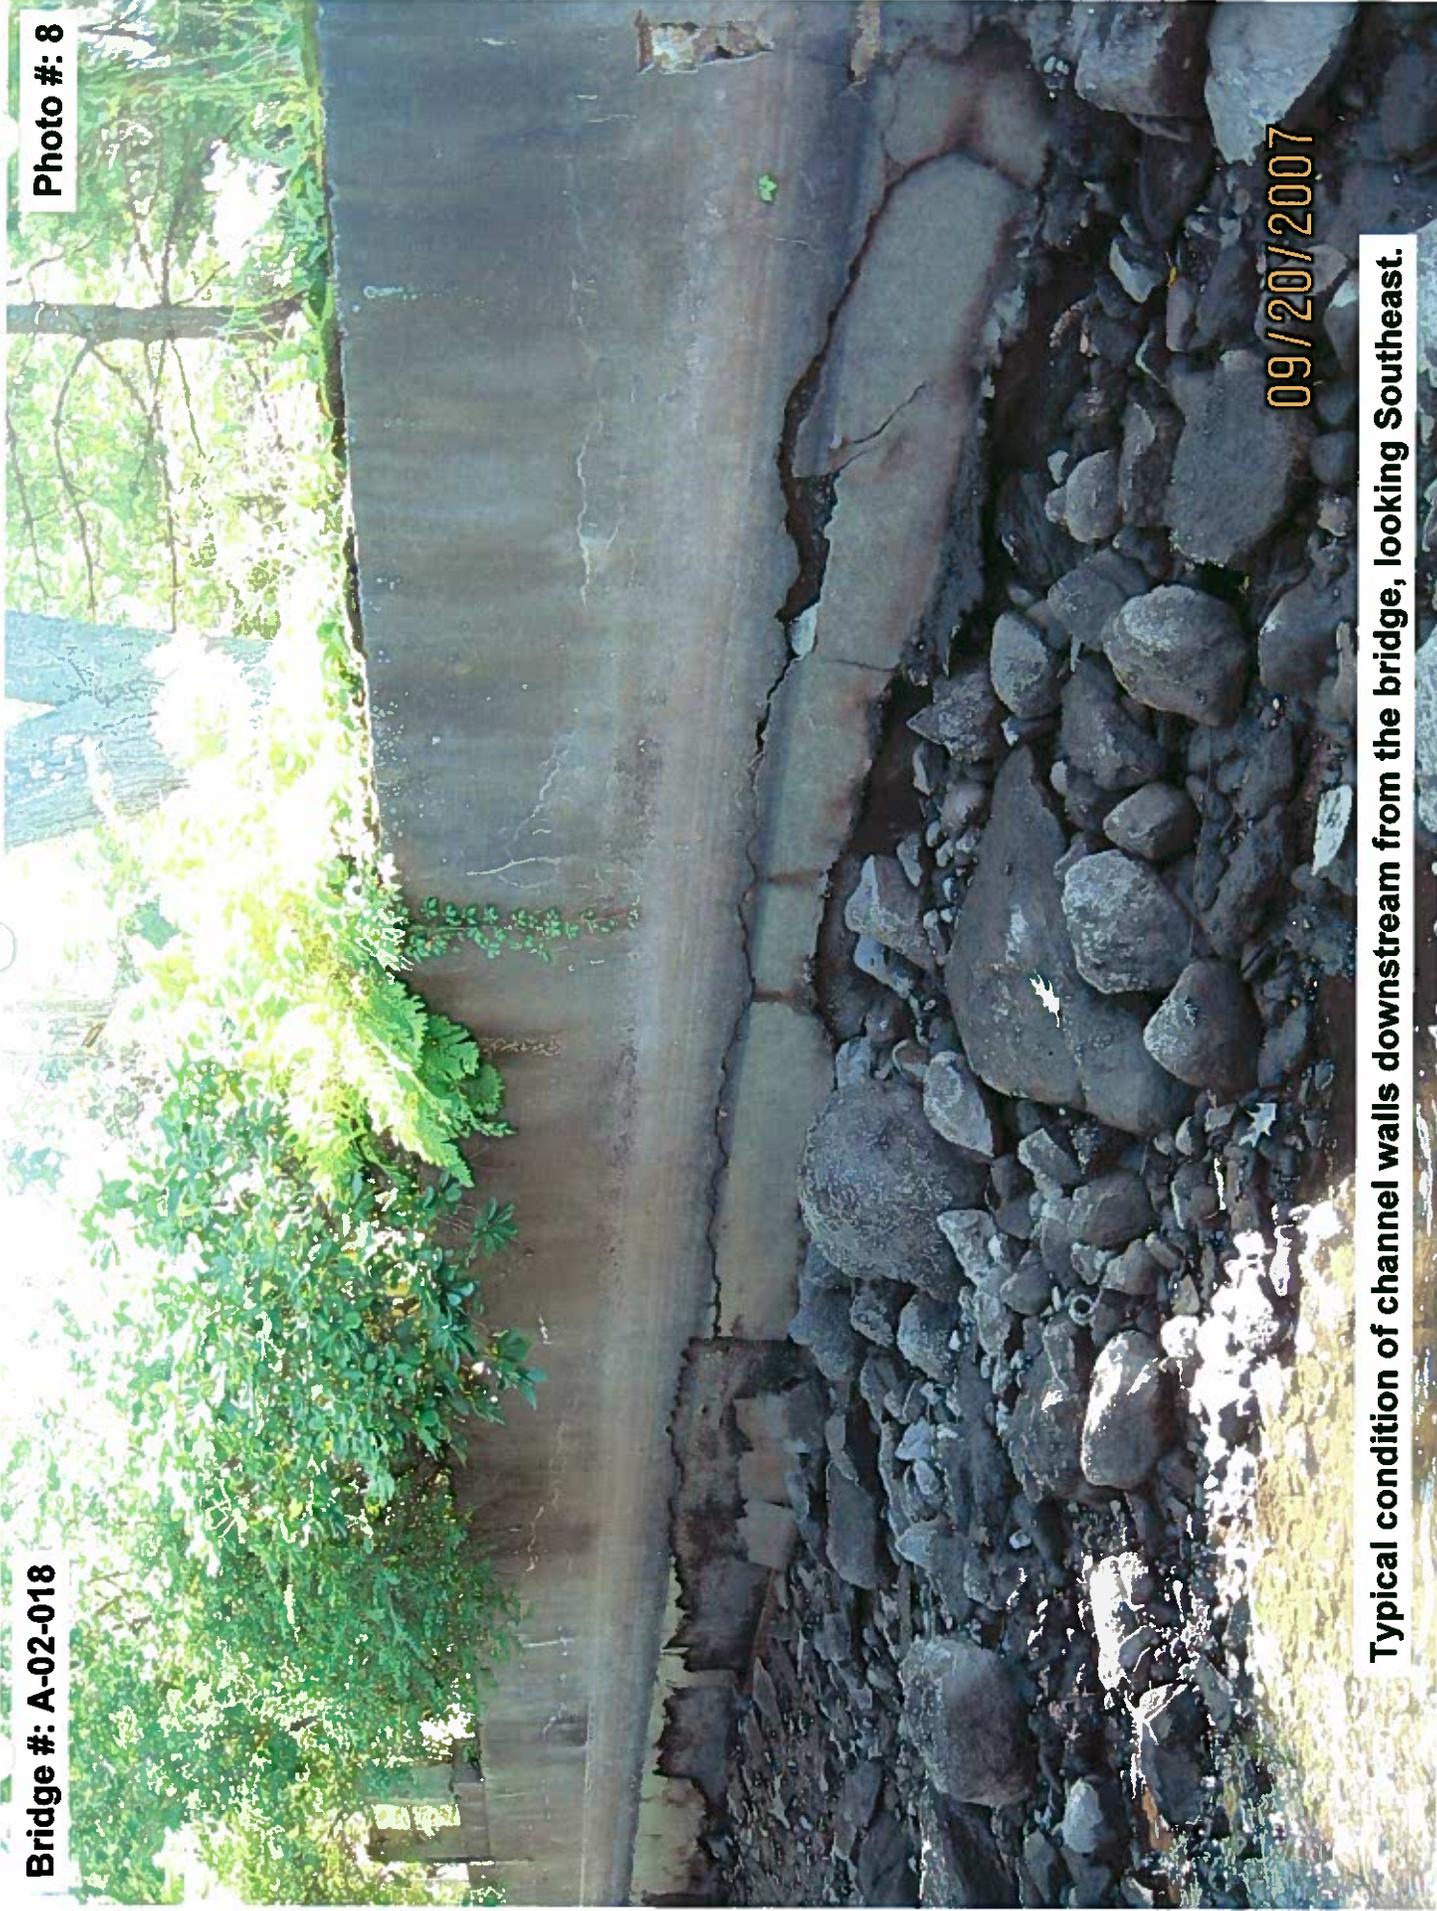
Photo #: 8

Typical condition of channel walls downstream from the bridge, looking Southeast.

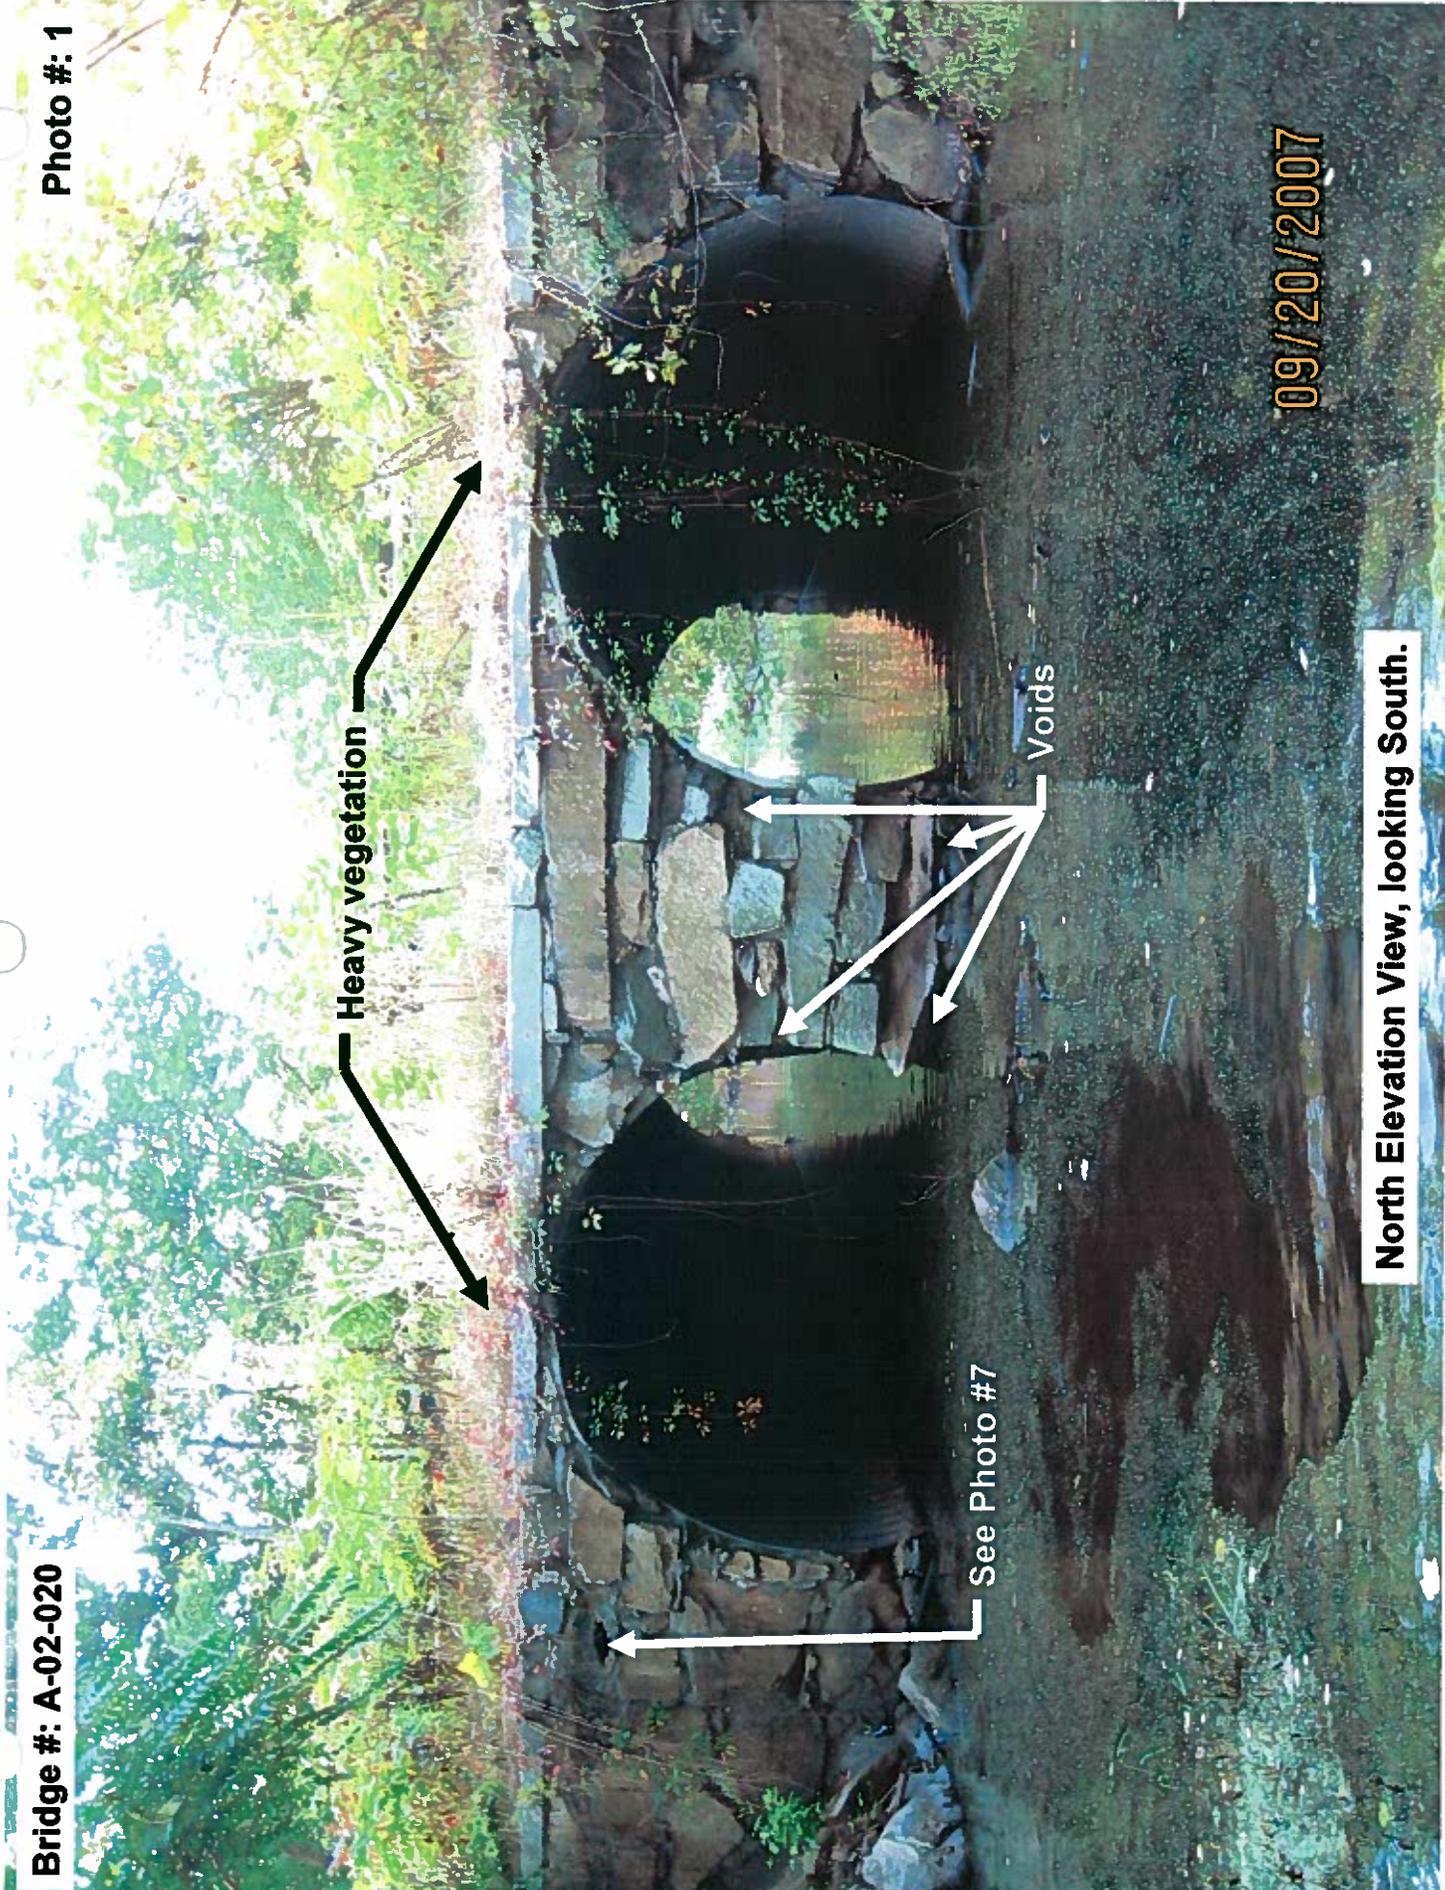
North Elevation View, looking South.

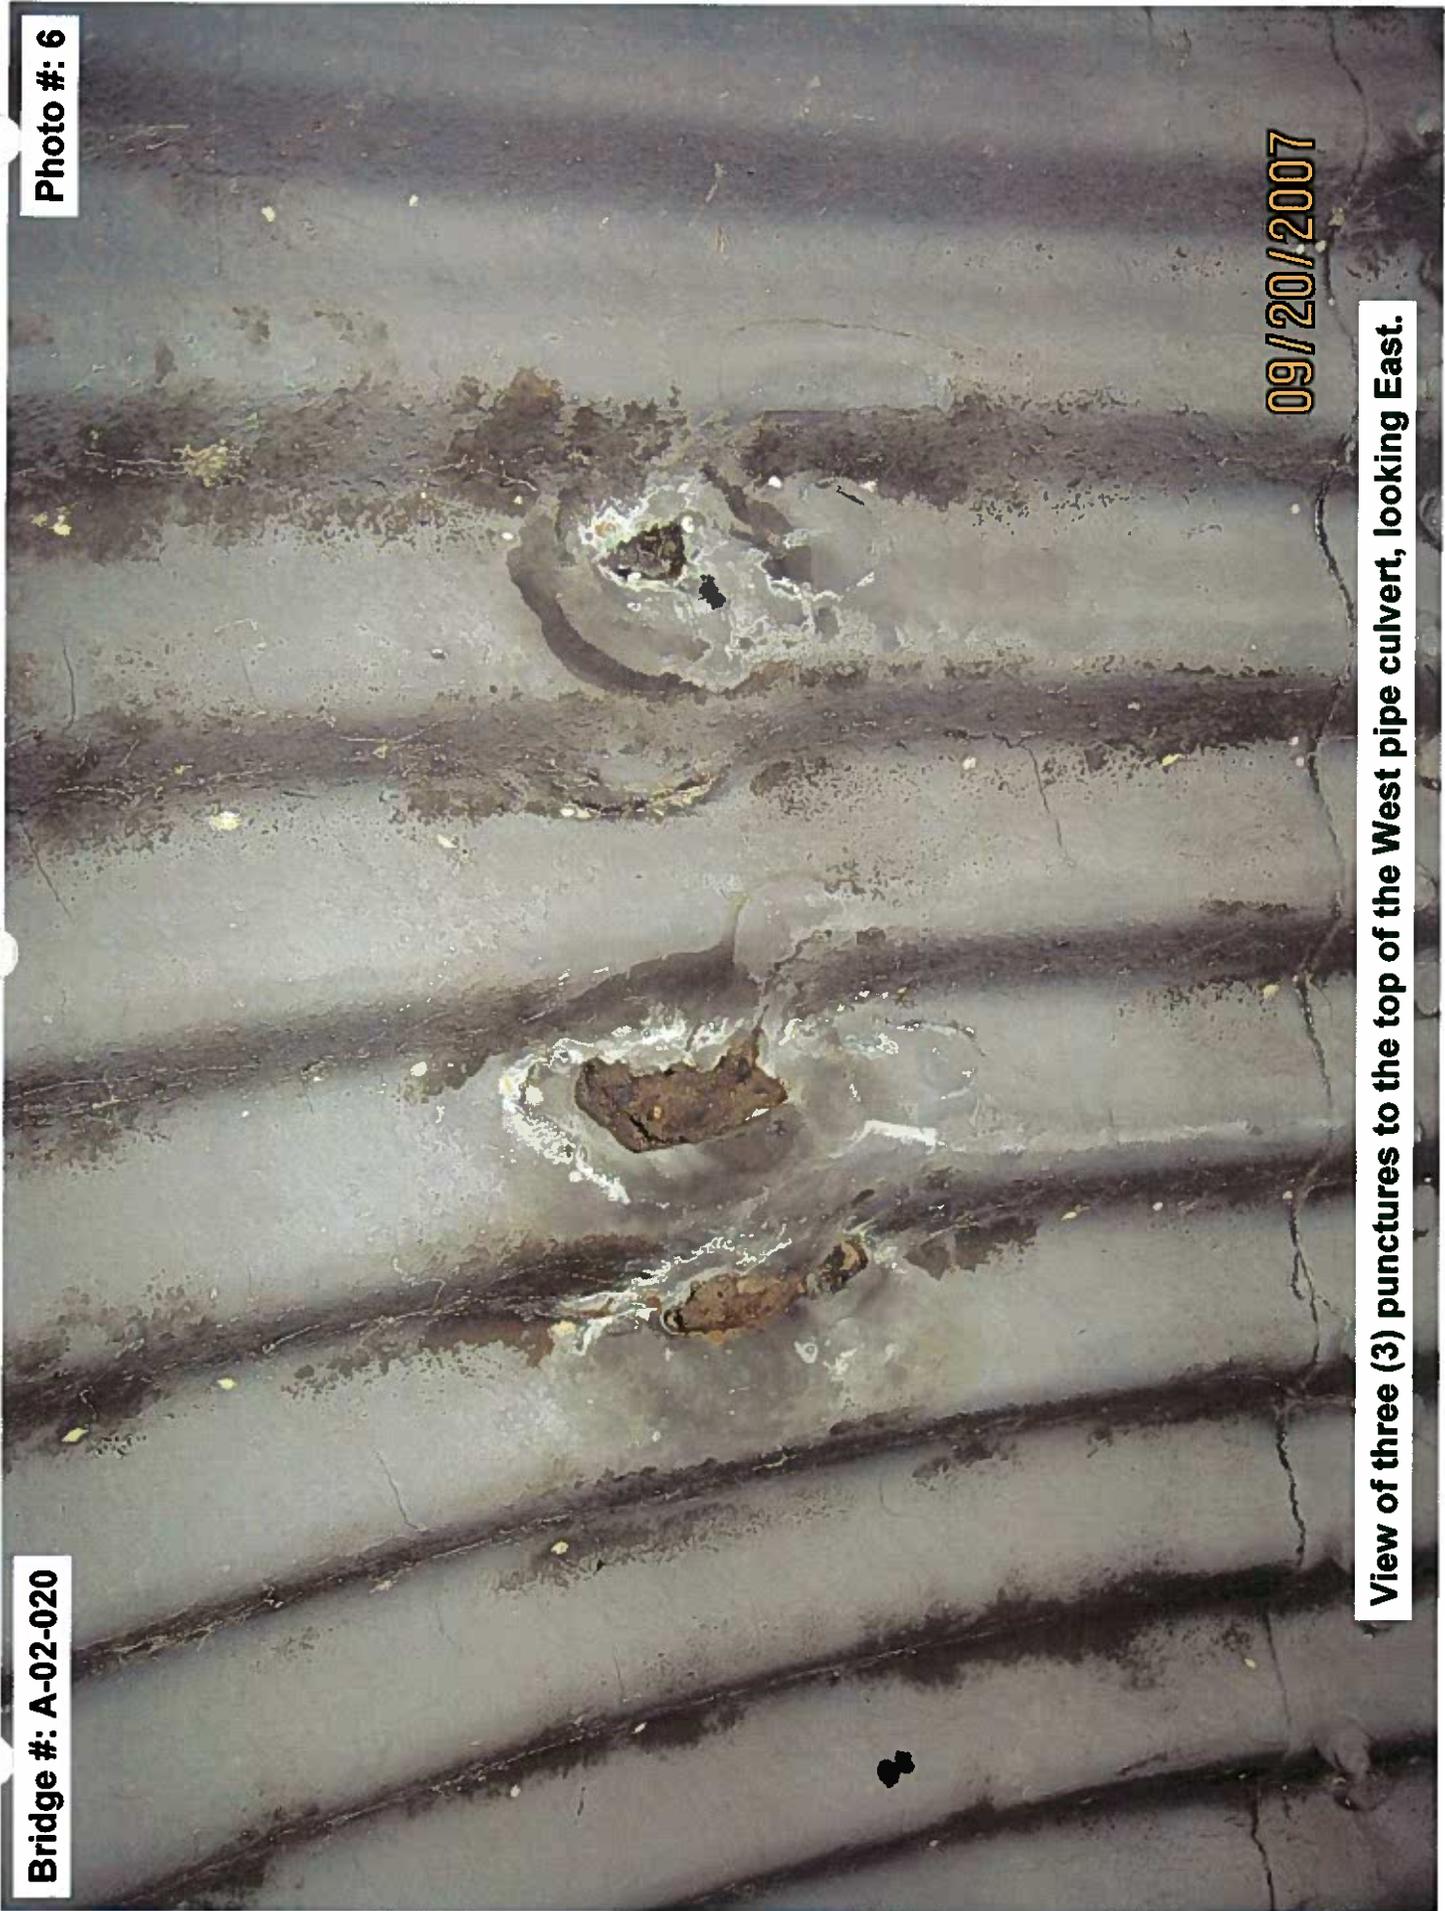
Photo #: 6

View of three (3) punctures to the top of the West pipe culvert, looking East.

#3	Top of West pipe culvert	Three punctures from guard rail installation	Weld repair plate	Moderate
#4	Top of East pipe culvert	Two punctures from guardrail installation	Weld repair plate	Moderate
