# PHASE I- PRELIMINARY REPORT

## Town of Acton

### Summary of Conditions and Recommendations for the Repair/Rehabilitation of Town Owned Bridges

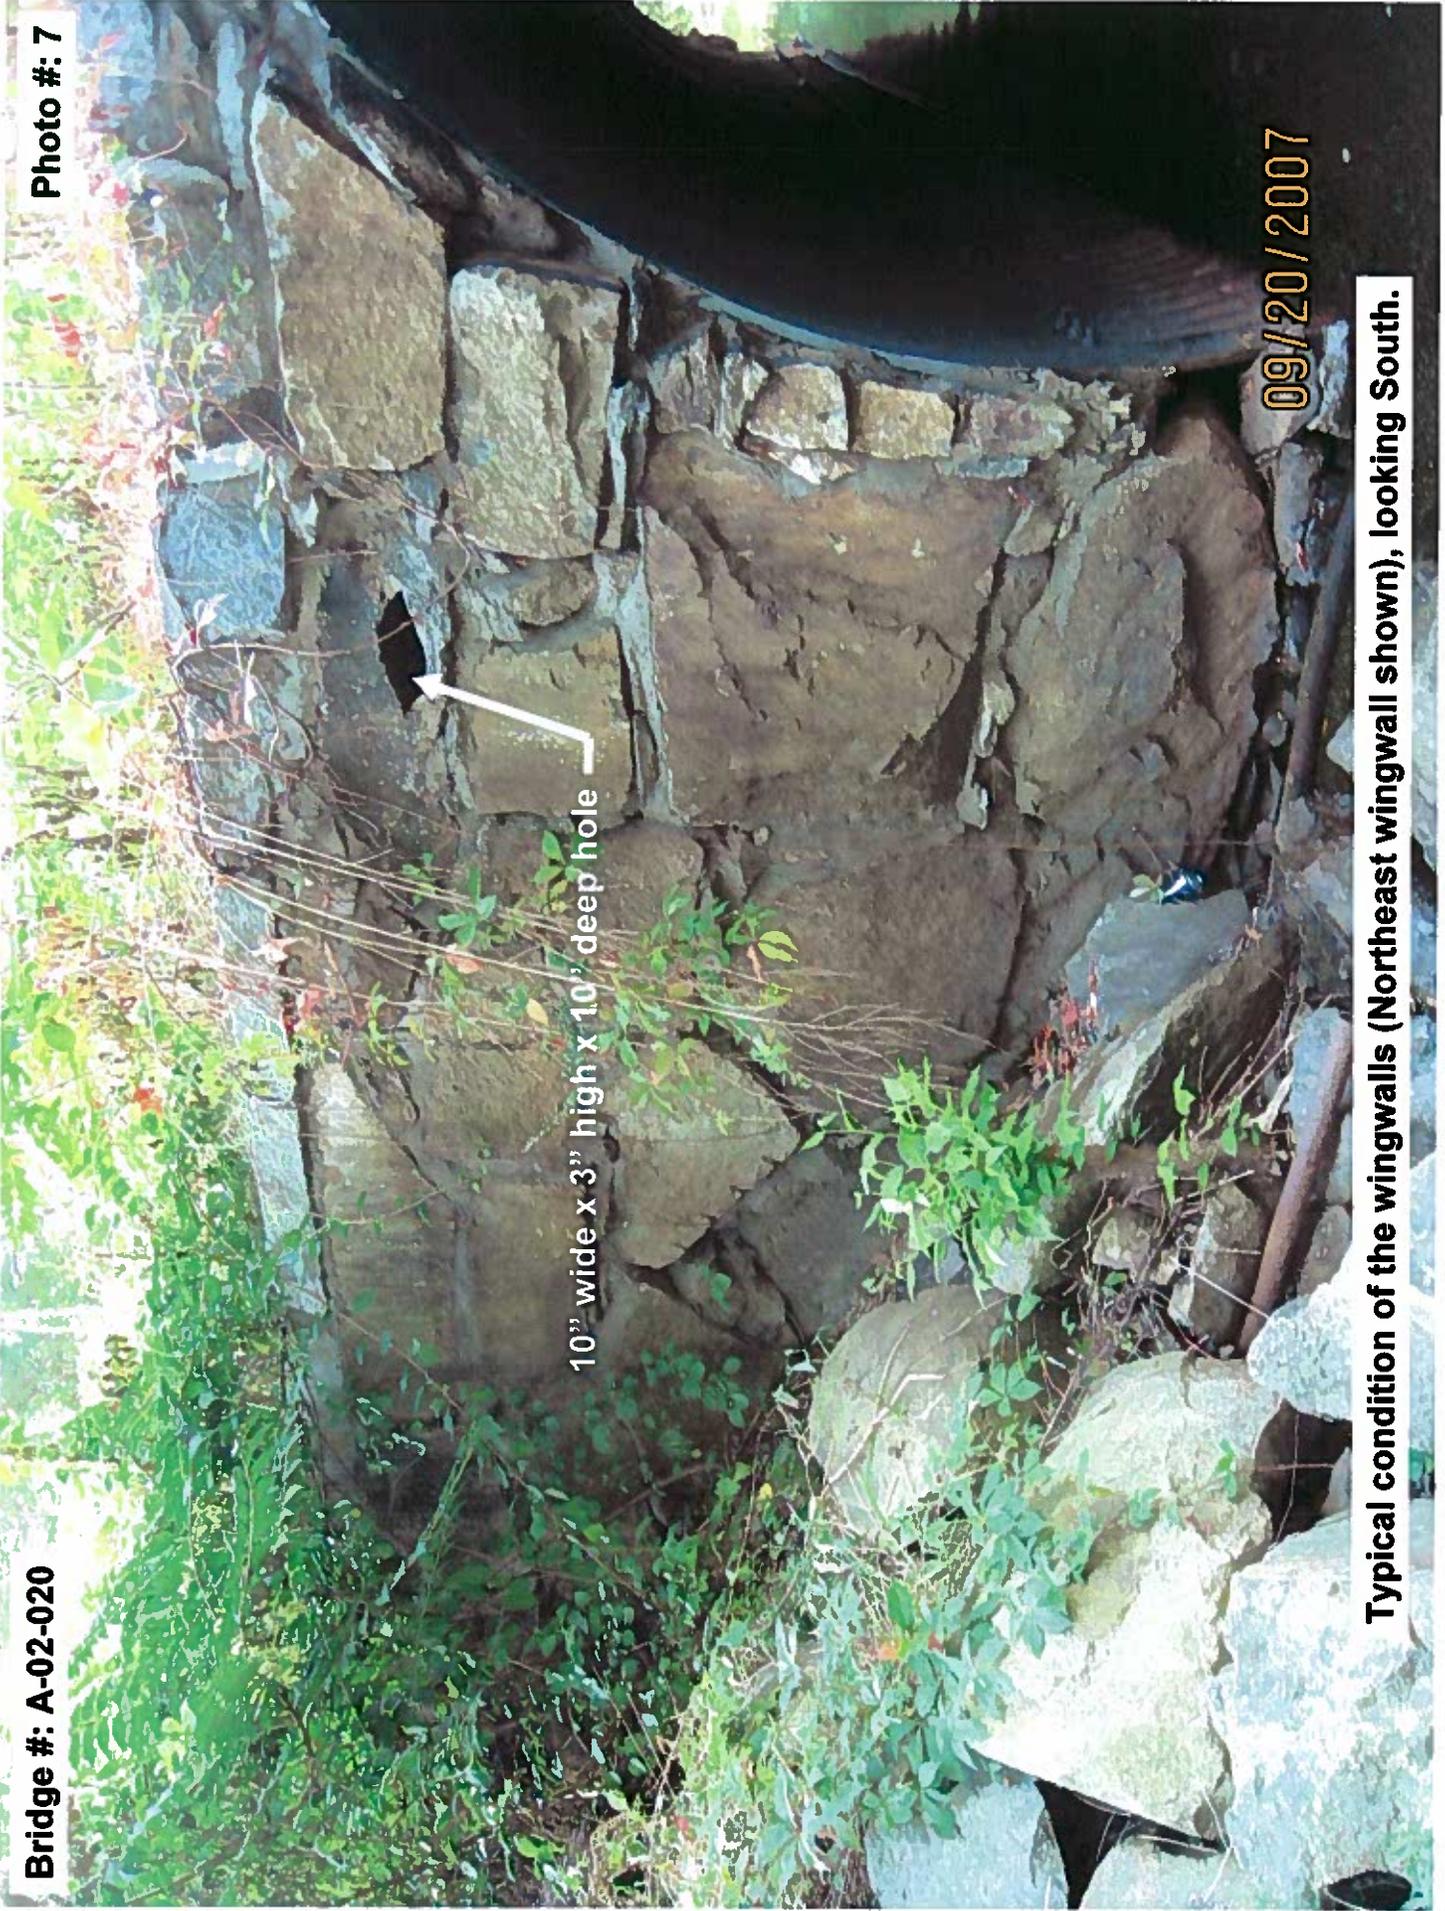
Photo #: 7

Typical condition of the wingwalls (Northeast wingwall shown), looking South.

#7	North headwalls around pipes	Voids	Fill holes/voids with concrete	High
#8	South headwalls around pipes	Voids	Fill holes/voids with concrete	High
#9	Wingwalls	Cracks in mortar and random voids	Fill any voids and repoint stone masonry as needed	Low

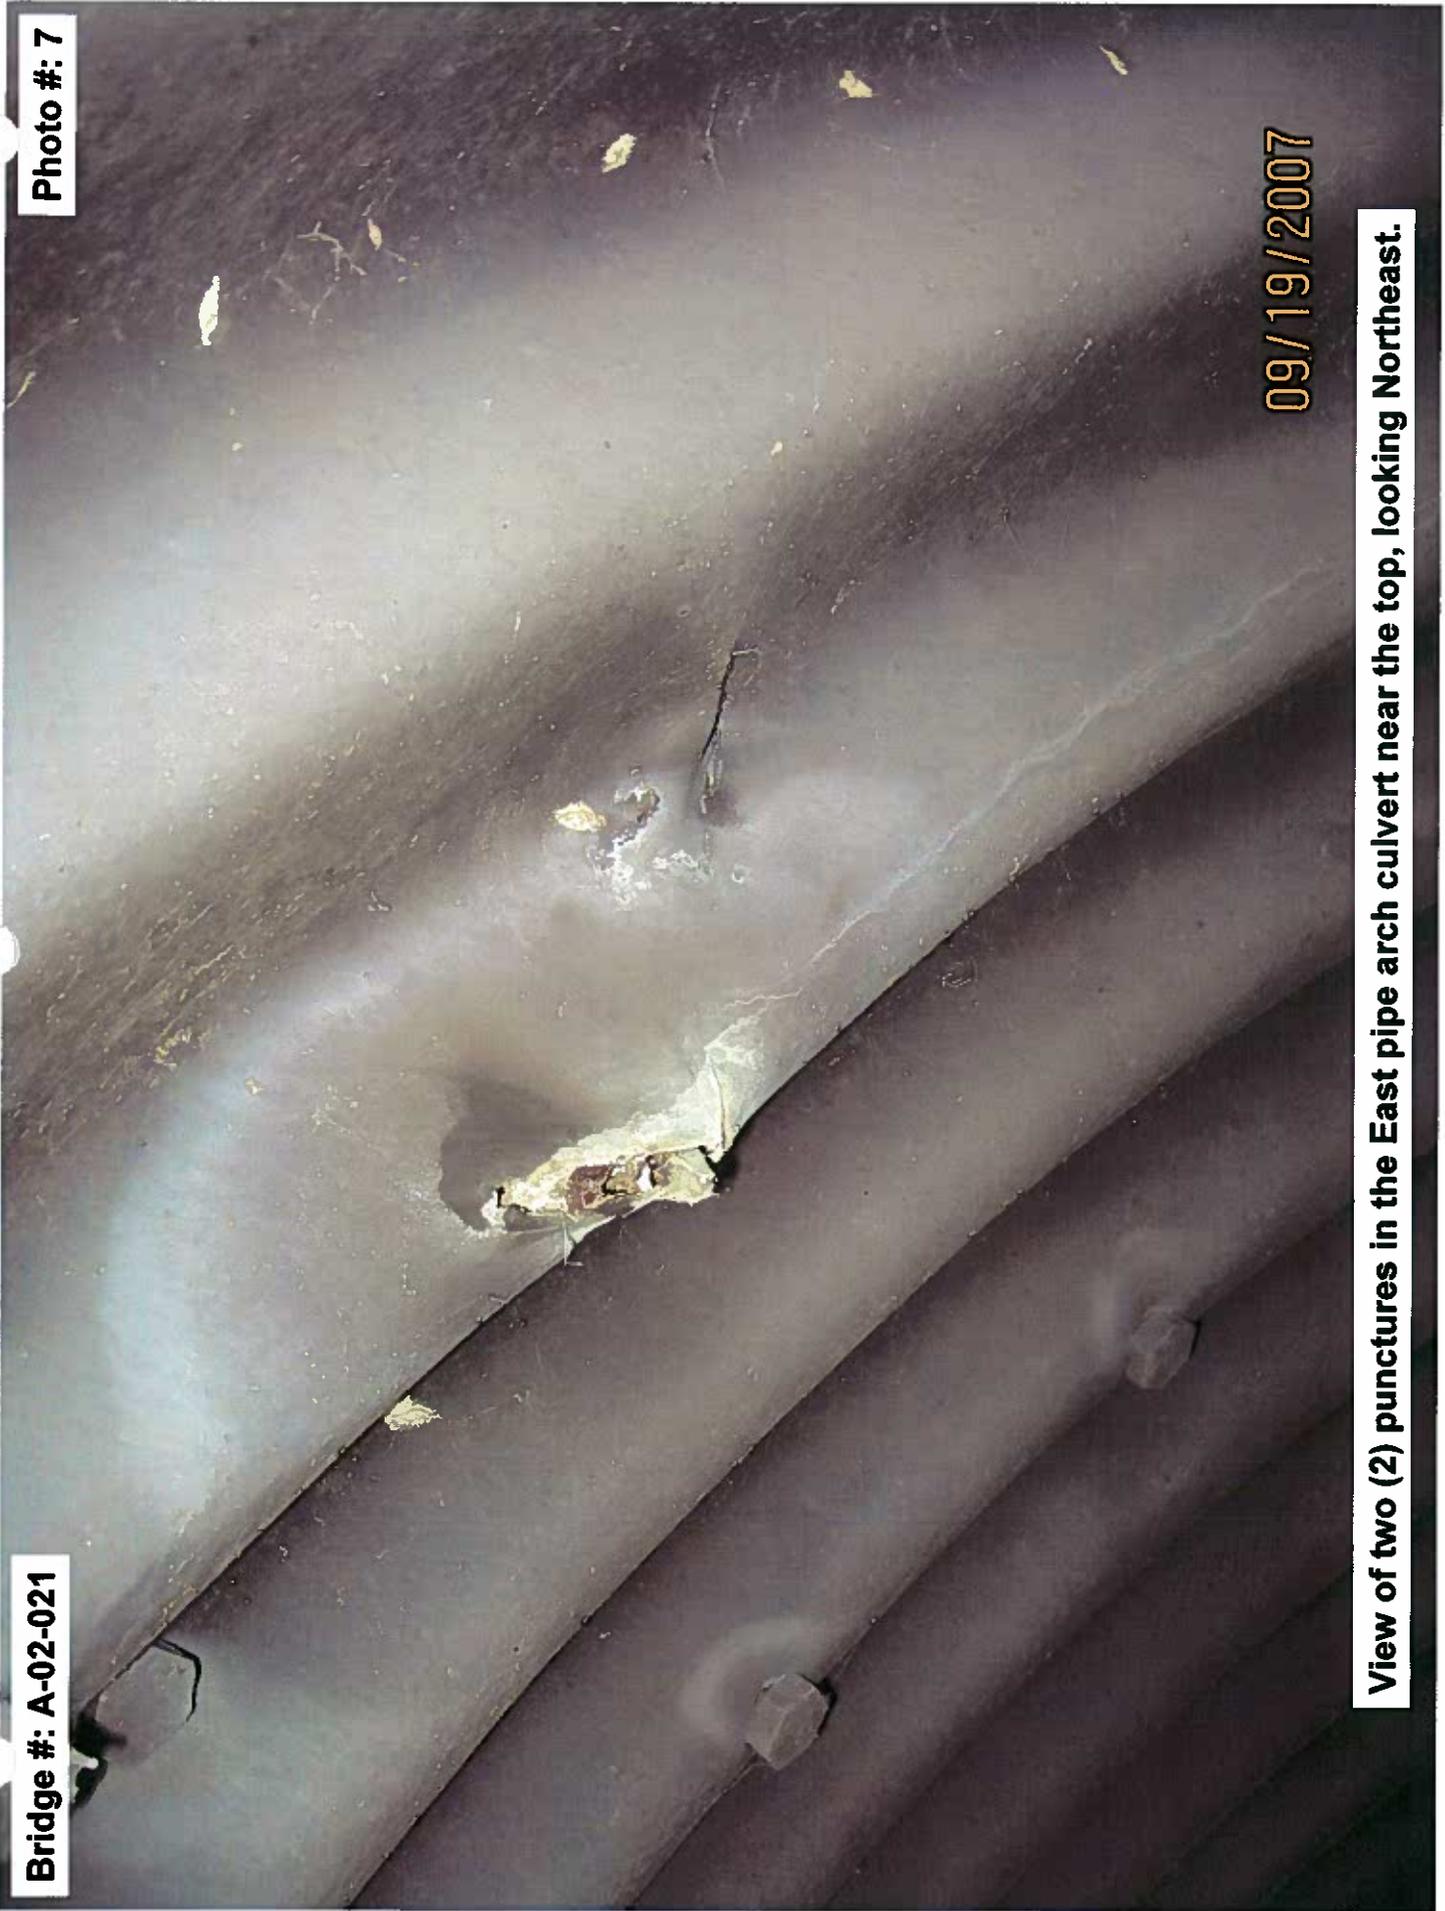
Photo #: 7

View of two (2) punctures in the East pipe arch culvert near the top, looking Northeast.

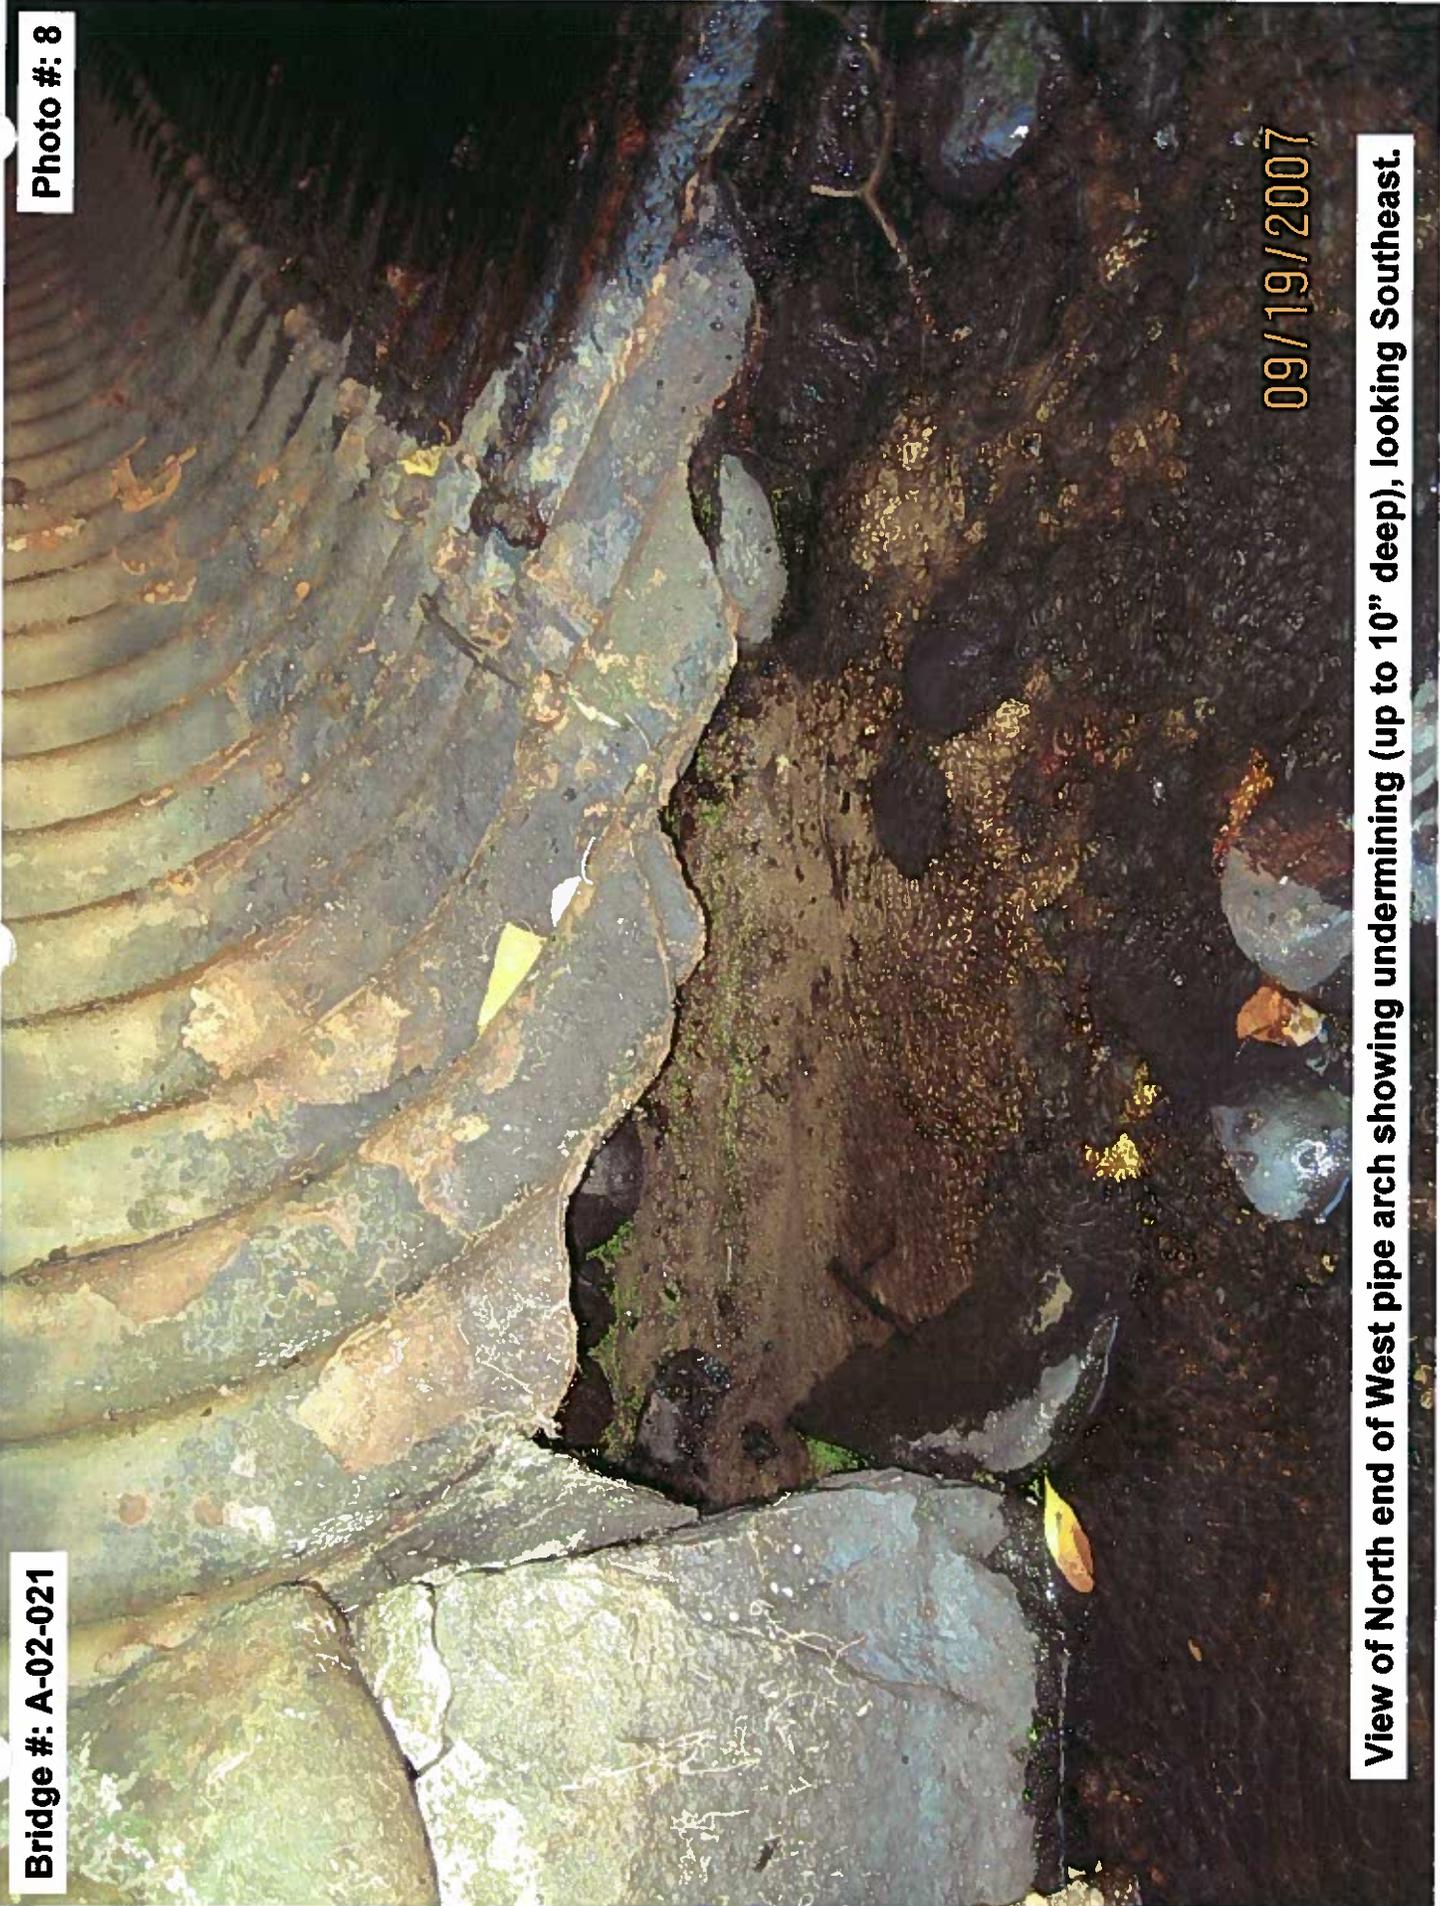
Photo #: 8

View of North end of West pipe arch showing undermining (up to 10" deep), looking Southeast.

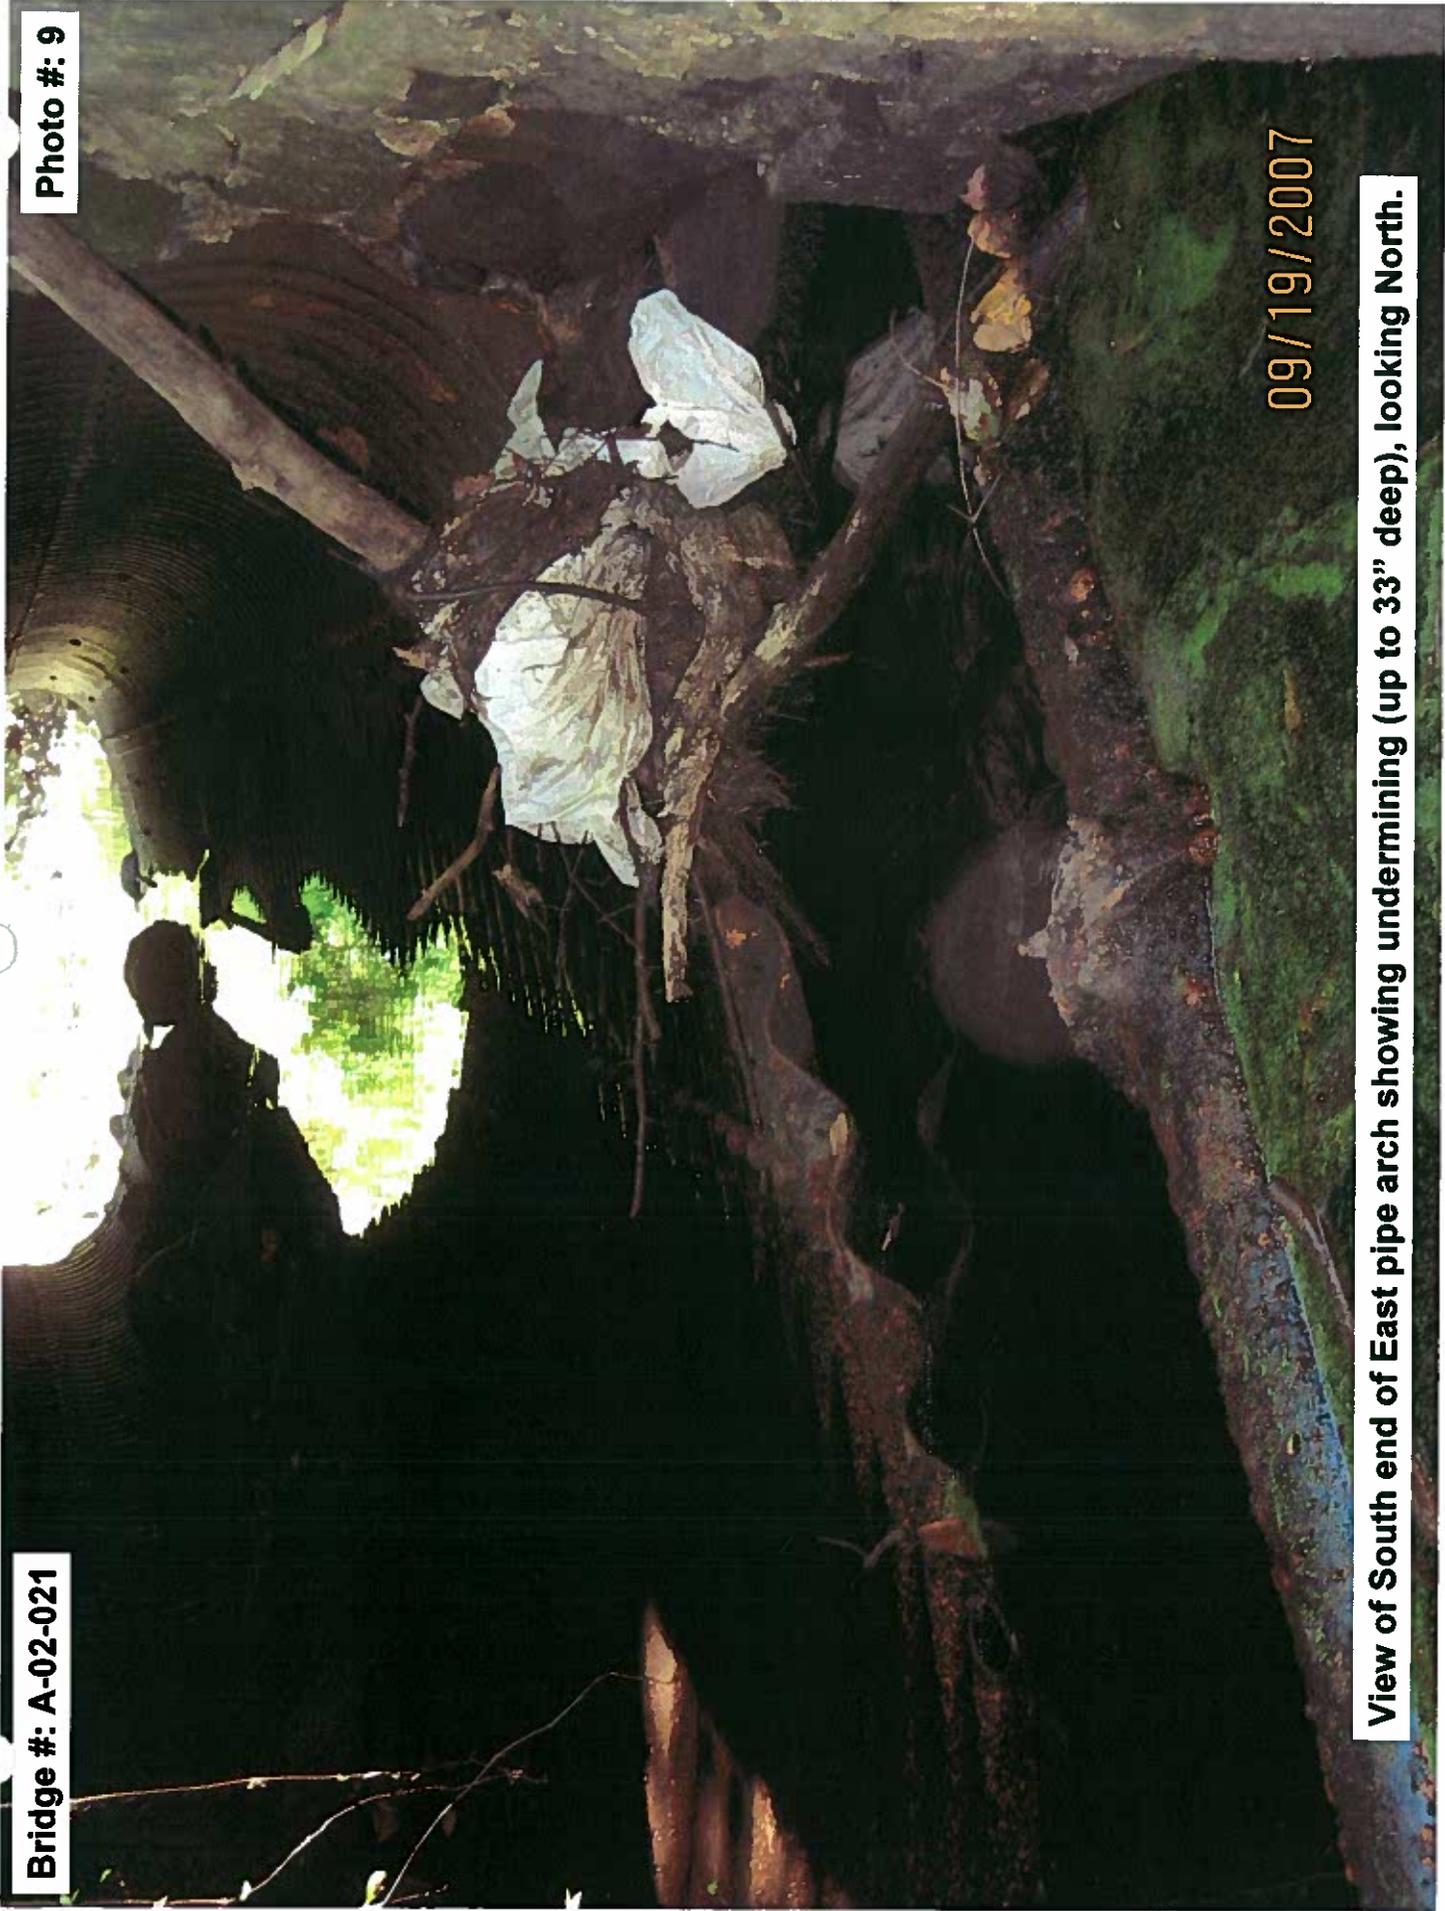
Photo #: 9

View of South end of East pipe arch showing undermining (up to 33" deep), looking North.

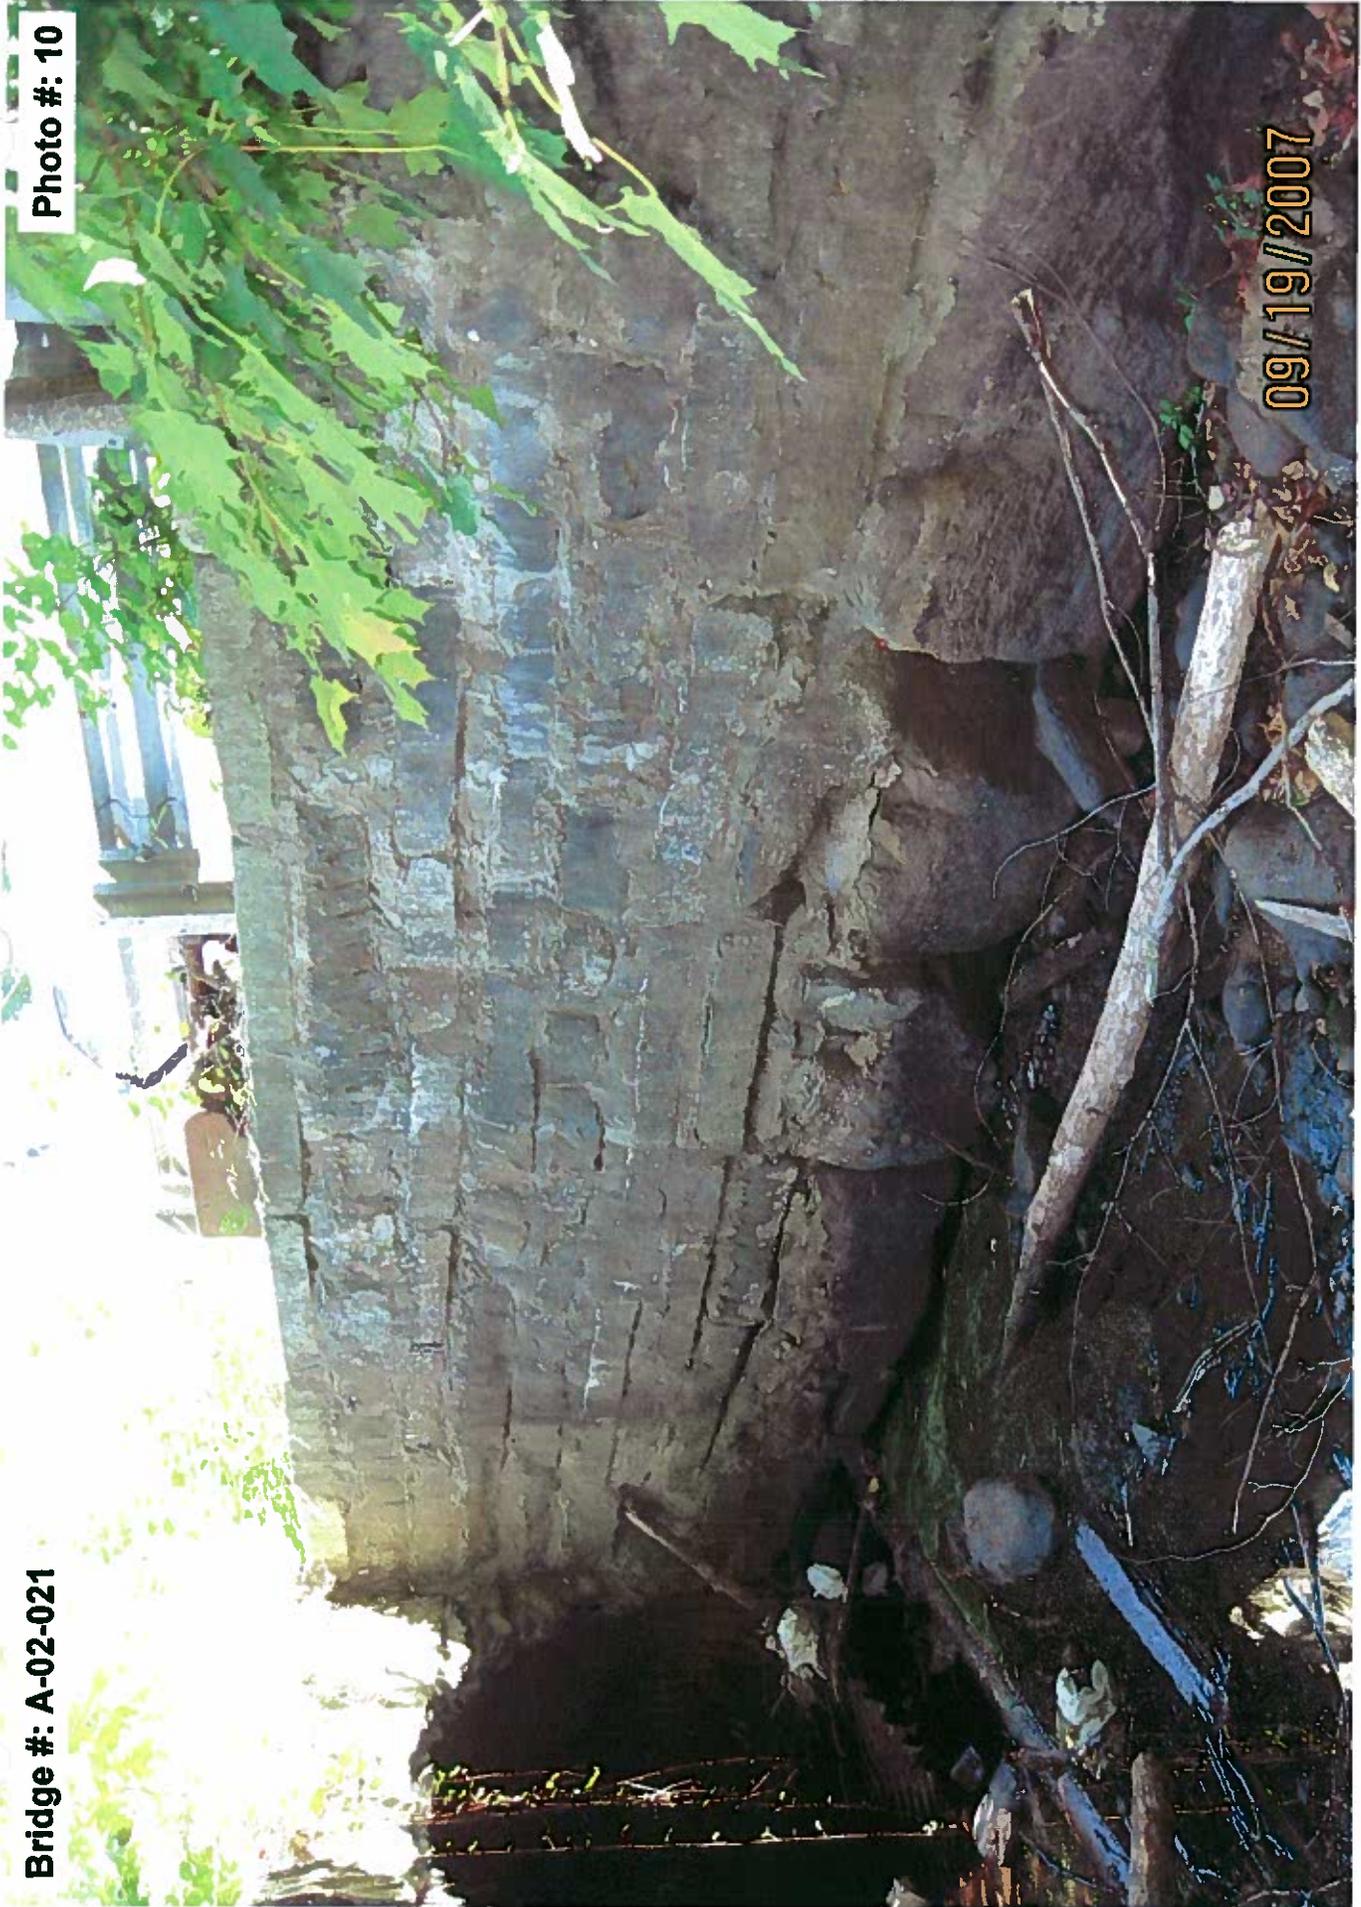
View of Southeast wingwall showing minor settlement of stones and voids (up to 18" deep), looking Northeast.

#9	South headwalls around pipe arches	Voids around pipes/headwalls	Fill holes/voids with concrete	High
#10	Wingwalls	Narrow to medium random cracks in mortar	Repoint stone masonry as needed	Low

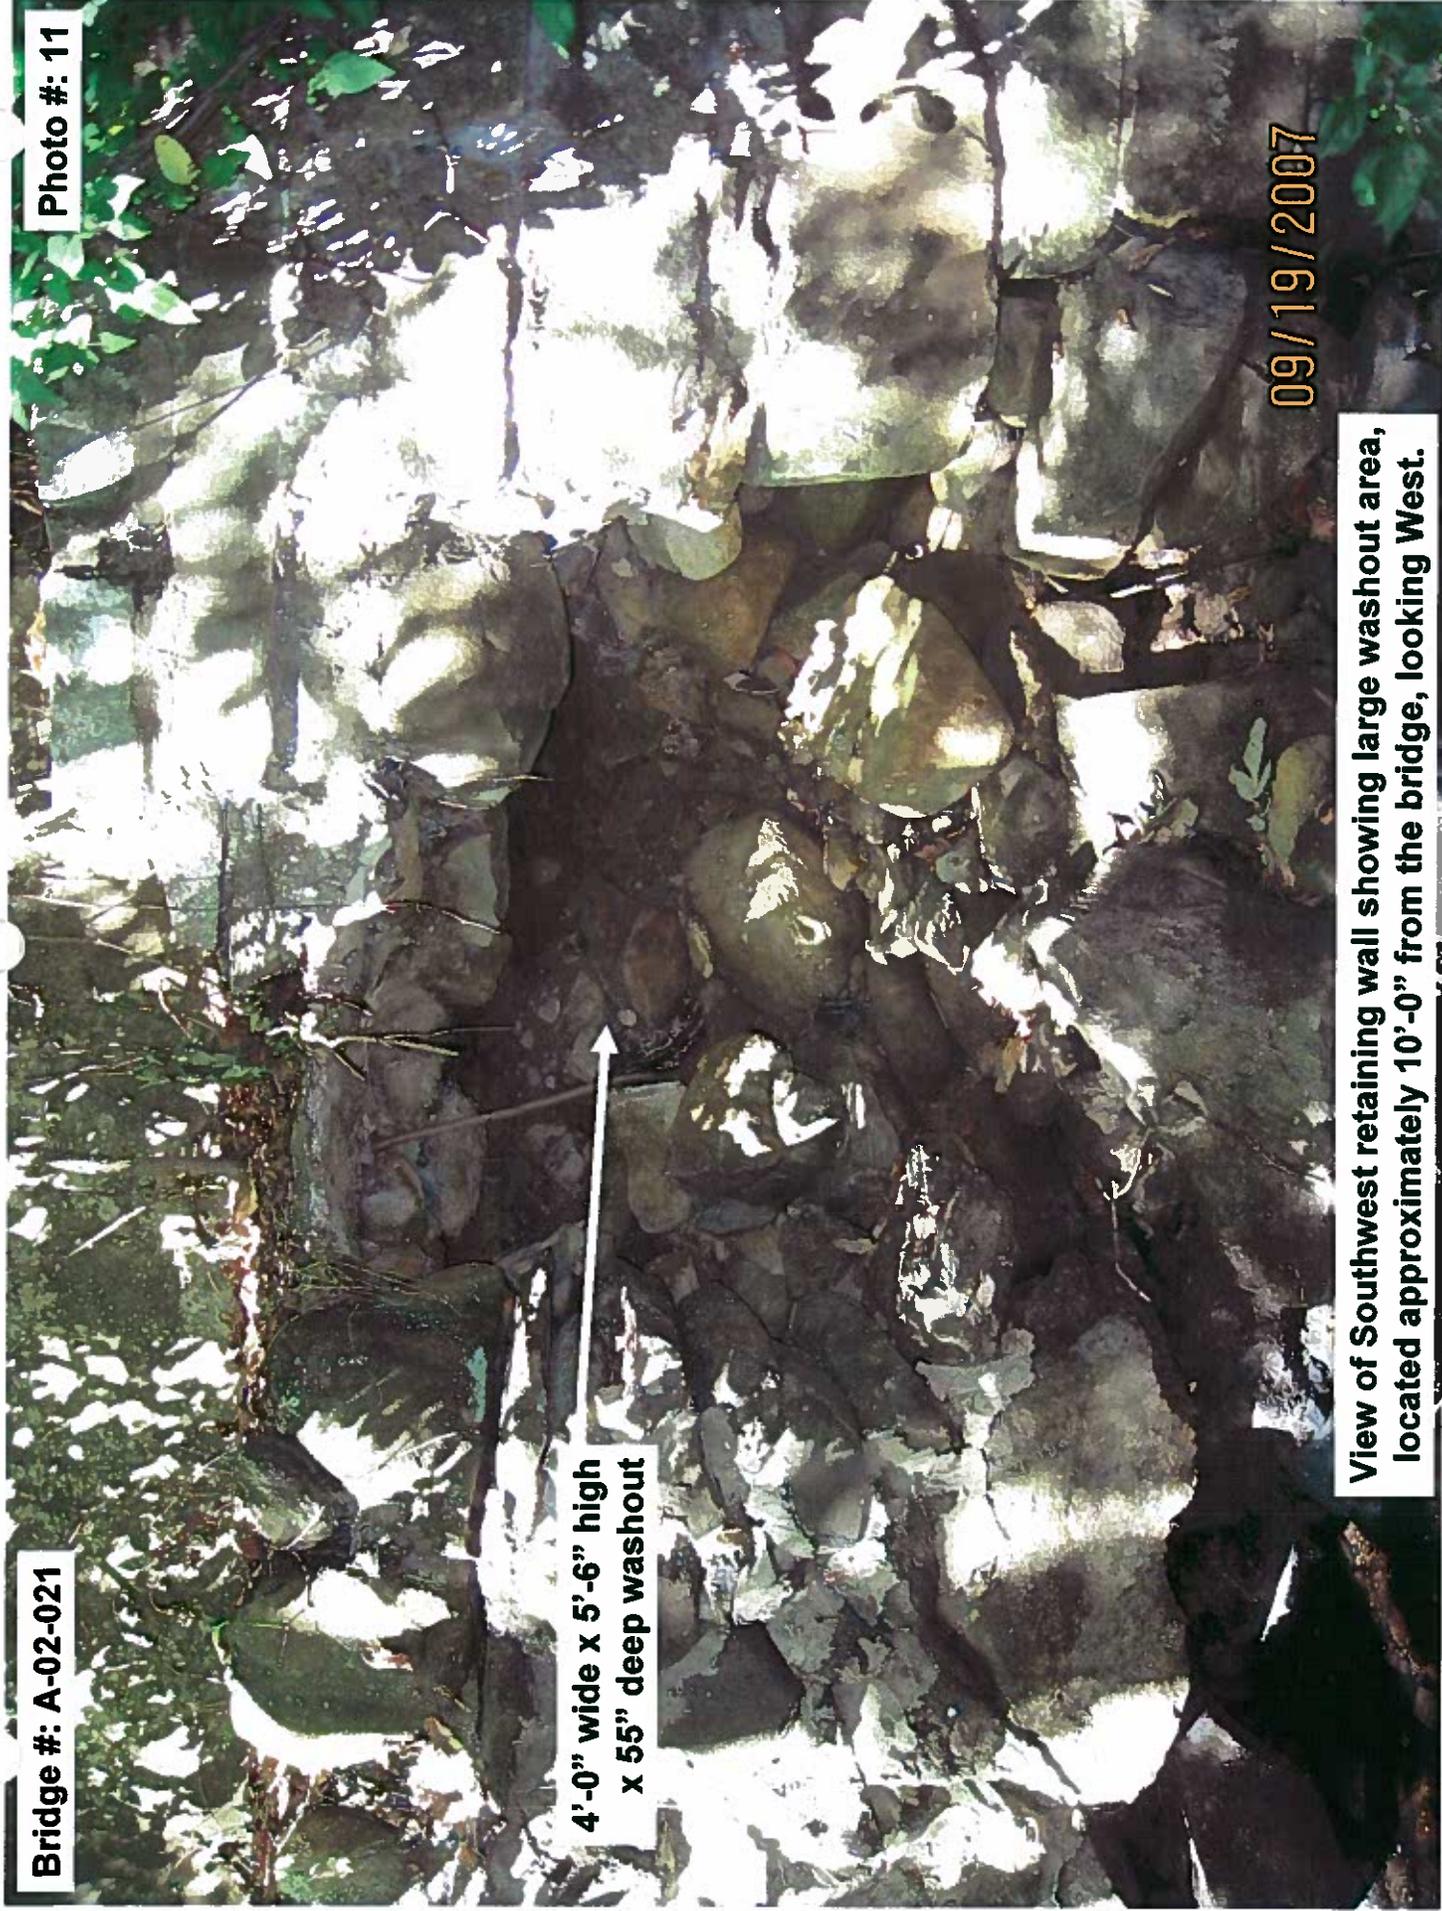
Photo #: 11

View of Southwest retaining wall showing large washout area, located approximately 10'-0" from the bridge, looking West.

#11	SW Retaining wall, approximately 10.0' upstream from bridge	Partial failure of wall	Rebuild failed portion of wall	Moderate
#12	Upstream face of both pipe arches	Debris	Remove debris from channel	Moderate

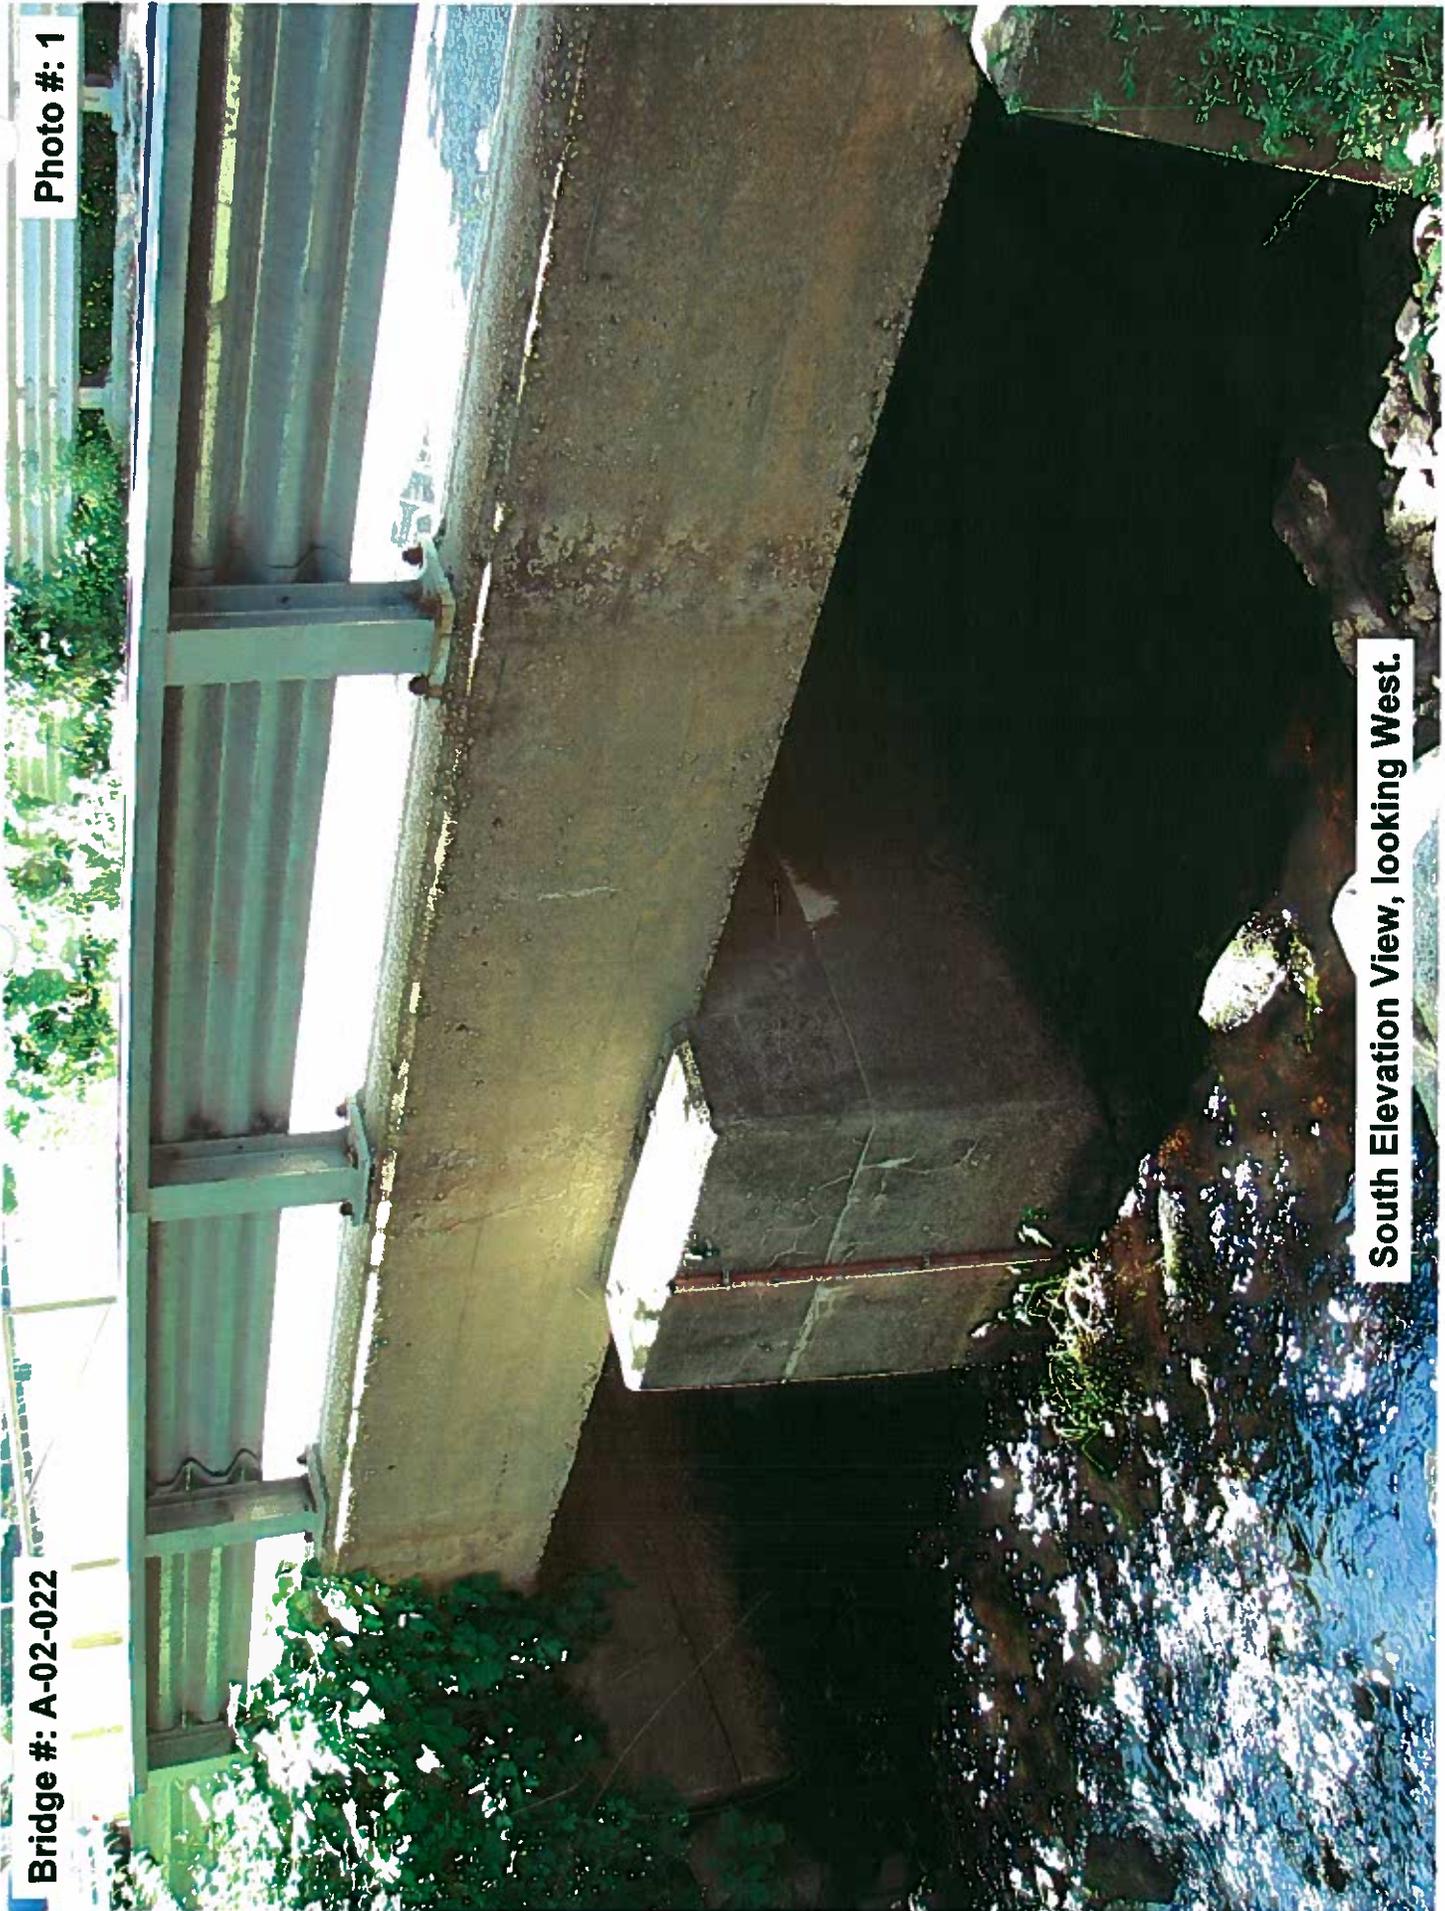
Photo #: 1

South Elevation View, looking West.

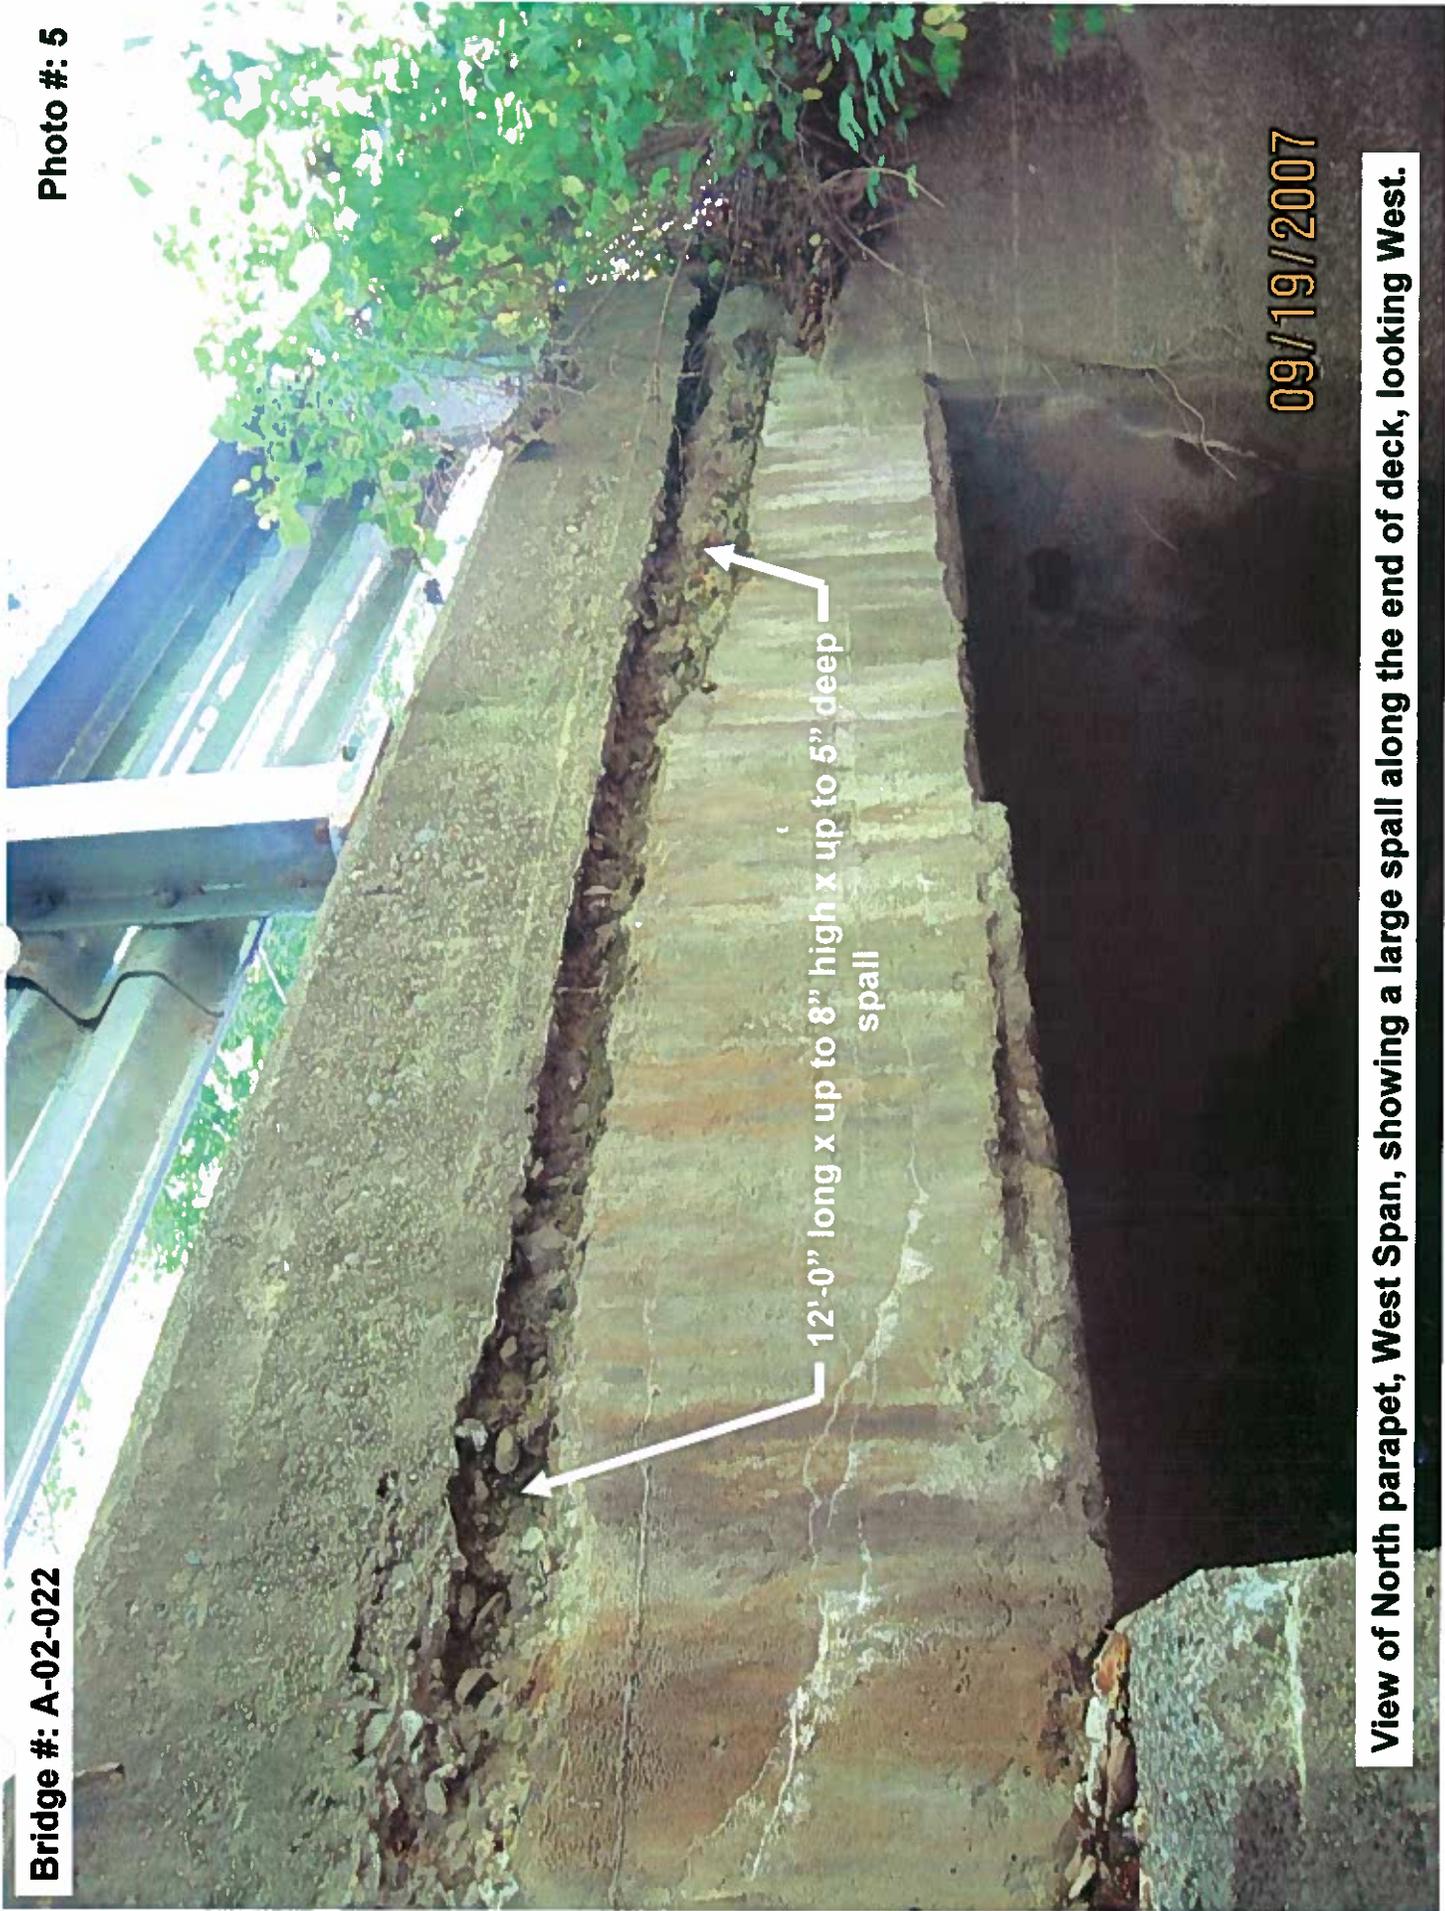
View of North parapet, West Span, showing a large spall along the end of deck, looking West.
