# PHASE I- PRELIMINARY REPORT

## Town of Acton

### Summary of Conditions and Recommendations for the Repair/Rehabilitation of Town Owned Bridges

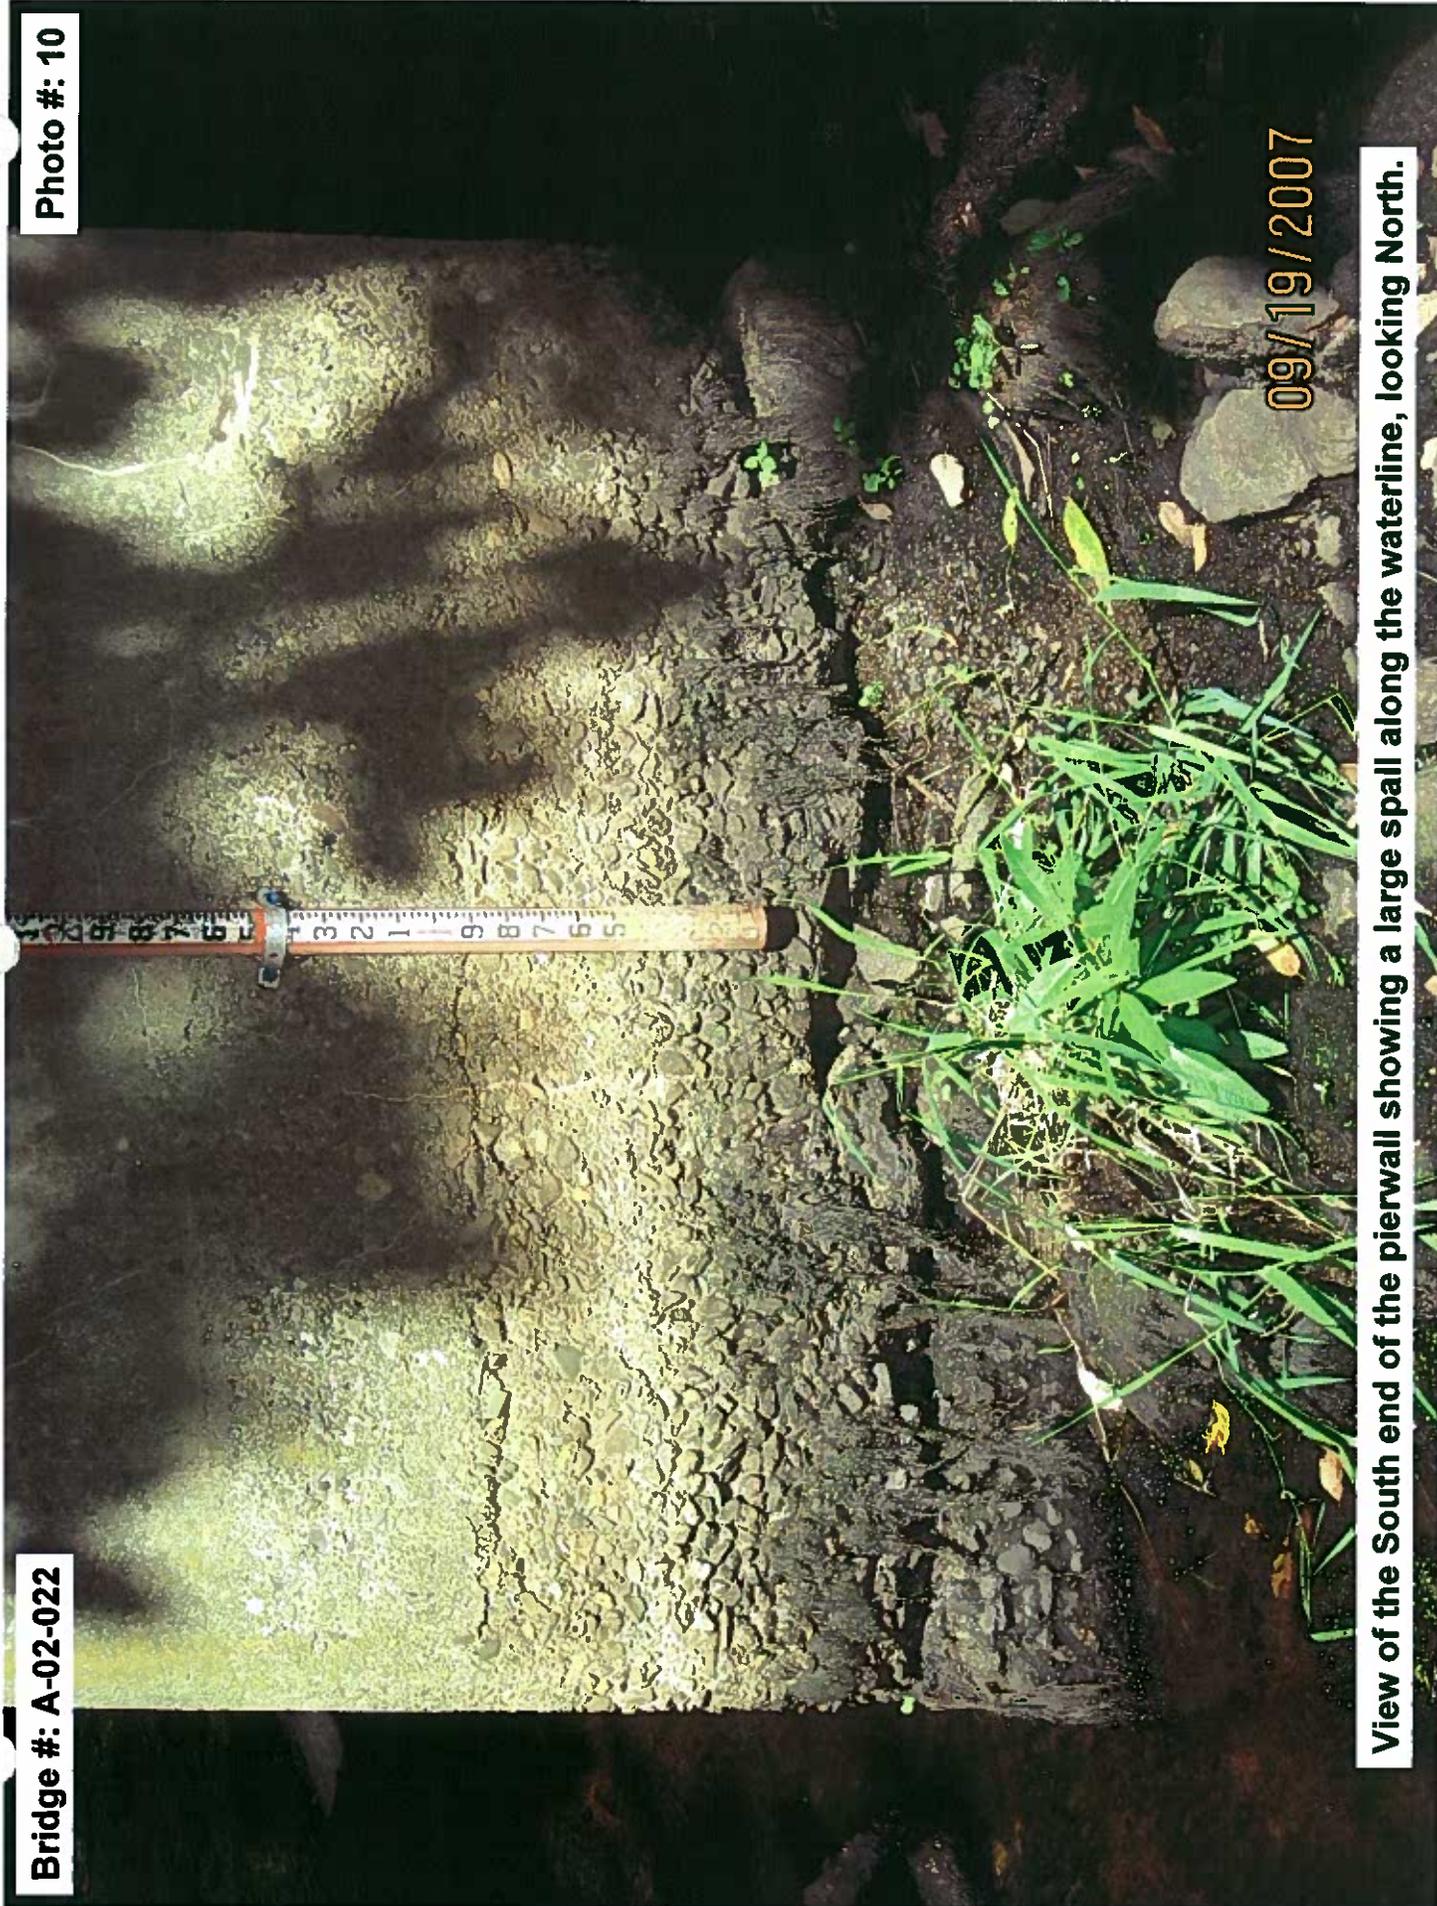
View of the South end of the pierwall showing a large spall along the waterline, looking North.

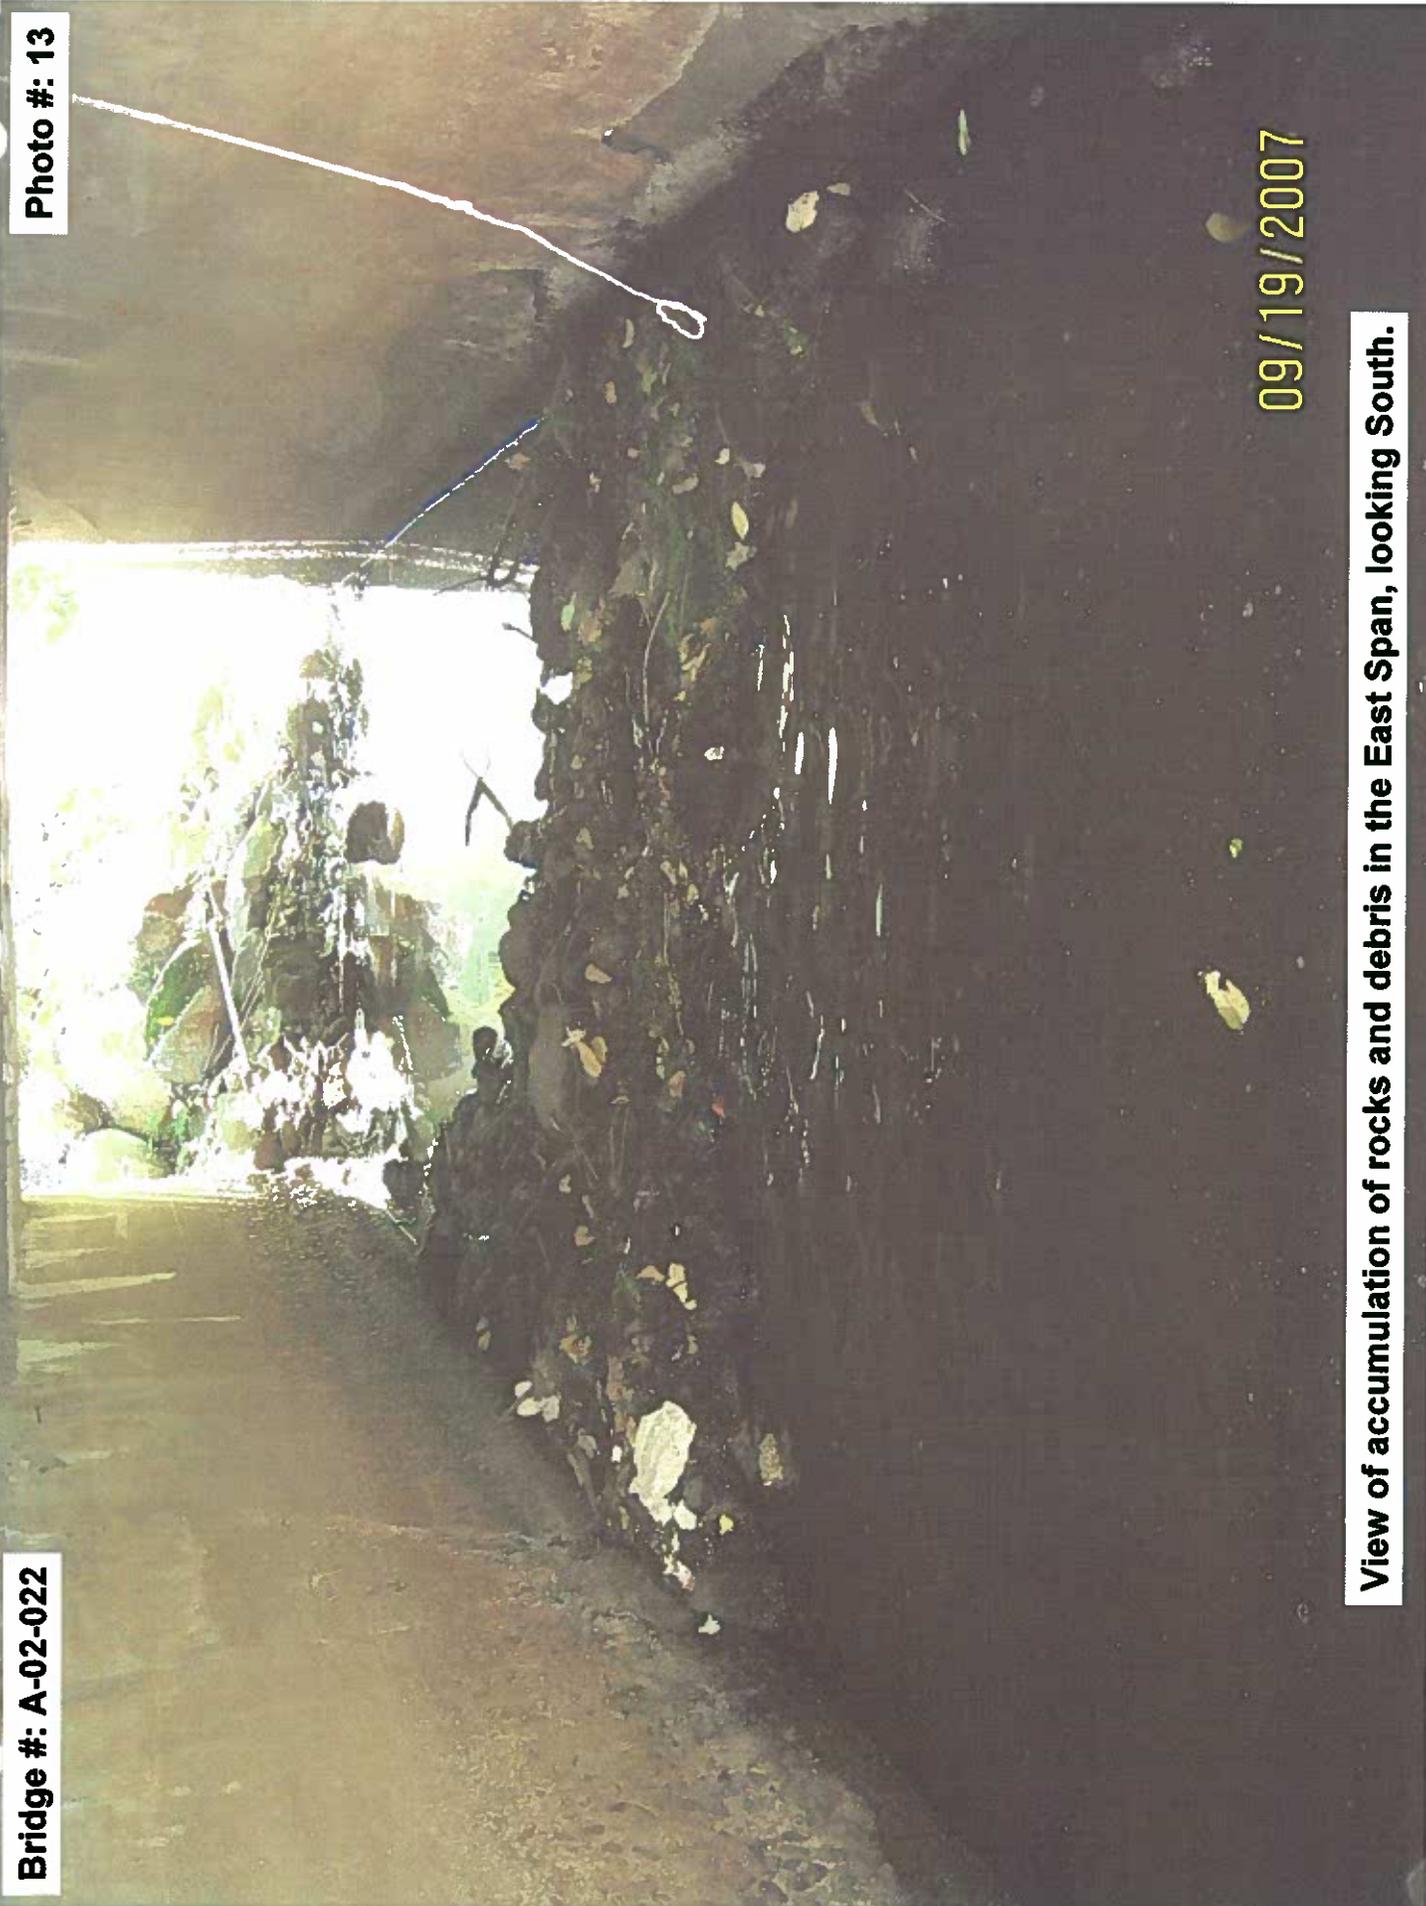
Photo #: 13

View of accumulation of rocks and debris in the East Span, looking South.

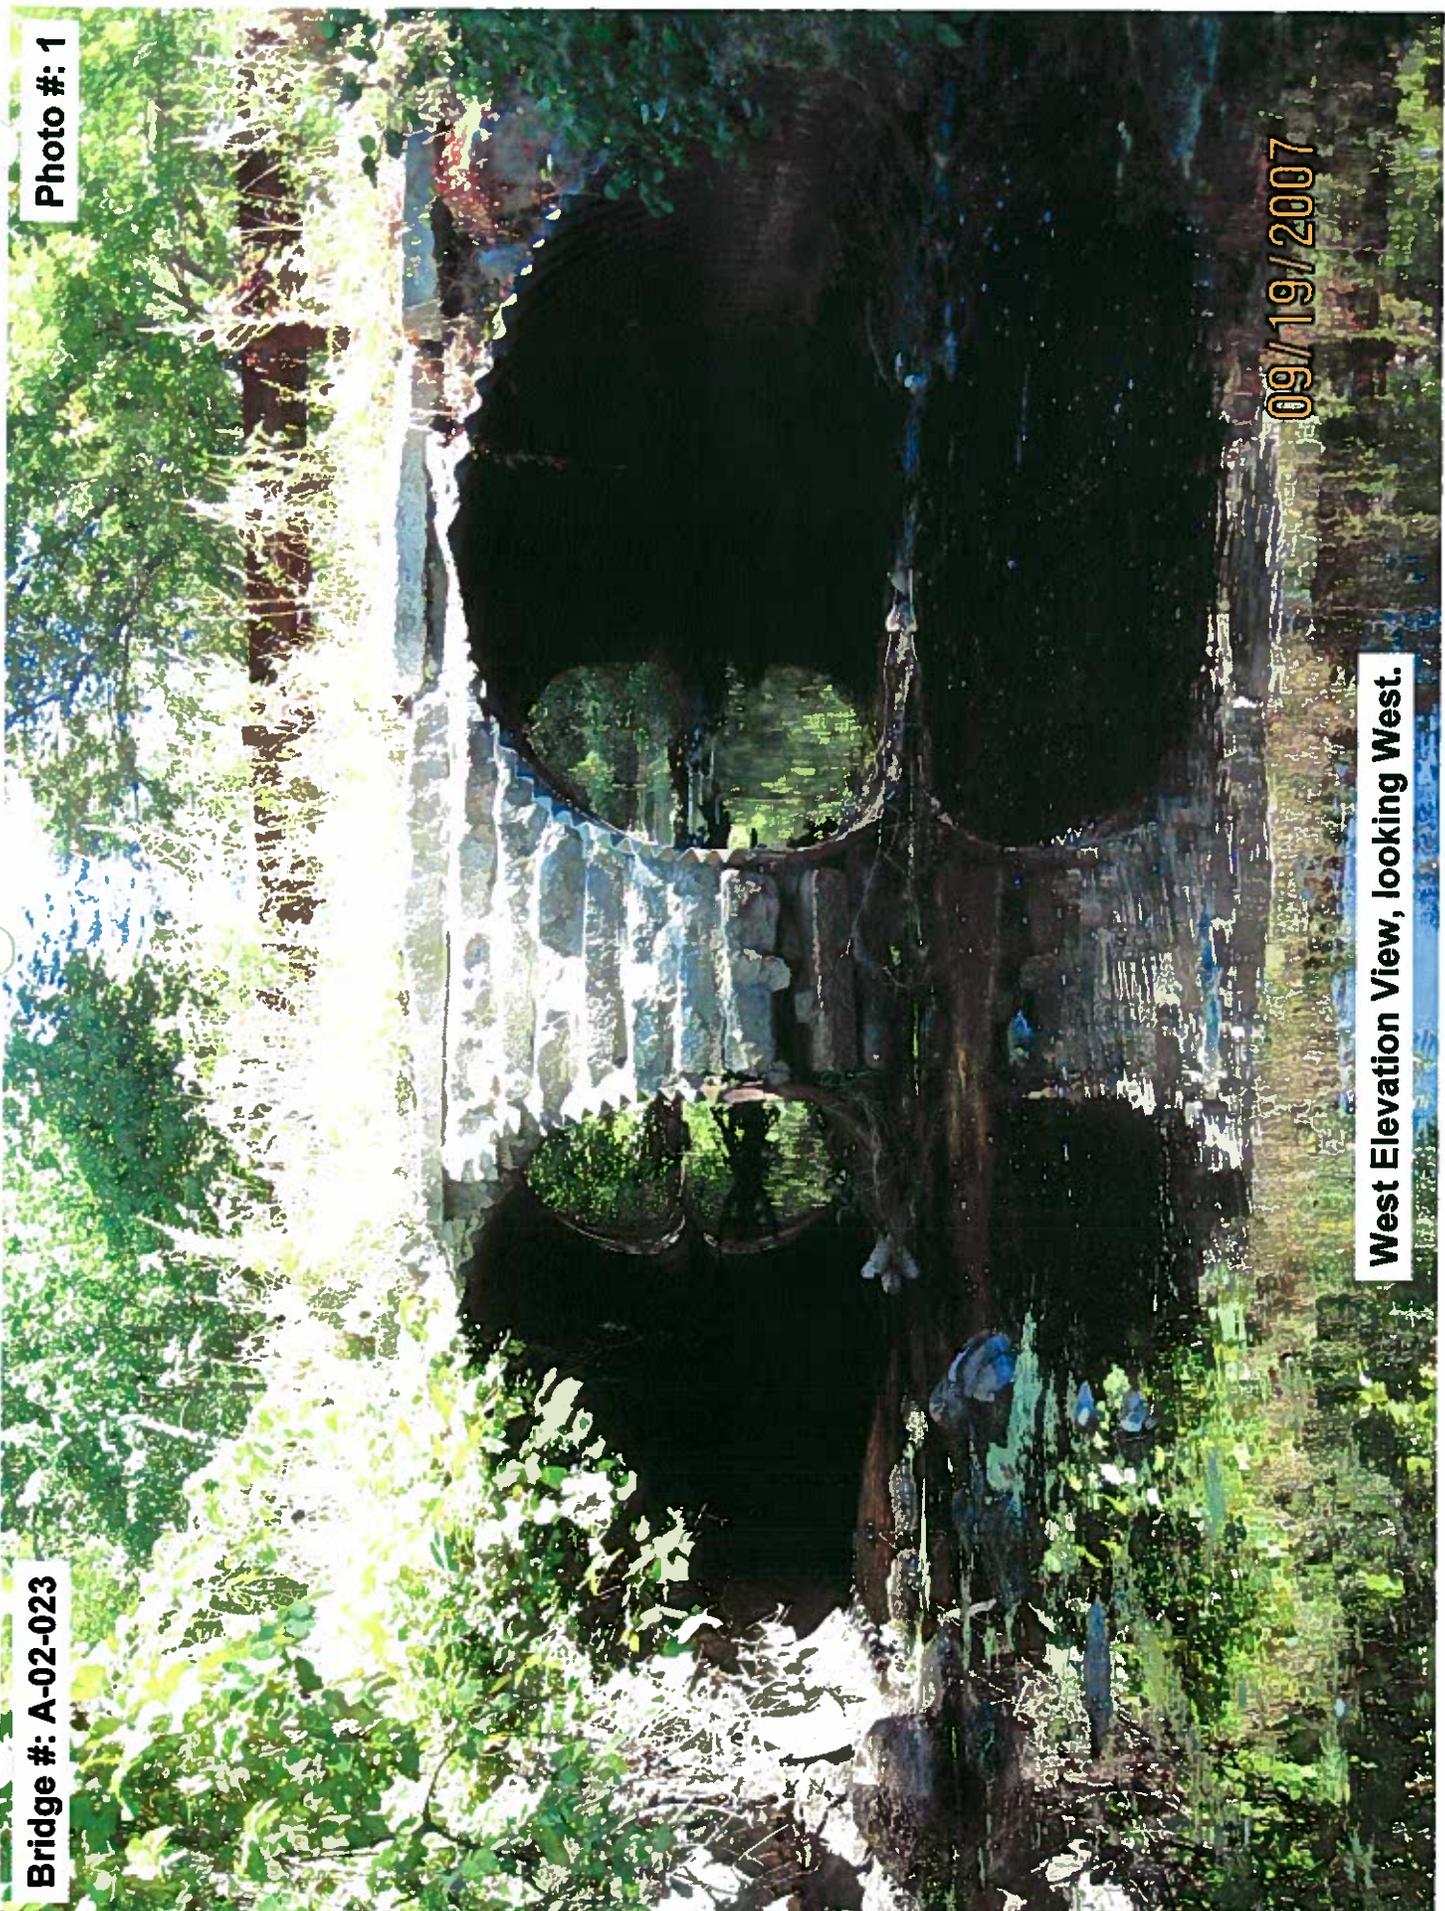
West Elevation View, looking West.

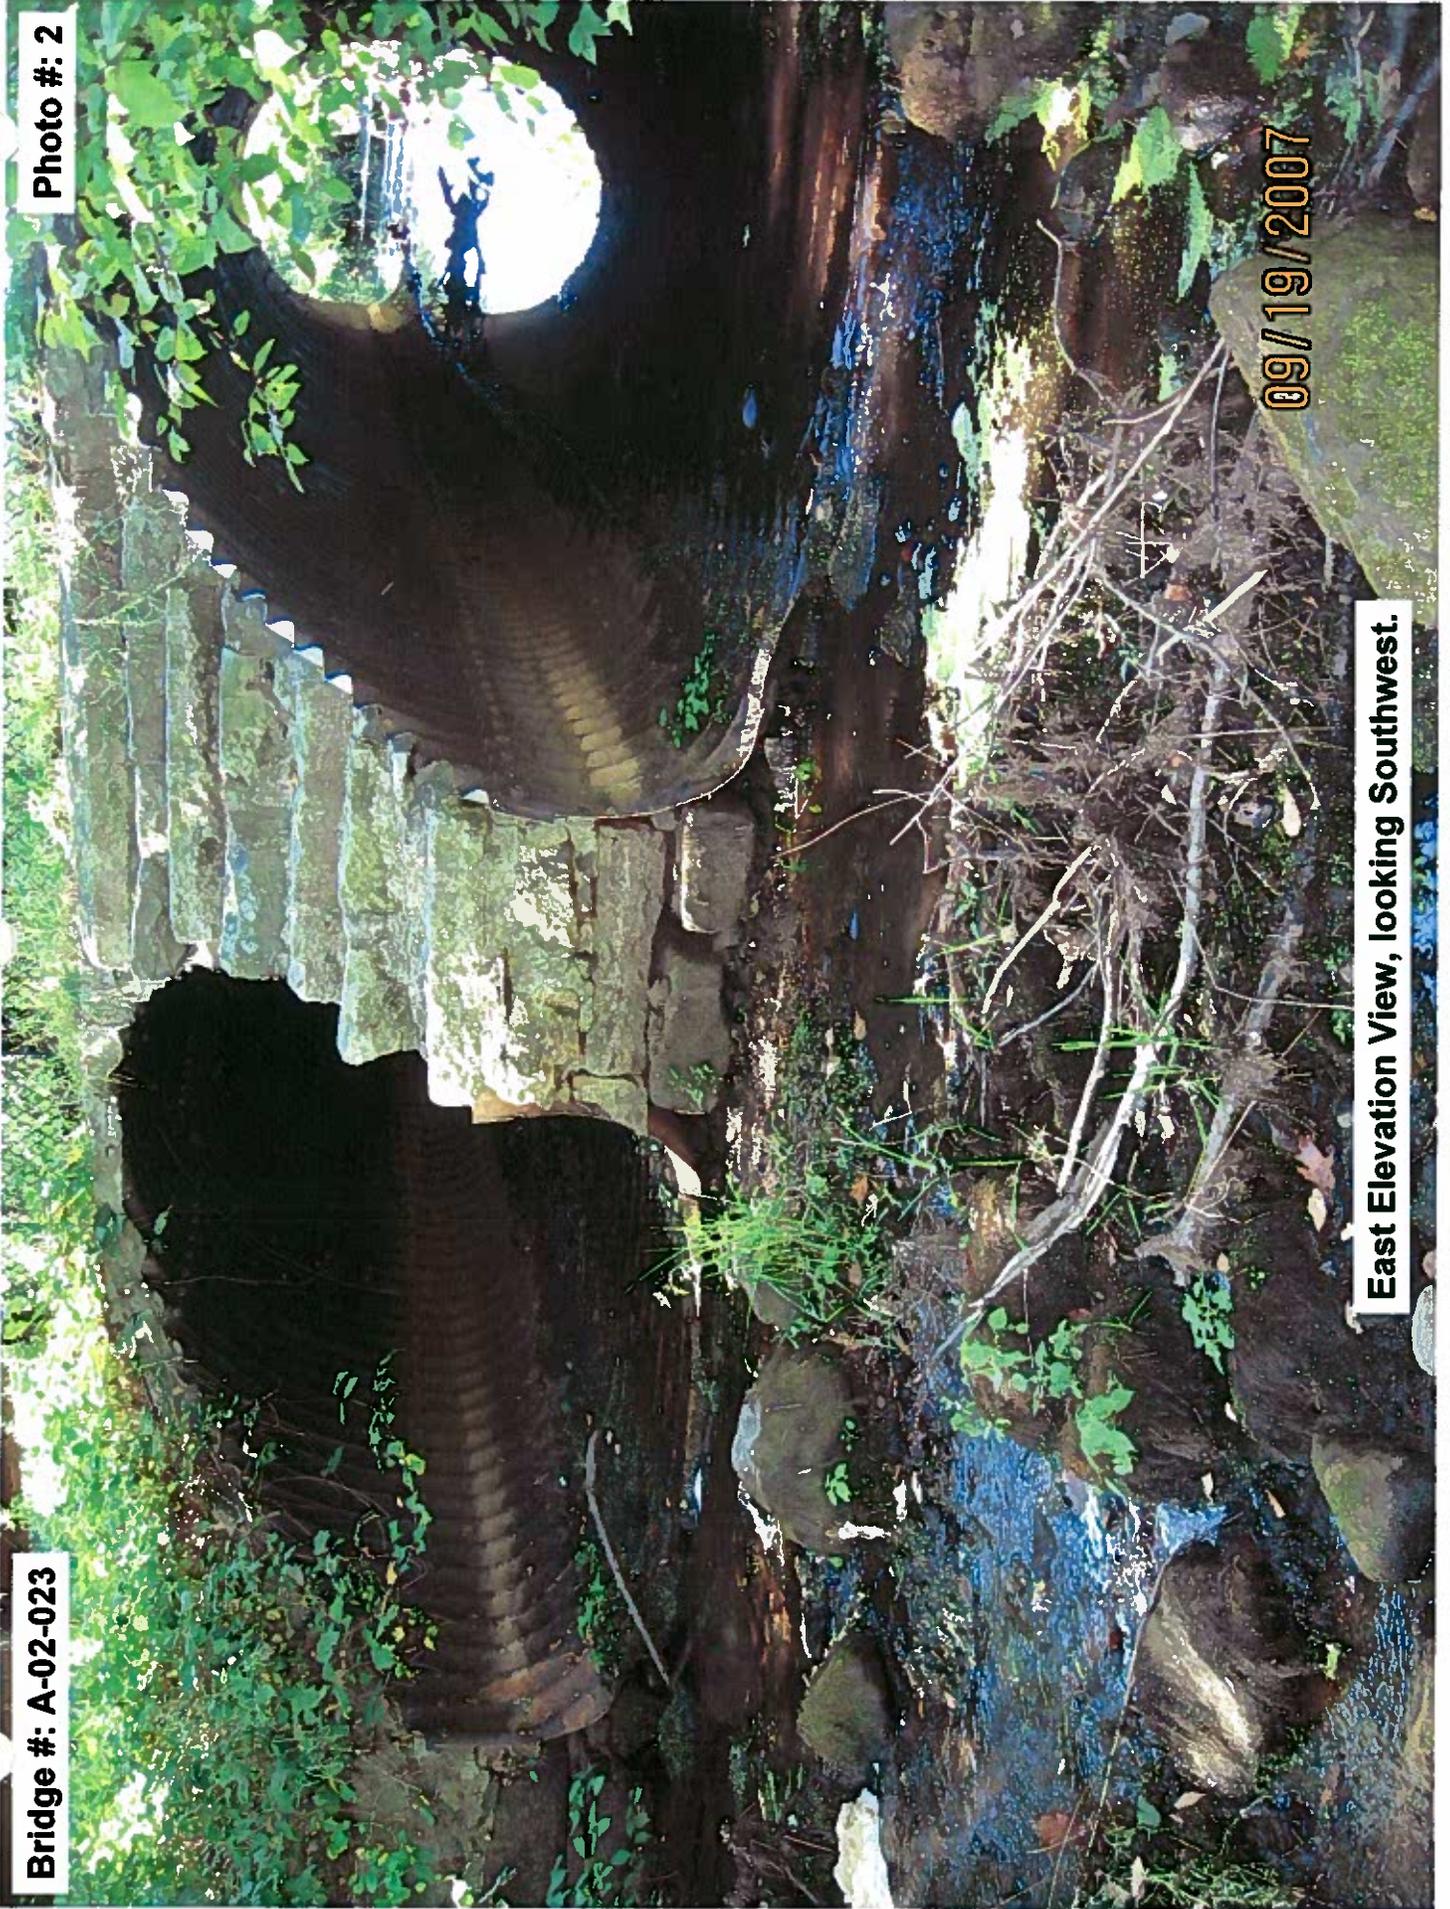
Photo #: 2

East Elevation View, looking Southwest.

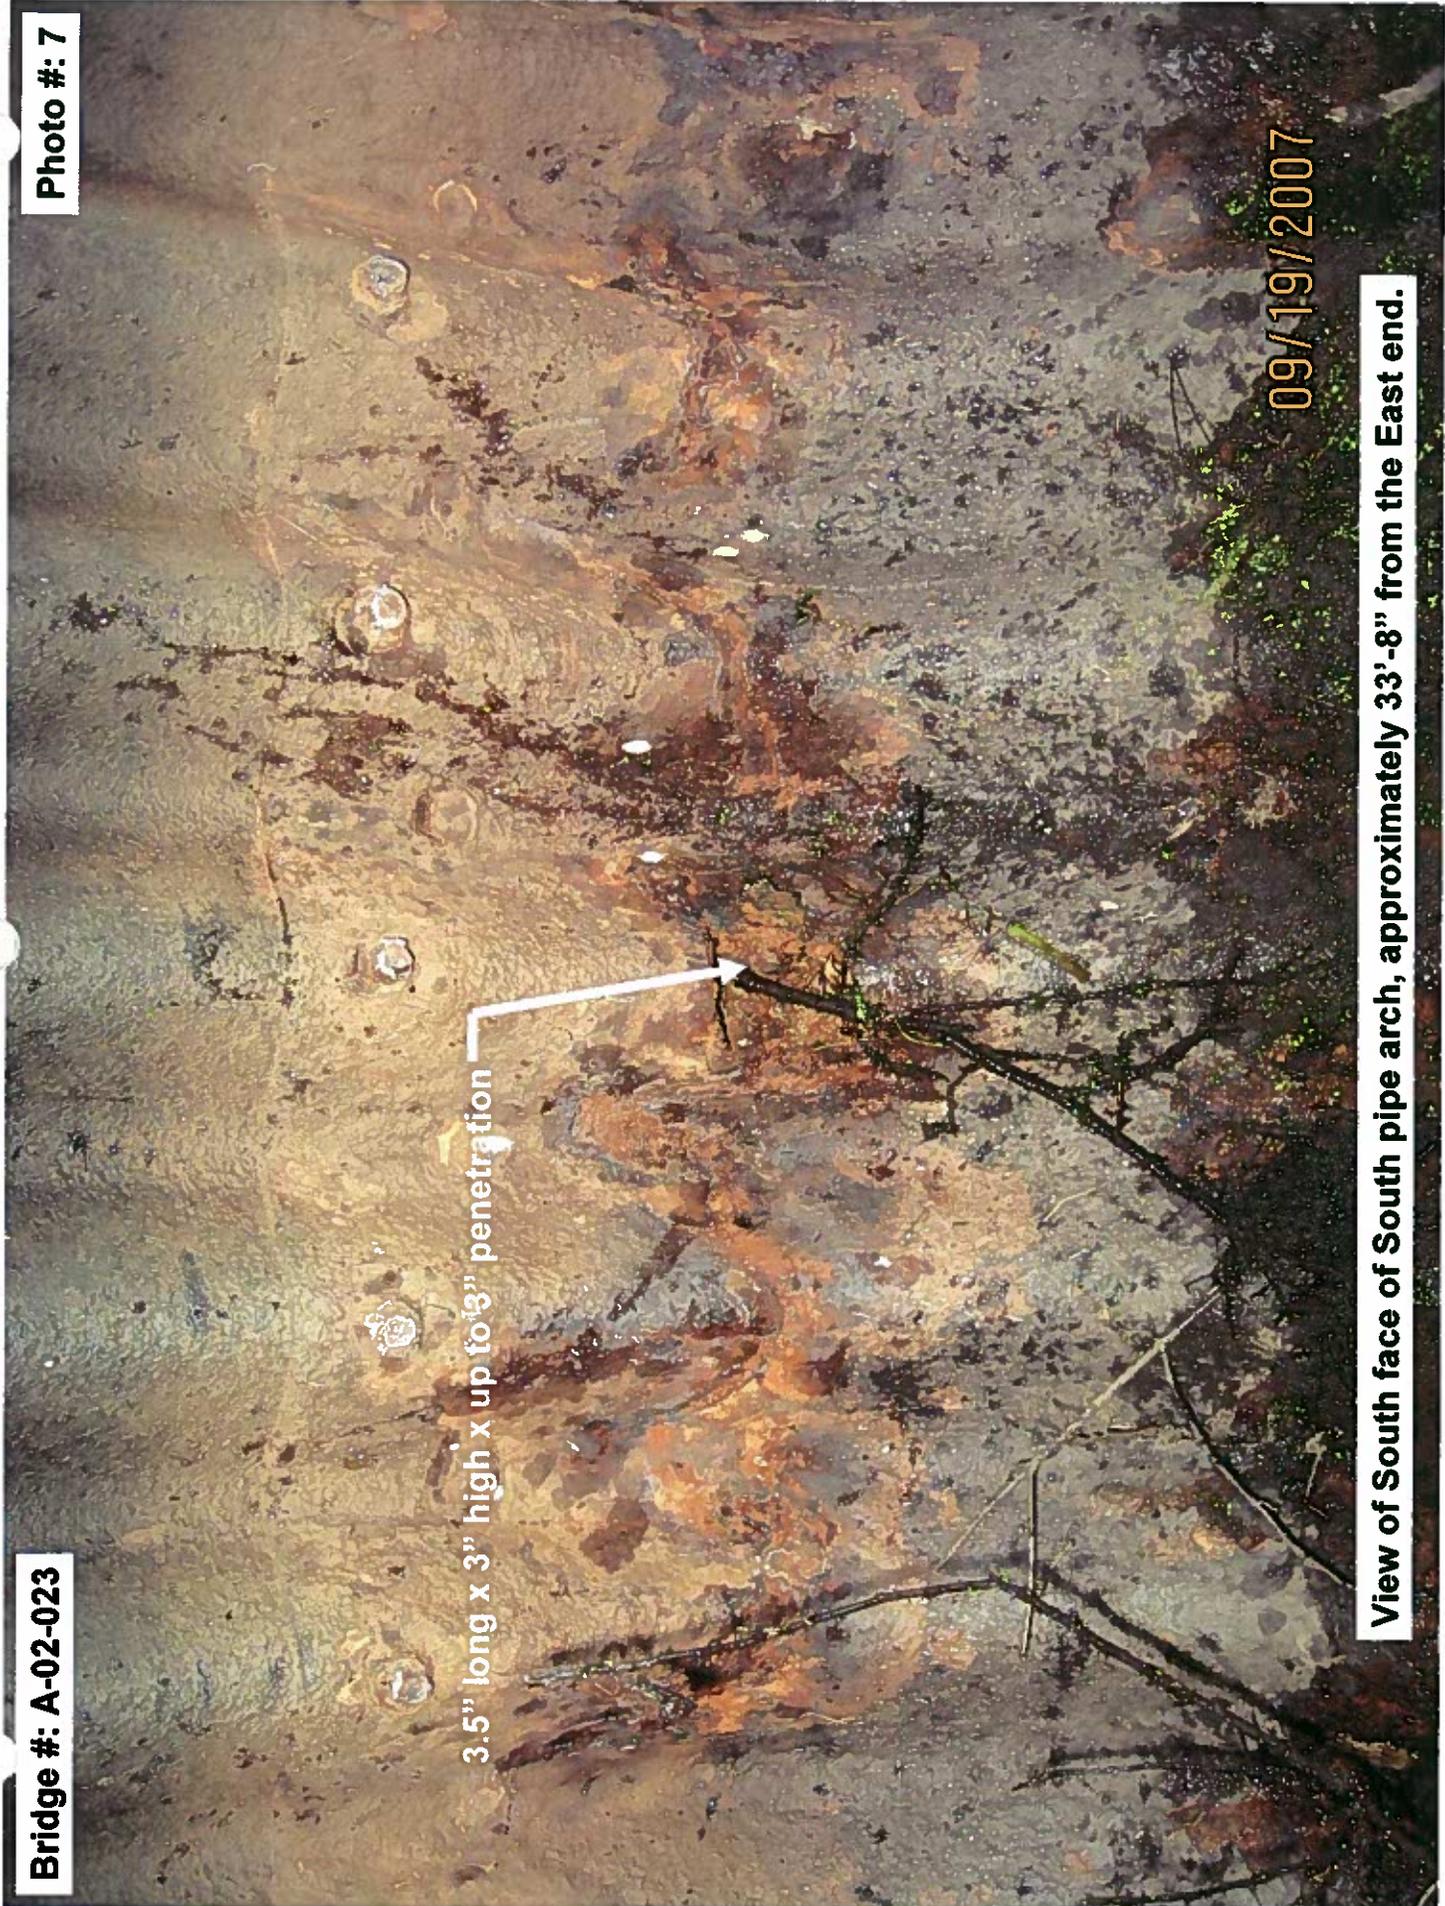
Photo #: 7

View of South face of South pipe arch, approximately 33'-8" from the East end.

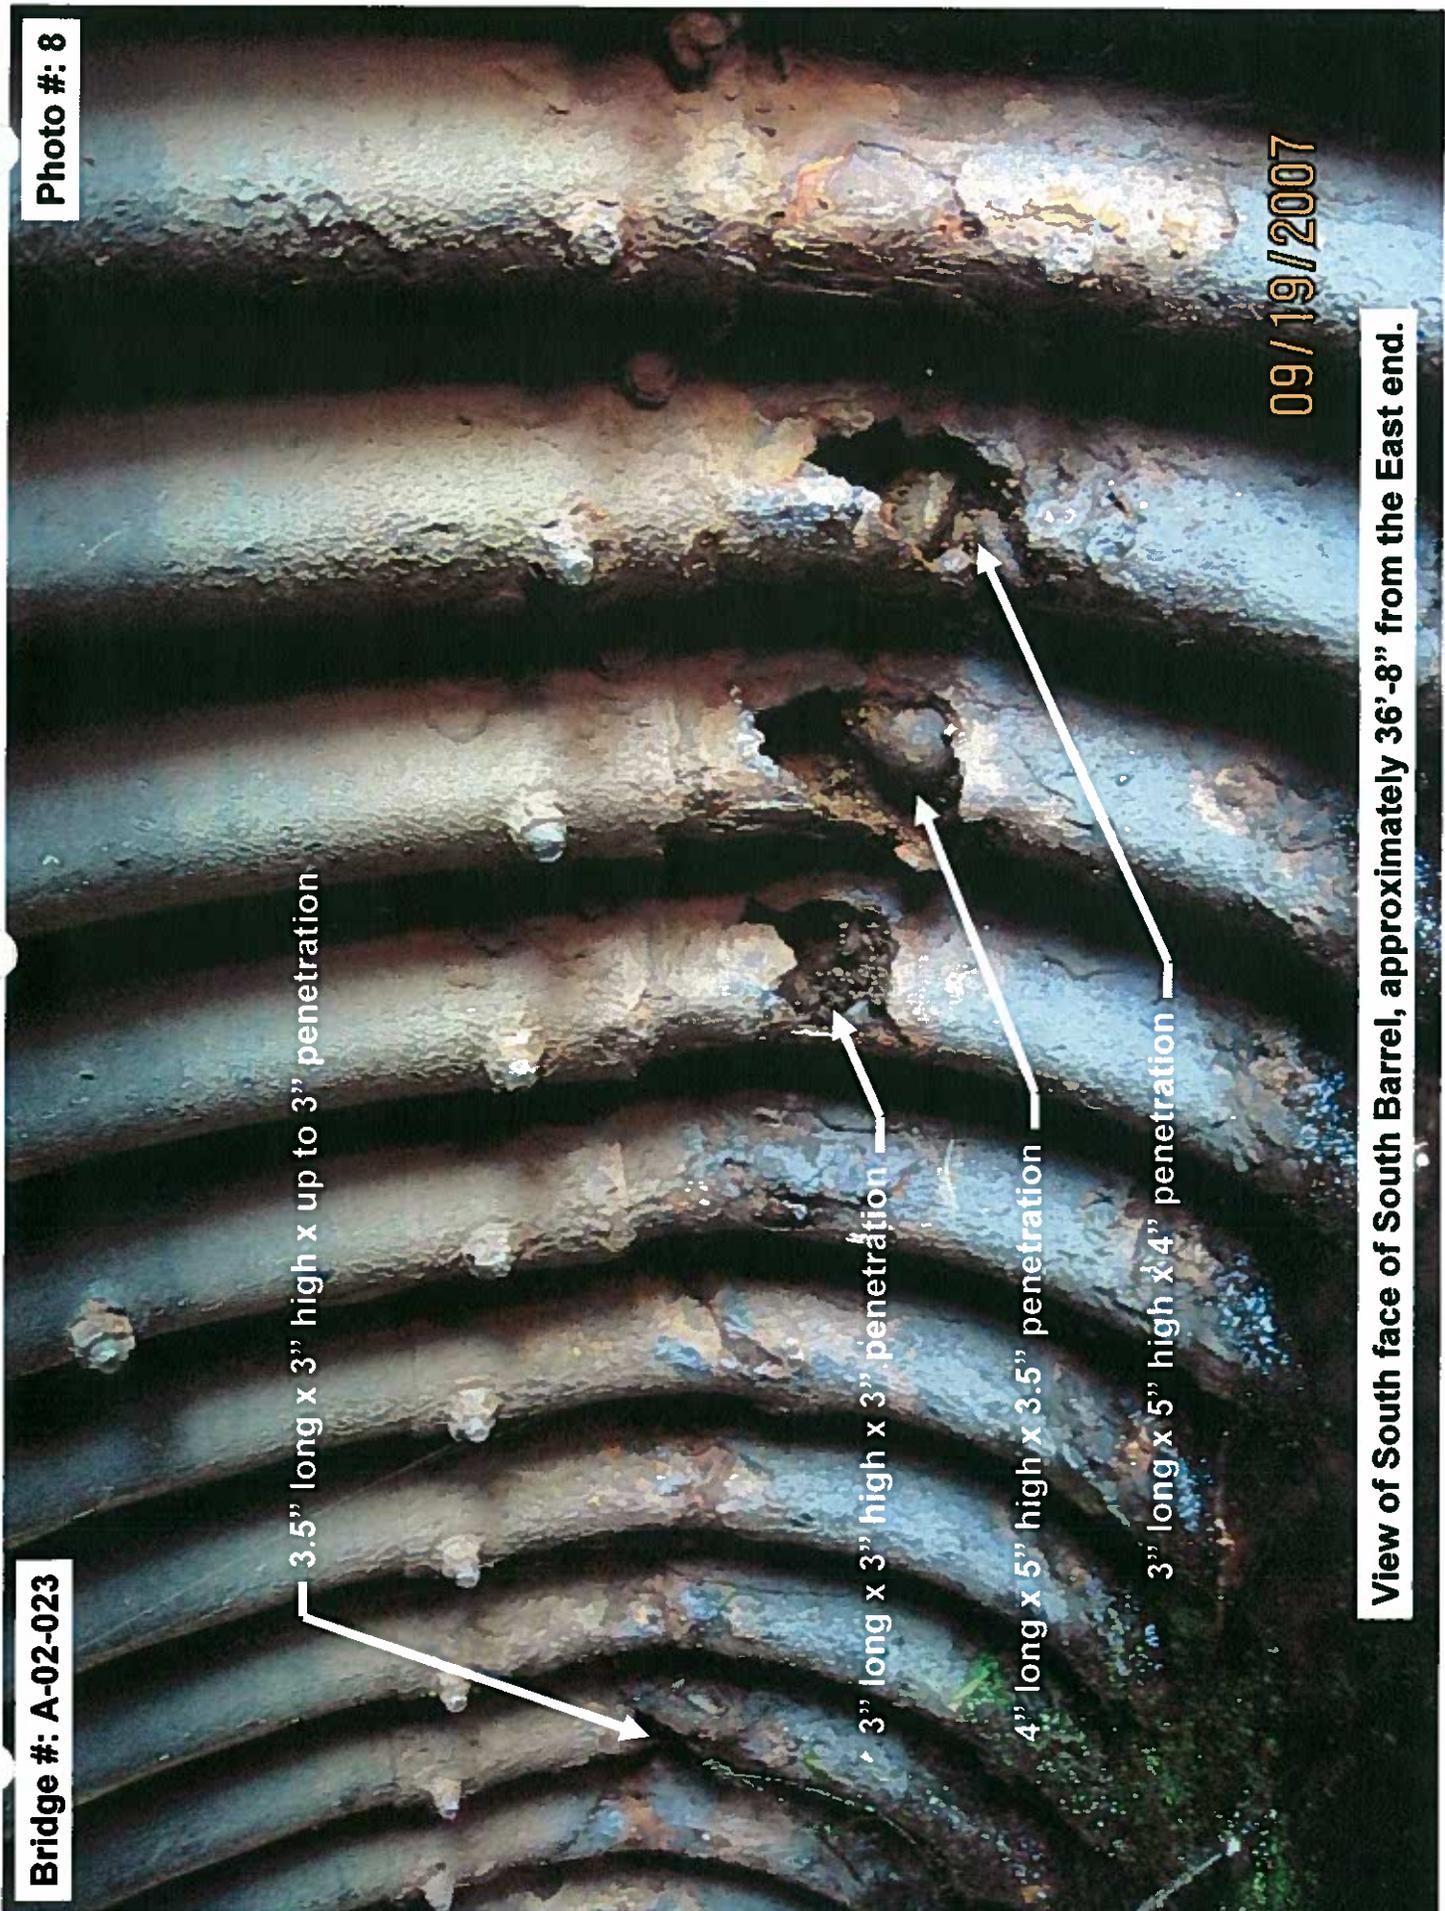
**Photo #: 8**

**View of South face of South Barrel, approximately 36'-8" from the East end.**

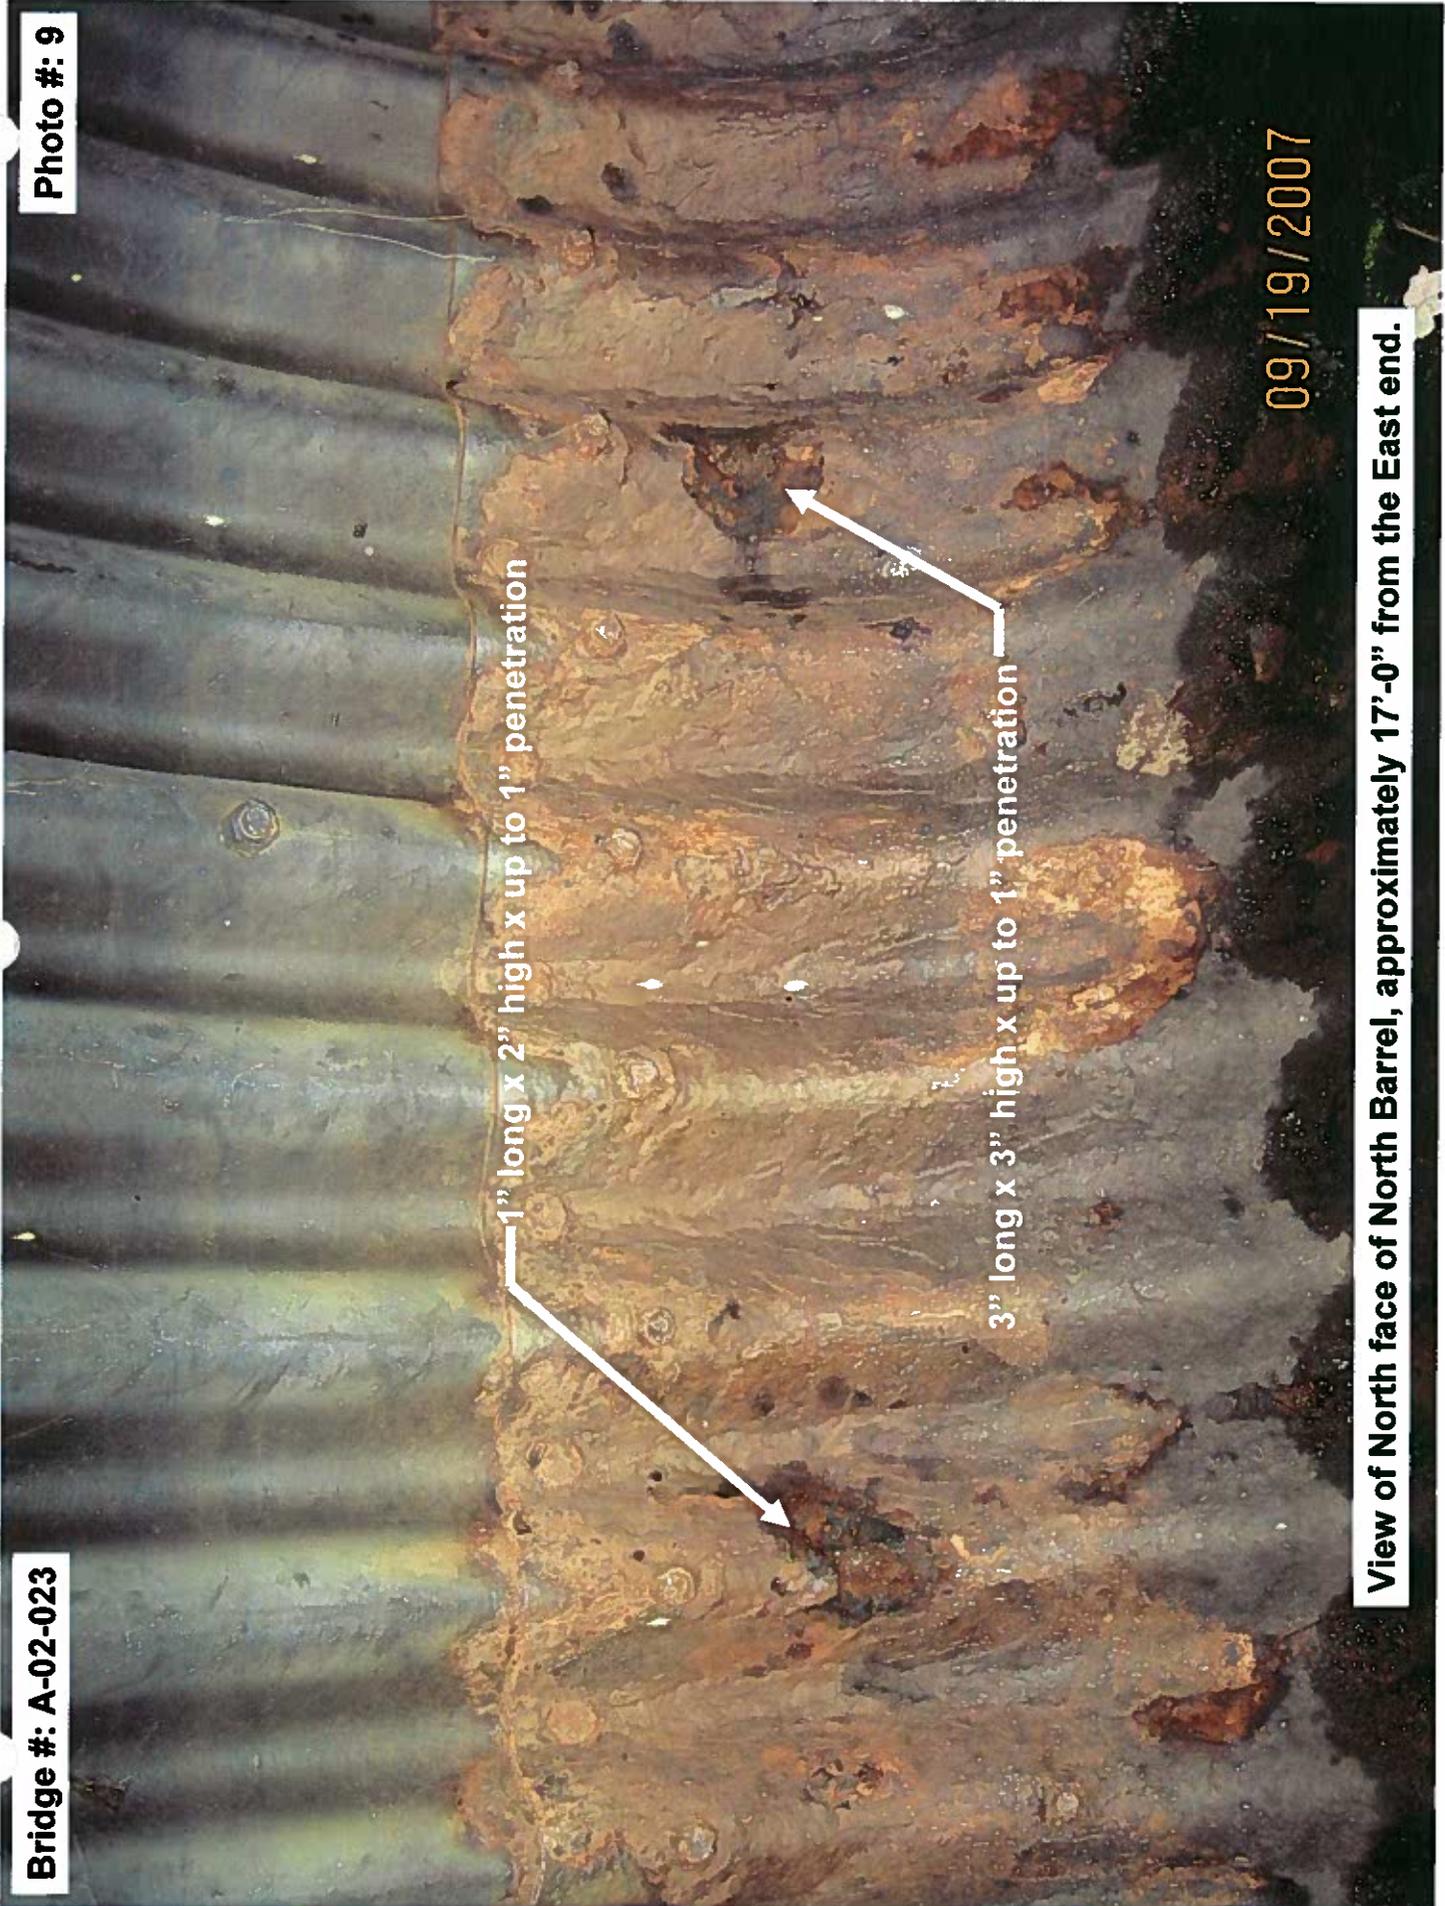
Photo #: 9

View of North face of North Barrel, approximately 17'-0" from the East end.

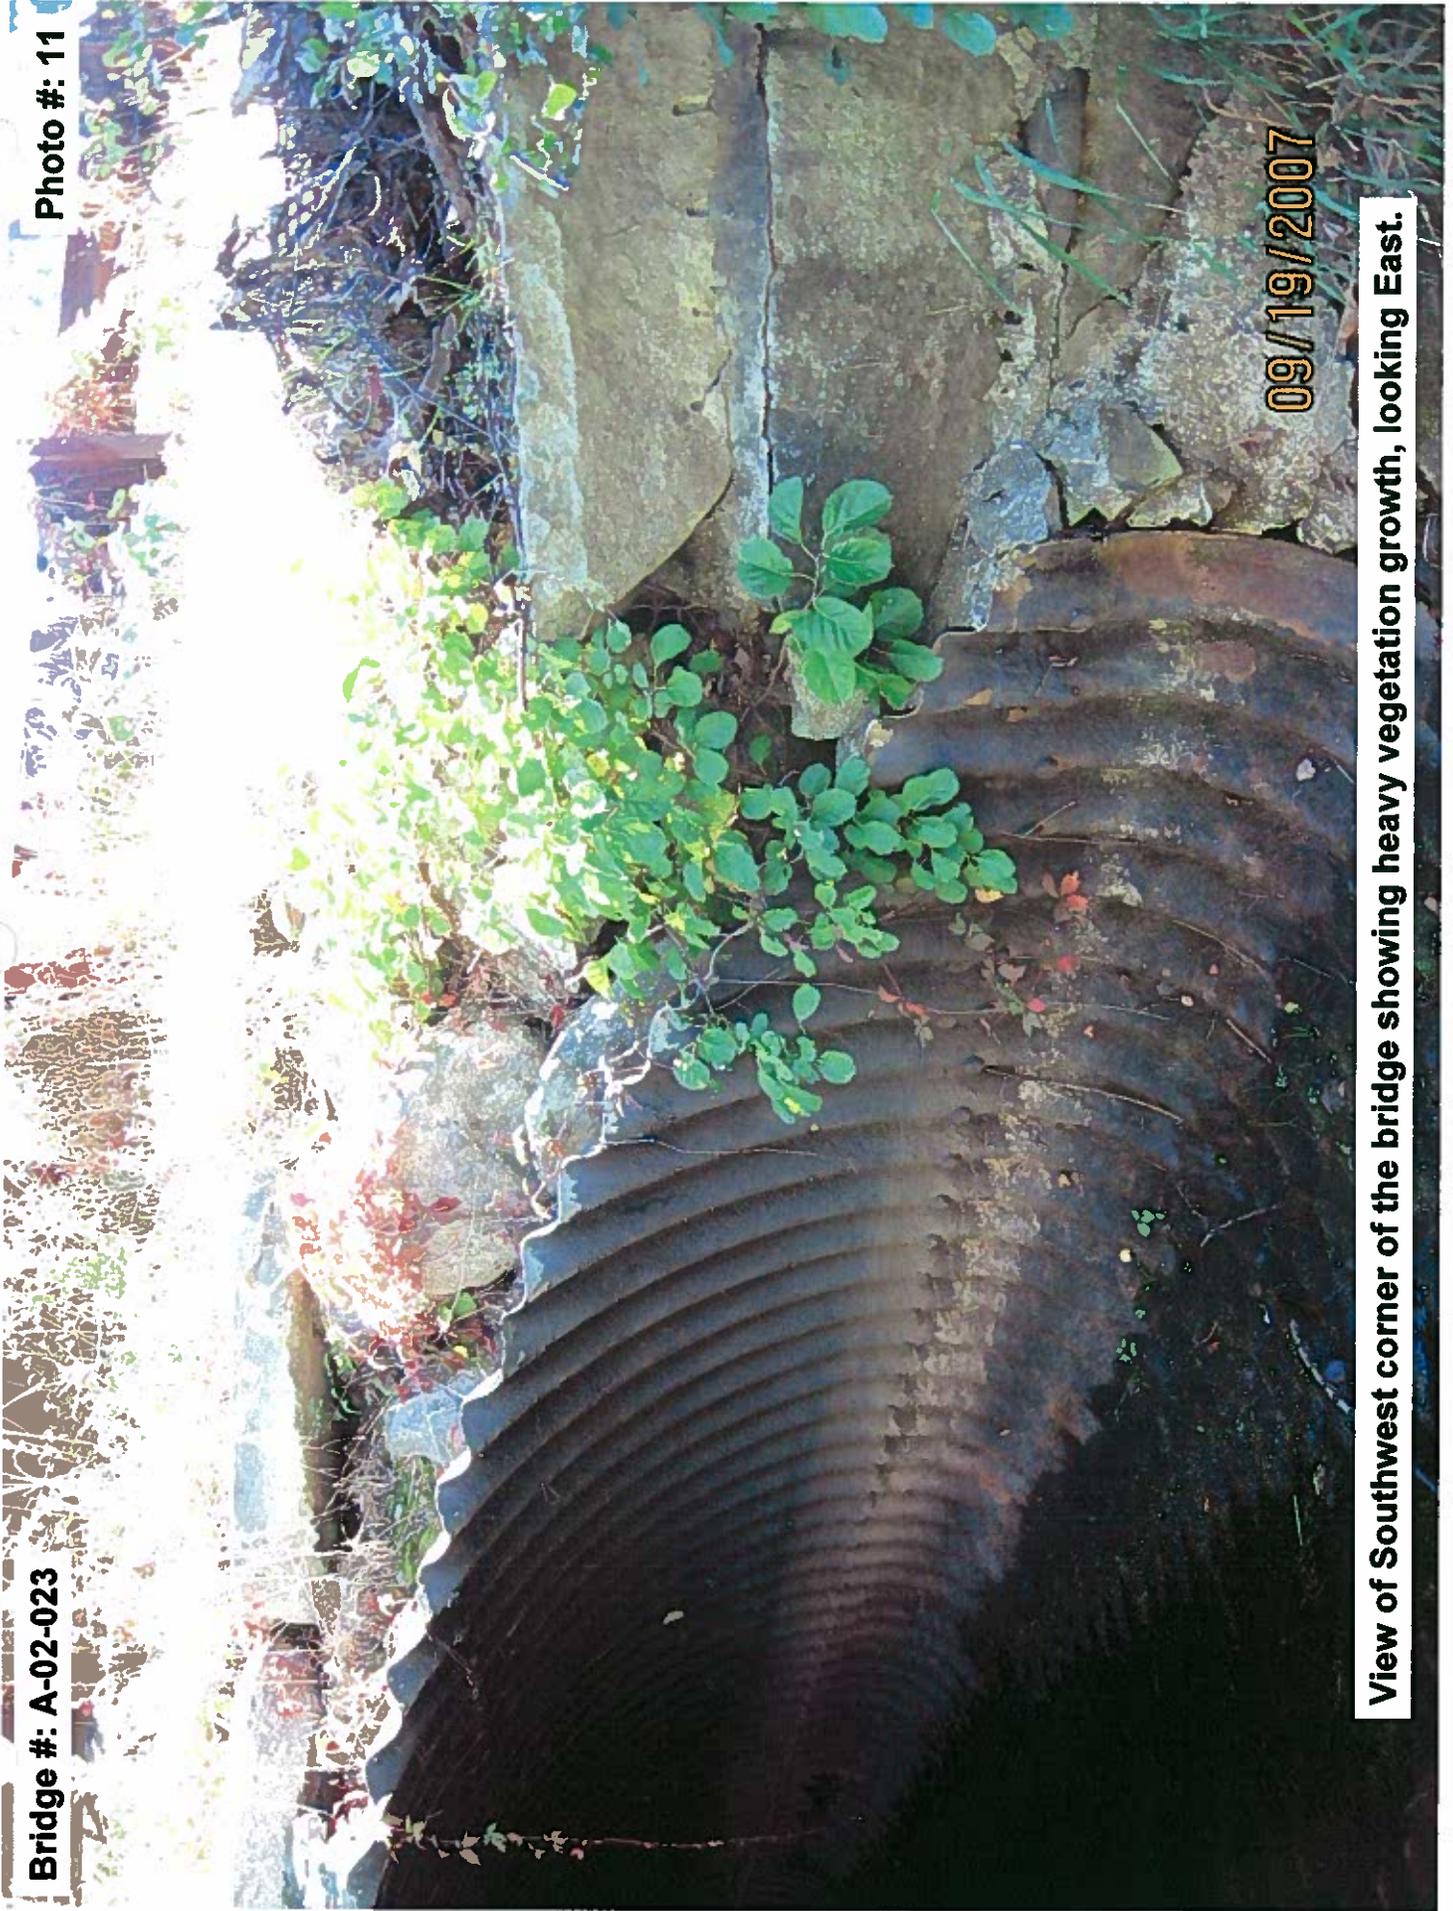
Photo #: 11

View of Southwest corner of the bridge showing heavy vegetation growth, looking East.

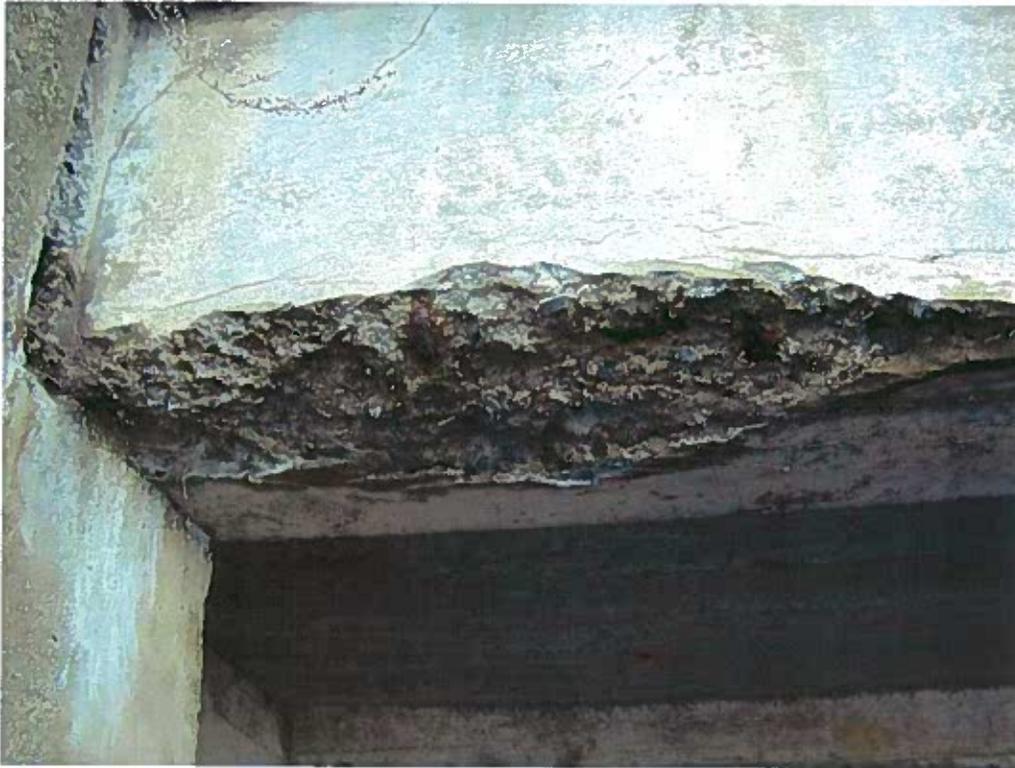
**Photo 5: Scaling to the bottom Southeast end of beam #7.**
