# PHASE I- PRELIMINARY REPORT

## Town of Acton

### Summary of Conditions and Recommendations for the Repair/Rehabilitation of Town Owned Bridges

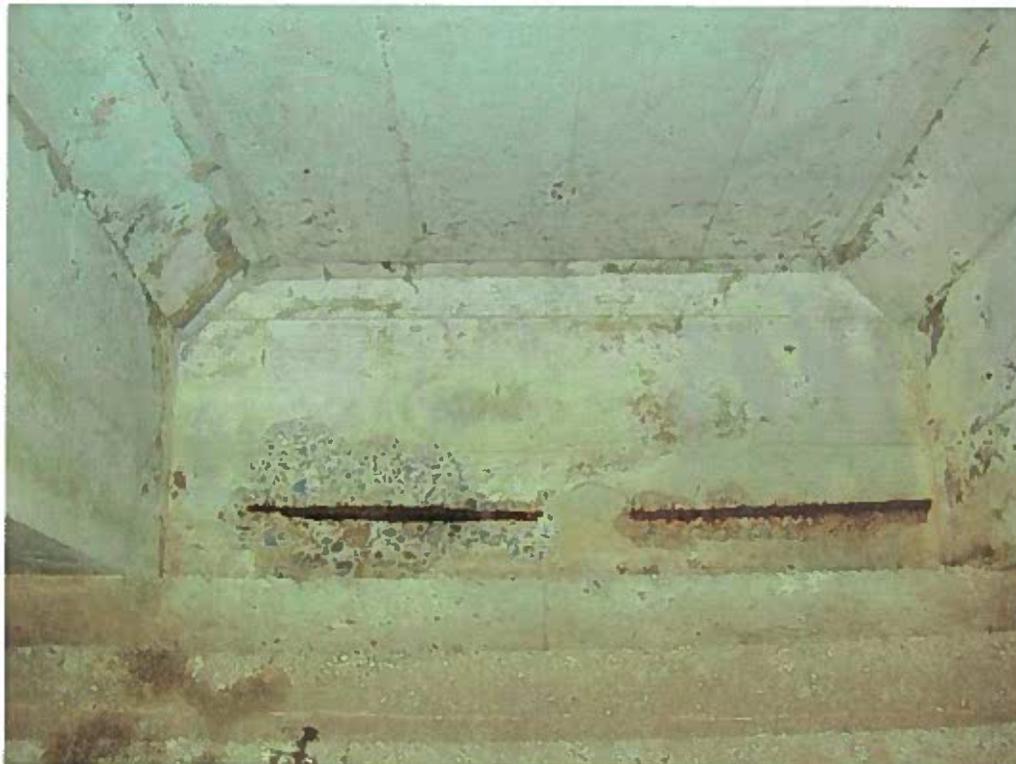
**Photo 6: Pop outs in the North backwall of bay #4. Typical.**

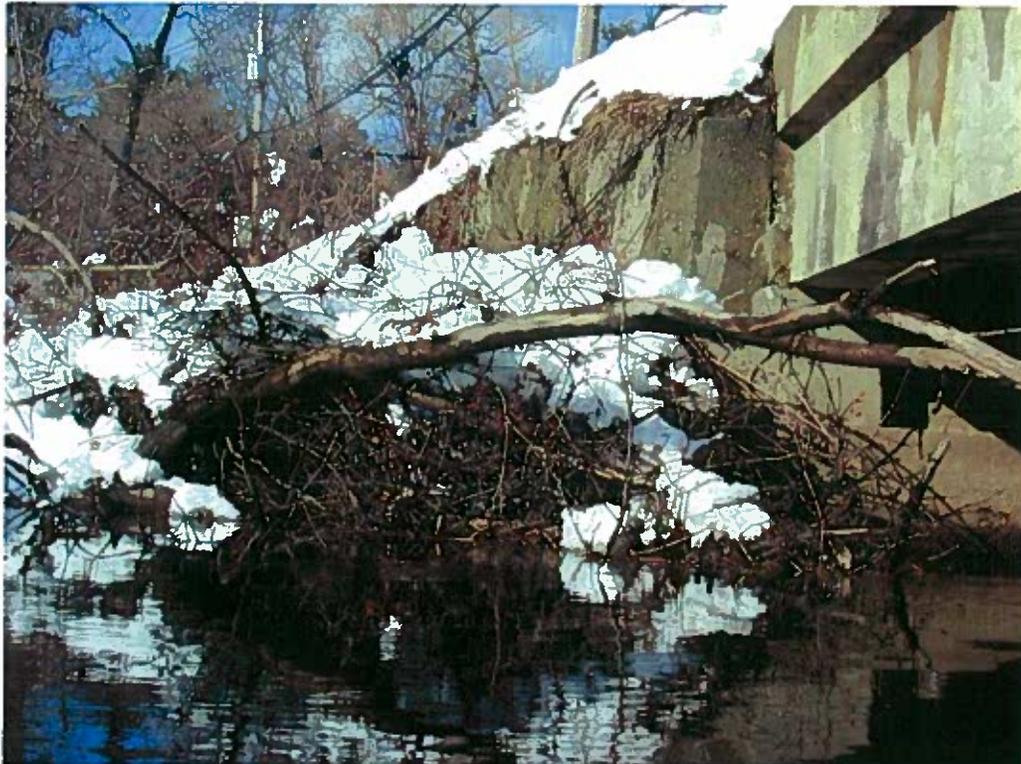
**Photo 8: Debris at the Northwest wingwall/abutment.**

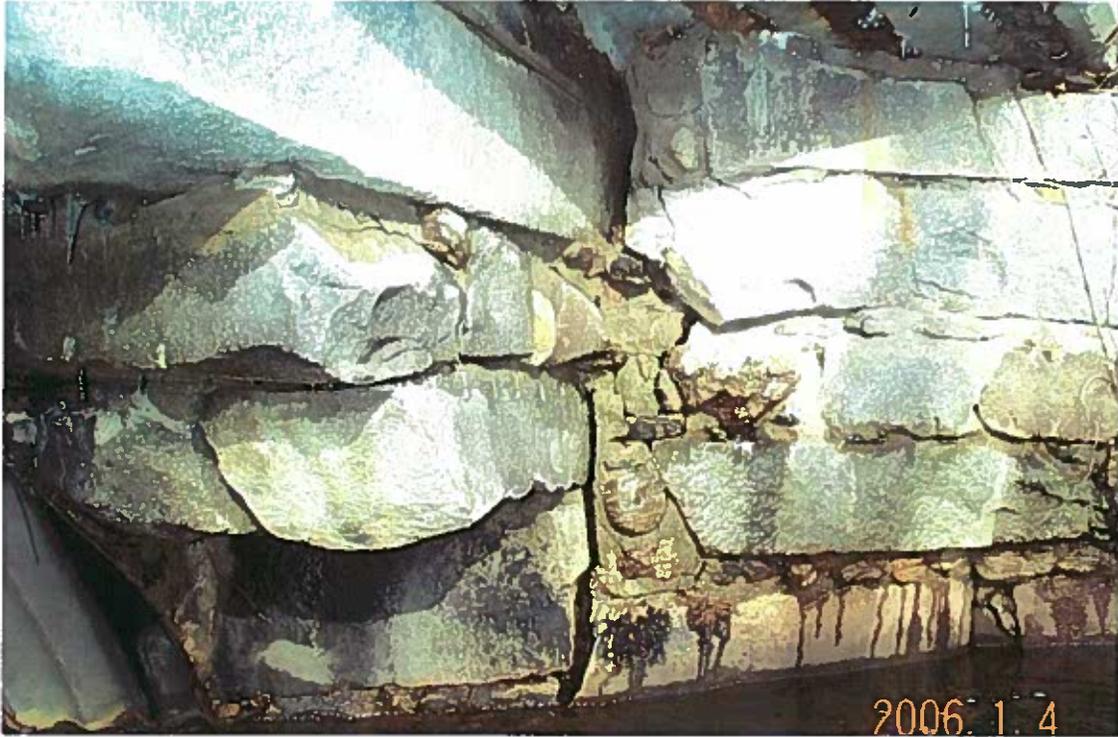
**Photo 5: Two inch separation between the East spandrel wall and Northeast wingwall.**

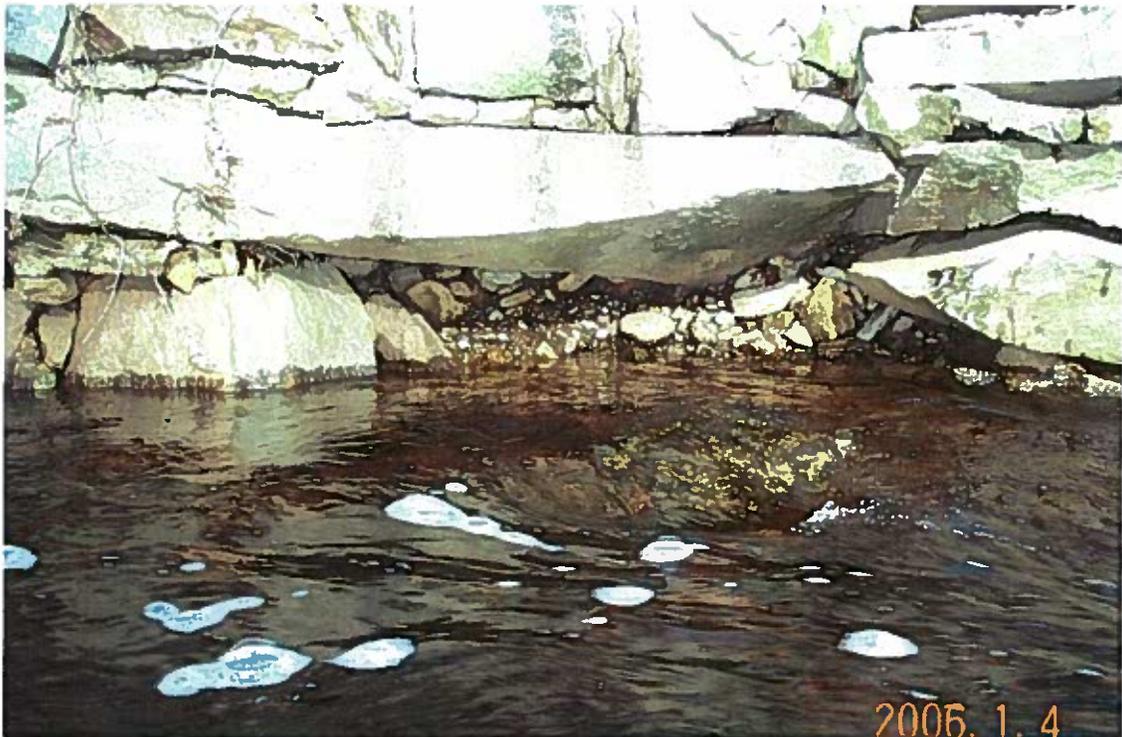
**Photo 6: Void at the base of the Northeast wingwall.**

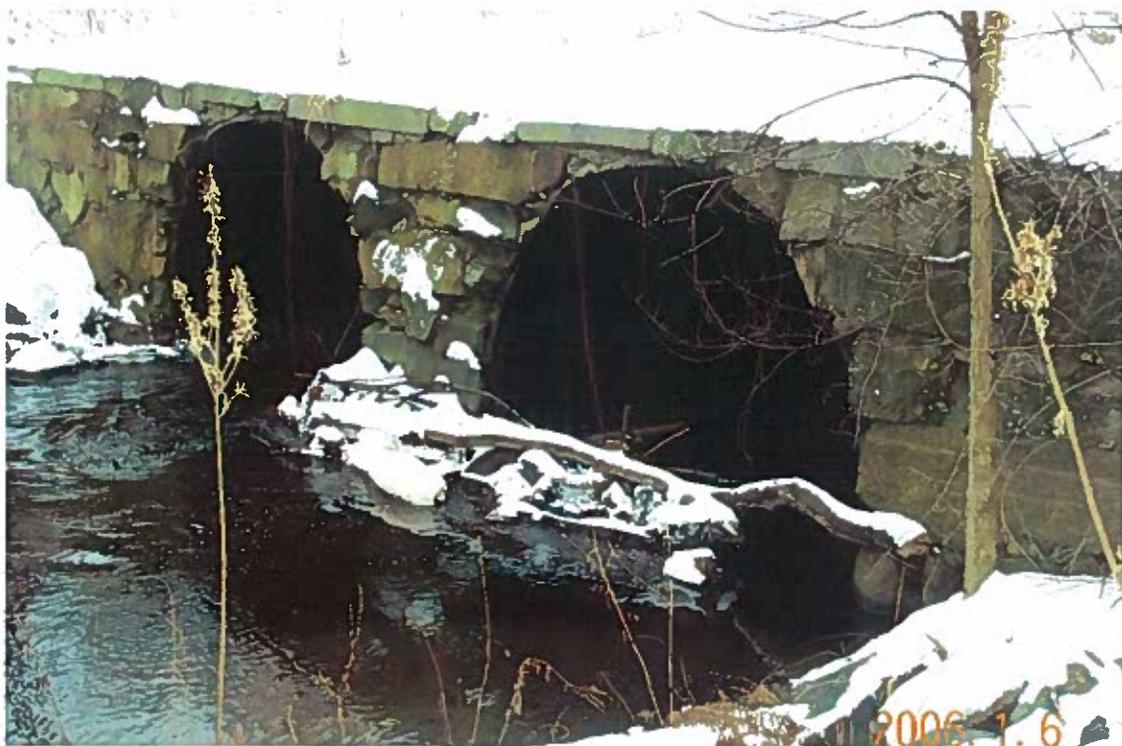
**Photo 2: Debris at upstream side of W culvert barrel.**

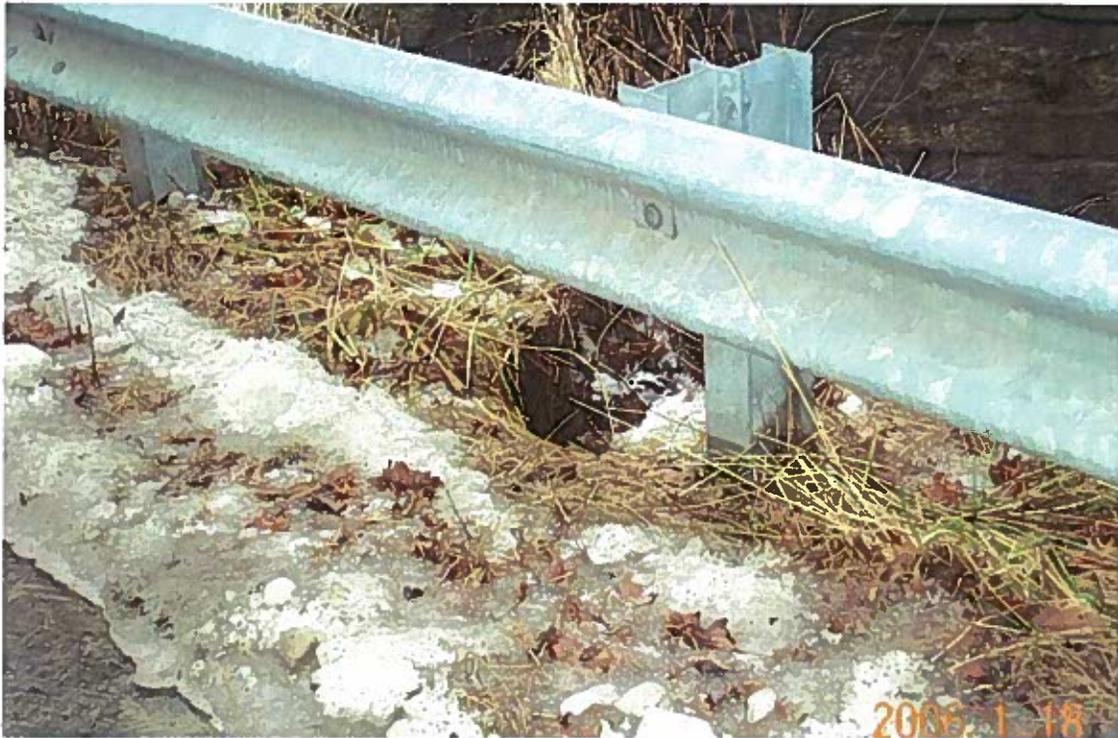
**Photo 3: Sinkhole above barrel #2. South end.**

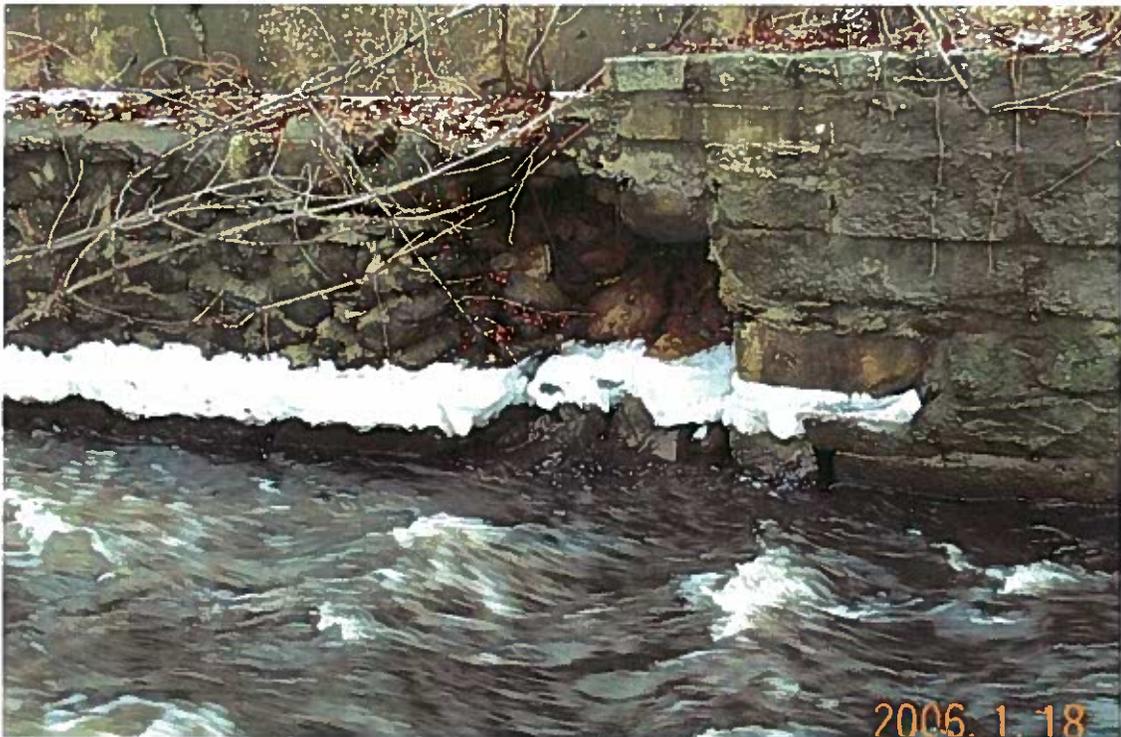
**Photo 4: Collapse to the Southwest channel wall.**

Repairs are needed to the channel walls downstream from the bridge. As previously mentioned, these walls may be beyond the Town's Right of Way (owned by others.) Therefore, there may be a question as to whether the Town is responsible for maintenance of these walls.

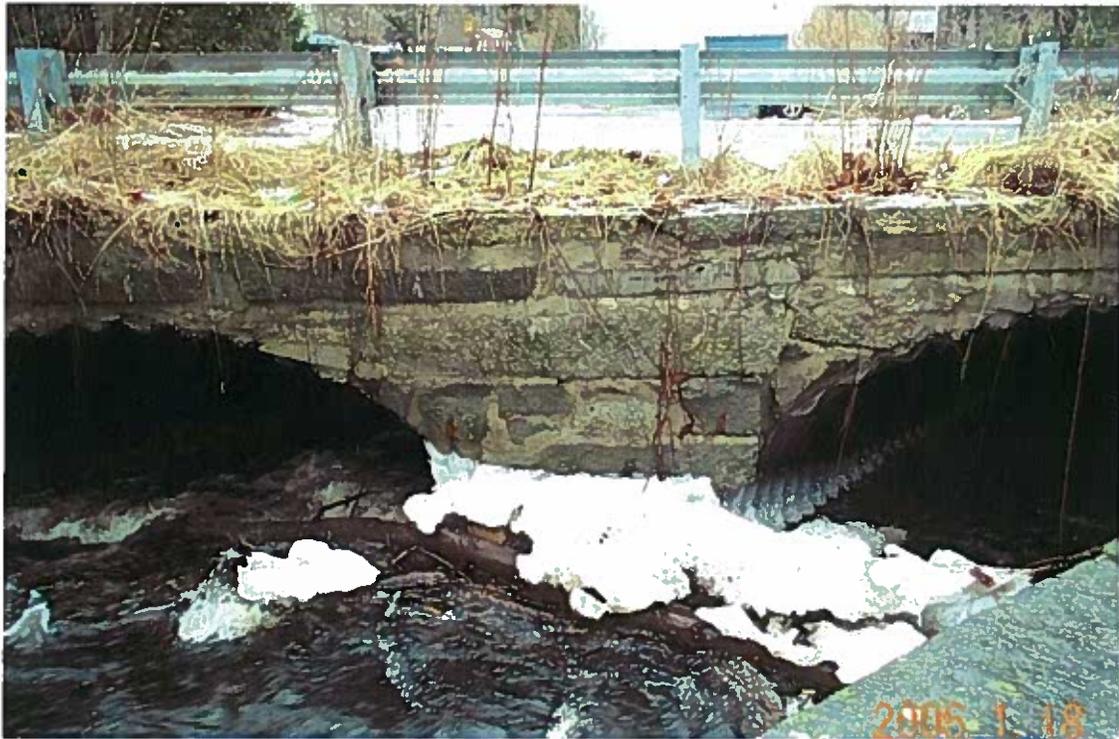
**Photo 5: Debris across both barrels at the upstream end.**

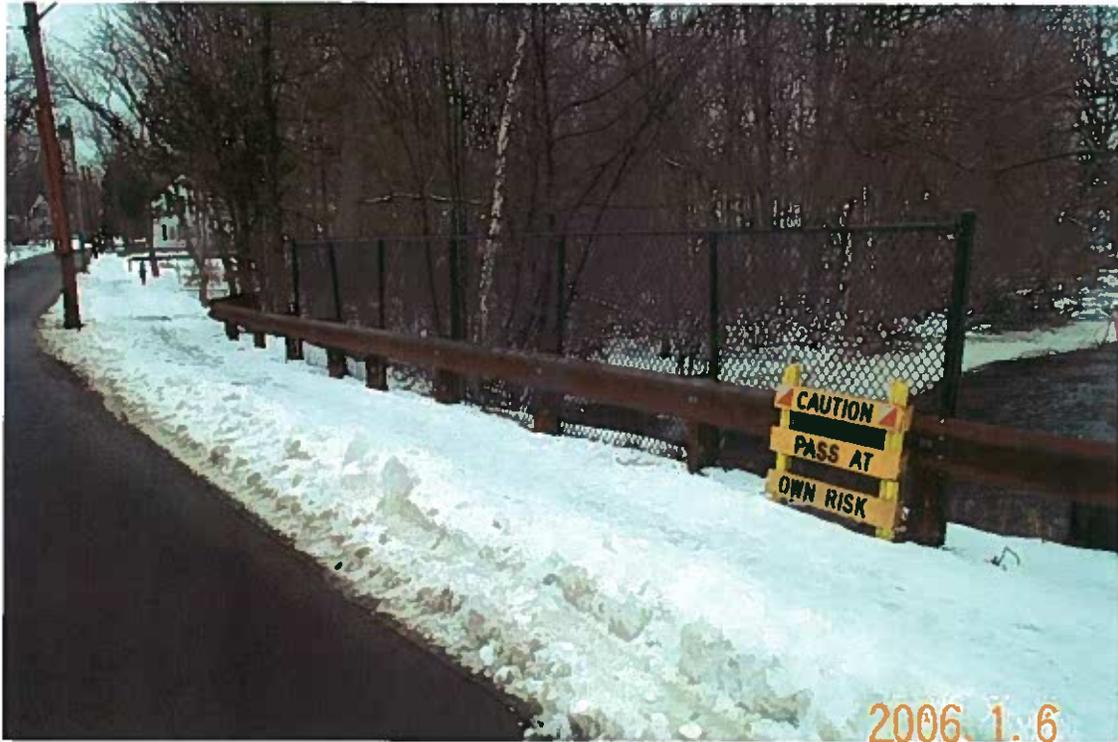
**Photo 1: Chain link pedestrian barricade at E side of culvert (sidewalk side)**
